# NATIONAL TRANSPORTATION SAFETY BOARD

## AIRCRAFT ACCIDENT REPORT

WESTERN HELICOPTERS, INC.  
BELL UH-1B, N87701  
VALENCIA, CALIFORNIA  
JULY 23, 1982

NTSB/AAR-84/02 → SUPERSEDED BY AAR 84-14

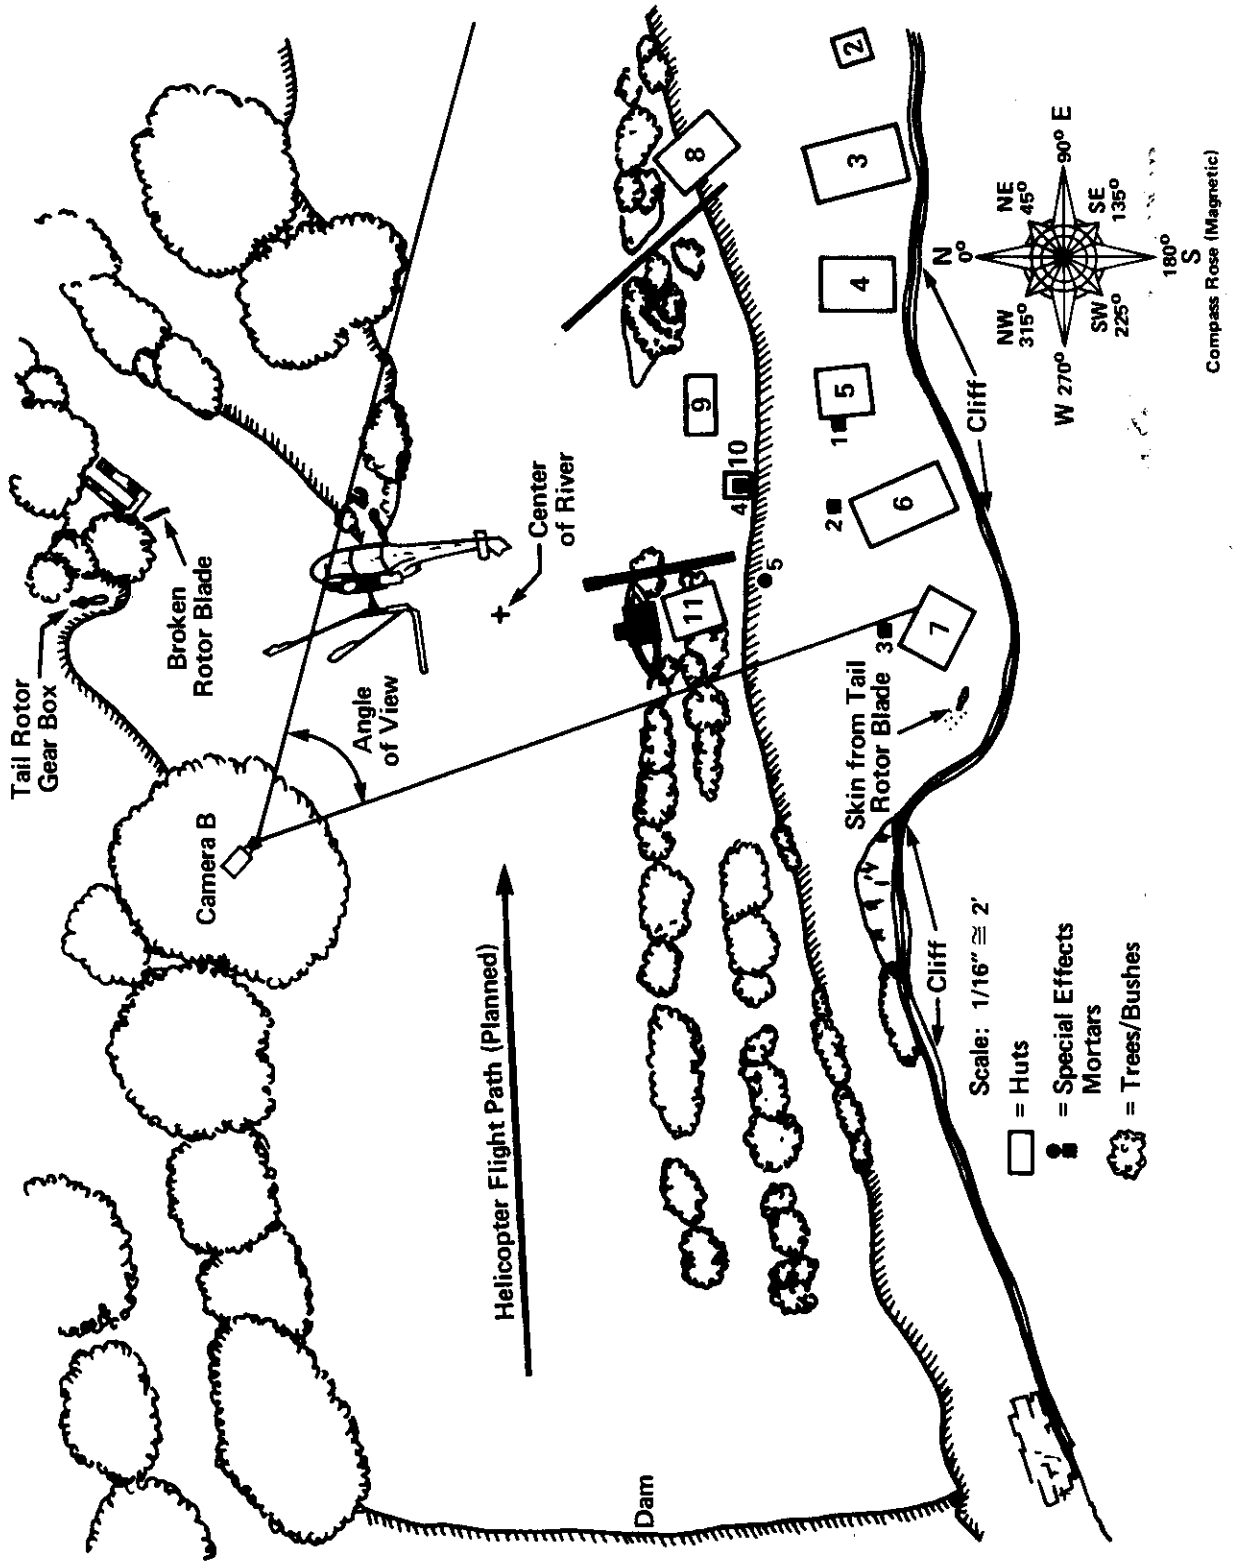
Figure 1.--Accident site.

Three filming sessions were scheduled at the movie set on July 22 and 23. (See figure 1.) About 2100 P.d.t, <sup>1/</sup> the helicopter departed the takeoff/landing area for the first filming session and proceeded about 600 feet east to the movie set. The helicopter was used as a camera platform during this session, hovering above the set while the ground scene was filmed. The special effects devices were detonated to simulate the ordnance as specified in the script. When the scene was completed, the helicopter returned to the takeoff/landing area.

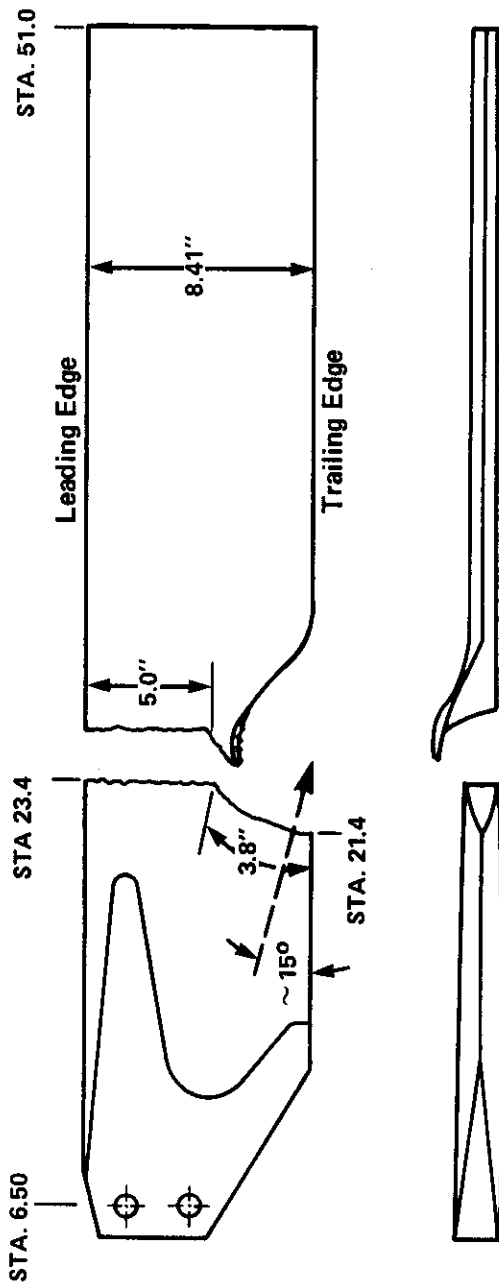
Figure 2.—Blade damage.

The tail rotor 90° gearbox, with one intact blade and the butt portion of the other blade attached to the hub assembly, was found about 41 feet north of the main wreckage. Tail rotor blade, serial No. A3-84197, had separated 18 1/4 inches outboard of its butt end. The outboard portion of the blade was found about 21 feet southwest of the tail rotor 90° gearbox. The broken tail rotor blade exhibited a semicircular indentation about 3 1/2 inches deep on its trailing edge; the indentation spanned the fracture line in the blade. (See figure 2.) The left side of the blade had two rectangular punctures just aft of its leading edge. Foreign particles were found on both fracture surfaces of the blade. Tail rotor blade serial No. A3-84164 remained attached to the hub assembly. About 33 1/4 inches of the blade skin was missing; the skin was found behind hut No. 7. (See figure 1.) Visual examination of the skin disclosed extensive curling at the butt end and extensive heat damage. Also, particles of a rubbery substance with wood embedded were found on the right side of the skin.

A foreign object impacted the tail rotor blade trailing edge approximately 18.25 to 22.3 inches (463.55 - 566.42 mm) from the butt end. The impact of the foreign object deformed the aft 4 inches of the tail rotor blade trailing edge at station 25. This deformation created an out-of-track condition of the tail rotor blade that may have resulted in the separation of the 90° gearbox and blades from the aircraft.

The separated portion of the one tail rotor blade was found 21 feet away from the tail rotor gearbox to which the blade hub with the mating fracture surface was still attached. This evidence indicates that the fracture occurred during flight. A matching semicircular indentation existed on the trailing edges of both portions of the fractured tail rotor blade. The matching indentations are conclusive evidence that the blade was struck by an object before the blade fractured and that the fracture was precipitated by the damage inflicted by the object.

The Safety Board believes that the condition of the full tail rotor blade that remained attached to the rotor hub further illustrates the hazardous conditions to which the helicopter was exposed. The skin of part of this blade had separated from internal structure because the bonding had been exposed to high temperatures from the special effects explosions. However, the skin probably separated after the fracture of the other blade, and therefore, was not a significant factor in the loss of the tail rotor assembly.
