# Shift in the natural frequencies of the deck of Bangabandhu Jamuna bridge due to CFRP strengthening

A.F.M.S. Amin, M.M. Islam, N. Fuad, M.S.I. Choudhury, A. Hasnat & K.M. Amanat  
*Bangladesh University of Engineering & Technology, Dhaka, Bangladesh*

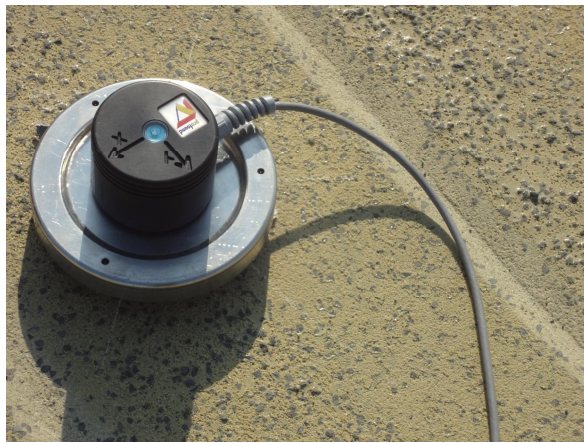
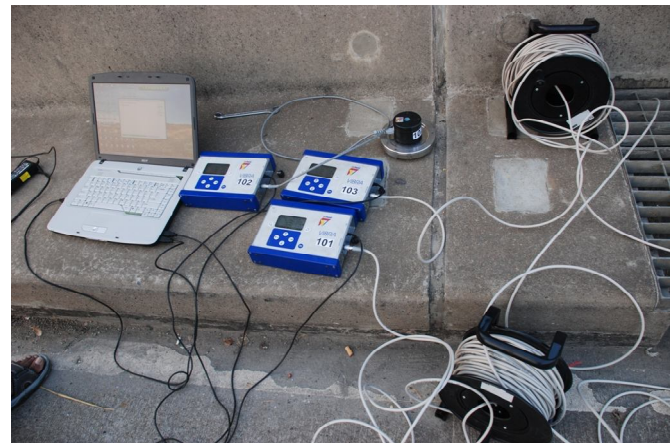
Figure 4. Field campaign for vibration measurement (a) Sensors installed on the deck before placing the stone mastic asphalt. (b) Data collection arrangement

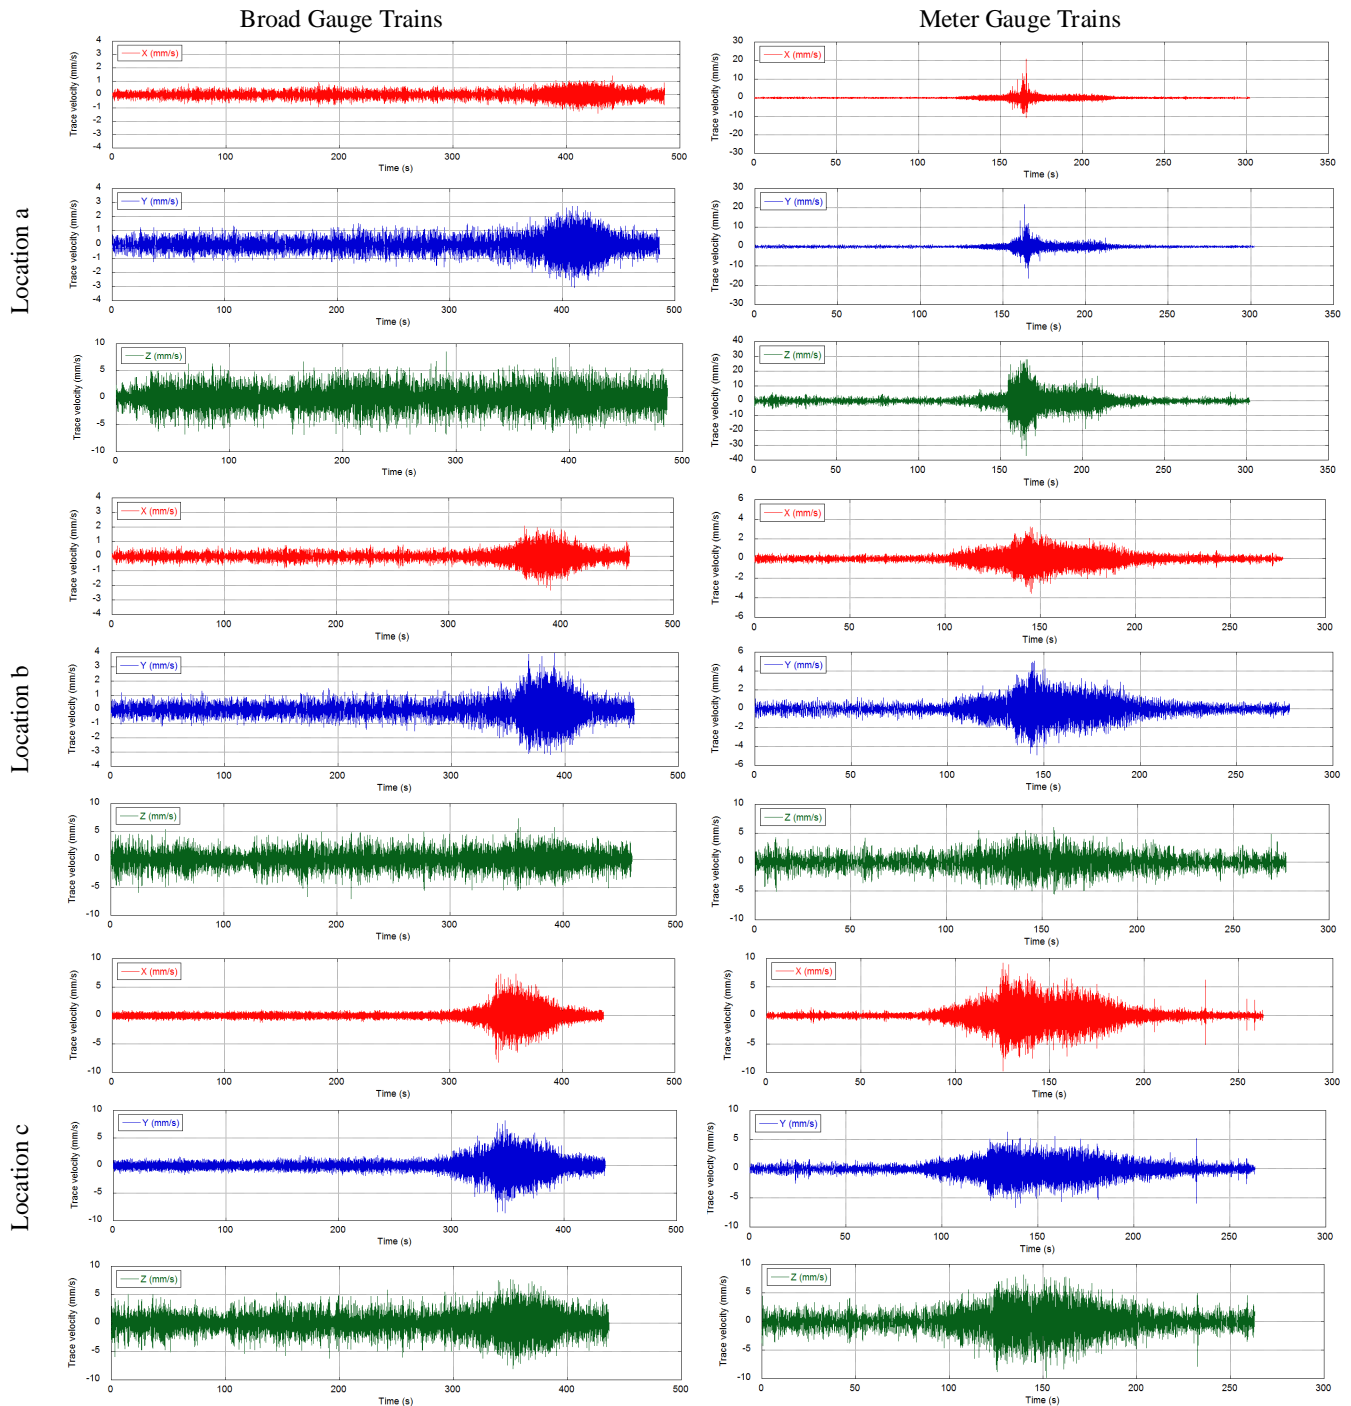
Figure 5 presents the comparison for x, y and z axes measurements. A trace data clearly shows significantly larger vibration in all measurement locations and all axes for the meter gauge trains. The broad gauge trains, although have larger static wheel loads, induces smaller vibration amplitudes due to greater stability achieved from wider axels.

Figure 5. Typical vibration records for broad gauge and meter gauge trains at mid-span locations (Measurement Section 3, Figures 1-3)

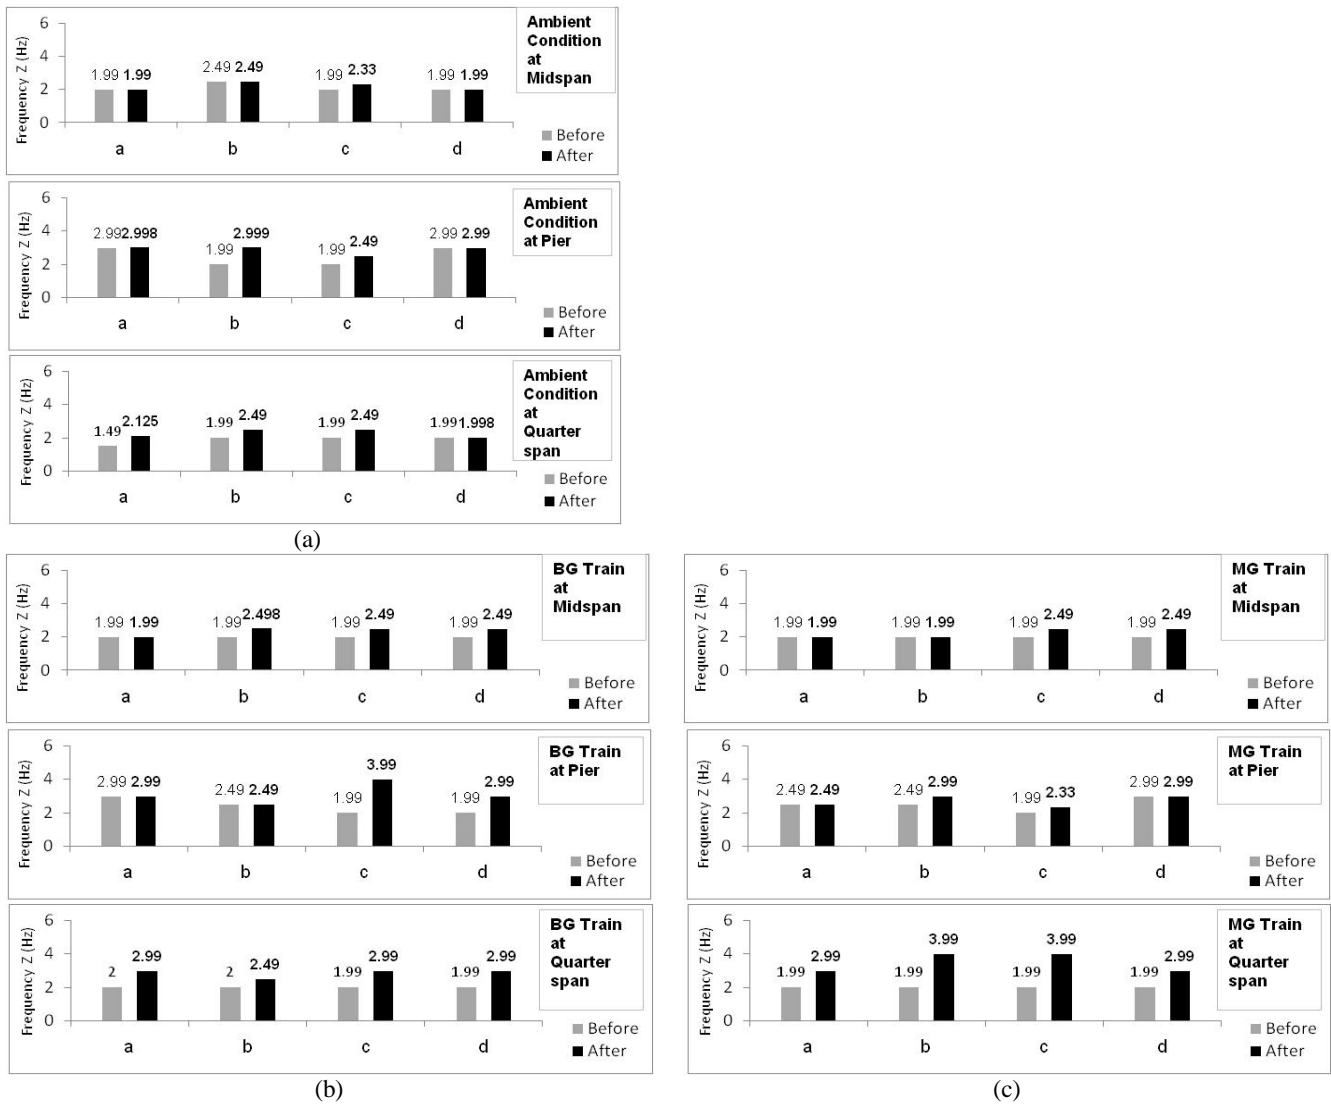
A preliminary evaluation of the fundamental natural frequencies at each of the locations for Z-direction is compared in Figure 6 by analyzing the measurements taken before (bare and cracked concrete) and after strengthening conditions. The measurements taken due to excitation from ambient vibration are compared with those due to broad gauge and meter gauge trains. At present, a train takes about 20 to 30 min to cross a bridge.

Therefore, to exclude the forced vibration situation from train movement, the excitation data after the passage of train was considered for analysis. However, even in such situation, the disturbance from traffic plying over the down stream lanes could not be excluded. However, all ambient vibration data were taken when all traffic over the bridge was closed for a brief period and restricted at least 1 km away from the measurement location (Figure 1) on both sides of the bridge. Within all these limitations, a comparative assessment of pre-repair and post-repair vibration measurements shows a significant increase in deck stiffness, particularly at the mid-span (Location c) and downstream cantilever (Location d). This indicates the cure of crack propagation and substantial strengthening of the deck which was one of the leading objectives of the work undertaken by the Bangladesh Bridge Authority.

Figure 6. Fundamental natural frequencies obtained from field vibration measurements. (a) Ambient condition, (b) Excitation due to broad gauge train, (c) Excitation due to meter gauge train
