TELEDYNE CONTINENTAL [®] **AIRCRAFT ENGINE**

MANDATORY SERVICE BULLETIN

MSB94-4G FAA APPROVED SUPERSEDES MSB94-4F

SUBJECT: STARTER ADAPTER SHAFTGEAR AND CRANKSHAFT GEAR INSPECTION

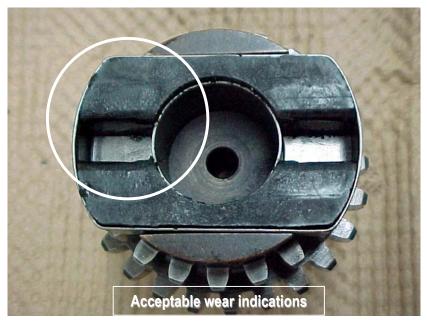
FIGURE 1. MAGNETO DRIVE RUBBER BUSHINGS

- 6. Remove the left and right magneto drive gear assemblies.
- 7. Inspect the left and right magneto drive rubber bushings for damage. Refer to Figure 1 on page 3 for typical wear signatures.

If there is visible damage to the magneto rubber drive bushings, proceed with step number 8.

Replace the magneto drive rubber bushings with new bushings. Insure that the rubber bushings are installed with the beveled edge facing out. Lubricate the magneto drive gear needle bearing with Molyshield Grease, TCM P/N 656817, and reinstall the left and right magneto drive gear assemblies and magnetos in the reverse order of removal. Time the magnetos to the engine in accordance with the instructions detailed in the latest revision of TCM Mandatory Service Bulletin MSB94-8. Torque attaching hardware to the value specified in the latest revision of TCM Service Bulletin SB96-7.

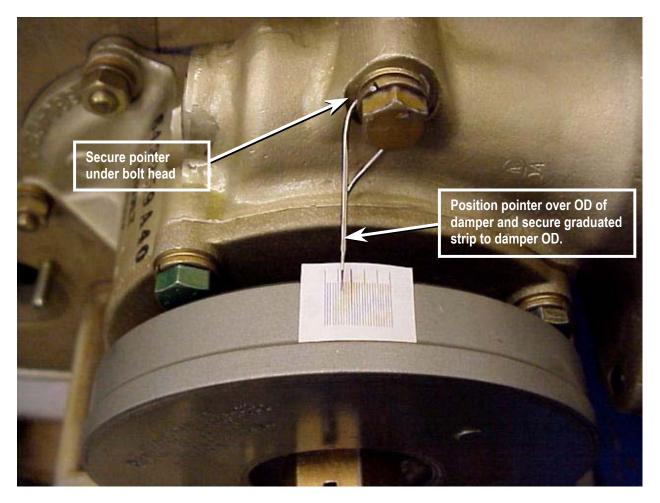
FIGURE 4. DAMPER SHAFT BACKLASH MEASUREMENT

- 11. If none of the four measurements exceeded .06 inches, proceed to step 13.
- 12. If any of the four measurements exceed .06 inches, remove the starter adapter and perform the inspection specified in Part 3, "VISUAL INSPECTION PROCEDURE" section of this bulletin.

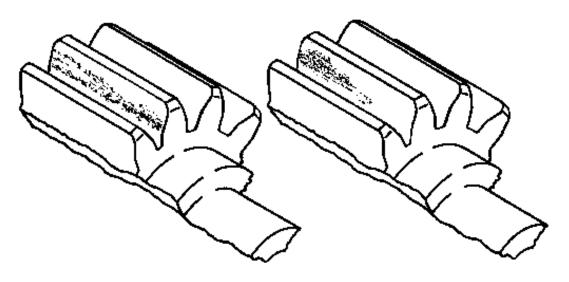
FIGURE 6

UNACCEPTABLE HEAVY WEAR, SPALLING AND PITTING FULL TOOTH WIDTH UNACCEPTABLE HEAVY WEAR, SPALLING AND PITTING PARTIAL WIDTH

The crankshaft gear, starter adapter assembly and viscous damper must be replaced at the same time if the tooth wear of either gear is unacceptable in accordance with this bulletin.

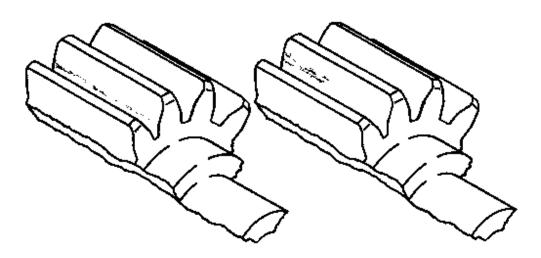
FIGURE 7

8. If the condition of the crankshaft gear and starter adapter shaft gear teeth are acceptable, as indicated in Figure 7 on page 9, they may be continued in service. Comply with the recurring inspections listed in the "COMPLIANCE" section of this bulletin.

ACCEPTABLE LIGHT WEAR LINE, FULL TOOTH WIDTH UP TO .01 INCH WIDE ACCEPTABLE MODERATE WEAR LINE, NO MORE THAN 50% TOOTH LENGTH AND .05 INCH WIDE
