# National Transportation Safety Board Aviation Accident Final Report

<b>Location:</b>	Las Vegas, NV	<b>Accident Number:</b>	DCA15FA185
<b>Date &amp; Time:</b>	09/08/2015, 1613 PDT	<b>Registration:</b>	G-VIIO
<b>Aircraft:</b>	BOEING COMPANY BOEING 777-236	<b>Aircraft Damage:</b>	Substantial
<b>Defining Event:</b>	Uncontained engine failure	<b>Injuries:</b>	1 Serious, 19 Minor, 150 None
<b>Flight Conducted Under:</b>	Part 129: Foreign

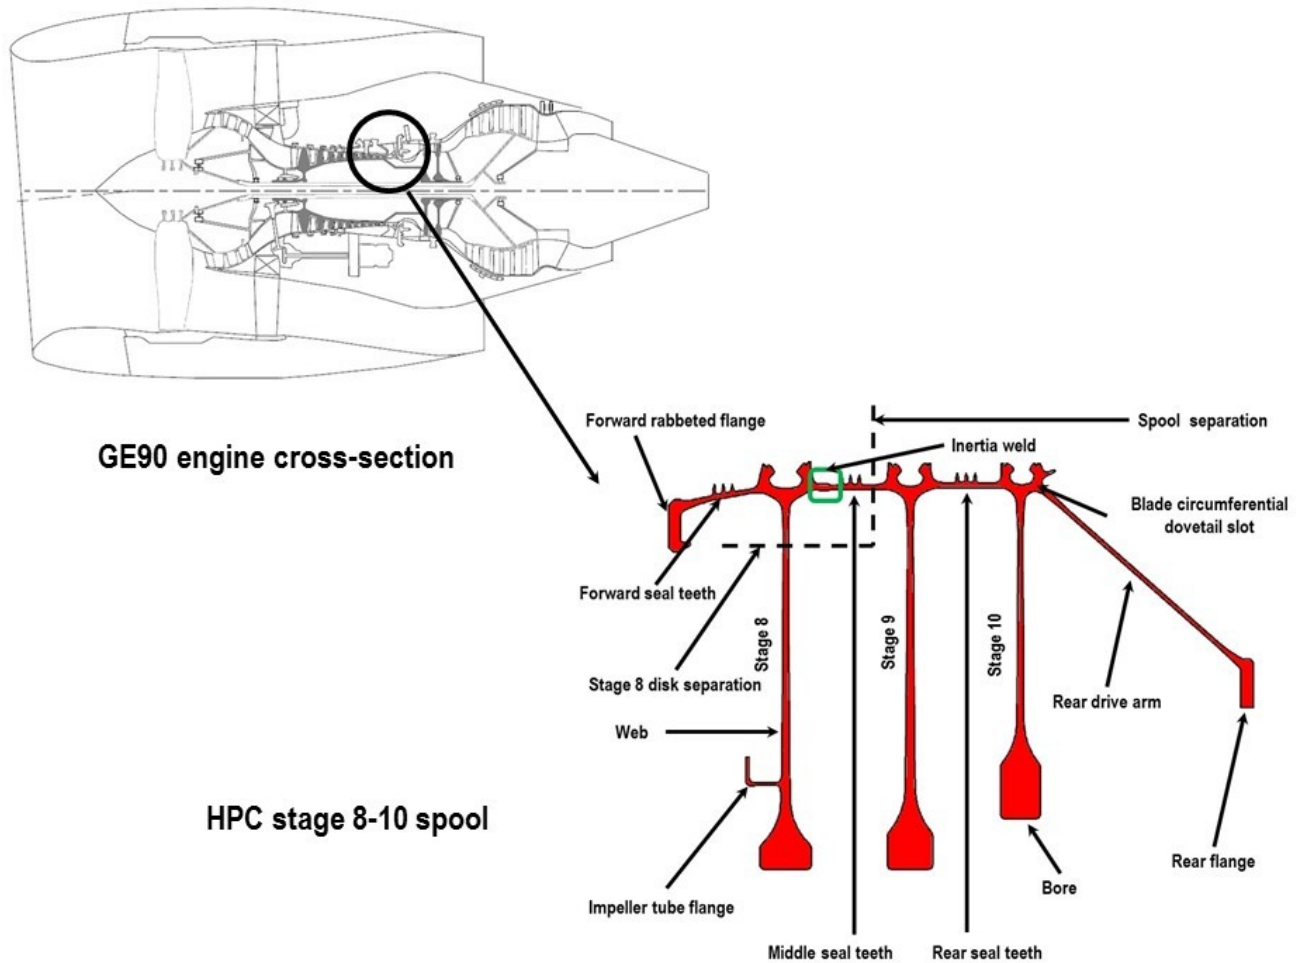
On-scene examination of the left engine revealed that the HPC aft extension case was breached from about the 11:30 to the 5:00 position (58 inches circumferentially), exposing the internal HPC parts. The examination also found that the HPC stage 8-10 spool separated aft of the middle seal teeth between the stage 8 and 9 disks and that the stage 8 disk separated below the circumferential blade slot, as shown in figure 1. Other noteworthy damage included the following:

Figure 1: GE90 engine cross-section with the locations of the HPC stage 8-10 spool separation and stage 8 disk separation.

Disassembly of the engine was performed at GE's facility in Evendale, Ohio. The HPC aft extension case was cut to access the HPC stage 8-10 spool. The HPC stage 8 disk was fully detached from the stage 7 and 9 disks and was fractured about 200° circumferentially at the transition radius of the web to the blade circumferential dovetail slot rim. About 37 inches of the dovetail slot rim remained attached to the stage 8 disk. The impeller tube assembly was fractured and detached from the front side of the stage 8 disk, and the impeller tubes were fractured, splayed open, or mostly intact. Most, but not all, of the stage 8 disk forward rabbeted flange had fractured from the stage 8 disk and remained attached to the stage 7 disk. The rear drive arm of the HPC stage 8-10 spool was fractured and had fully separated near the compressor discharge pressure seal land.

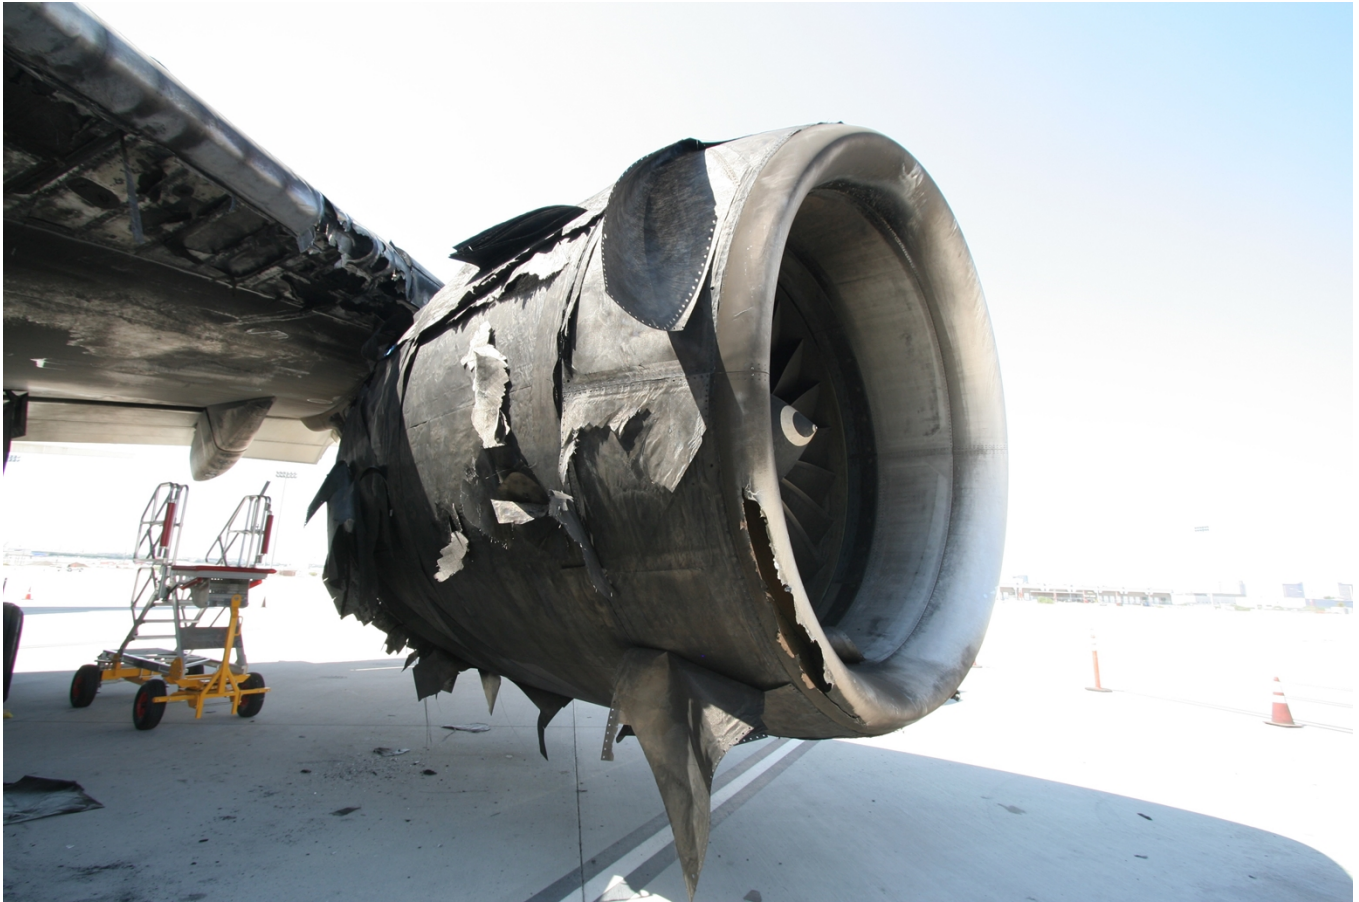
Thermal damage on the exterior of the airplane was concentrated along its midsection, from the left engine to the right side of the fuselage. On the left engine, the cowling was thermally damaged from the 4:00 to 12:00 positions (as viewed from the front of the engine). The thermal damage between the 6:00 and 12:00 positions (the inboard side of the left engine, as shown in figure 2) caused the composite cowling to delaminate and the aluminum leading edge of the cowling to partially melt along the 7:00 to 8:00 positions. The interior of the left engine had soot on some surfaces but no significant thermal degradation to the components.

Figure 2. Inboard side of left engine

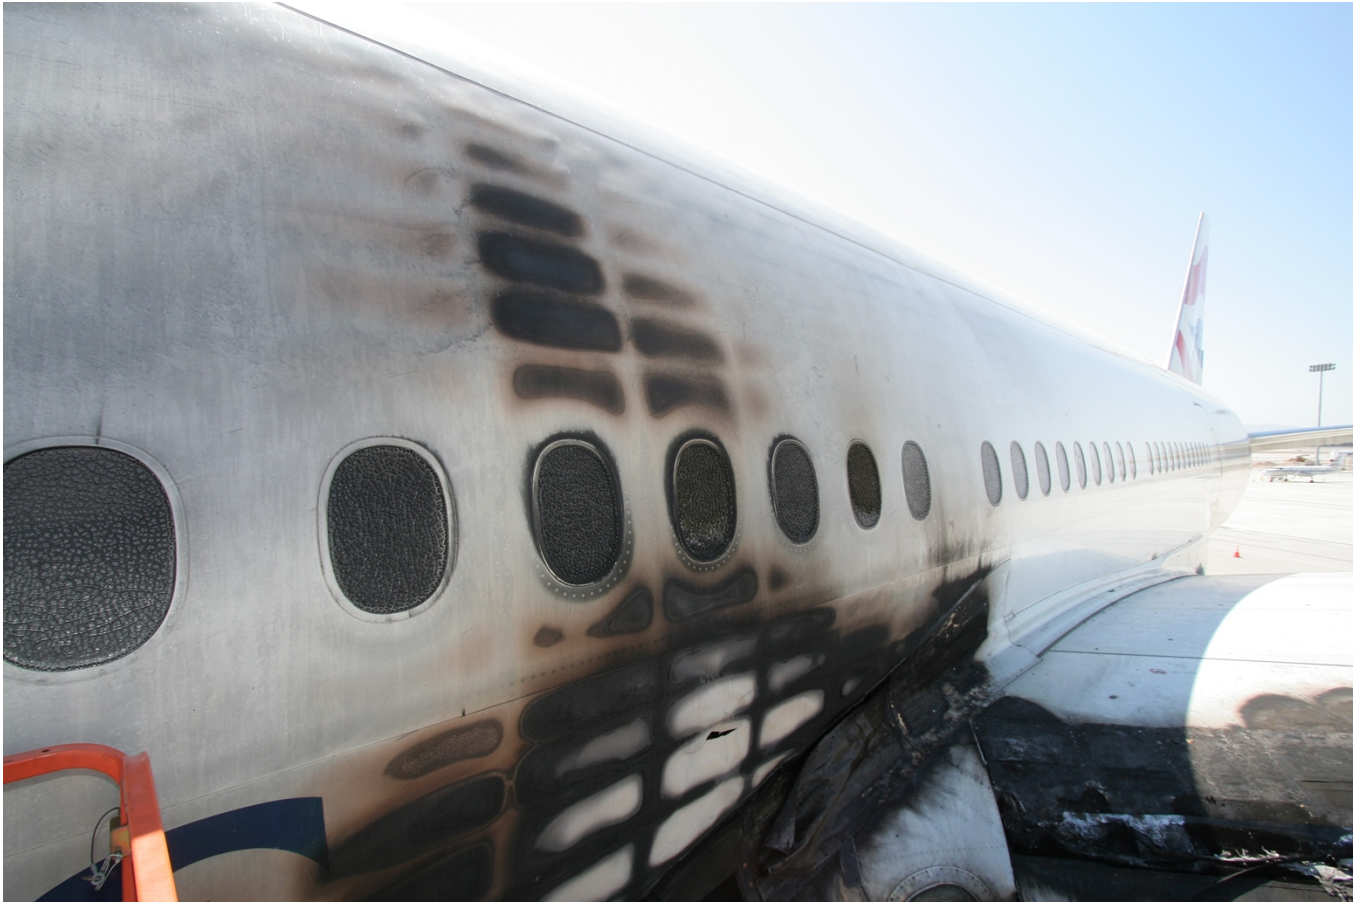
The left-side fuselage skin exhibited thermal damage (missing and charred paint) from just aft of the 2L door to just past the wing leading edge, and the center of this thermally damaged area exhibited buckling and cracks in the skin, the longest of which was about 12 inches. The cracks in the skin coincided with the area of most severe thermal damage to the wall panels in the interior of the airplane. There were 13 thermally crazed windows on the fuselage that extended from the 2L door to about mid-span of the wing, as shown in figure 3.

Figure 3. Thermally damaged fuselage skin and thermally crazed windows

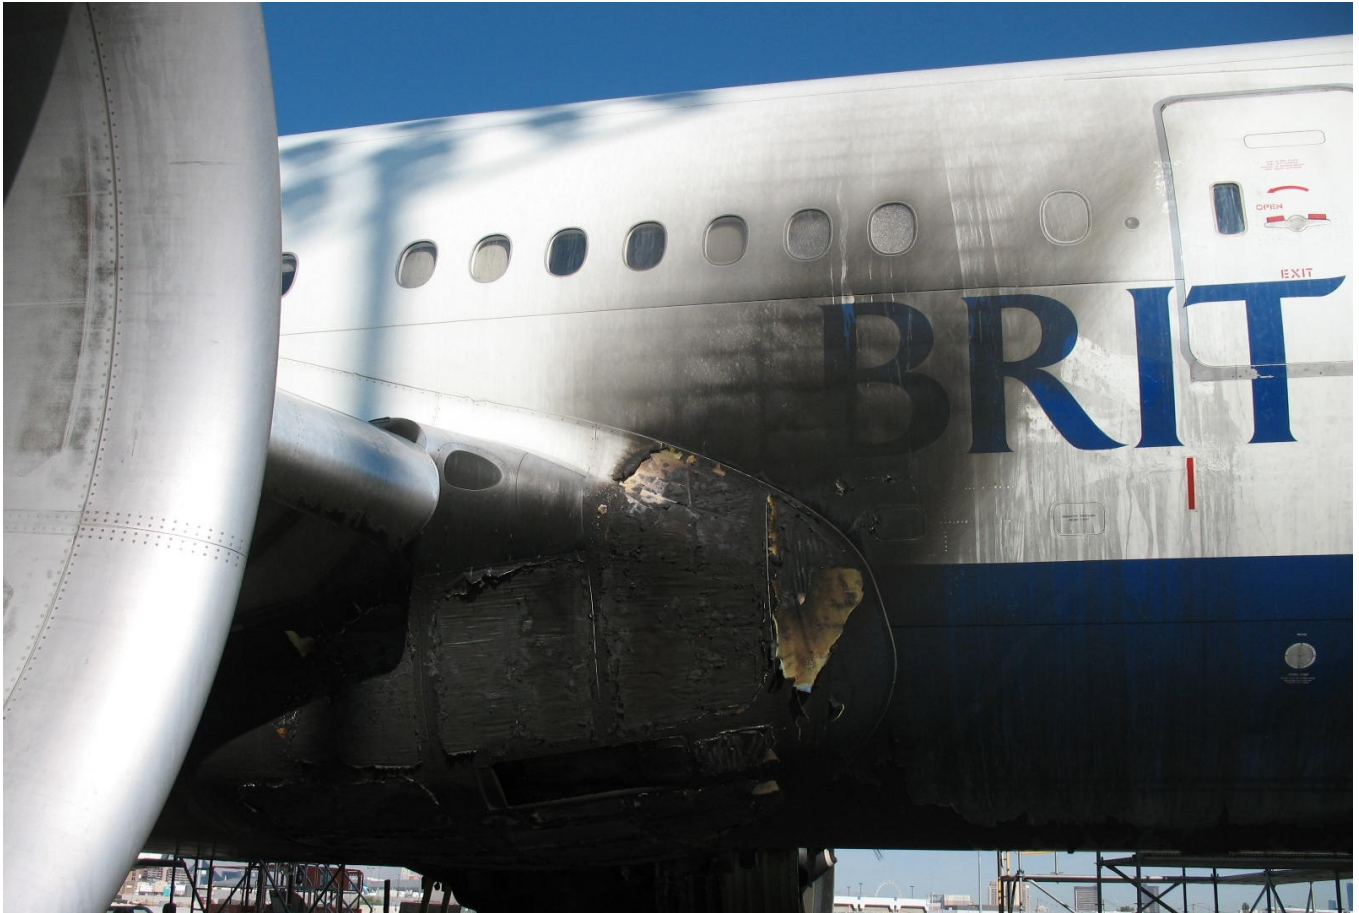
Soot appeared on the right-side fuselage above the wing-to-body fairing, as shown in figure 4. Buckling that created a tactile waviness to the aluminum skin was found in the area. Two of the windows above this area exhibited thermal crazing.

Figure 4. Soot and thermal damage to the right-side fuselage

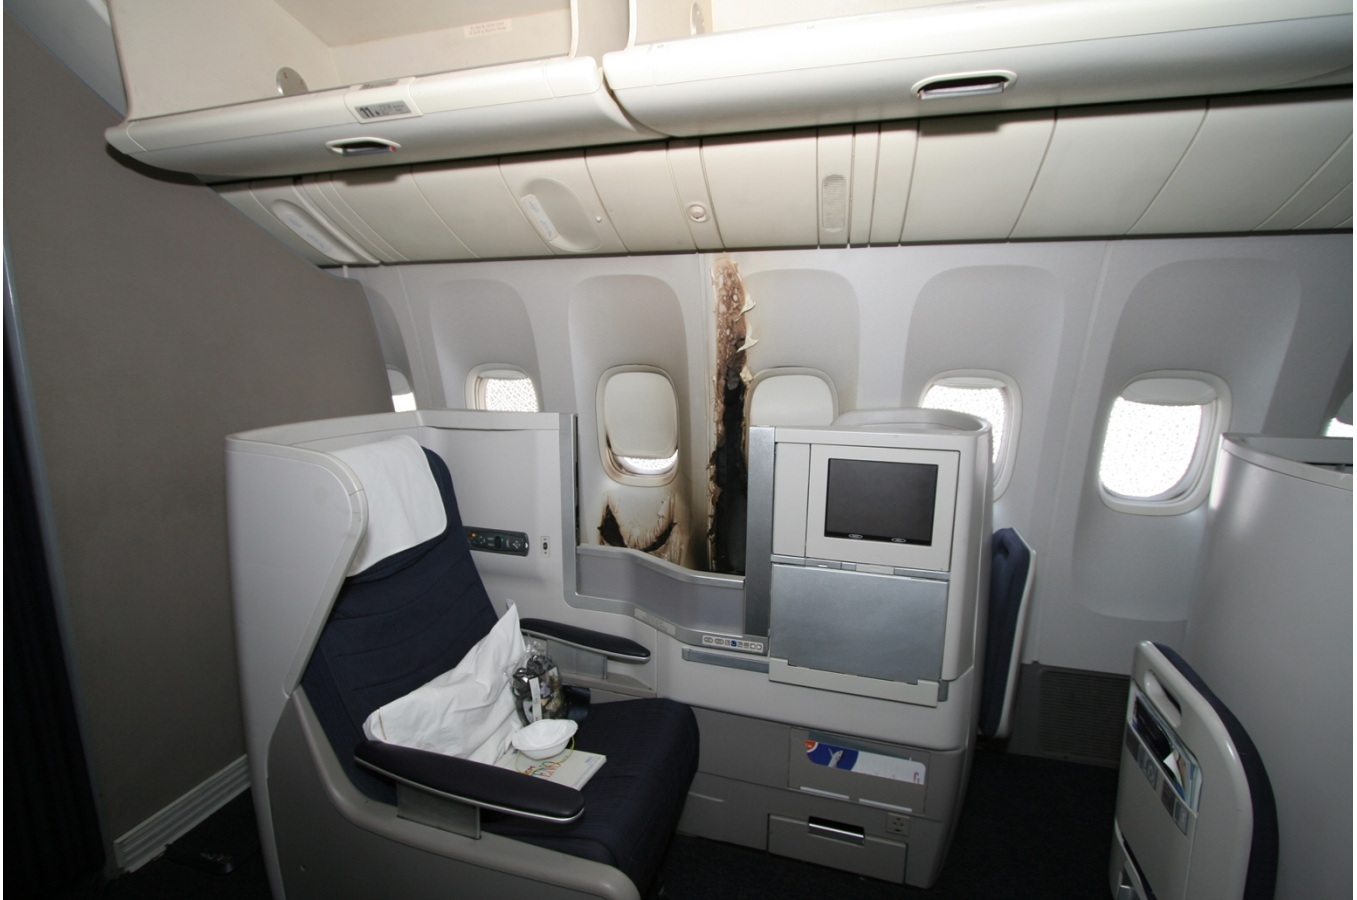
Thermal damage to the interior cabin was confined to the wall panels at the location of seat 11A, as shown in figure 5. The thermal damage consisted of blistering and charring on the wall panels; no soot was observed on any adjacent surfaces. The damage was consistent with thermal decomposition and charring and not flaming combustion on the inboard surfaces of the damaged panels.

Figure 5. Cabin interior at seat row 11

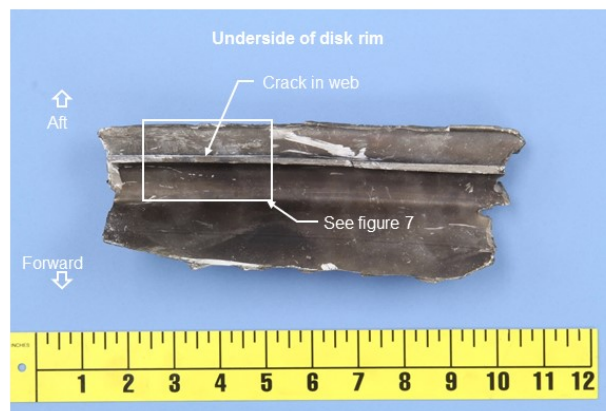
The fracture surfaces of the fragments were examined to determine where the engine failure initiated. The web of one of the stage 8 disk rim fragments had a feature, located about 0.90 inch inboard of the blade slot bottom at the thinnest (about 0.12 inch) part of the web, that

indicated the presence of a tinted/discolored flat fracture region. This region was about 0.63 inch wide in the circumferential direction and extended from the aft face of the web to within 0.004 inch of the forward face of the web. The orientation of the fracture region was consistent with a crack initiating on the aft face of the web, and the tinted appearance was consistent with high-temperature oxidation of the fracture surface. Figure 6 shows the underside of the disk rim and the location of the crack. The flat fracture region transitioned to a 45°-inclined tinted/discolored region that was consistent with cyclic tensile loading. The region with cyclic tensile loading extended circumferentially from both sides of the flat fracture region over a total length of about 1.7 inches, after which the appearance of the fracture surface was consistent with tensile overstress.

Figure 6. Location of crack in HPC stage 8 disk web

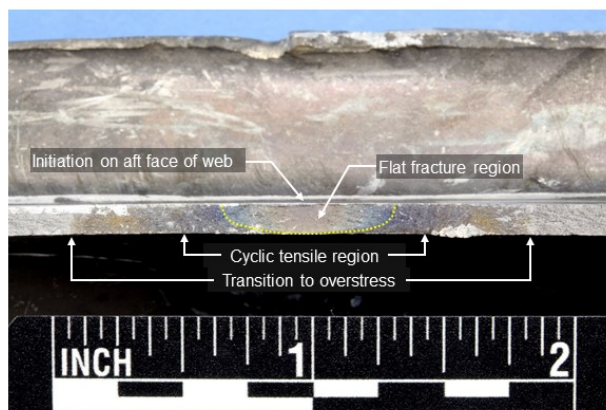
Examination of the flat fracture region using a scanning electron microscope (SEM) showed that the region had an intergranular appearance near the crack initiation site (the aft face of the web) and a transgranular appearance farther away from the initiation site. (The disk material, made from a nickel-based superalloy, had an internal structure that consisted of microscopic crystals called grains. The planar intersection of two grains is called a grain boundary. Cracks that follow grain boundaries are intergranular and cracks that cut across grains are transgranular.) The transgranular regions exhibited striations (linear features on a fatigue fracture surface that indicate how far a crack advanced with each stress cycle) consistent with low-cycle fatigue crack growth. (In airplane engines, low-cycle fatigue is associated with one striation per flight cycle.) Figure 7 shows an image of the underside of the HPC stage 8 disk rim at the location shown in figure 6.

Figure 7. Optical image of underside of HPC stage 8 disk rim
