SERIOUS INCIDENT

Aircraft Type and Registration:	Boeing 737-8K5, G-TAWG	
No & Type of Engines:	2 CFM56-7B27E turbofan engines	
Year of Manufacture:	2012 (Serial no: 37266)	
Date & Time (UTC):	21 July 2020 at 0500 hrs	
Location:	Birmingham Airport	
Type of Flight:	Commercial Air Transport (Passenger)	
Persons on Board:	Crew - 6	Passengers - 187
Injuries:	Crew - None	Passengers - None
Nature of Damage:	None	
Commander's Licence:	Airline Transport Pilot's Licence	
Commander's Age:	41 years	
Commander's Flying Experience:	10,262 hours (of which 2,615 were on type) Last 90 days - 16 hours Last 28 days - 13 hours	
Information Source:	Aircraft Accident Report Form submitted by the pilot and information from the operator

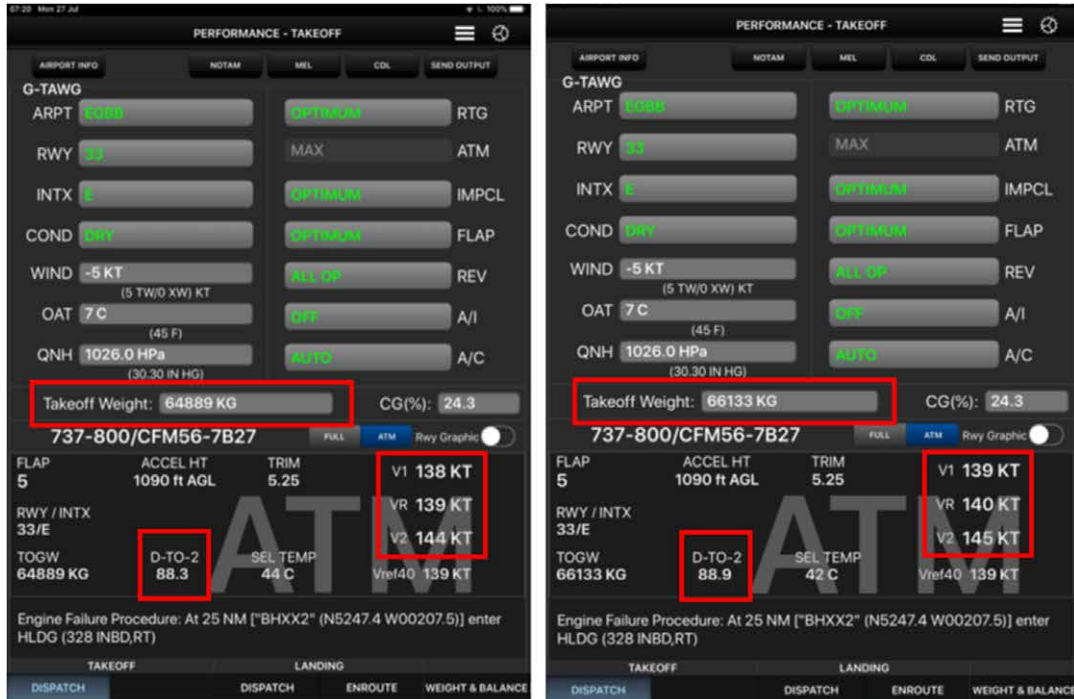
Figure 3

Subsequent use of the actual takeoff weight for performance calculations showed that all departure airspeeds should have been one knot greater than those used on the incident flight, and the thrust required should have been 88.9% N_1 compared to the 88.3% N_1 set on the incident flight. The screen displays from the Boeing OPT are shown in Figure 3, with the incorrect load sheet takeoff weight on the left and the correct takeoff weight on the right. The resulting one knot difference in takeoff speeds (V_1 , V_2 and V_R) can be seen in the bottom right of each screenshot, and the different takeoff thrusts on the bottom left.

A calculation was carried out for the actual TOW and environmental conditions, using a calm wind rather than assuming a 5 knot tailwind. The result showed that a thrust of 88.2% N_1 would have been required to meet regulatory requirements.

Boeing Onboard Planning Tool performance data
