Volume II

Appendix D.13

STS-107 In-Flight Options Assessment

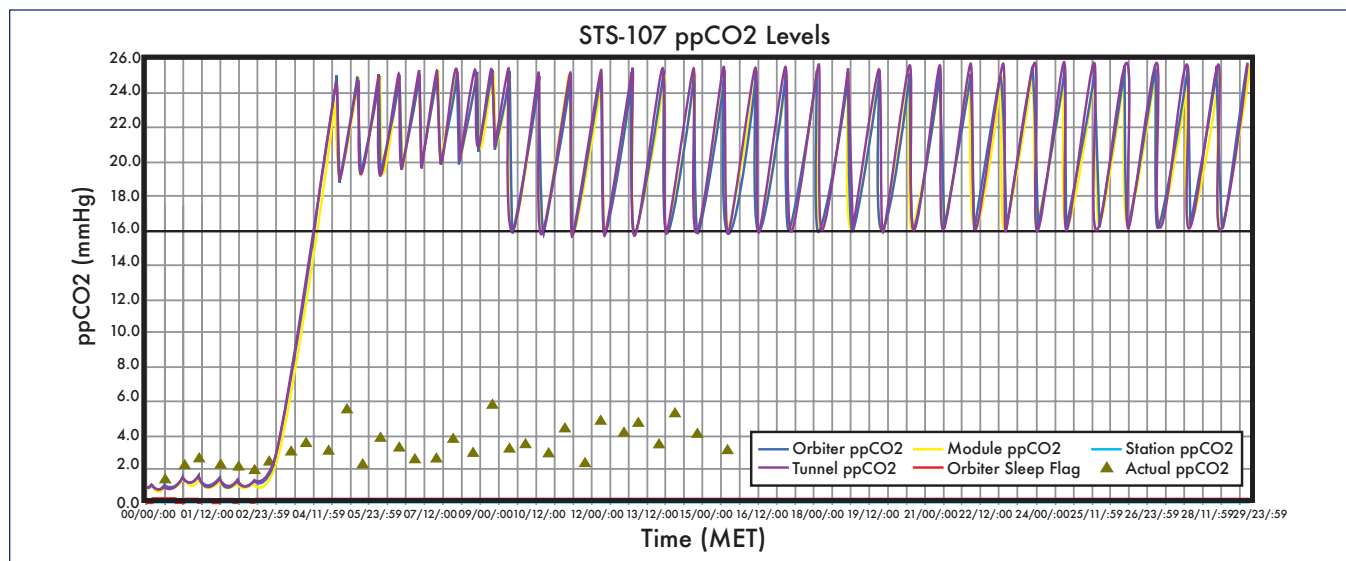
Figure 1. ppCO₂ plot with 8 hours of Crew Sleep.

The plots show the relationship of metabolic rate and LiOH changeout level. If the metabolic rate could be kept to the equivalent of a 12 hour sleep, 12 hour awake rate, the on-board LiOH could be stretched to 30 days Mission Elapsed Time (MET) without violating the 15 mmHg Mission Rule limit. If the crew metabolic rate could not be reduced (by sleep, inactivity, or by medication), accepting the increased limit of 25 mmHg would also provide 30 days of on-orbit lifetime. Thirty days MET is equivalent to the morning of February 15.

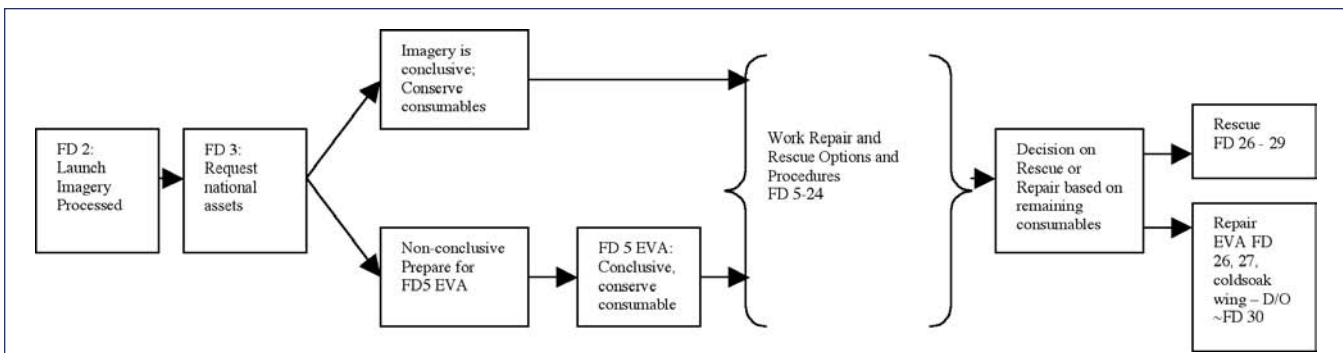
Figure 3. Decision path timeline.

Figure 3 shows the anticipated decision timeline.

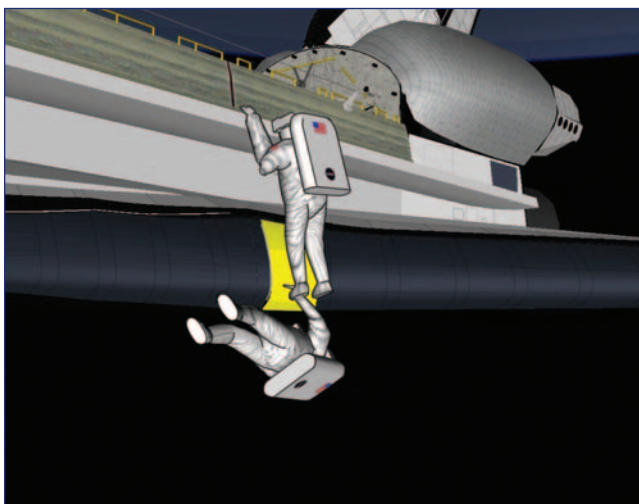
Figure 5. EV-1 position between payload bay door and wing leading edge.

Two experienced EVA astronauts and two EVA flight controllers assessed this task in the Johnson Space Center virtual reality lab. The level of difficulty of the EVA inspection procedure is moderate. The risk of injury to crew is low and of further damage to the site is low to moderate. The expectation of mission success (providing conclusive information regarding damage severity) is judged to be high.

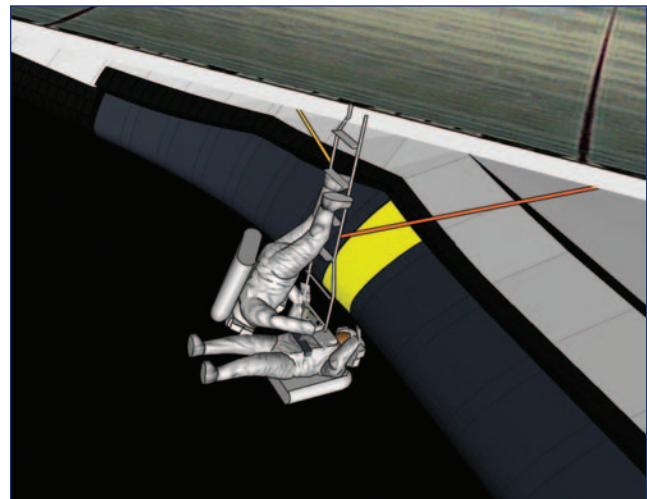
Figure 11. Repair EVA.

The assessment of the level of difficulty of the repair operation is high. The level of risk to the crew is moderate and the risk of doing additional damage to the Orbiter is high (i.e. enlarging the wing leading edge breach). The overall assessment of the expectation of task success is moderate to low, depending on damage site characteristics and the required repair technique.

At the start of the EVA, the EV crew would egress the airlock, retrieve the required EVA tools from the payload bay and translate with the middeck ladder along the port payload bay door. The first activity would be to restrain the middeck ladder at the worksite. The ladder would be inverted with the foam-protected portion against the wing leading edge. The ladder would be secured to the payload bay door using EVA retention devices and would be carefully tensioned to pull the ladder against the wing leading edge. EV1 and 2 would then transfer the repair hardware to the worksite. EV1 would translate down the middeck ladder and, with assistance from EV2, attach the preintegrated MWS to the EMU fittings (thus restraining himself to the ladder near the worksite). EV2 would then help to stabilize EV1 and assist with repair materials and hardware as required.

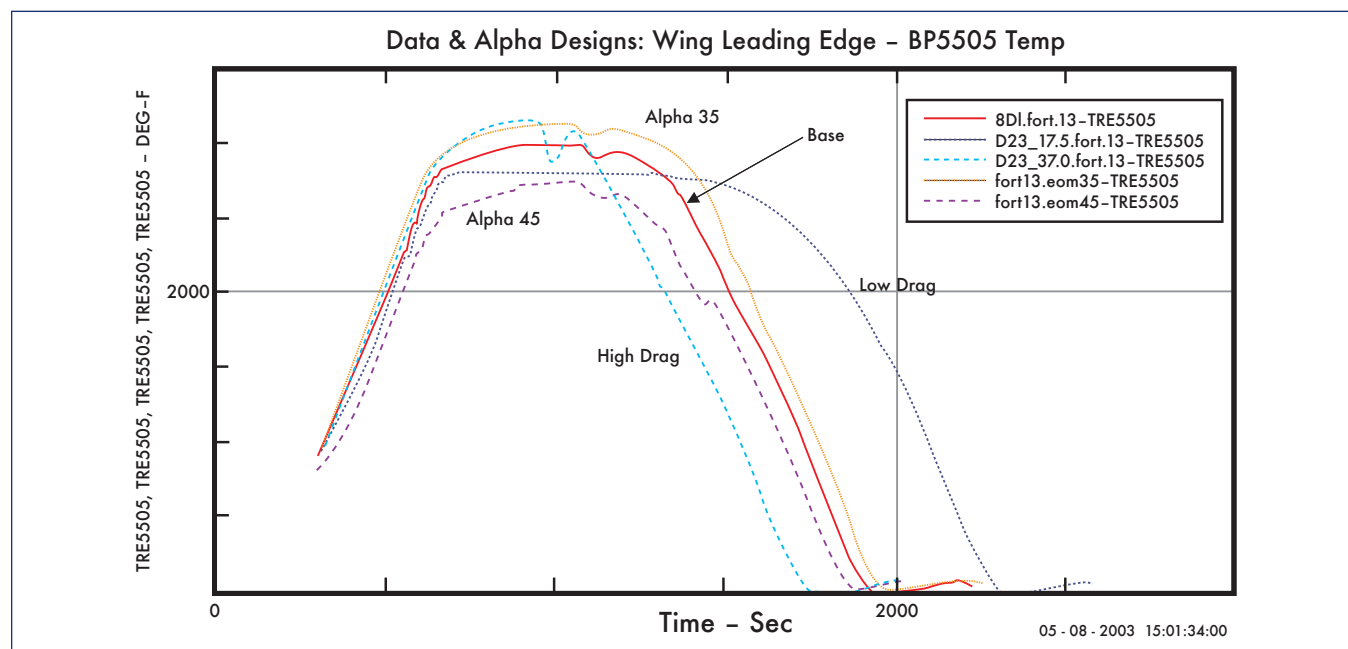
Figure 12. Relative Wing Leading Edge Temperature (No Boundary layer trip).

As previously stated, the team does not believe that an accurate thermal analysis can be performed to determine the effectiveness of any repair option. Rather, this is the best option relative to the other candidates, and it is possible that the combination of the repair, coldsoaking the wing, deorbiting from the minimum perigee, jettisoning available cargo bay hardware, and flying a 45 degree angle of attack could potentially provide enough relief to reach an acceptable bailout altitude. Limited thermal analysis was done on the option,

which assumed a flat plate of metal behind a flat plate of ice, behind a layer of AFRSI. The results while inconclusive, do not indicate this option was likely to succeed. However, the team believes it is sufficient to say that this would have been the best option to try, given the limited time and materials.
