AIRCRAFT ACCIDENT REPORT

UNITED AIRLINES FLIGHT 663
BOEING 727-222, N7647U
DENVER, COLORADO
MAY 31, 1984

NTSB/AAR-85/05

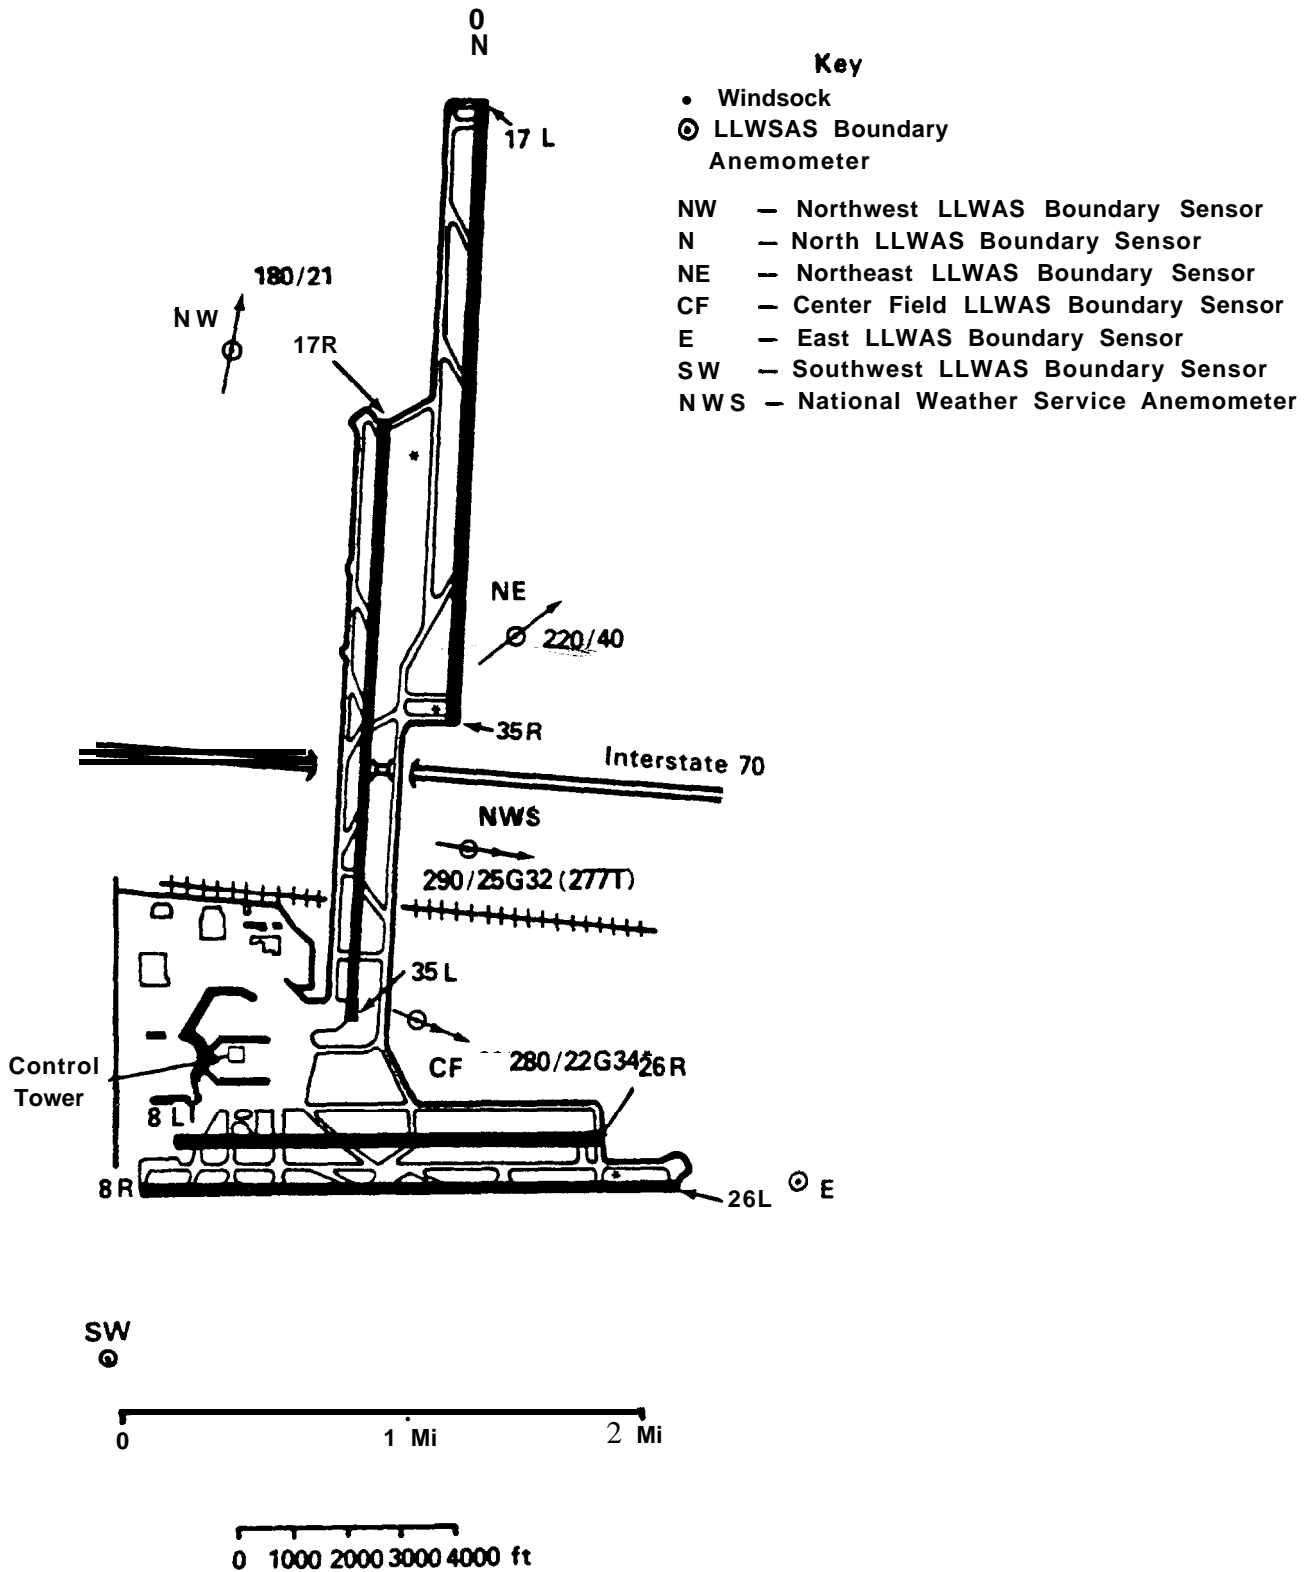
Figure 1.--Partial plan view of Denver Stapleton Airport showing locations of LLWAS boundary sensors and the microburst winds recorded about 1333.

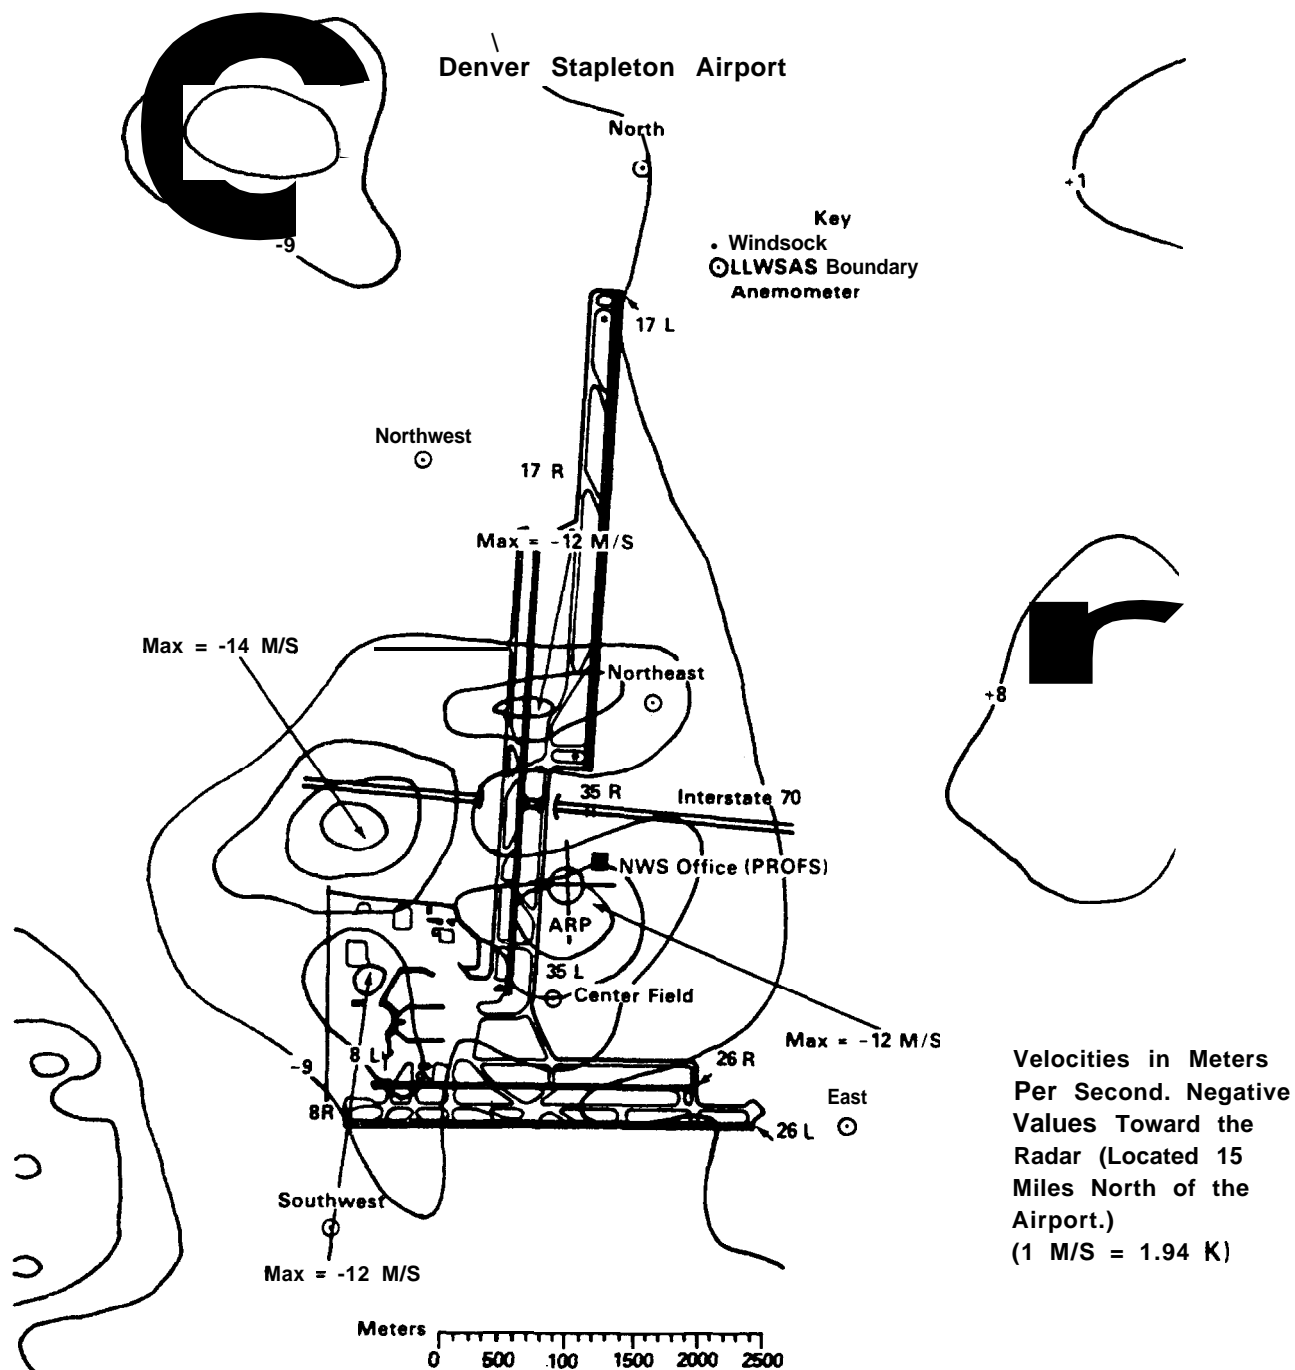
Figure 2.--Radial velocities observed by the NCAR CP-4 doppler radar at 1334.38.

The available weather data showed that "high base" thunderstorm activity had been approaching Stapleton from the southwest. This type of thunderstorm has a base high above the ground, generally **between** 8,000 and 12,000 feet, and a dry adiabatic lapse rate 14/ in the atmosphere below **the** thunderstorms. These high-based thunderstorms are quite common in the summertime over **the** high plains east of the Rocky Mountains and over the desert to the southwest where the combination of very hot dry surface air and mid-level moisture are present. Descending virga were associated with this activity near Stapleton creating downdrafts which spread outward as they reached the ground, causing strong surface gusts. The evidence disclosed that this event was the result of a microburst. Wind shear from a microburst, as compared to wind shear resulting from a gust front, is particularly hazardous because it is a short-period event which creates very strong wind gusts with a large variation in direction over **a** very short distance (1/2 to 2 1/2 miles in diameter). All indications were **that the** microburst which affected **the** departures on runways 35L and 35R was from a cell which was passing about 1 mile northwest of the control tower. From 1326 to 1334, the microburst apparently affected the surface of the airport only north of runway 8L/26R and **south** of the departure end of runway 35R. This is based upon the fact **that** neither the southwest, east, or north LLWAS boundary anemometers showed the effects of a gust during this time. (See figure 2 and appendix E.)

NCAR Doppler radar scan at 0.7" elevation at 1334:38 MDT, 31 May 84, representing radial flow with respect to CP-4 radar to the north, at 500-700 meters above runway level. Runway location approximate

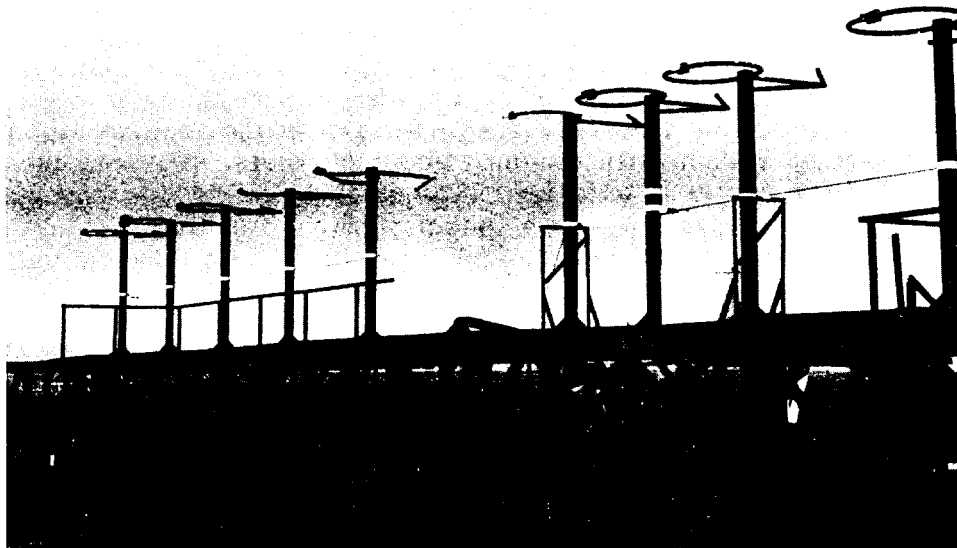
The ILS V-ring **localizer** antenna array platform located 1,074 feet from the departure end of runway 35L was damaged. The No. 6 antenna array stanchion was bent over, the antenna arrays on top of the Nos. 4, 5, and 7 stanchions were damaged, and some of the platform railing was damaged. The grass was scorched by jet exhaust from a point 300 feet beyond the end of the runway to a point 245 feet in front of the antenna platform.

The airplane struck the localizer antenna located 1,074 feet beyond the end of runway 35L about 2 to 3 feet from the top of the antenna array. (See figure 3.) The airplane sustained substantial impact damage to the right side of the fuselage, just forward of the aft cargo door between body stations (BS) 1010 and 1090 (see figure 4), and minor impact damage on the opposite side of the fuselage between BS 992 and BS 1246. There also were minor impact damage and paint transfer marks on the number one, outboard main landing gear tire, on the underside of the right inboard trailing edge flap, and on the number four, right main landing gear tire.

Figure 3.-Runway 35L ILS localizer antenna.

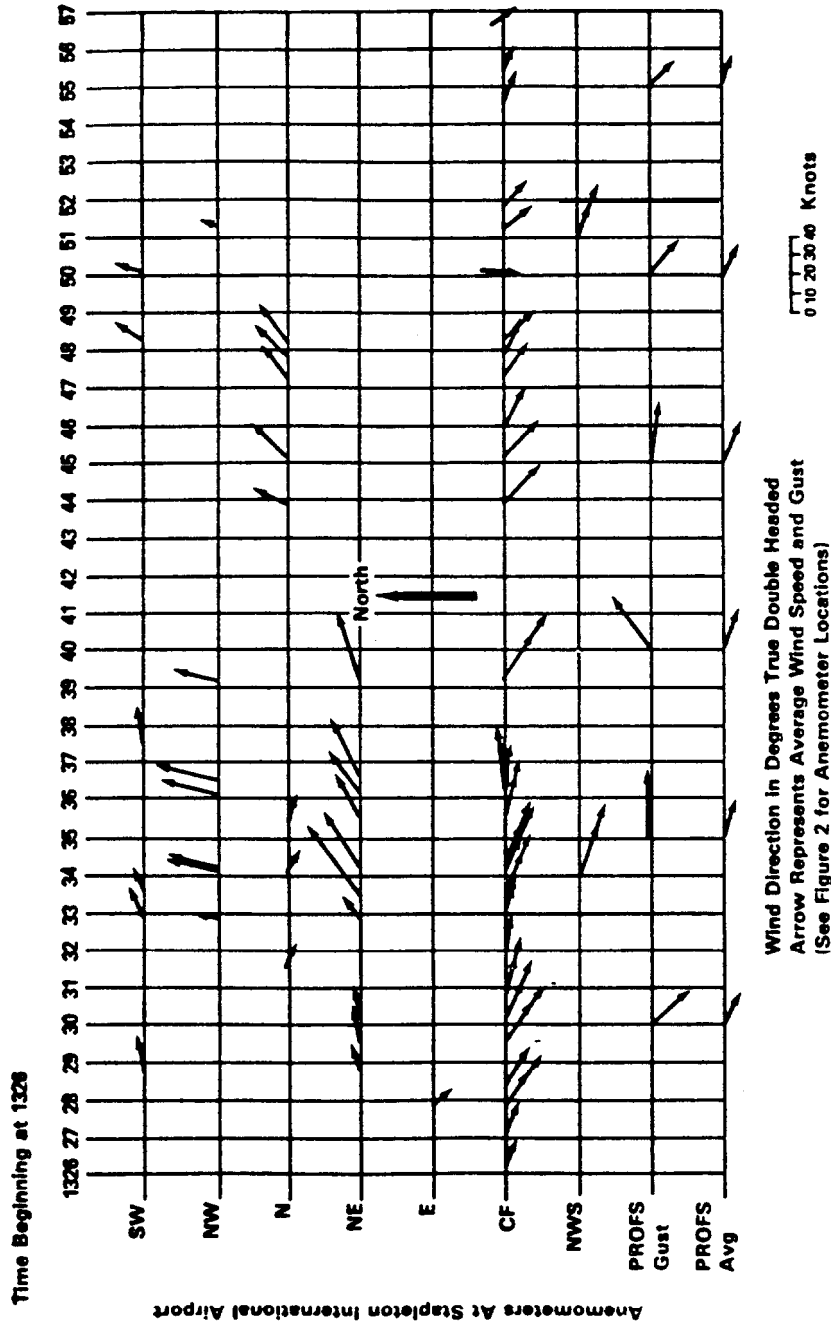
WIND ANALYSIS CHART

Appendix D
Observed Winds at Stapleton International Airport
