## THE GALILEO HIGH GAIN ANTENNA DEPLOYMENT ANOMALY

Michael R. Johnson  
California Institute of Technology  
Jet Propulsion Laboratory  
Pasadena, California

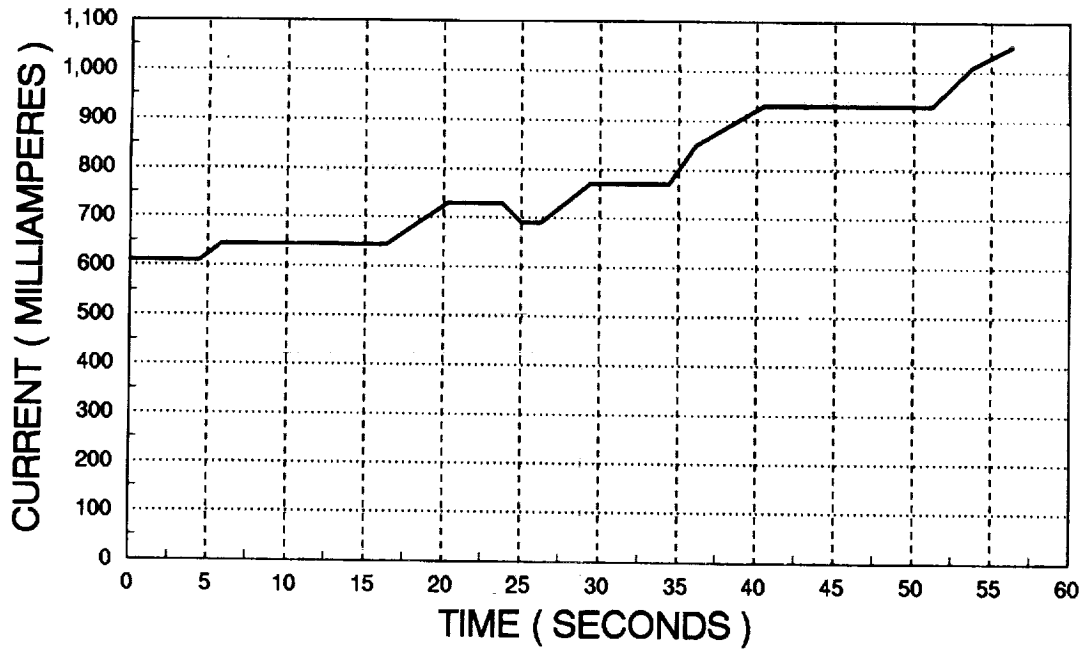
**Figure 11.**  
**Motor Current Telemetry**  
 (Start : 19:51:23 spacecraft time)

overheating (if stalled) and to allow enough time for a single motor operating at cold temperature to fully deploy the antenna. The motor current telemetry received from the spacecraft is shown in Figure 11. The current drawn by the motors started higher than expected and continued to rise until it leveled off 56 seconds after initiation.

The motor current telemetry indicated that the motors stalled at 56 seconds after initiation. The telemetry was then used to determine how far the ballscrew in the Mechanical Drive System had rotated from the stowed position. The motors on the DDA are brushless dc motors. The DDA, therefore, has the speed-torque-current relationship shown in Figure 14.

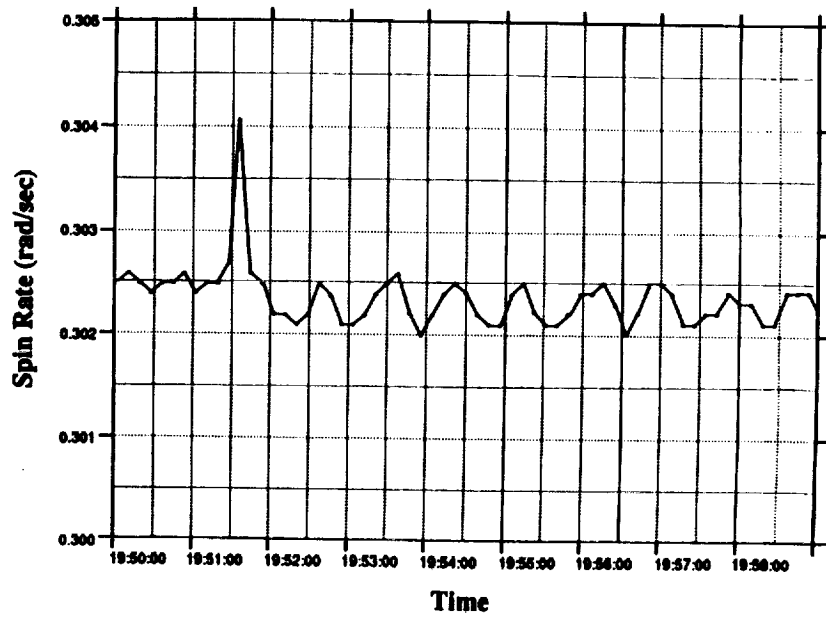
**Figure 12.**  
**Spin Detector Telemetry**

The other telemetry significant to the anomaly received from Galileo during the HGA deploy attempt are a spike in the Spin Detector output (Figure 12), a reduction in the output of the Sun Gate at certain clock angles (Figure 13), a decrease in the spin rate, and an

increase in the wobble of the spacecraft. The Spin Detector is a very sensitive accelerometer mounted on the spinning portion of the spacecraft. This sensor is used to detect the spin rate of the spacecraft. At eight seconds after the start of the deployment, a sudden acceleration occurred and produced the Spin Detector output spike shown in Figure 12. Figure 13 shows the output of the Sun Gate after the deploy attempt. The Sun Gate is a detector that is used to protect the spacecraft from exceeding an angle of 15 degrees between the sun and Galileo's long axis. This was necessary to protect the Galileo during the portion of the mission when it was close to the sun. During the HGA deploy attempt, the Sun Gate output dropped at a spacecraft clock angle

The Spin Detector spike occurred at a time in the deployment that coincided with an increase in torque for the DDA. The initial thinking that the spike was due to the release of some other restrained ribs was not consistent with the increase in torque required from the drive system.

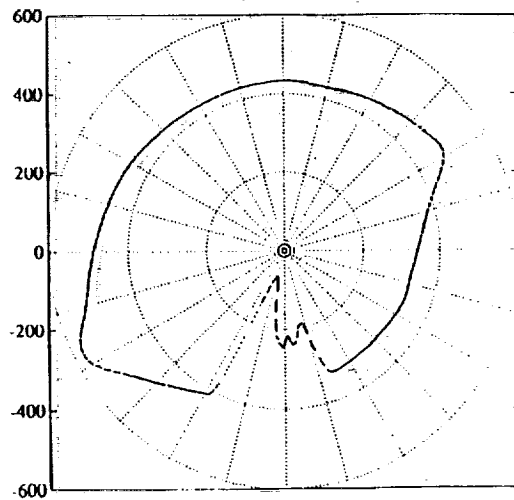
**Figure 13.**  
**Sun Gate Output vs. Clock Angle**

of 265 degrees. The clock angle is an angular position measurement on the spacecraft with the origin at the rotational center of Galileo and in a plane perpendicular to the HGA long axis. Also, the decrease in spin rate was not enough for a fully deployed antenna (due to the increase in the antenna's moment of inertia) and the reason for the increase in wobble was not initially understood.

The first conclusion that can be drawn from the Sun Gate data is that the output was reduced by the shadow of an antenna rib. Analysis of the Sun Gate's location with respect to the antenna shows that only one rib can shadow the Sun Gate and that this rib can only shadow it at deployment angles of 34 to 43 degrees given the spacecraft-to-sun angle at the time of the deploy attempt (5.39 degrees). Analysis of the amount of obscuration of the Sun Gate indicated that the one rib that can shadow the Sun Gate was deployed about 35 degrees from its stowed position.

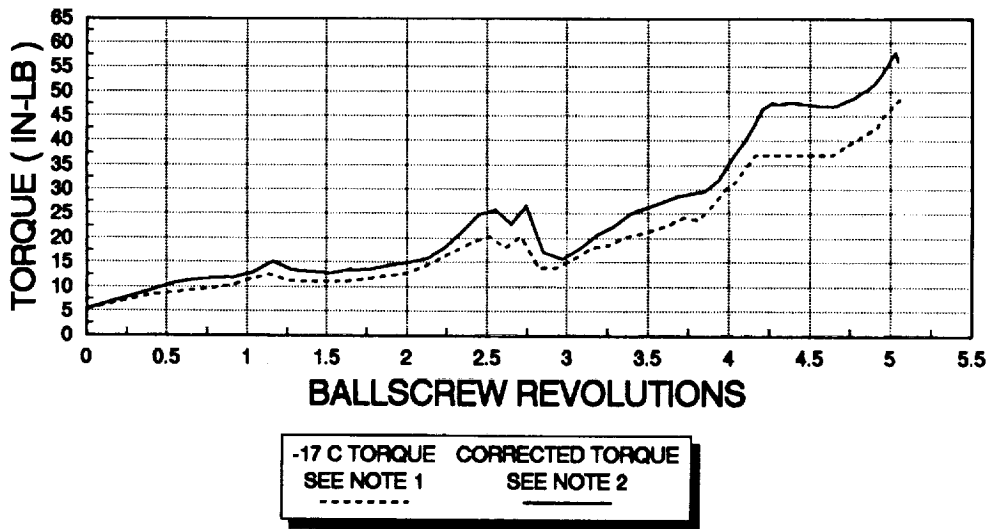
Figure 15.  
Torque vs. Ballscrew Revolutions  
for the High Gain Antenna Deployment Anomaly

This allows the expression of speed as a function of current. Utilizing this relationship, the current telemetry from the spacecraft, and integrating over time allowed the determination of the ballscrew position as a function of time. Taking into account the granularity of the current telemetry, converting the current telemetry to torque, and plotting this as a function of ballscrew revolutions resulted in the curve shown in Figure 15. The data indicates that the ballscrew rotated just over five turns. (A full deployment requires 25 rotations of the ballscrew.) Converting the five rotations to carrier movement and then to rib rotation indicates that the ribs could not have deployed to an angle greater than 11 degrees, which is inconsistent with the Sun Gate data. The way the ribs are connected to the carrier allows for an asymmetric deployment of the ribs if one or more ribs are restrained by something. After several tests on the spare antenna, it was determined that the most likely configuration of the antenna was three ribs restrained at their stowed position. This would allow the opposite rib (over the Sun Gate) to deploy to the position indicated by the Sun Gate data. Also, the number of ballscrew revolutions and the torque required to deploy the antenna under these conditions is consistent with the current telemetry. Figure 16 is a photograph of the spare antenna in the three restrained rib configuration. This asymmetrical configuration is also consistent with the amount of reduction in the spin rate and the increase in wobble.

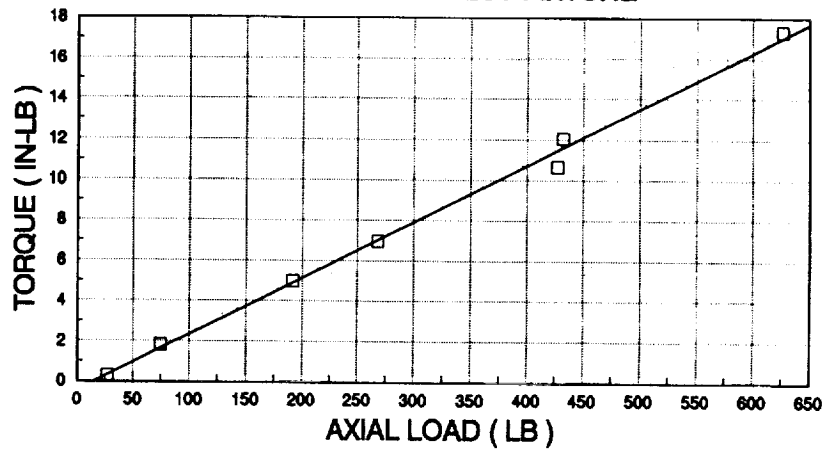
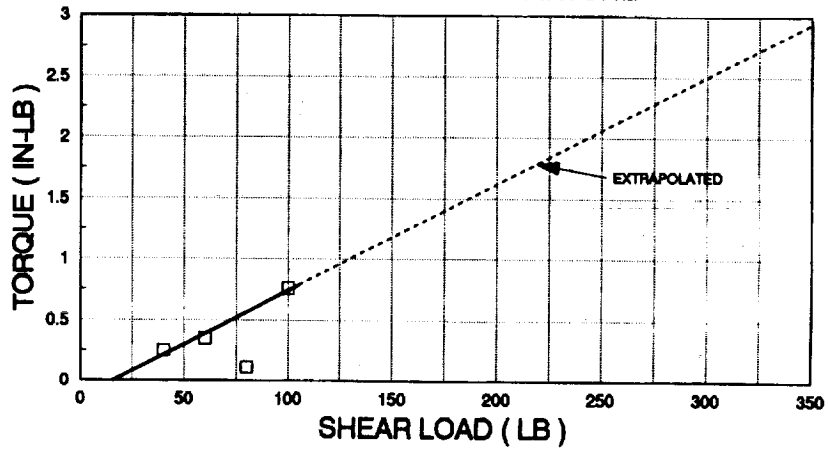
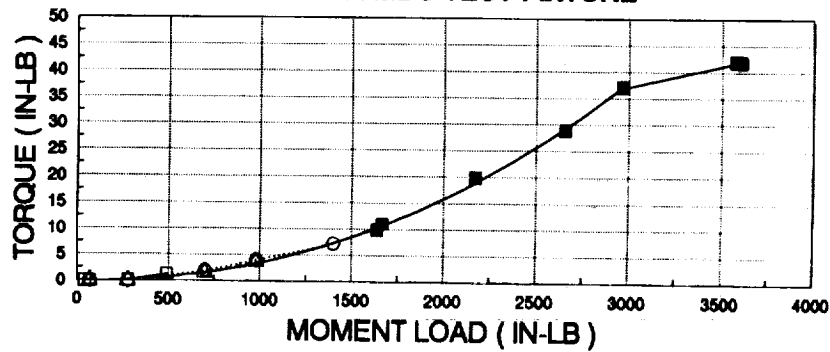
**Figure 18.  
Mechanical Drive System  
Test Fixture Results  
(Torque required to turn ballscrew with the specified loads applied)**

bearing housing (see Figure 5), due to the sliding contact of the ballscrew with the stationary outer housing. The needle roller bearing in the lower housing is not capable of supporting a large moment load, allowing the ballscrew to rotate relative to the housing and come in contact with it. The result of these torque losses was that very little torque was available to move the ribs against their restraints.

was about 6.33 N-m (56 in-lb). A test was performed on a mock-up of the MDS to determine how it would respond to the odd loading condition created by the antenna. The test fixture shown in Figure 17 was used to apply moment, axial, and shear loads to the "carrier plate" individually and in combination. The results of these tests showed that shear and axial loads do not significantly affect the efficiency of a ballscrew. Moment loads, however, result in very significant losses in a ballscrew/ballnut assembly. The graphs in Figure 18 show that the application of a moment of 339 N-m (3000 in-lb) to a ballnut results in torque losses of 4.18 N-m (37 in-lb), or more than half of the available torque from the DDA. This large amount of torque loss is due to jamming of the balls in the ballnut and sliding contact of the ballscrew with the ballnut body. Also, it was found that further losses occurred at the lower
