EVALUATION OF LANDSLIDE HAZARDS RESULTING FROM  
THE 5-8 OCTOBER 1985, STORM IN PUERTO RICO

Randall W. Jibson  
U.S. Geological Survey  
Reston, Virginia 22092

U.S. Geological Survey Open-File Report 86-26

A report submitted to the Federal Emergency Management Agency  
in fulfillment of a mission assignment to evaluate  
landslide hazards related to disaster FEMA-746-DR-PR

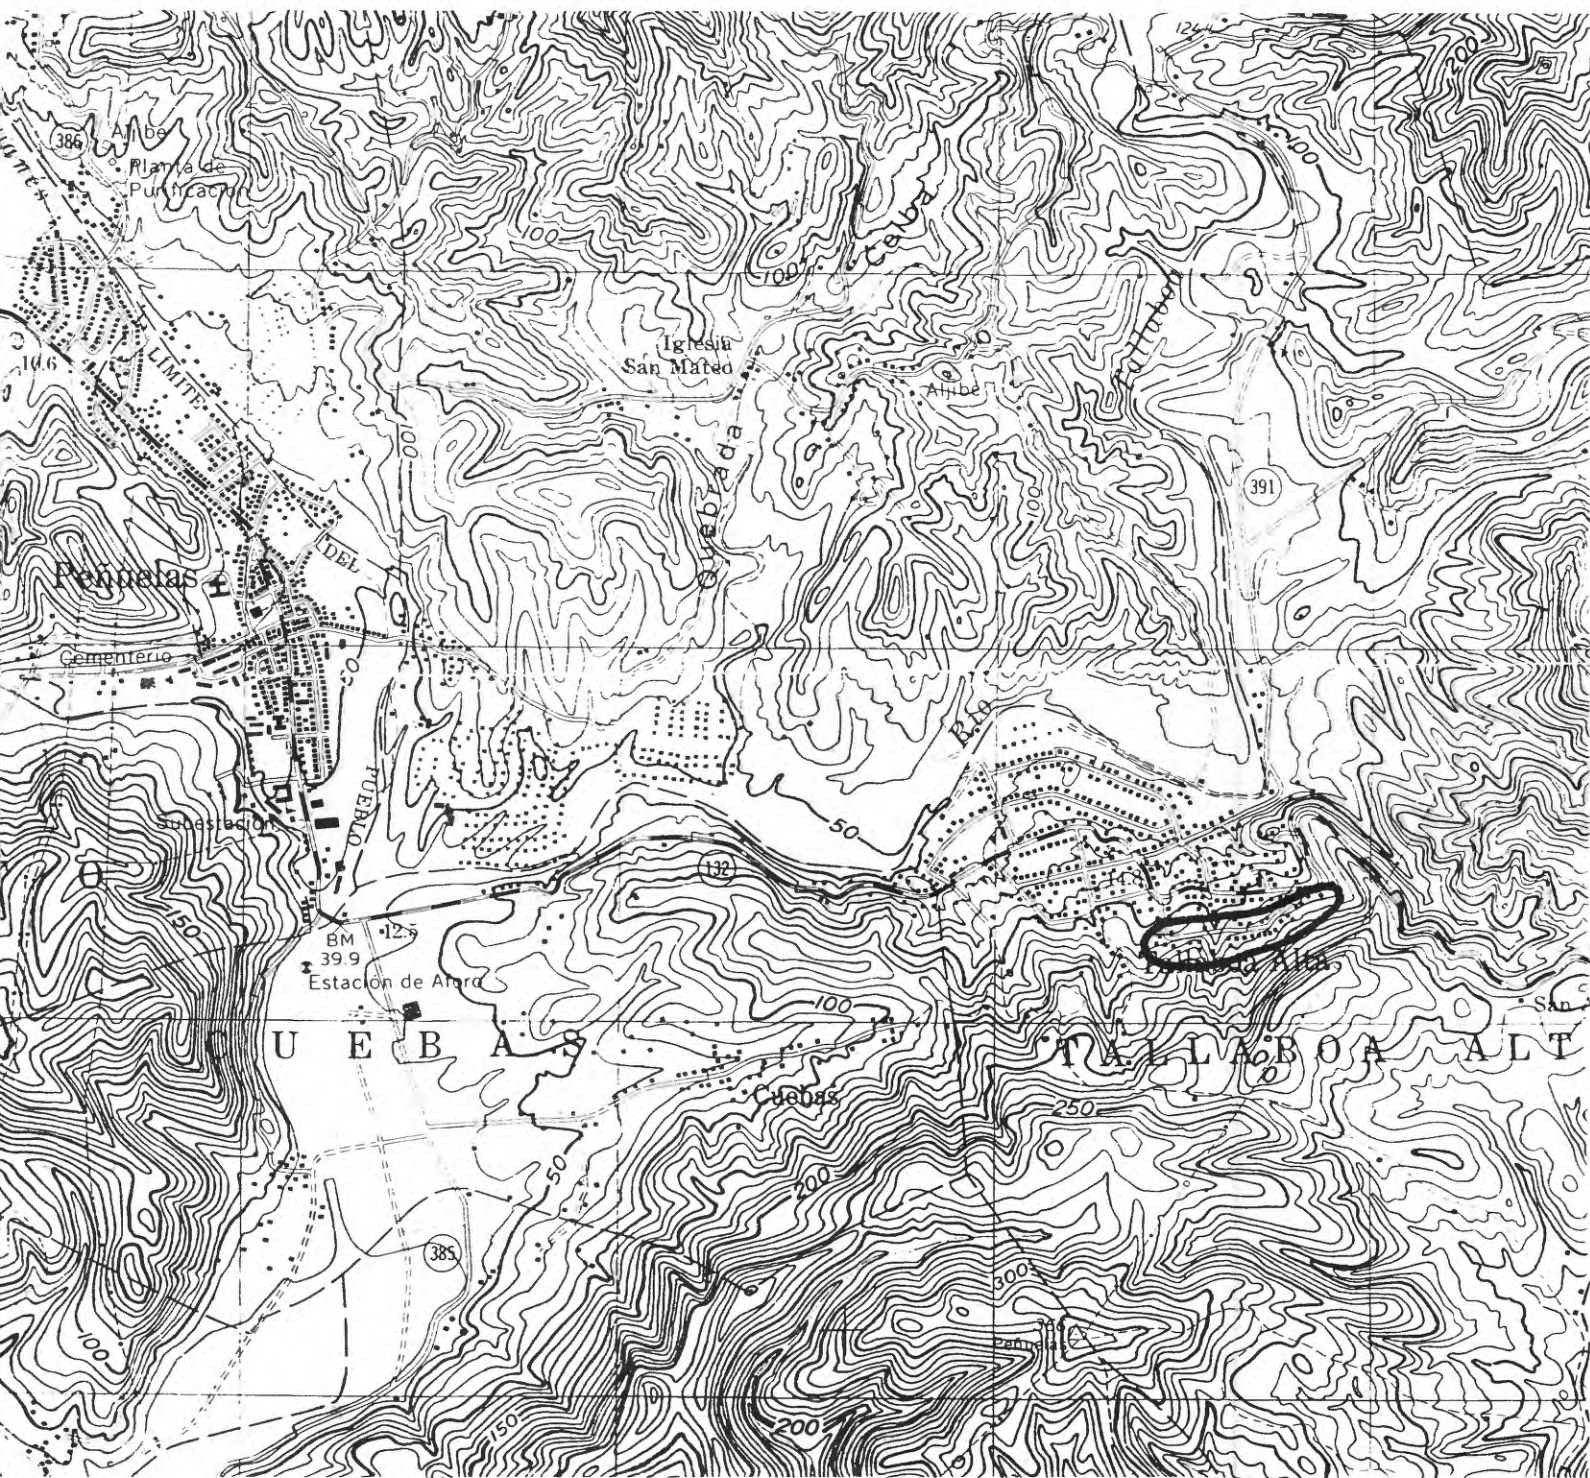
The slopes above Tallaboa Alta, two miles east of Penueles, produced several debris flows that caused significant damage to property. Fortunately, no homes were completely destroyed and no injuries were reported, but the landslides that formed easily could have destroyed as many as 10 homes and caused several casualties. As along Road 385, evidence shows that repeated debris-flow activity has occurred in the area, and several homes are built high on the slopes where rapidly moving debris can cause serious damage. At present, no immediate threat exists in normal rainfall conditions. Future major storms, however, will almost certainly trigger debris flows that will significantly damage or destroy homes in the area and endanger lives. For long-term hazard mitigation based on these geotechnical considerations, I recommend removing the homes along the road above Highway 132 (highlighted in figure 1) and relocating the inhabitants to other, less hazardous sites.

Figure 1. Map showing topography in the vicinity of Tallaboa Alta. Area enclosed by heavy circle is susceptible to damage from debris flows.

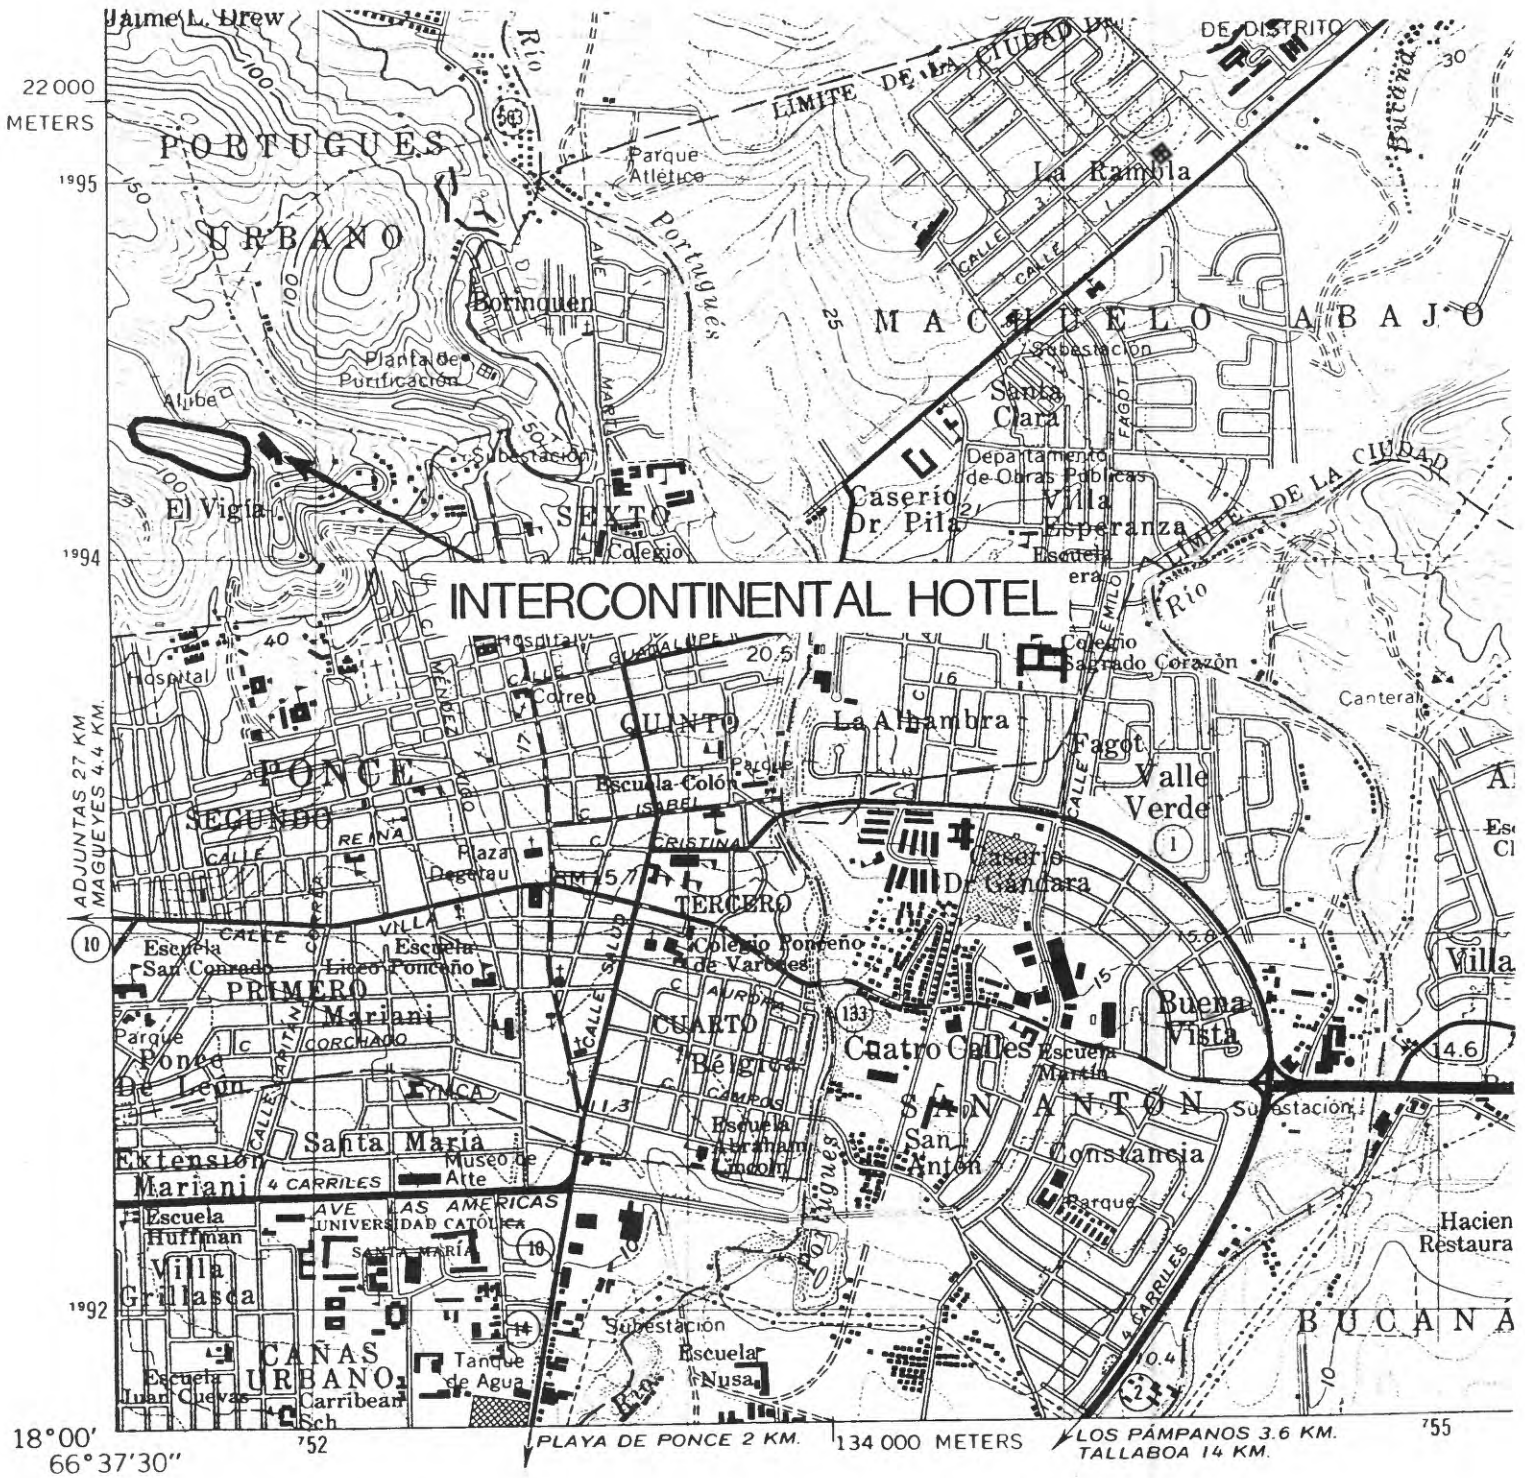
Figure 3. Map showing topography in the vicinity of the Intercontinental Hotel. Slope inclosed by heavy circle is a dip slope having similar geometry to the hillside that failed at Mameyes.

The slopes to the south and west of the hotel are also susceptible to shallow debris slides that would be similar to those just mentioned. Of more concern is the potential for landsliding similar to that which destroyed Mameyes. The Mameyes landslide occurred on a dip slope, that is, a slope whose ground surface is nearly parallel to the dip of the rock formations that form the slope. The formations underlying the Intercontinental Hotel dip about 20° to the south, thus south-facing slopes (highlighted in figure 3) may have the potential to fail in a manner similar to the Mameyes slide. Although the possibility of such a catastrophic landslide on the highlighted slope cannot be ruled out, I judge it unlikely for the following reasons:

1. At Mameyes, an incised stream channel extended along the base of the slope that failed. This channel probably exposed the potential failure surface and thus provided the necessary geometry for slope failure. No such channel or geometry exists at the base of the highlighted slope, so a dip-slope failure may be inhibited.

2. Dense housing with cesspools that saturate the slope may have contributed significantly to slope failure at Mameyes. The highlighted slope is uninhabited.

4. The highlighted slope remained intact during the recent storms with no discernable ground movement and so is probably stable in conditions at least that serious provided all other site characteristics remain unchanged.

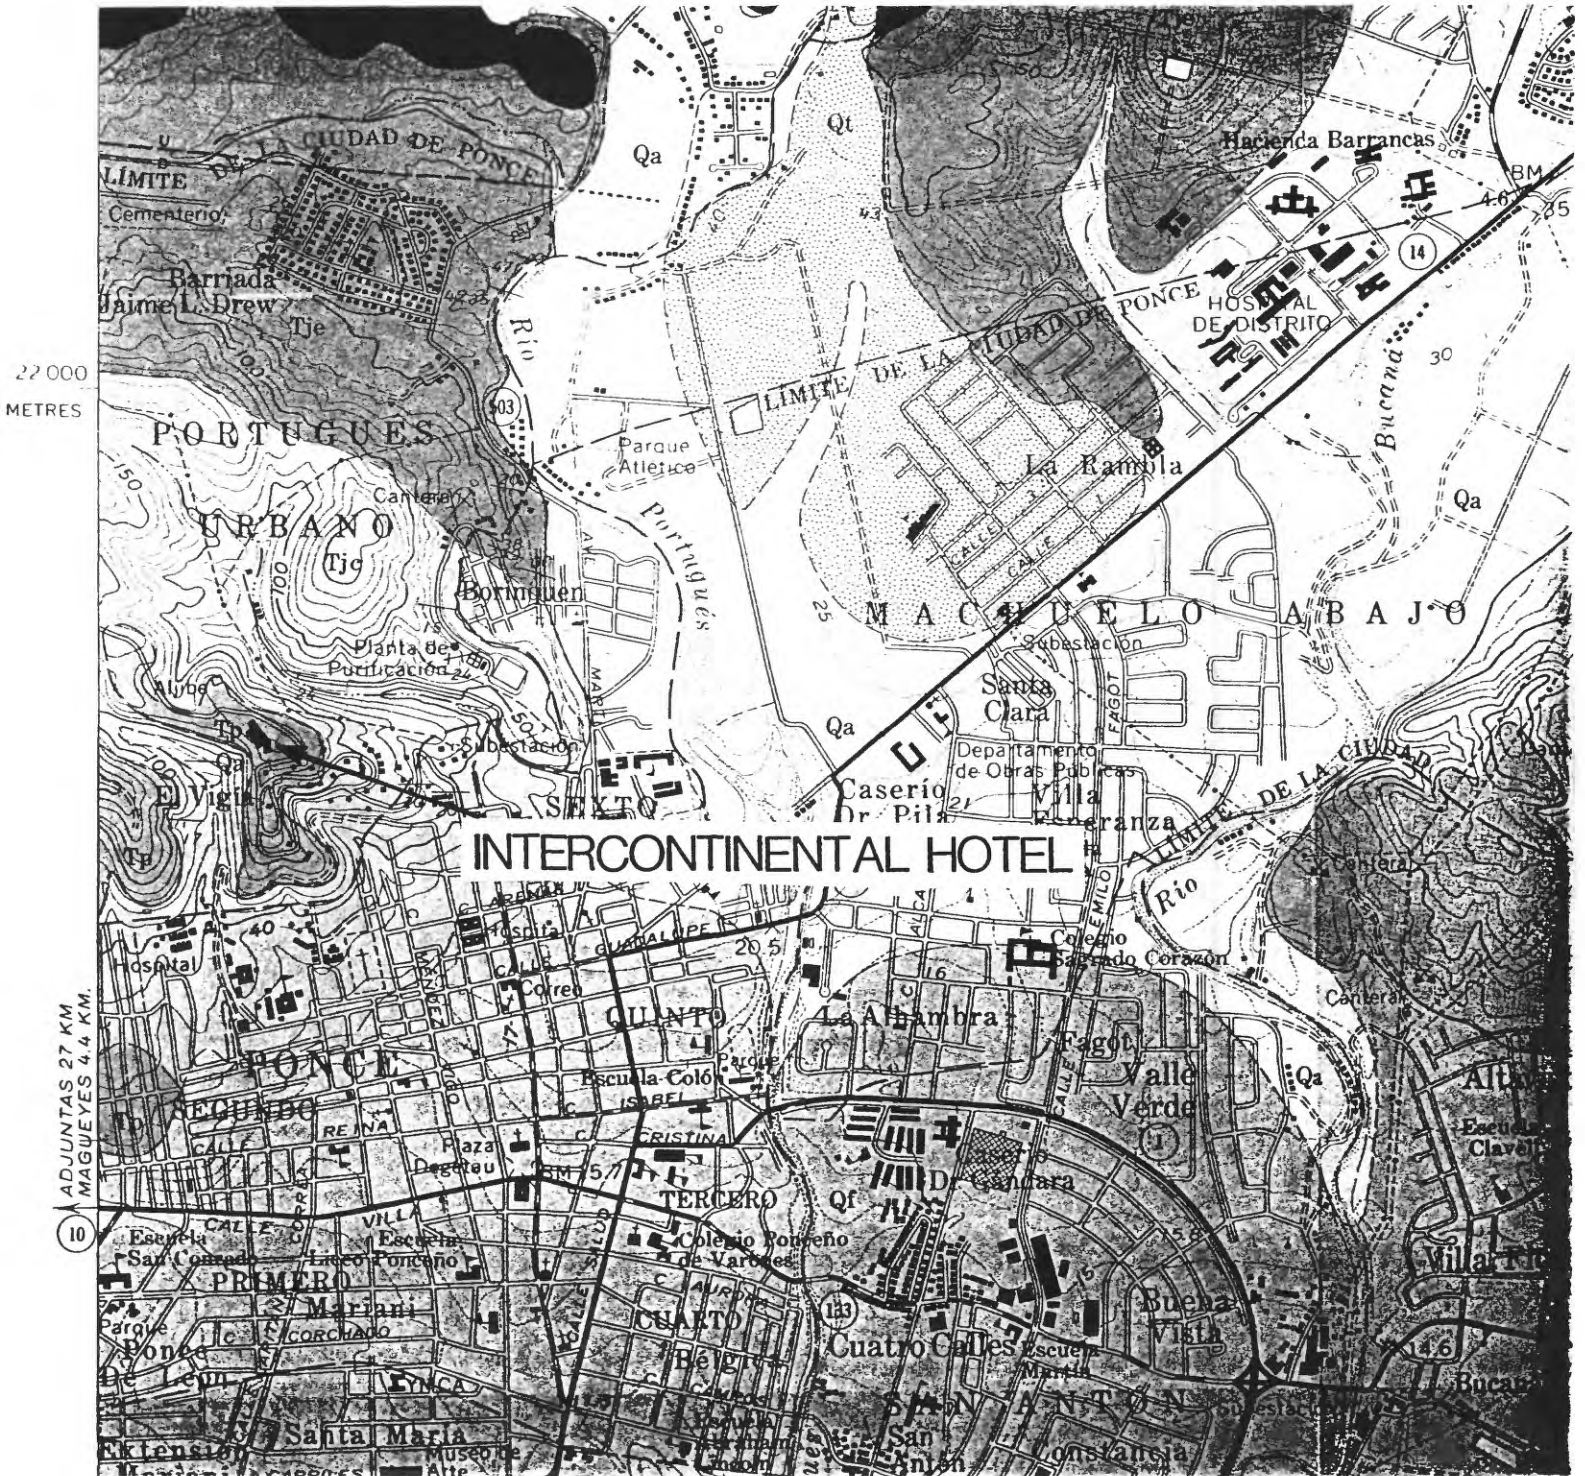
Figure 4. Map showing geology in the vicinity of the Intercontinental Hotel. Unit Tp is the Ponce Limestone, and unit Tjc is the calcareous unit of the Juana Diaz Formation.
