### **The Cosco Busan**

Allision of Hong Kong-Registered Containership M/V *Cosco Busan*  
with the Delta Tower of the San Francisco–Oakland Bay Bridge  
San Francisco, California  
November 7, 2007

NTSB/MAR-09/01

# **Marine Accident Report**

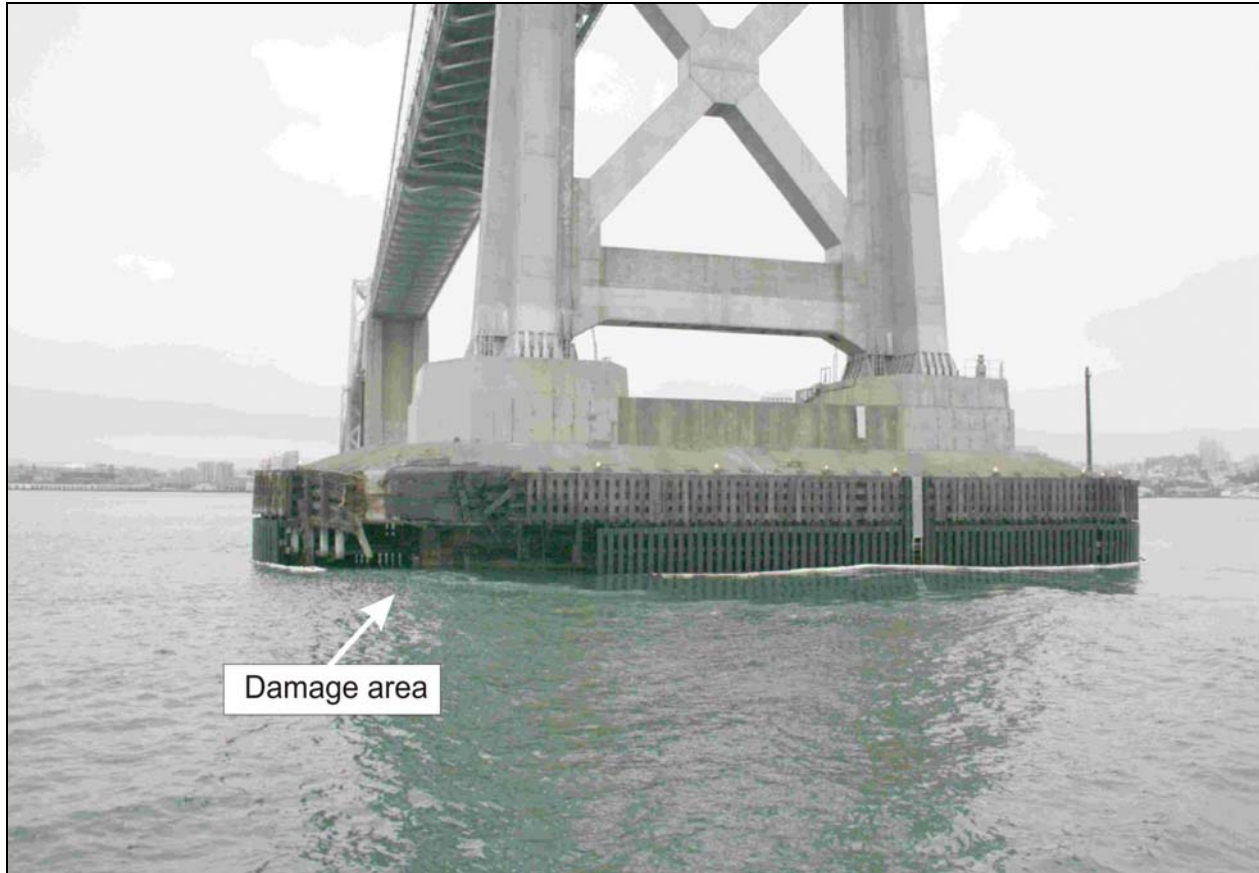
engineer, and a state transportation engineer inspected the pier. They found that about 100 feet of the fendering and skirt at the southeast corner of the Delta pier had been damaged (see figures 5 and 6), but they found no damage to the pier itself or to any other part of the bridge structure.

**Figure 5.** Damaged fendering system at the base of the Bay Bridge Delta tower.

Cost to repair the damage was \$1.5 million. By 0950, Caltrans engineers had completed their inspection and found no damage that would compromise the structural integrity of the bridge.

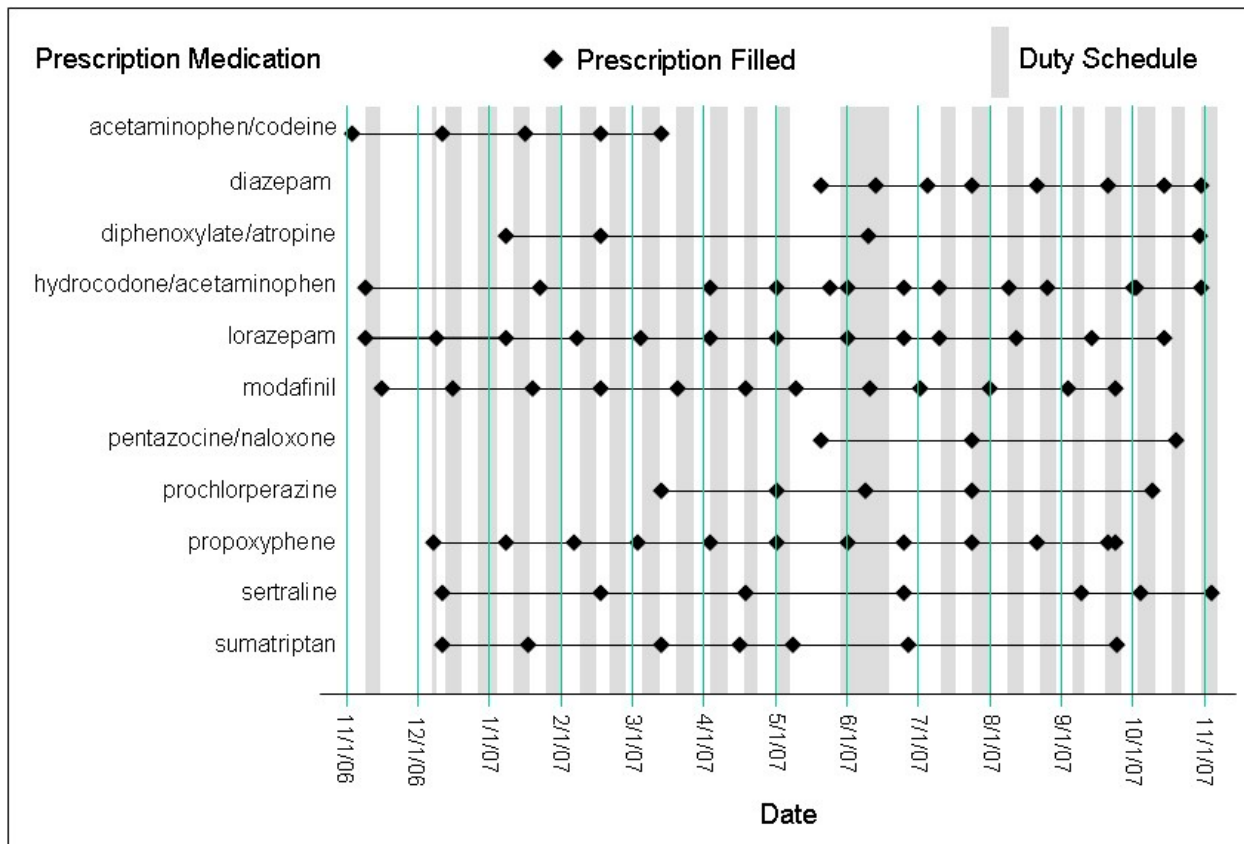
50 pentazocine<sup>62</sup>/naloxone<sup>63</sup> tablets, 100 diphenoxylate<sup>64</sup>/atropine<sup>65</sup> 2.5/0.025 mg tablets, 27 sumatriptan<sup>66</sup> 50 mg tablets, 90 modafinil<sup>67</sup> 200 mg tablets, and 90 sertraline<sup>68</sup> 50 mg tablets (figure 12).

**Figure 12.** Graphical display of the *Cosco Busan* pilot's prescription history and duty schedule for the year preceding the allision. Each diamond denotes the filling of a prescription for the medication indicated.

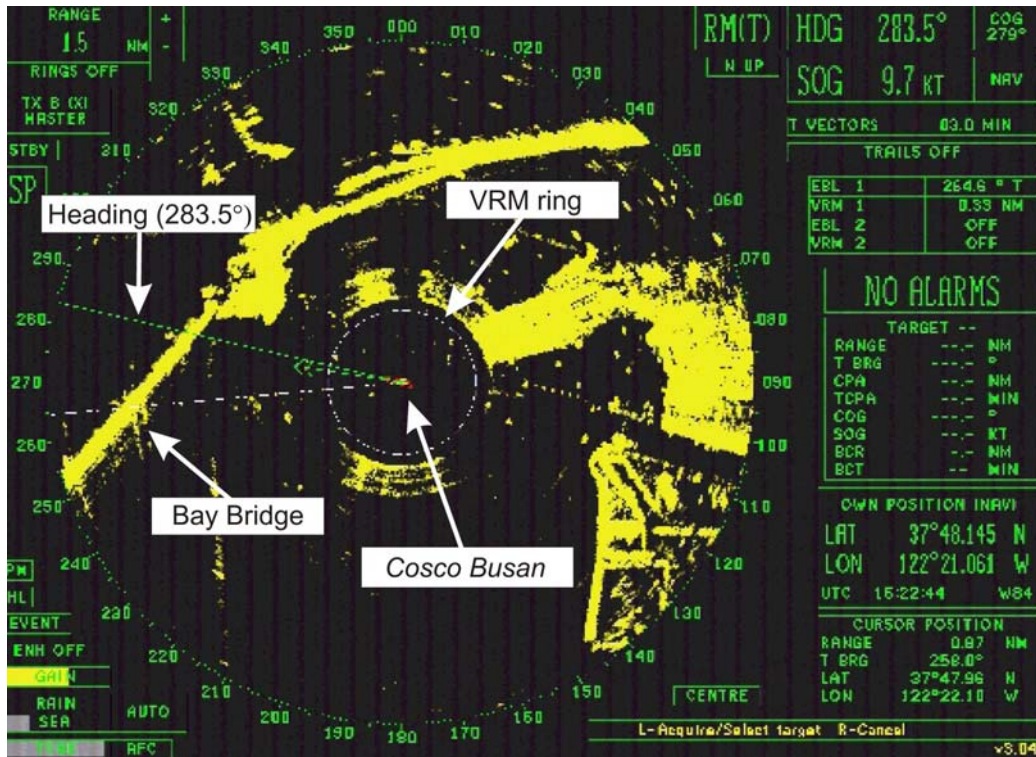
The *Cosco Busan* pilot told investigators that about the time the vessel began its initial turn to port (about 0823), “the radar picture of the bridge got distorted. It got wider. The bridge got wider. The RACON never appeared.” Investigators reviewed the radar images captured by the VDR and assessed the quality and consistency of the images that were displayed during the accident voyage (figure 13). This review revealed that the radar returns from the Bay Bridge did not change significantly from the time the bridge first became visible on the display about 0819 until about 0826 when the upper end of the bridge appeared to widen. The upper portion of the bridge appeared to widen on the radar image for about 1 minute before beginning to return to normal.

During the public hearing on this accident, the Sperry manager of product support and training reviewed the image and attributed the change in the bridge’s appearance to the *Cosco Busan* being almost abeam of the bridge at that point, with the top section of the bridge providing a much stronger radar return because the radar was “shooting . . . [radiofrequency] energy directly into the girders . . . .” Figure 14 shows the radar image that was being displayed on the *Cosco Busan* at the time the radar image of the Bay Bridge became, in the words of the pilot, “distorted.” After about 2 minutes, the entire bridge began to appear thinner on the radar screen as the ship approached the bridge and more of its radar waves passed beneath the bridge instead of being reflected back. The signature of the RACON transponder at the midpoint of the Delta–Echo span also appeared on the radar screen at regular intervals throughout the voyage.

**Figure 13.** (Top) Radar image displayed on the bridge of the *Cosco Busan* at 0822:44, just before the vessel turned to port, and (bottom) the radar image at 0826:14, just after the vessel made the turn to port. In the bottom image, note the identifier for the RACON at the center of the Delta–Echo span of the bridge.

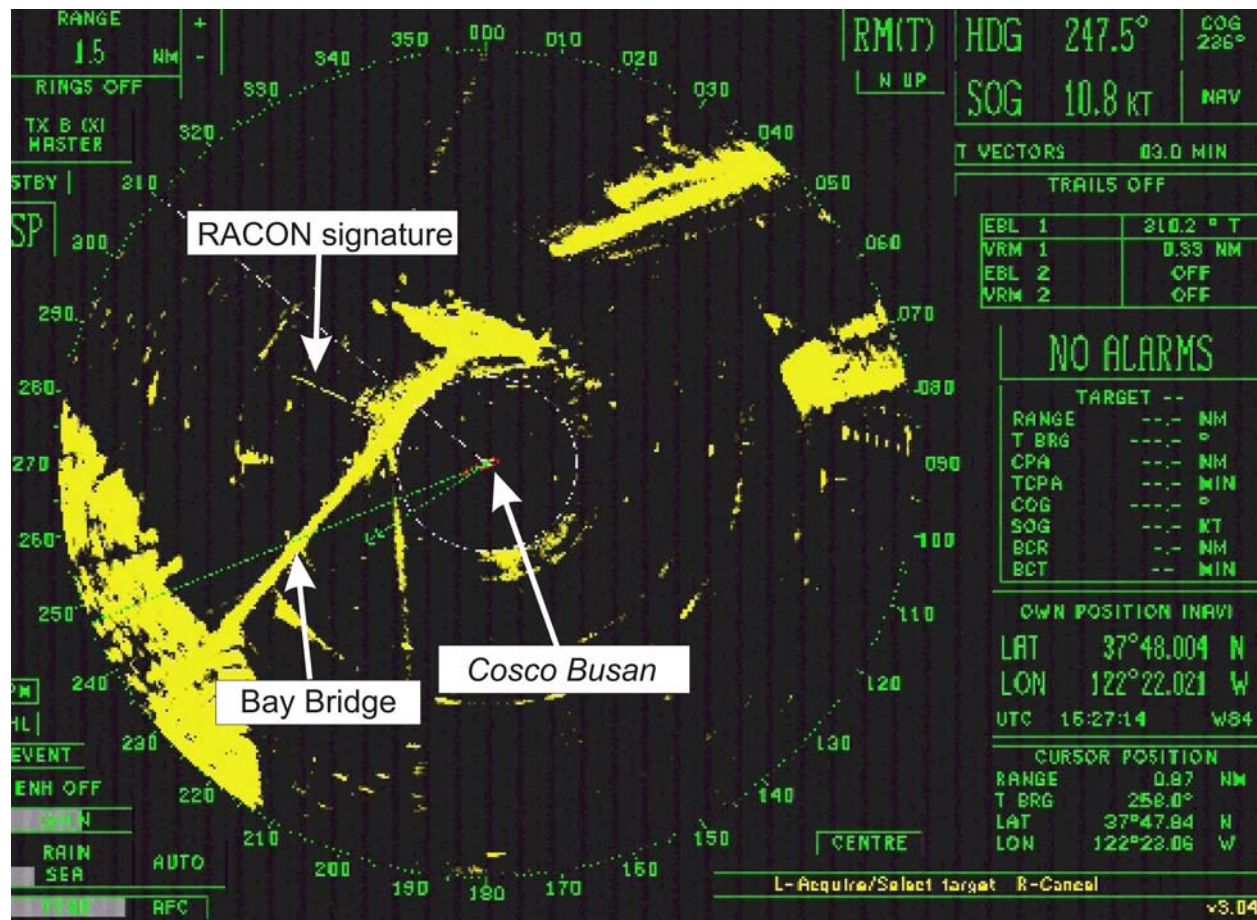
**Figure 14.** Radar image on board the *Cosco Busan* at 0827:14. According to investigators, 0827:14 was the time at which the upper portion of the bridge appeared the most enlarged on the radar image before returning to normal.
