METRORAIL TRAFFIC SAFETY ASSESSMENT

Prepared For:
Metropolitan Transit Authority of Harris County

By:
Texas Transportation Institute
Texas A&M University System
in association with
Korve Engineering Inc., JRH Transportation Engineering, and
Parsons Brinkerhoff Quade & Douglas

March 11, 2004

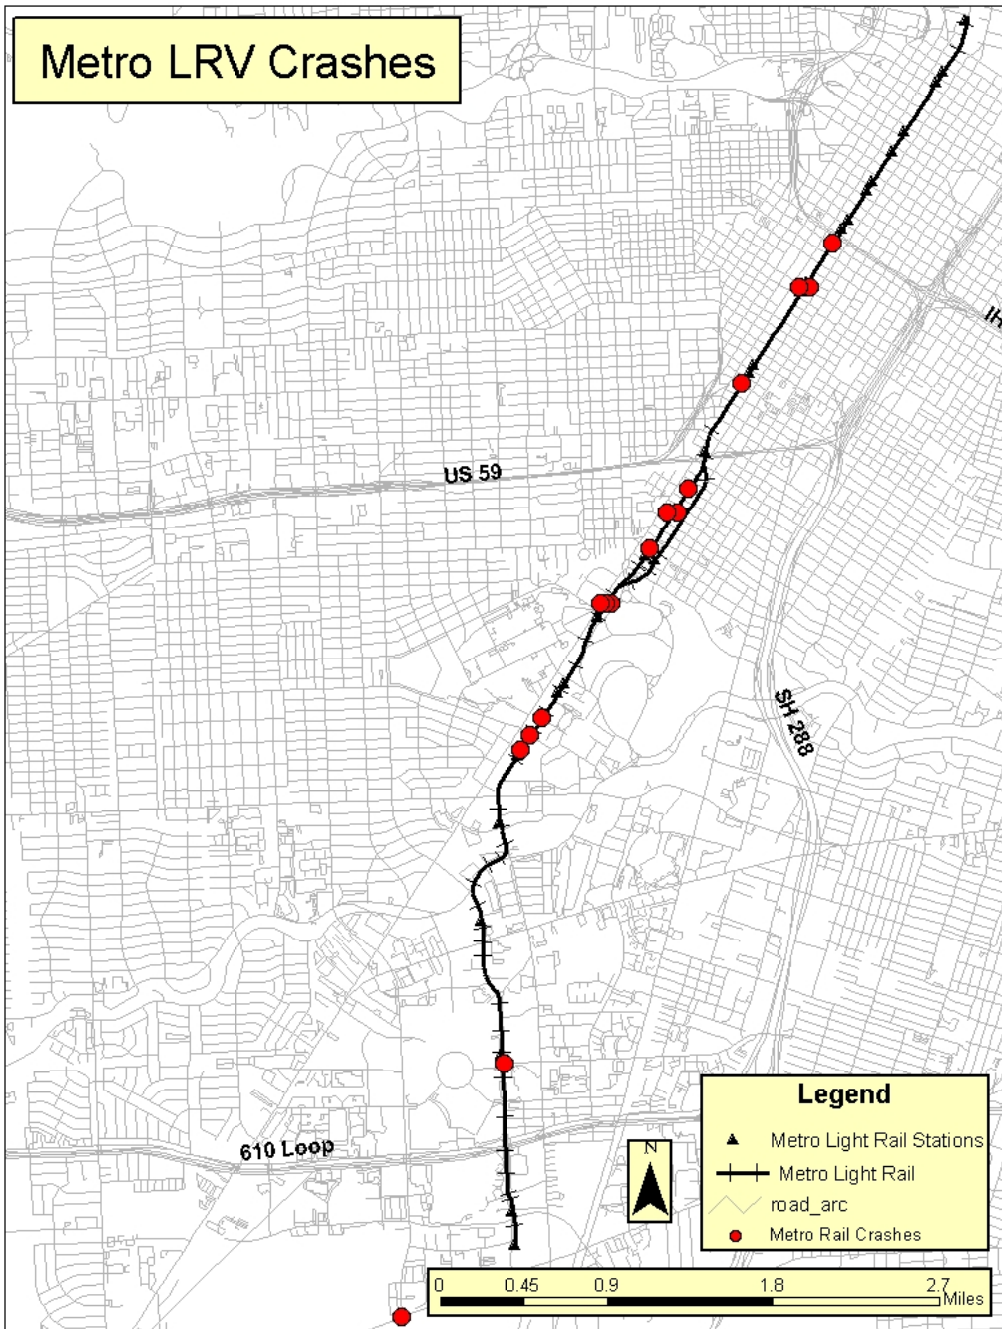
- All collisions appeared to be very sudden/unexpected and unavoidable from the LRV perspective (from vehicles turning from center lanes, or from vehicles stopping and pulling out into the path of the oncoming train).

- All collisions were a result of driver error or improper motor vehicle movements based on the information reviewed.
- The majority of the collisions appeared to be low speed.

Figure 1. Graphical location of METRO LRV Collisions.

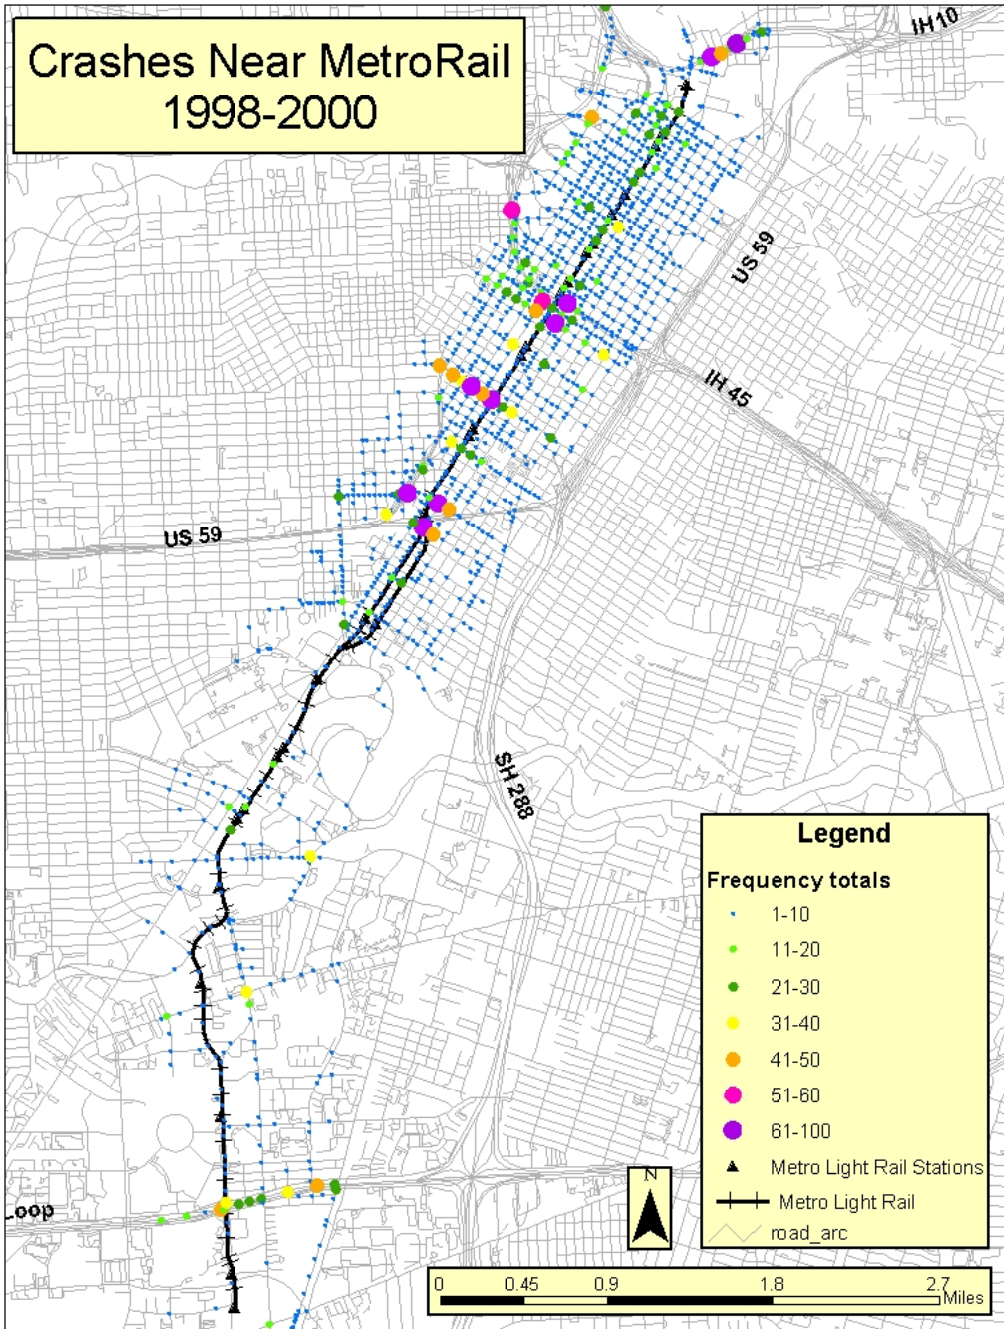
Figure 2. 1998 – 2000 DPS Collisions Along the METRO Main Street Rail Alignment.

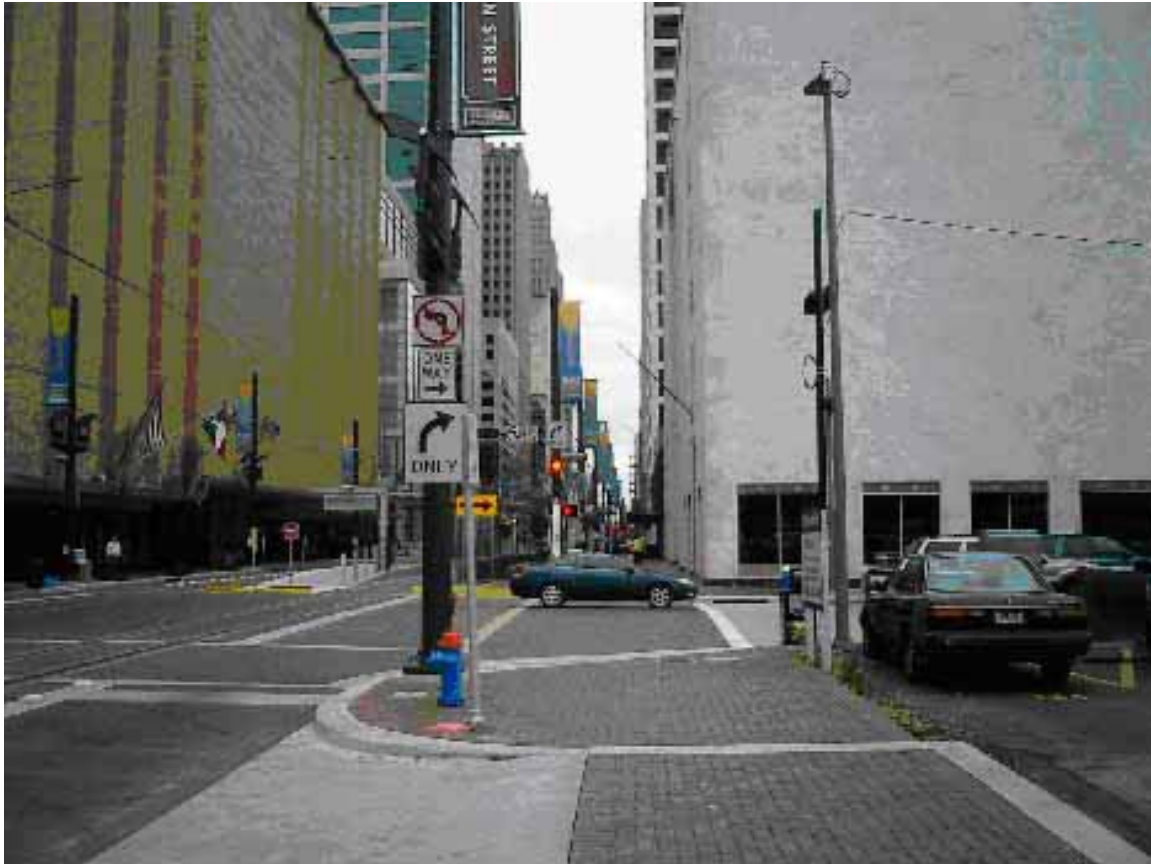
Cause: Some drivers appear to be confused by unexpected closed Main Street sections northbound at Dallas and southbound at Walker. The same is true for drivers approaching Main Street eastbound on Dallas and Westbound on Walker.

Figure 3. Existing Right Turn Only sign configuration in Downtown area.

- On Main Street:
 - Add advance ALL TRAFFIC MUST TURN RIGHT signs midblock on Main Street approaches to the closed blocks
 - Post a R3-5(R) right turn only arrow sign on signal mast arm (see Figure 3)
 - Install a right turn arrow pavement marking to supplement the sign
 - Consider installing (breakaway) bollards across the closed sections of Main Street, locating bollards behind the crosswalks and leaving a sufficient opening for the LRV dynamic envelope.

- Consider adding paint channelization forcing the right turn
- Add NO LEFT TURN ON MAIN STREET advance signs on Dallas and Walker Street approaches to Main Street
- Remove or replace DIVIDED HIGHWAY signs on Dallas and Walker Street approaches; they illustrate an allowable left turn, when left turns are actually prohibited

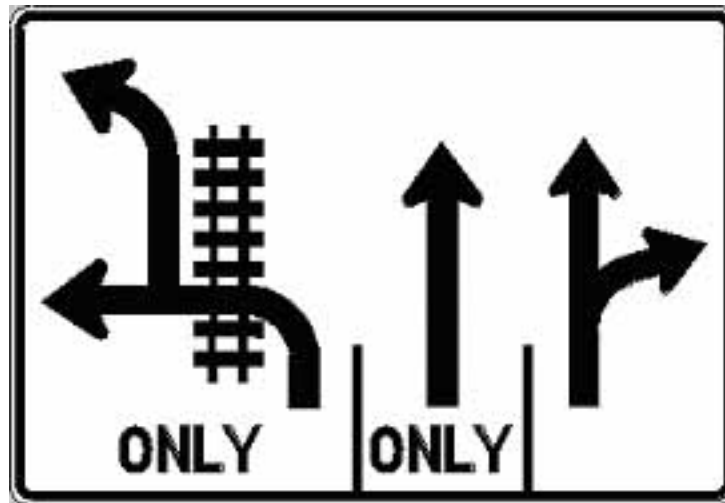
ISSUE: Complex geometry of the Fannin-Ewing intersection and signing may be contributing to the improper left turns being made on southbound Fannin at Hermann Drive. Also terminated southbound left through lane into a left turn lane may result in rear end collisions.

Cause: Proper movements starting at Ewing are complex and confusing due to the divider island that splits trackway and through lanes from left turns to both Hermann and Warwick Towers garage. Drivers are not entering Hermann left turn lane which has to happen at just south of Ewing. Directional lane assignment sign on divider island could be interpreted by stopped traffic

in through lanes as implying that the left most through lane is actually the turn lane. Landscaped divider island gives the illusion of a curb and disguises the trackway for traffic stopped in the far left through lane on Fannin. Dropping a through lane into a left turn lane causes some drivers to make evasive maneuvers at the last second to continue in a through lane.

Figure 4. Possible new sign to be mounted on median on SB Fannin at Ewing.

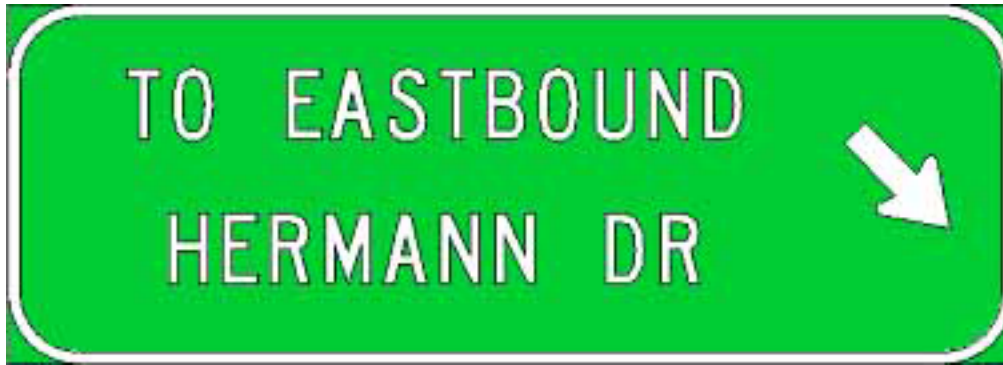
Figure 5. Possible new mast arm sign just south of Ewing over left SB Fannin lane to Hermann Drive.

- Remove small white on green direction information sign facing west from pole in southeast corner of intersection; replace with larger signs as shown in Figures 5 and 6.

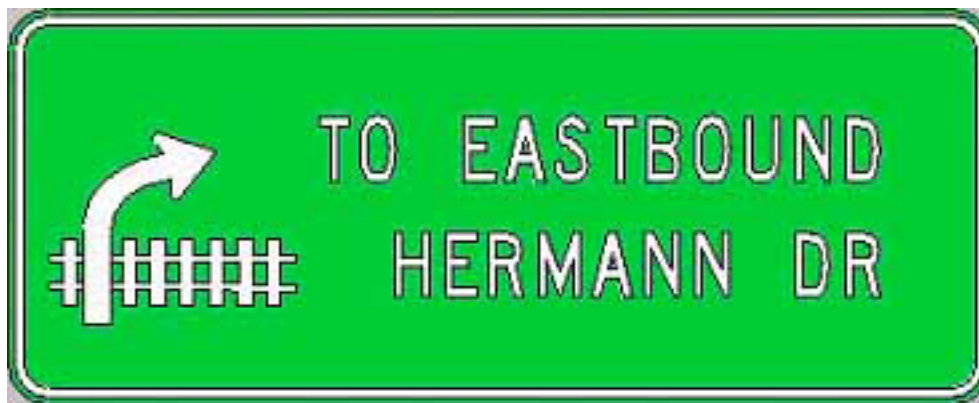
Figure 6. Possible new mast arm sign for EB Ewing at Fannin.

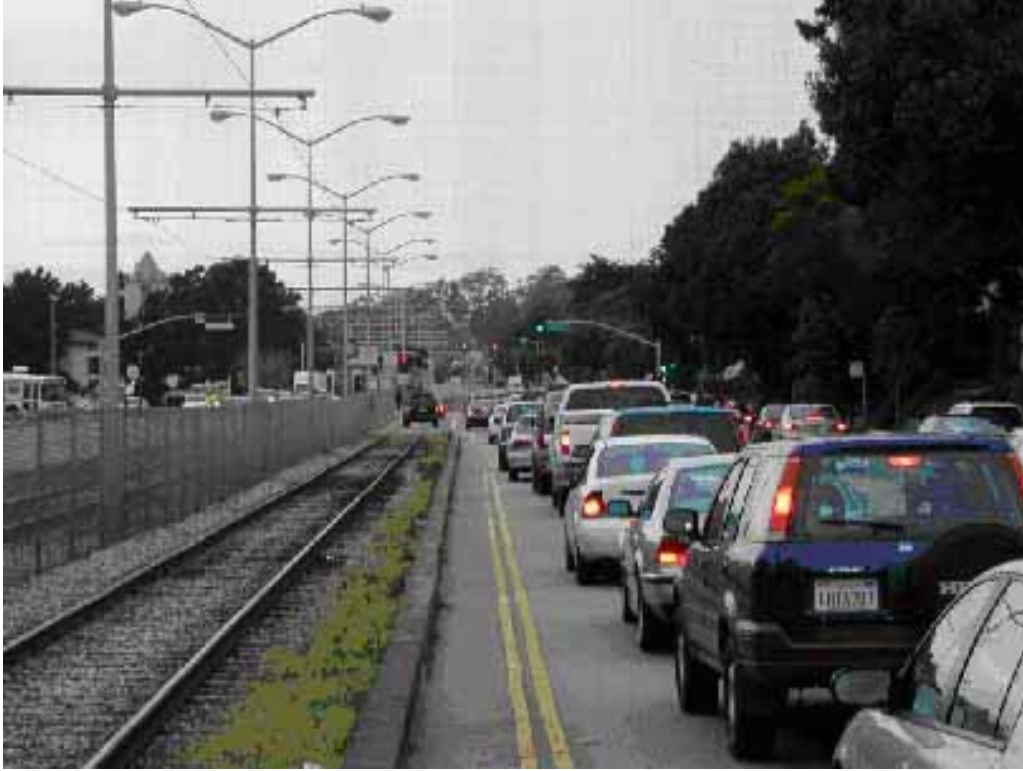
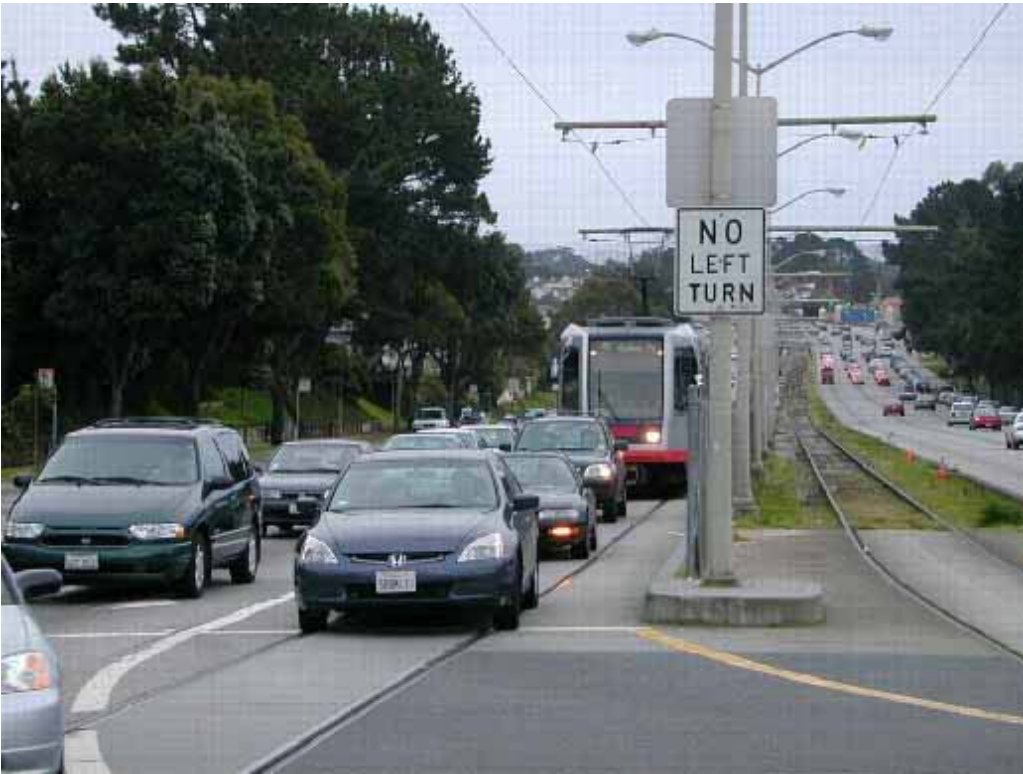
Figure 7. Left turn lanes, San Francisco Muni, with pavement around rail tracks to indicate shared rail and vehicle use. Track is not paved except for shared left turn lanes.

- If additional pavement markings and signs do not result in left turns being made from left turn lanes, replace or pave over stamped brick pavement in the left turn lane to provide pavement surface matching through traffic lanes (see Figure 7 for example of similar paving on San Francisco Muni light rail system)

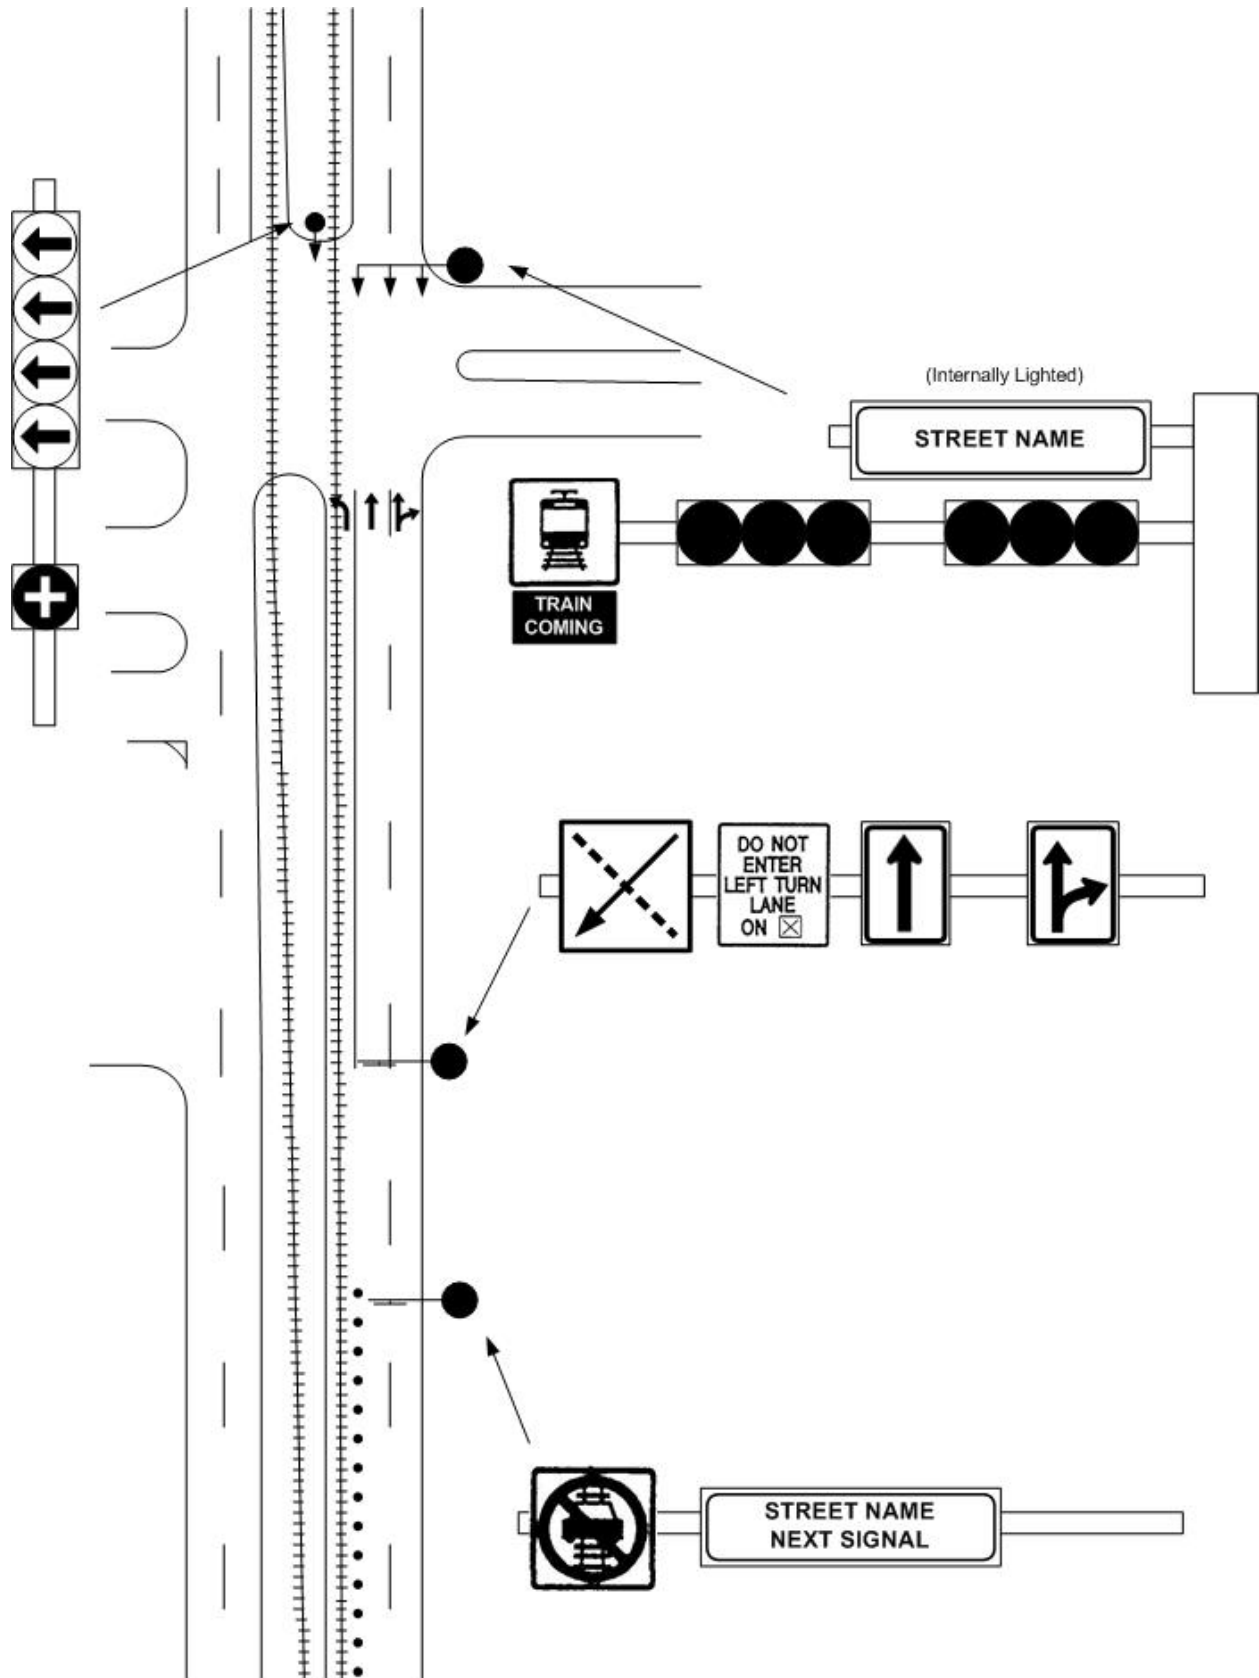
Figure 8. Existing Signing with Improved Destination Identification.

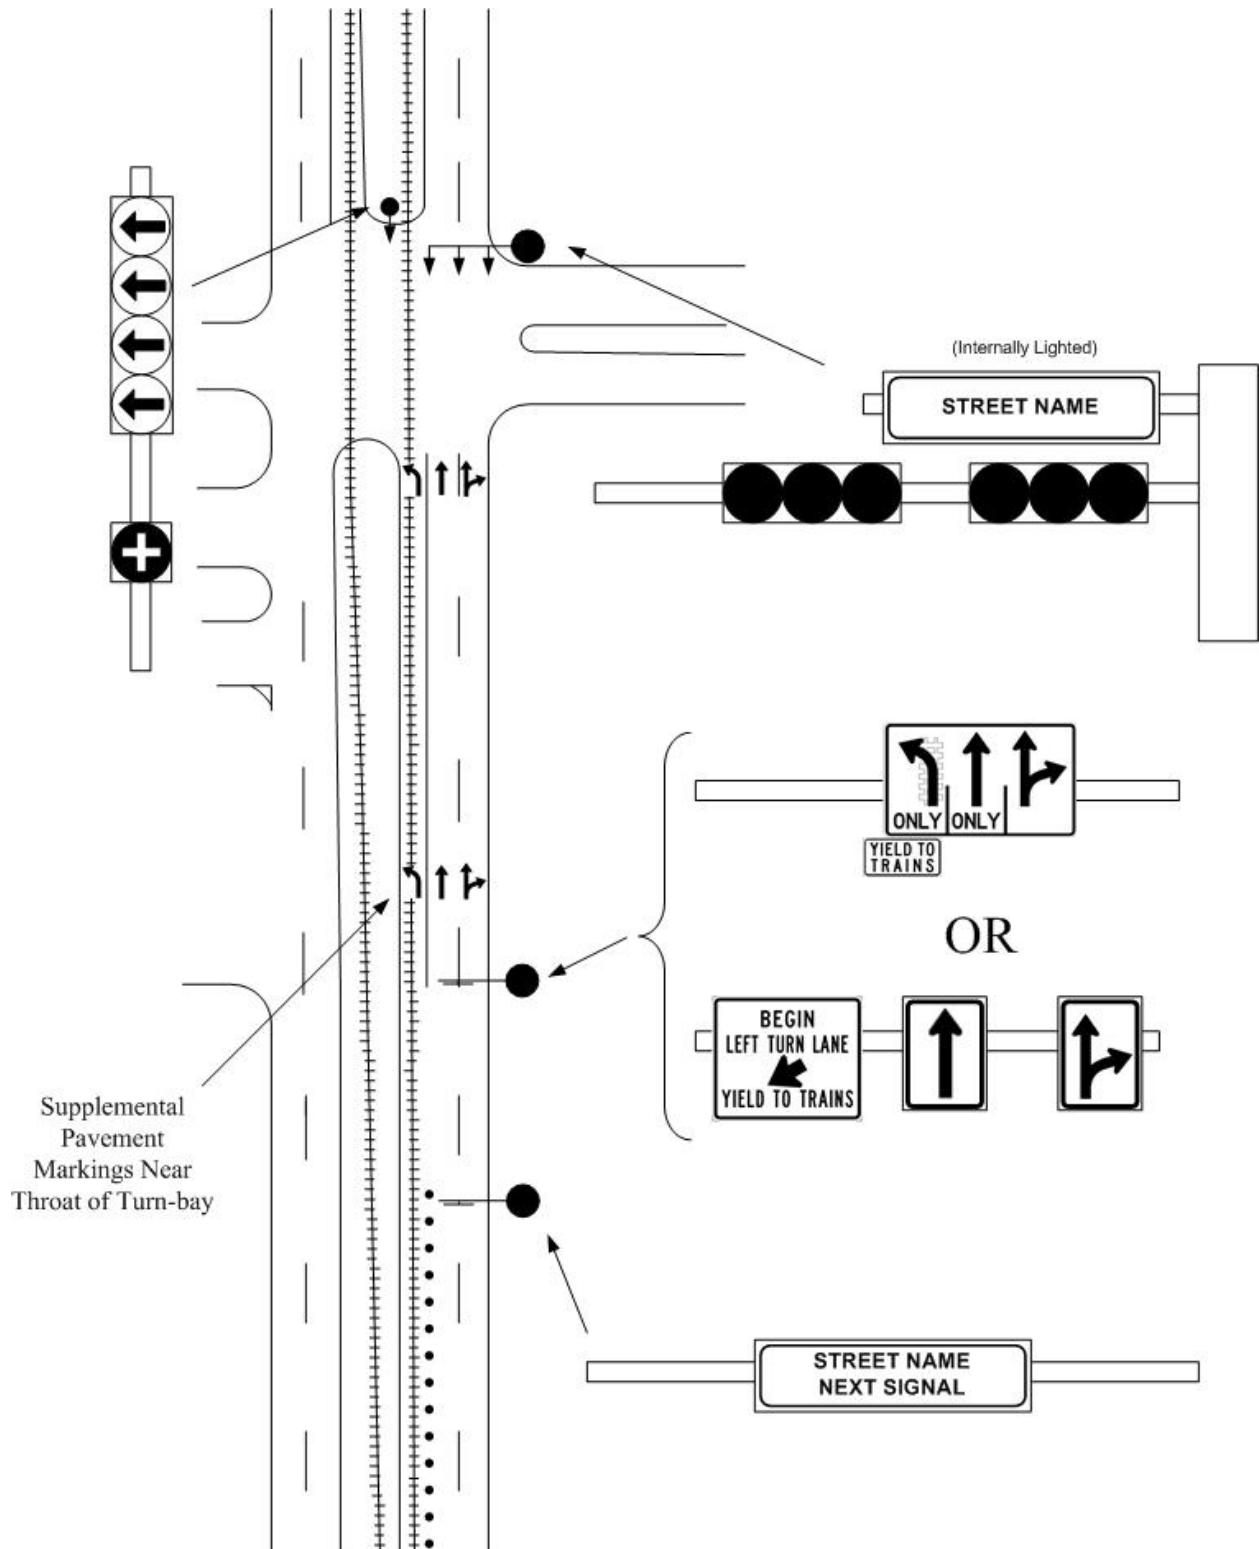
Figure 9. Possible New Mid-Block Lane Assignment Sign -- No Active Controls.

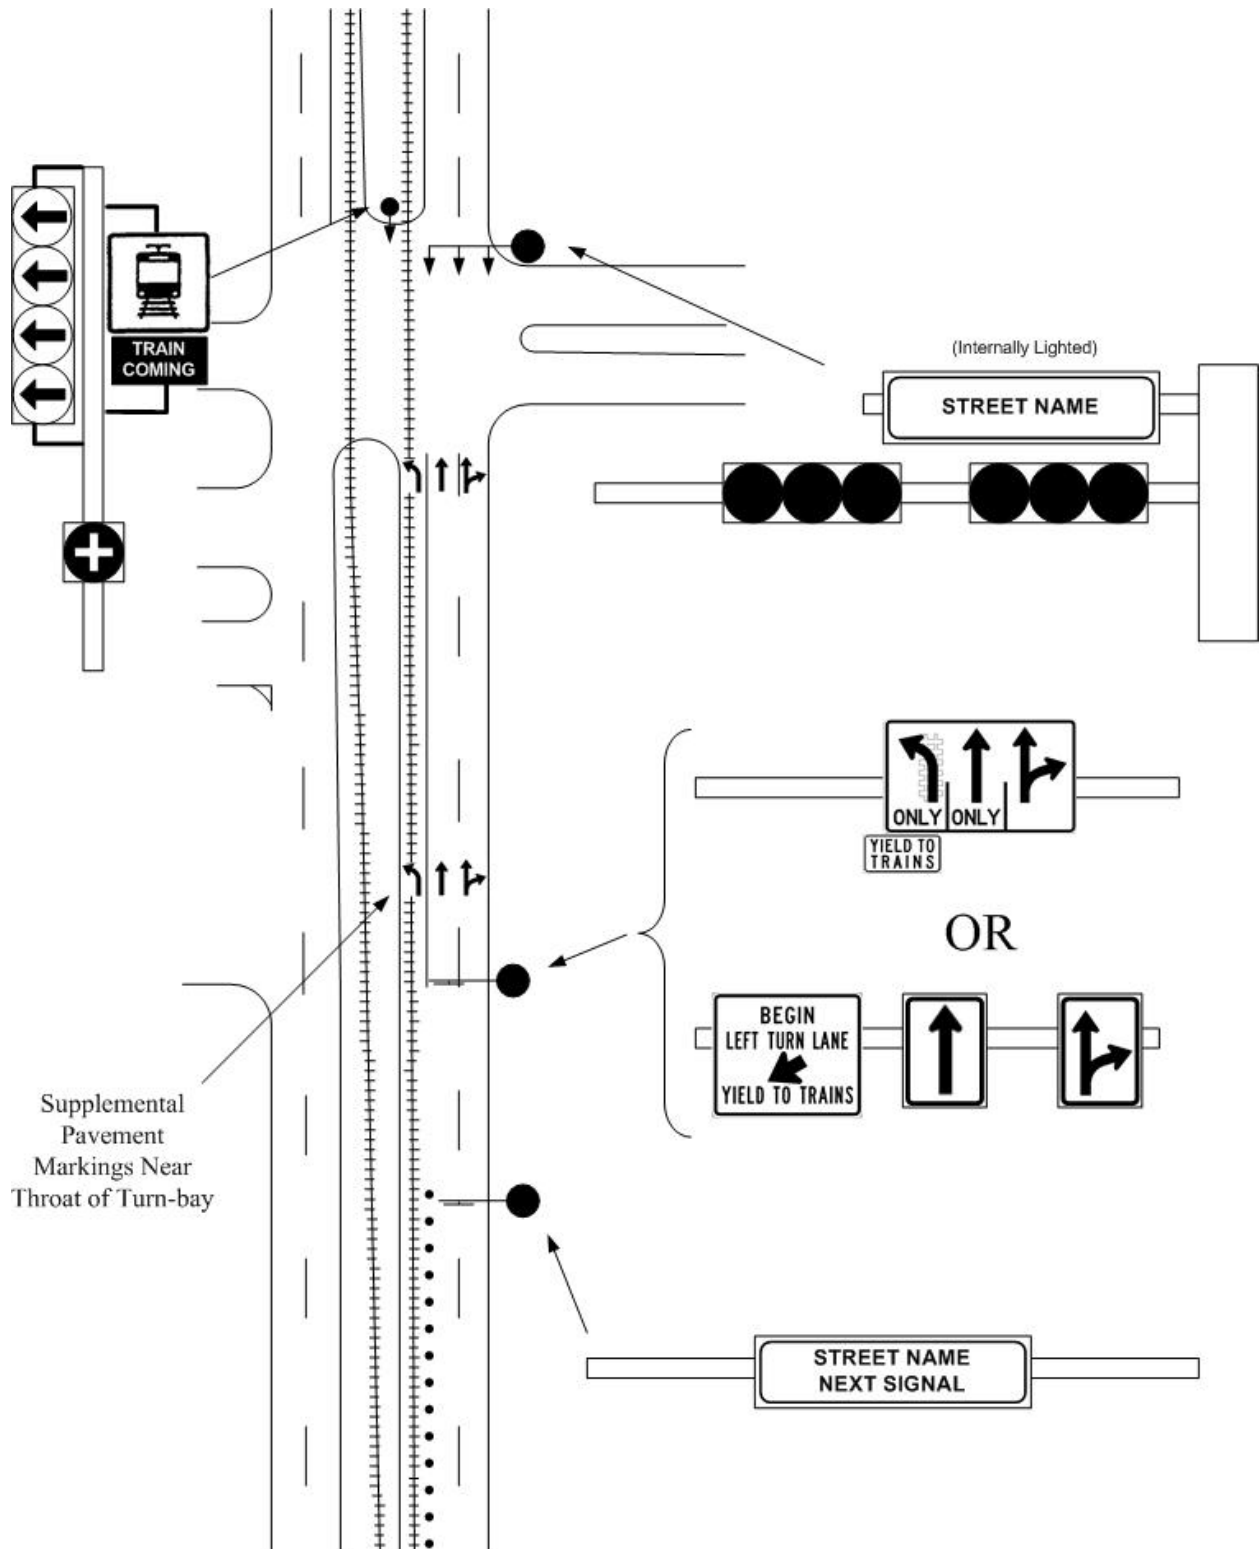
Figure 10. Possible New Mid-Block Lane Assignment Sign with Active Train Warning in Median.

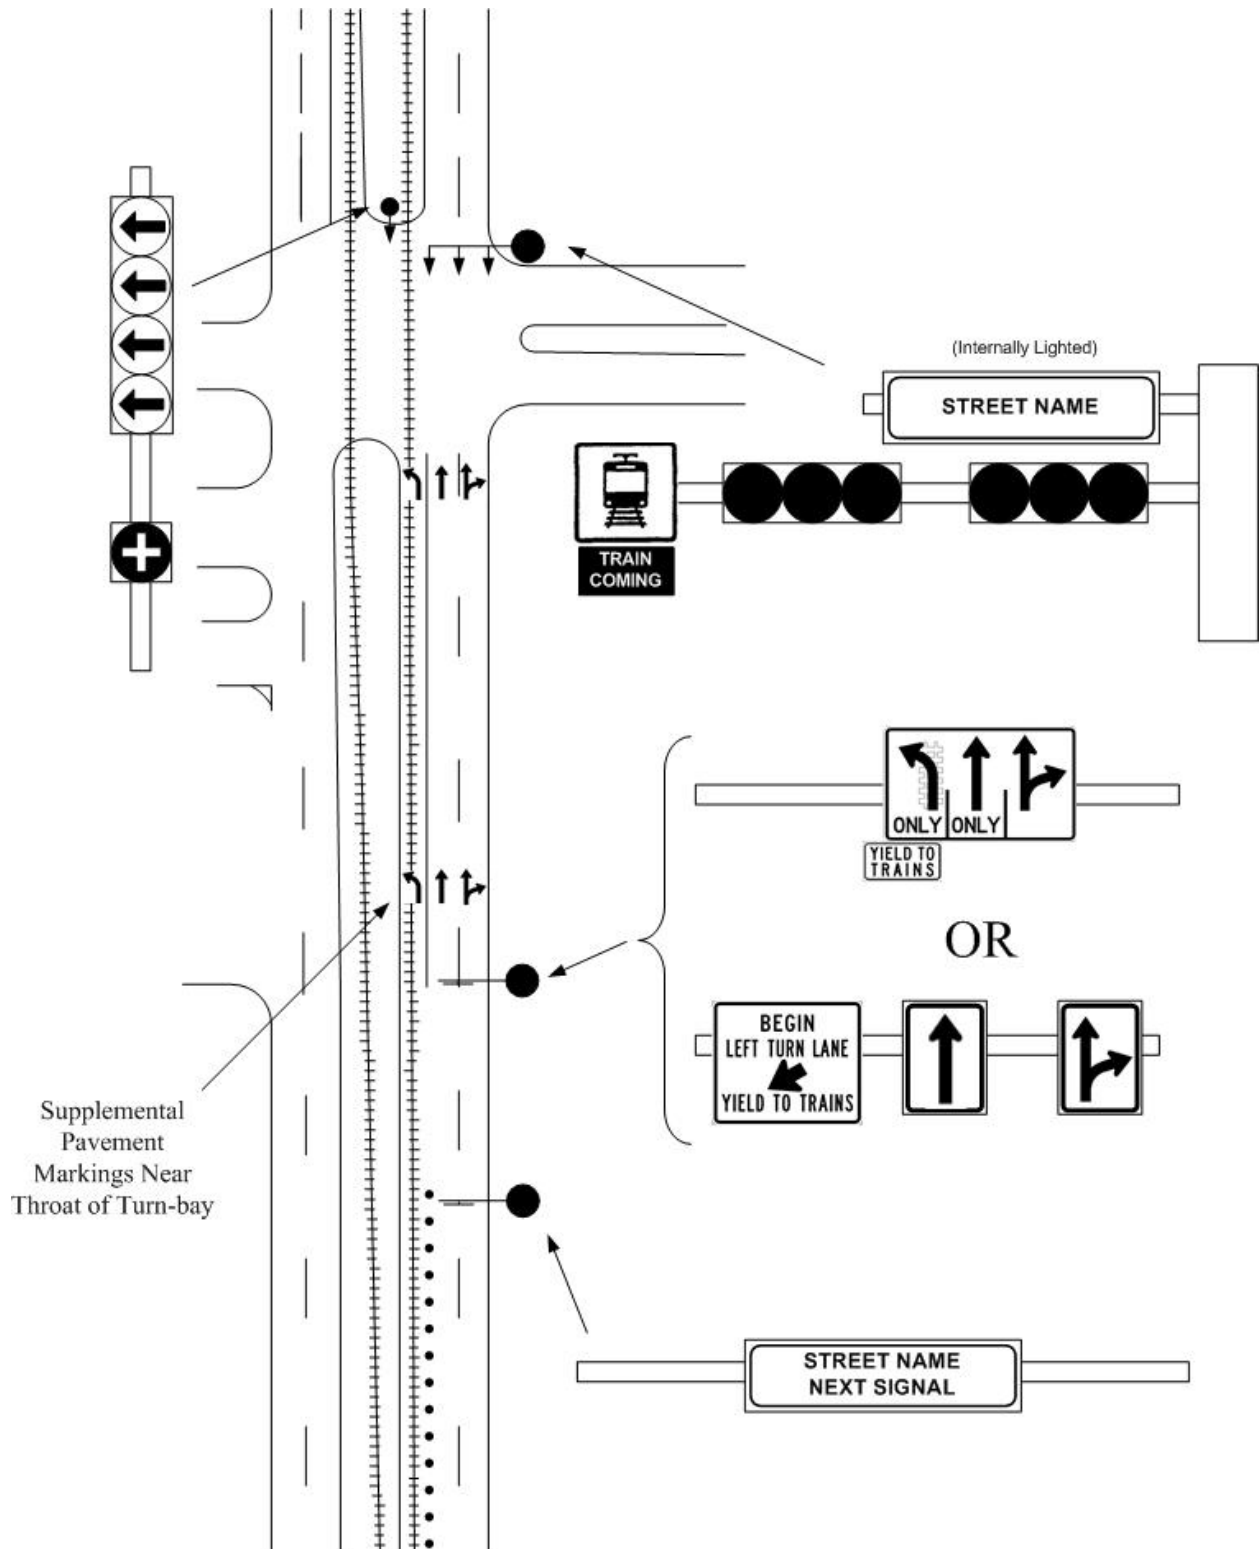
Figure 11. Possible New Mid-Block Lane Assignment Sign with Active Train Warning in Existing Location.

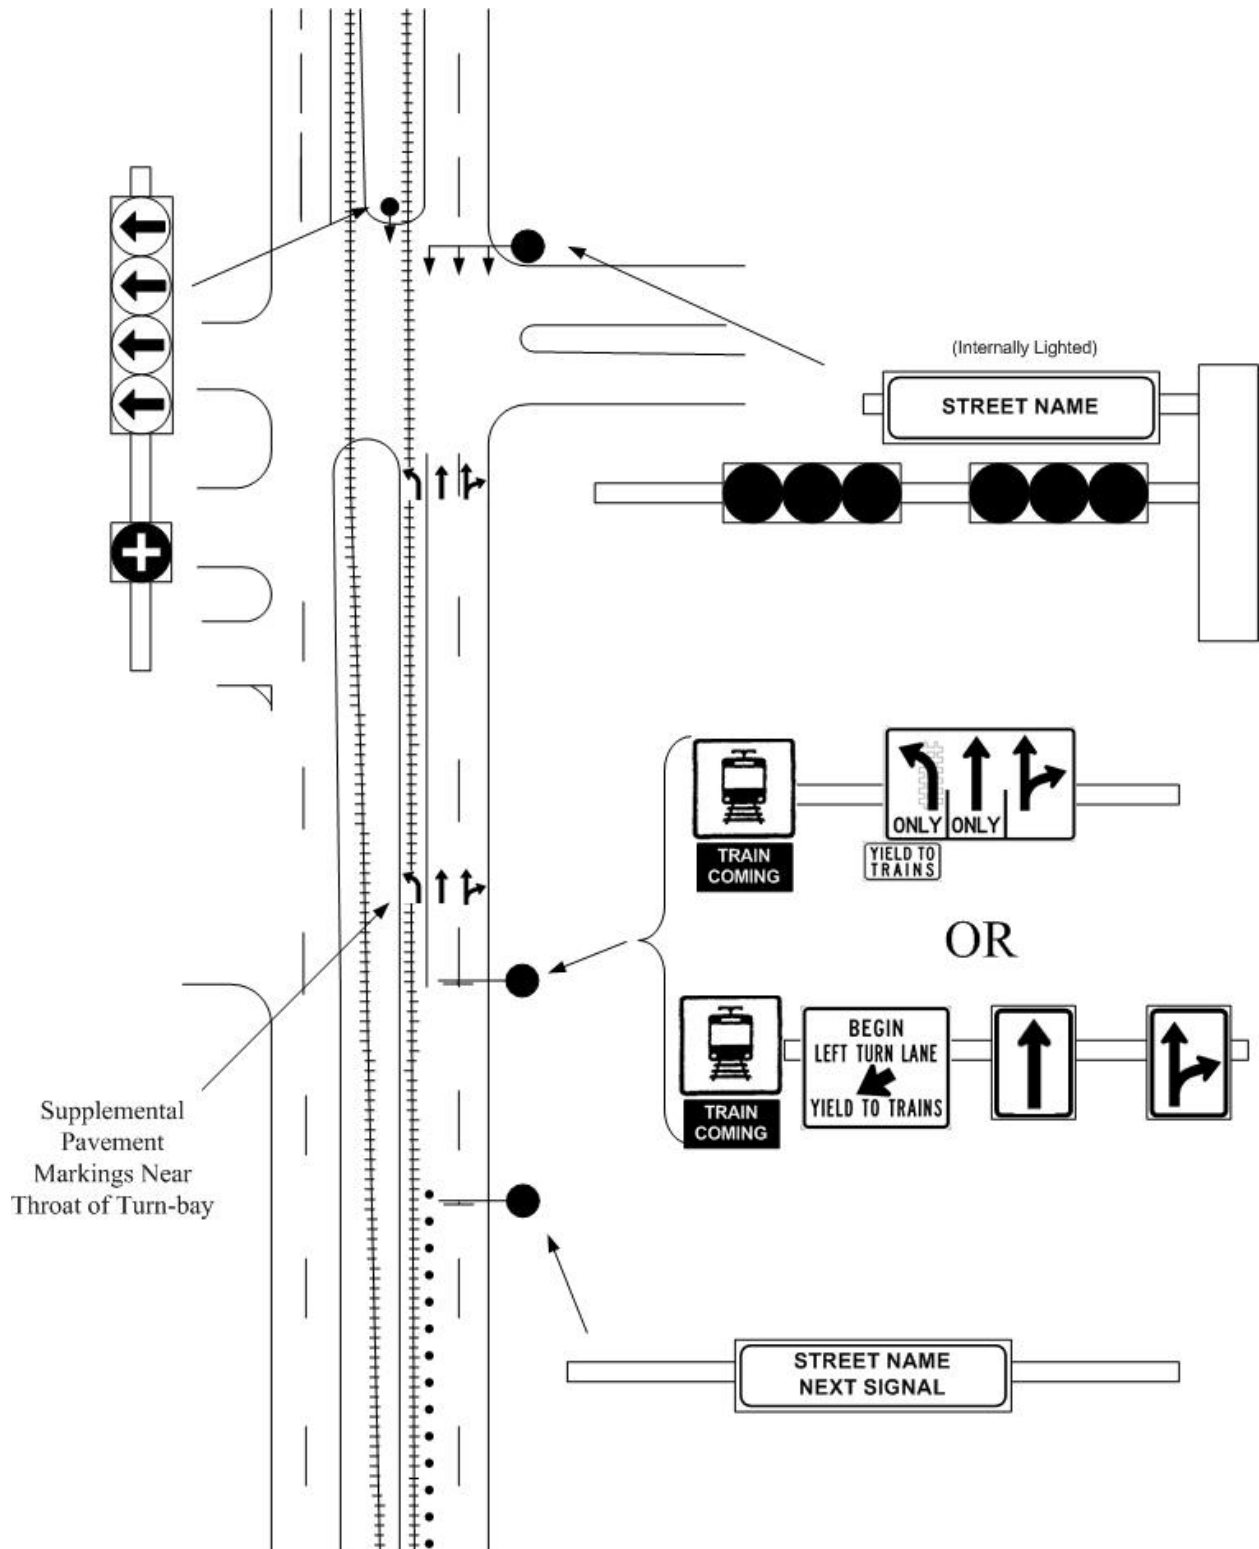
Figure 12. Possible New Mid-Block Lane Assignment Sign with Active Train Warning on Upstream Mast Arm.
