# **NATIONAL TRANSPORTATION SAFETY BOARD**

## **AIRCRAFT ACCIDENT REPORT**

**AIR CANADA FLIGHT 797  
McDONNELL DOUGLAS DC-9-32, C-FTLL  
GREATER CINCINNATI  
INTERNATIONAL AIRPORT  
COVINGTON, KENTUCKY  
JUNE 2, 1983**

**NTSB/AAR-86/02  
(SUPERSEDES - - NTSB/AAR-84/09)**

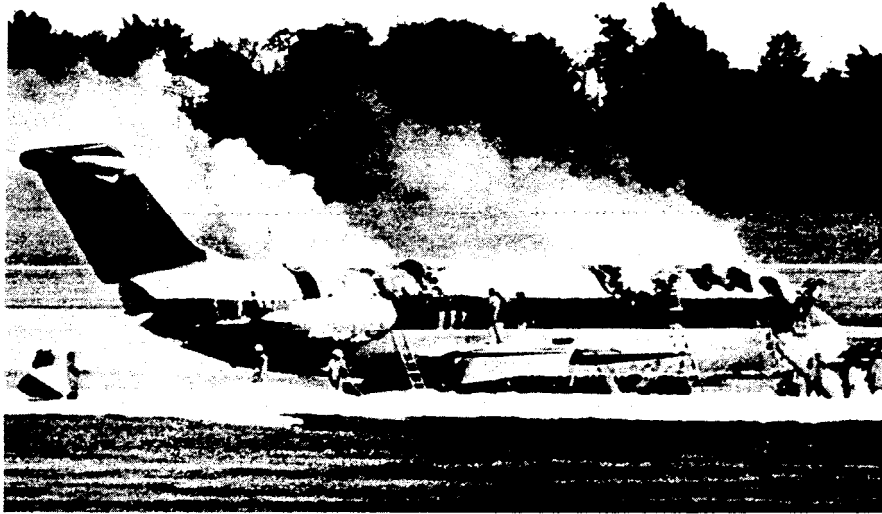
Figure 2.-Airplane after fire burned through top of fuselage.

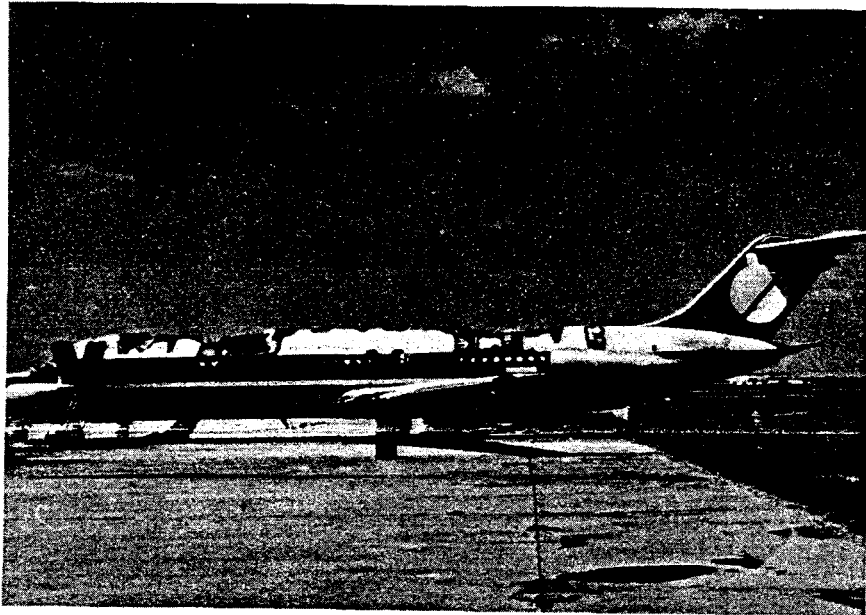
The cabin area of the upper fuselage down to below the level of the cabin windows was damaged heavily by fire; below that level the fuselage was relatively intact. The majority of the cabin windows were either missing or had partially melted out. (See figures 3 and 4.) Forward of the aft pressure bulkhead, the upper areas of the cabin windows were discolored and burned away in several locations. The fuselage skin above the left aft lavatory was intact, but a rectangular area corresponding closely to the shape of the lavatory had been discolored to dark brown and a large area of paint had been burned away. The rectangular area began above the engine pylon and extended to the top of the fuselage. (See figures 3 and 4.)

Figure S.-Left side of the airplane.

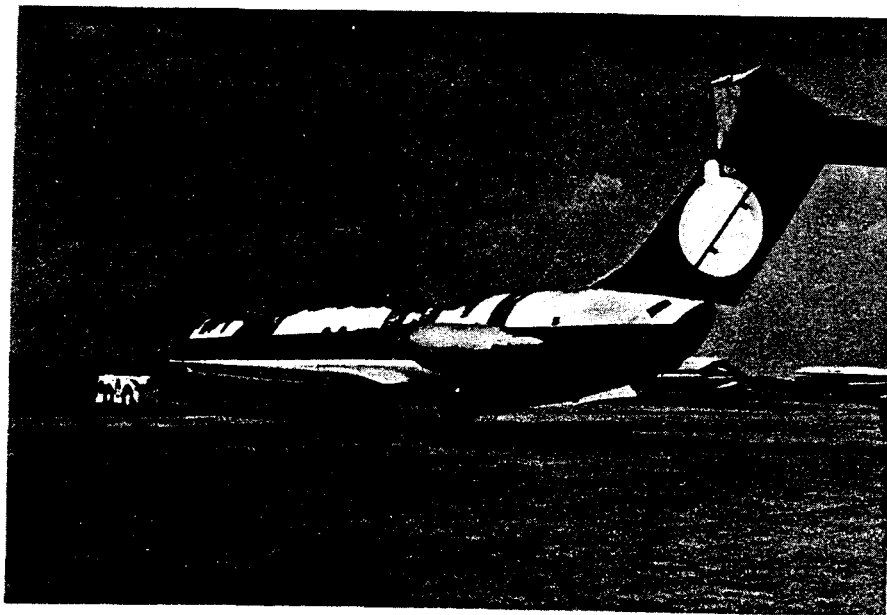
Figure 4.-Left side of the airplane, rear view, depicting rectangular burn pattern and Soot trail. .

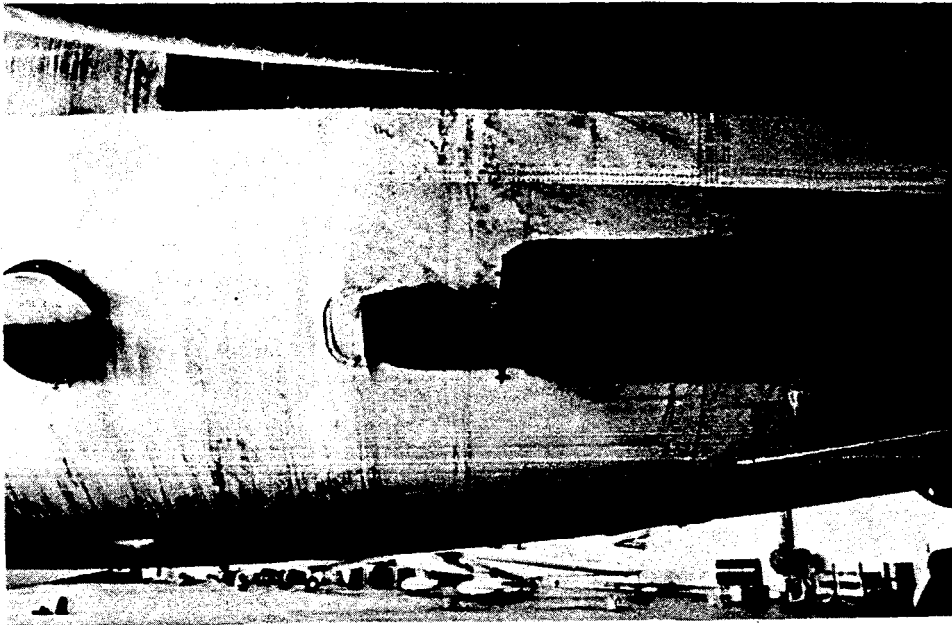
There were thick soot deposits along the lower side of the fuselage beginning at the cabin air outflow valve at FS 945 and from around the access **door** in the lavatory service panel at FS 965. The soot pattern trailed rearward along the airplane's side,

including the tailcone. The cabin air dump valve, at FS 920, was open, and light soot deposits trailed aft from around the edges of the valve. (See figure 5.)

Figure S.-Soot trail deposits on left side of fuselage at lavatory, service panel and outflow valve.

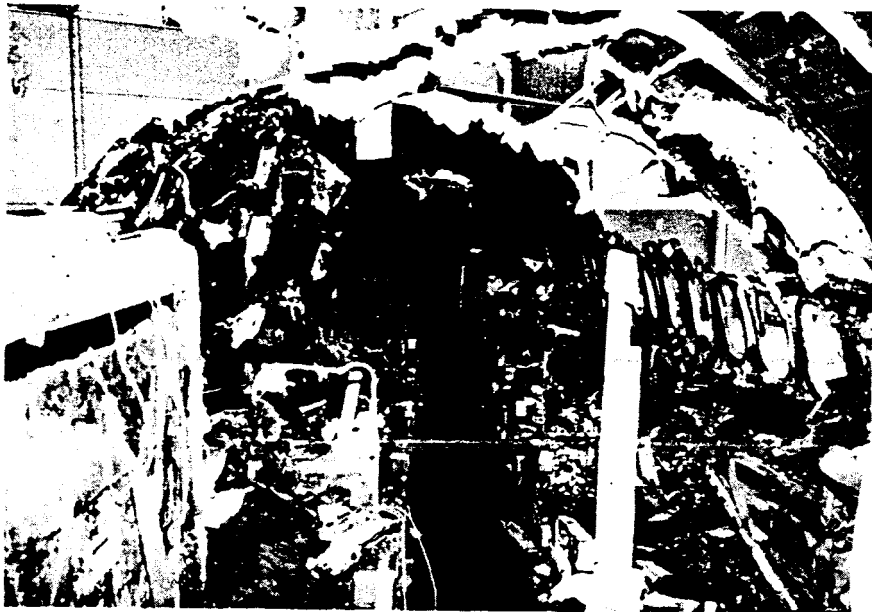
Except for the cabin floor and the aisle carpet, the entire passenger cabin back to the aft lavatory was either consumed or damaged by fire. The aisle carpet was covered by debris but had not been discolored or damaged by heat. Of the 100 passenger seats, only the seat frames and cushions of Nos. 12A and 12B remained intact. Seat Nos. 12A and 12B are adjacent to the left forward **overwing** emergency exit which had been opened during the passenger evacuation and had been used as access by firemen to apply water to the fire. The remaining seats were either completely or partially destroyed by the fire. (See figures 7 and 8.)

Figure 7.—Cabin interior viewed aft from the forward galley area.

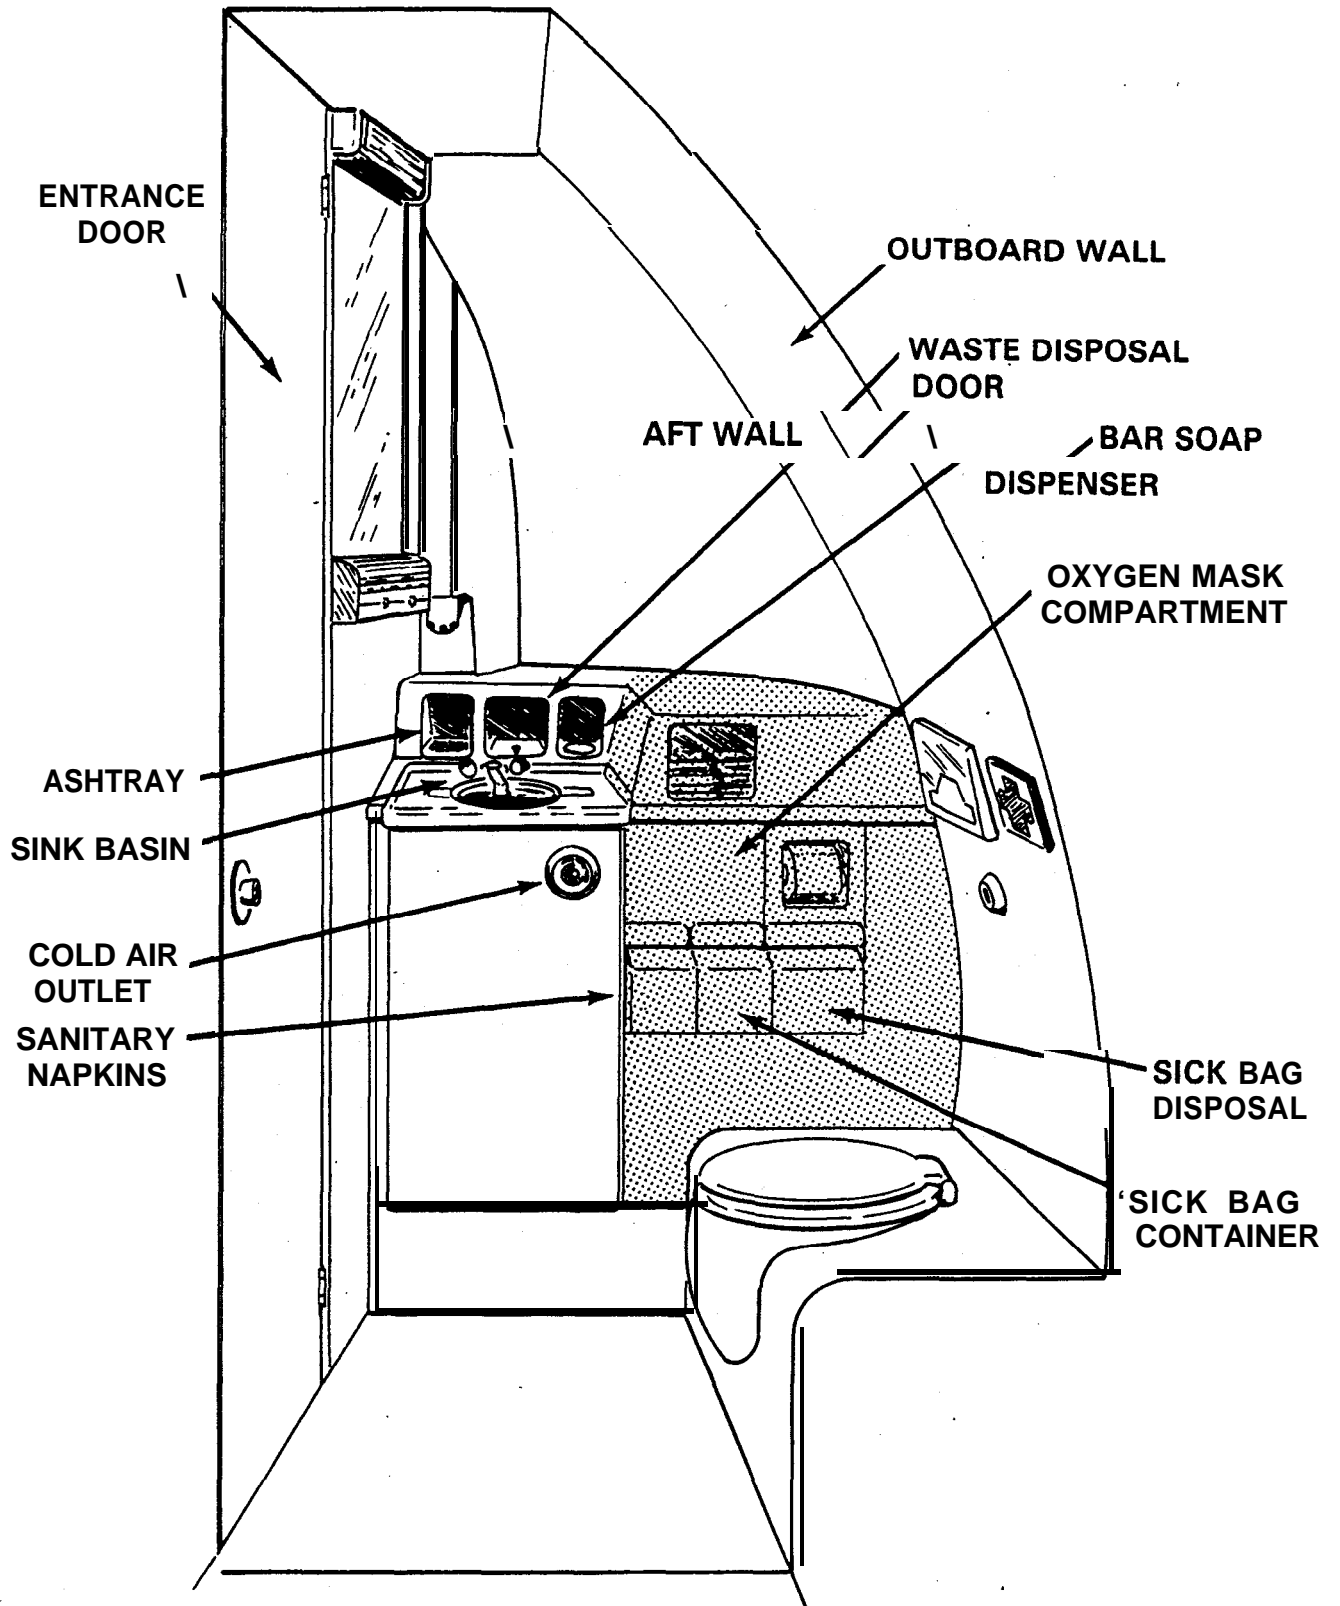
Figure 9.—Diagram of aft lavatory, viewed aft.

The aft lavatory was on the left side of the cabin, and began at FS 965 and extended aft to FS 1019, or just forward of the aft pressure bulkhead. The lavatory's outboard wall conformed essentially to the shape of the airplane's fuselage. There was a vanity section containing a stainless steel sink and amenities located along and extending forward from the aft wall. The commode containing a flushing motor was located along the lavatory's outboard wall. A trash chute and container were located below and behind the sink, and a fresh air supply outlet was positioned below the sink in the door of the vanity. Also, below the trash container, an aluminum shelf was installed. In addition, there was an oxygen outlet located in the oxygen mask compartment in the amenities section. (See figures 9 and 10.)

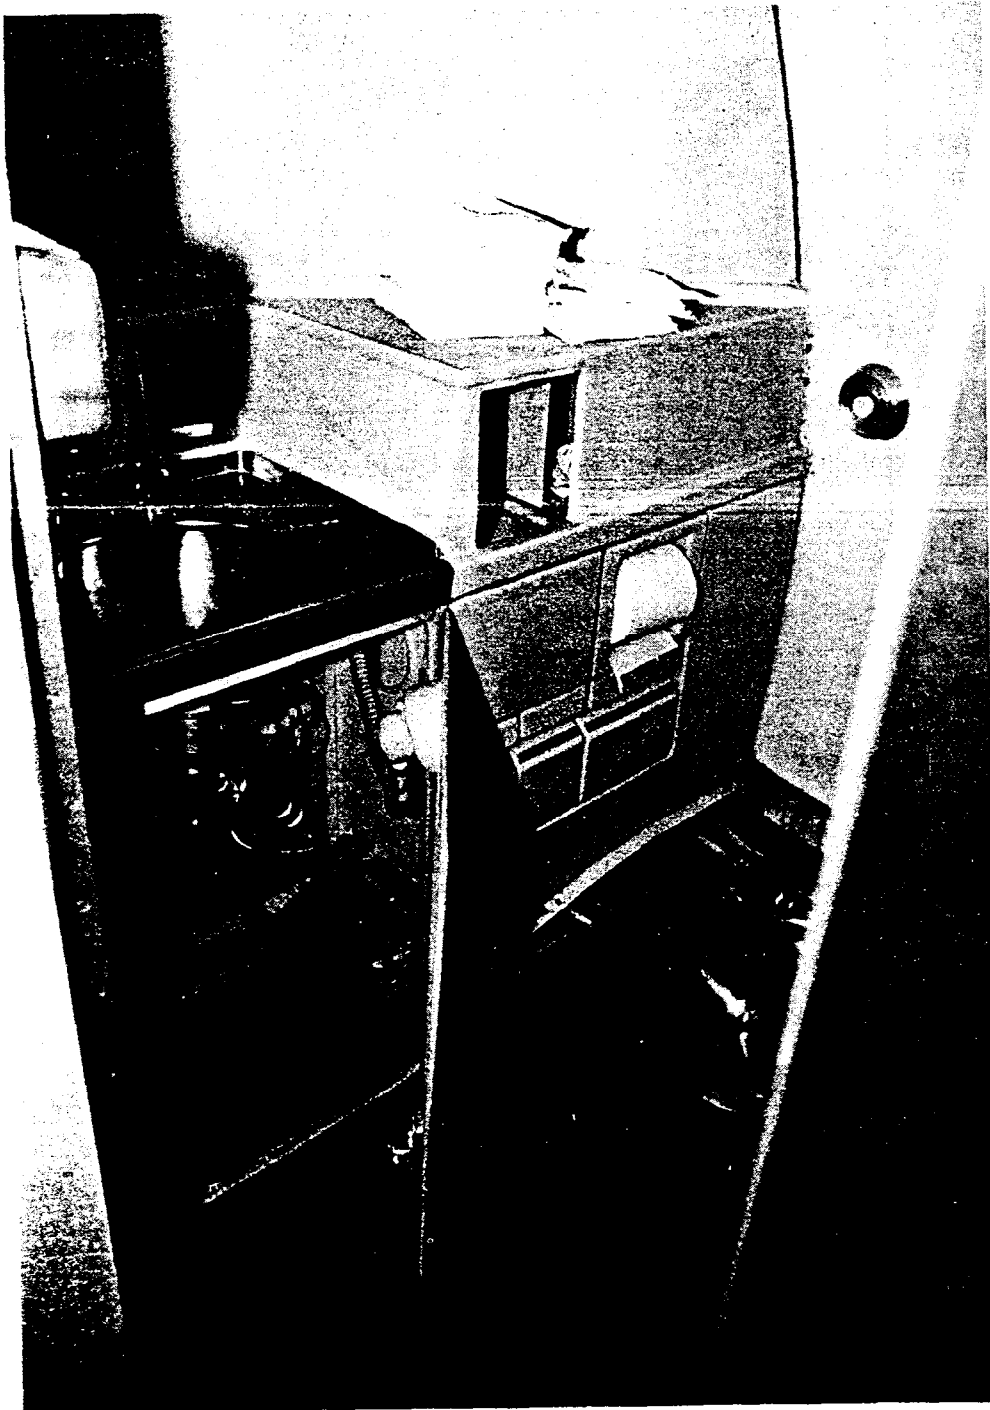
Figure 10.—Aft lavatory viewed toward aft and outboard wall.  
Lavatory sink door is open exposing trash receptacle:  
Toilet shroud has been removed showing the top of the  
flush motor between the commode and forward wall of  
the amenities section.

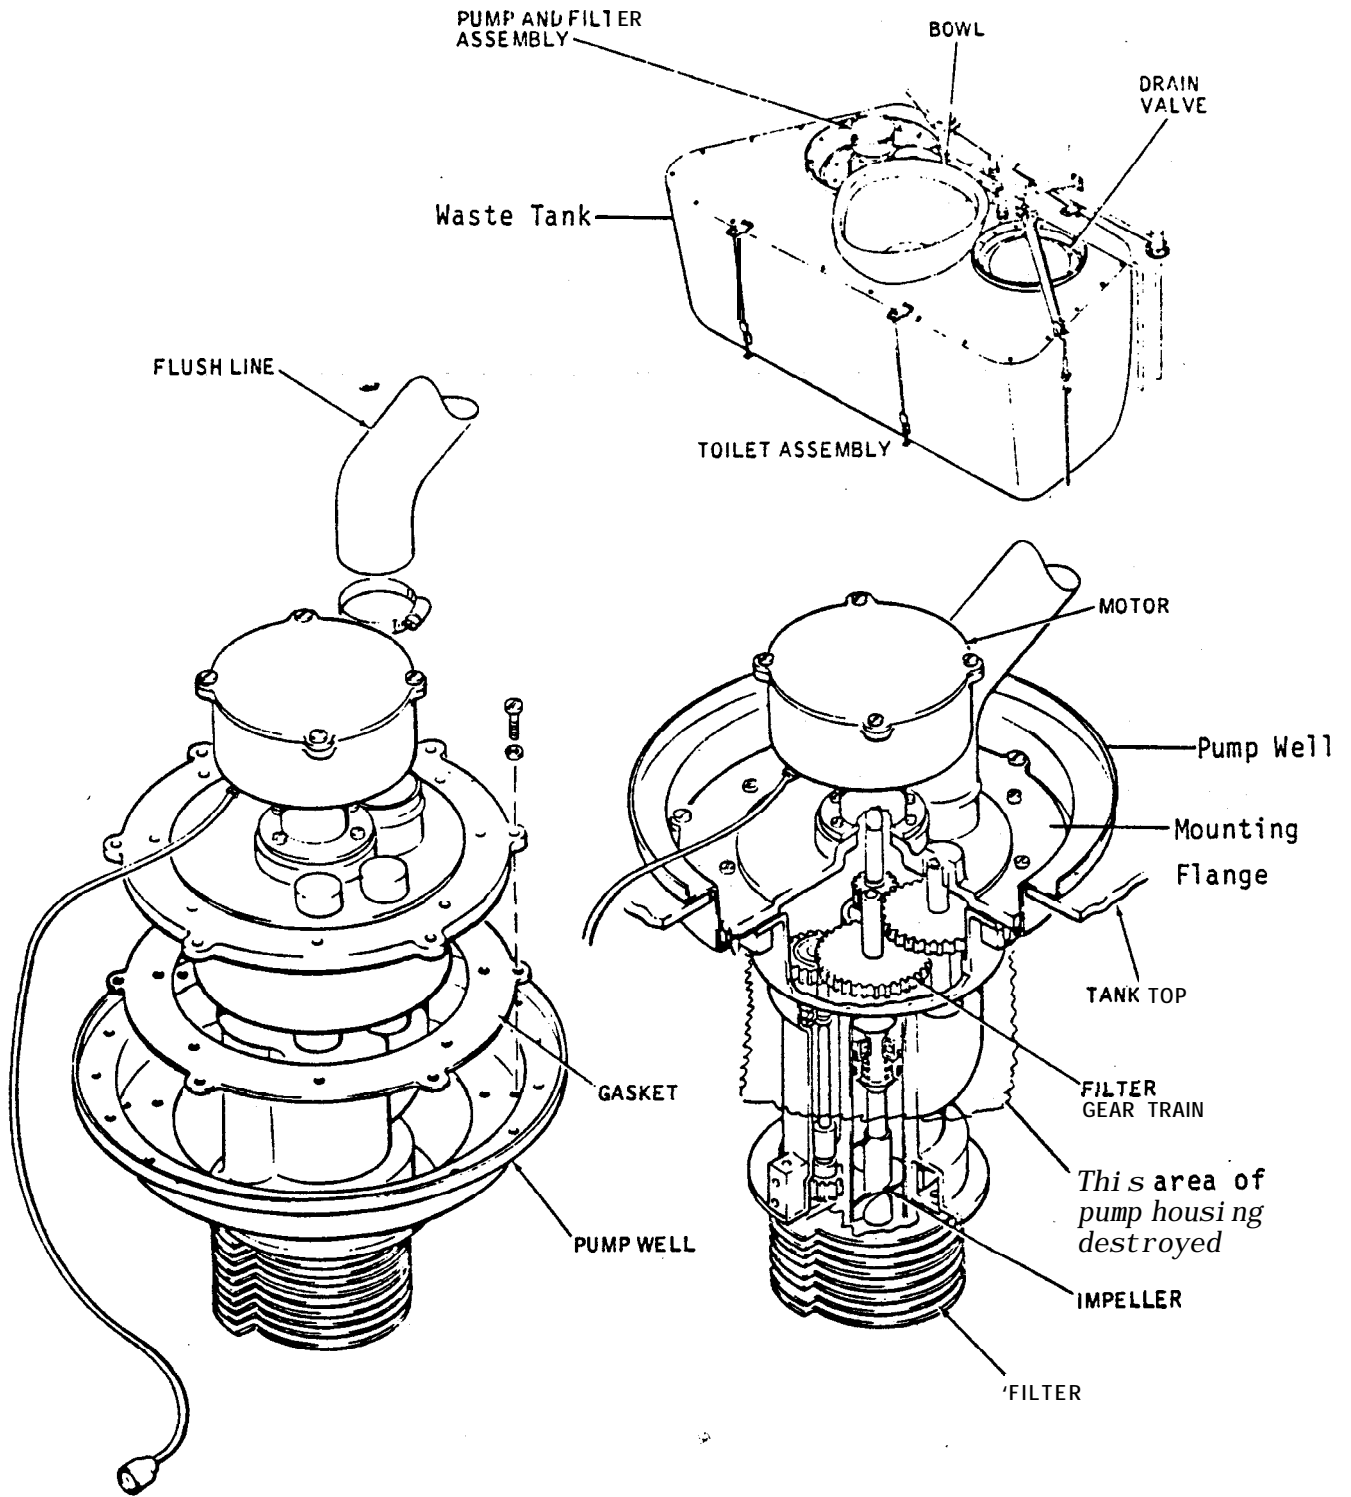
Figure 11.—Lavatory pump and filter system.

The flush motor was found attached to its mounting flange which was attached to the pump well. The flush motor assembly was found in approximately its normal position in the waste tank next to, but detached from, the flush pump and filter assembly. The motor housing was completely melted. Large concentrations of molten metal were found on the forward side of the mounting flange facing the toilet bowl, and on the aft side where the **3-phase** electrical leads enter the motor housing. A portion of the wiring harness which supplies **a.c.** power to the flush timer, flush motor, and flush button was encased in the molten metal on the aft side of the motor. The rotor section of the flush motor was encased in molten metal above the field windings; however, the rotor did not appear to have been damaged extensively by heat. (See figure 11.)
