# BUNCEFIELD MAJOR INCIDENT INVESTIGATION

Initial Report to the Health and Safety Commission and  
the Environment Agency of the investigation into the  
explosions and fires at the Buncefield oil storage and  
transfer depot, Hemel Hempstead, on 11 December 2005

Buncefield Major Incident Investigation Board

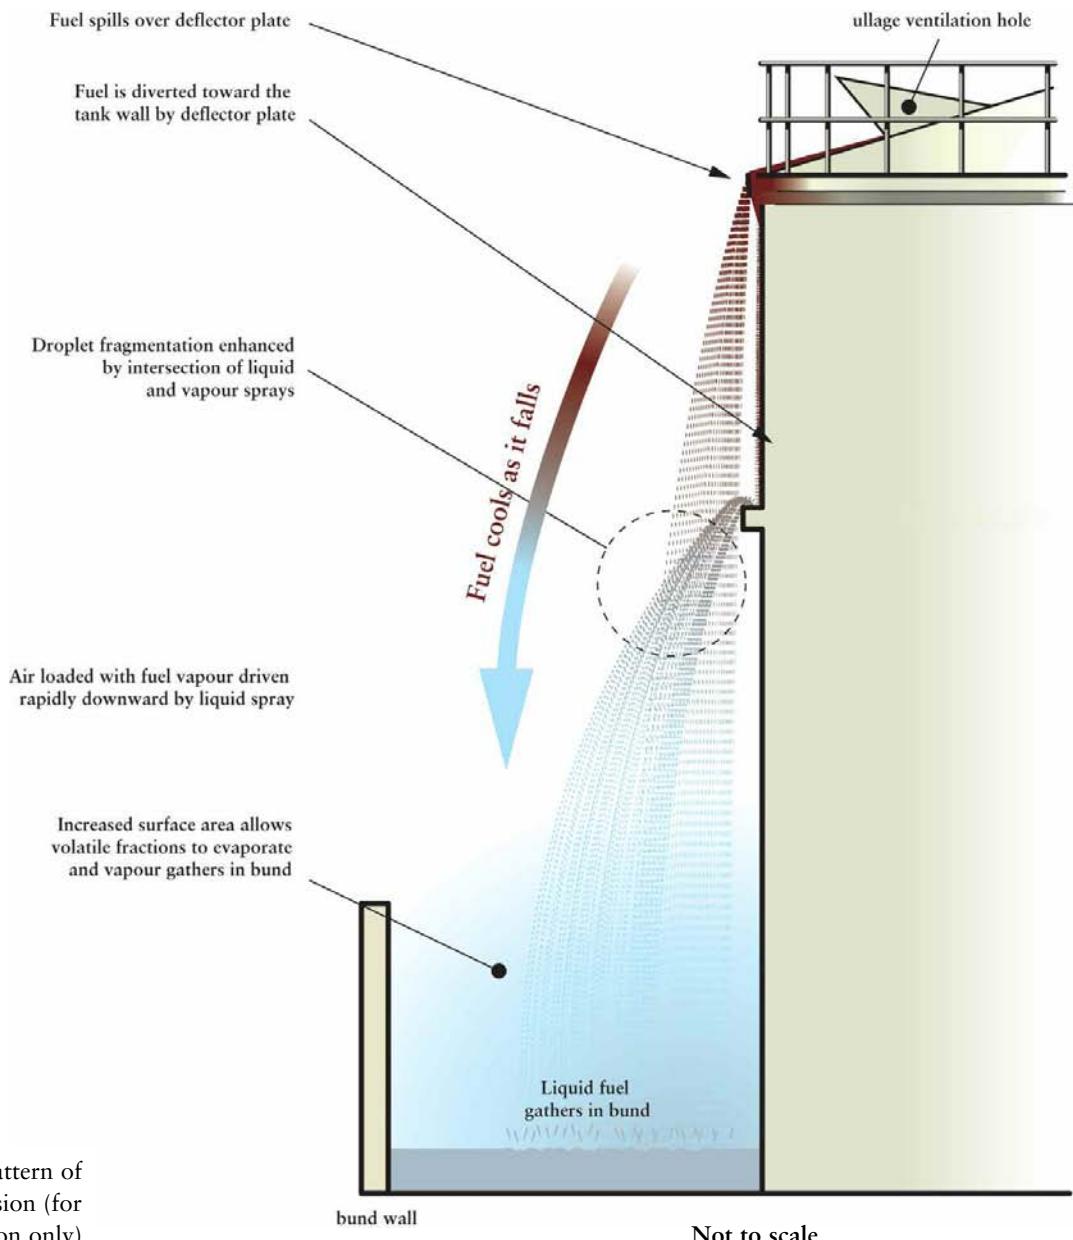
**Figure 2** The pattern of fuel dispersion (for illustration only)

25 The Third Progress Report described extensive tests undertaken to model the behaviour of fuel escaping from Tank 912 during overfilling. Tank 912 was fitted with a deflector plate, installed to direct water from sprinklers on the tank's top to its sides to provide cooling in the event of fire. The tests demonstrated that the deflector plate channelled some of the escaped fuel onto the tank wall, but the rest ran over the top of the plate, fragmenting into droplets that cascaded through the air. Most of the fuel running down the wall hit a wind girder (a structural stiffening ring) and detached from the tank wall, creating a second cascade of droplets.

26 These conditions would promote the evaporation of the lighter components of petrol, eg butanes, pentanes and hexanes. The free-fall of droplets leads to entrainment of air and mixing between the air and fuel vapour, and the formation of a rich fuel/air mixture. Cooling of the surrounding air, already saturated with water vapour by the evaporation, would cause some of the water content to precipitate as an ice mist, which is consistent with the cloud of mist visible on

CCTV. The fuel/air mixture and its accompanying ice mist were heavier than air and so were initially contained within the bund. As the volume of the mixture grew from the continuing overfilling of the tank, it flowed out of the bund, dispersing and flowing off site. Further mixing with the air would have reduced the vapour concentration to the point where significant volumes of the mixture could support an explosion.<sup>12</sup>
