AIRCRAFT ACCIDENT REPORT

BRANIFF AIRWAYS, INC.

LOCKHEED L-188, N9707C

NEAR DAWSON, TEXAS

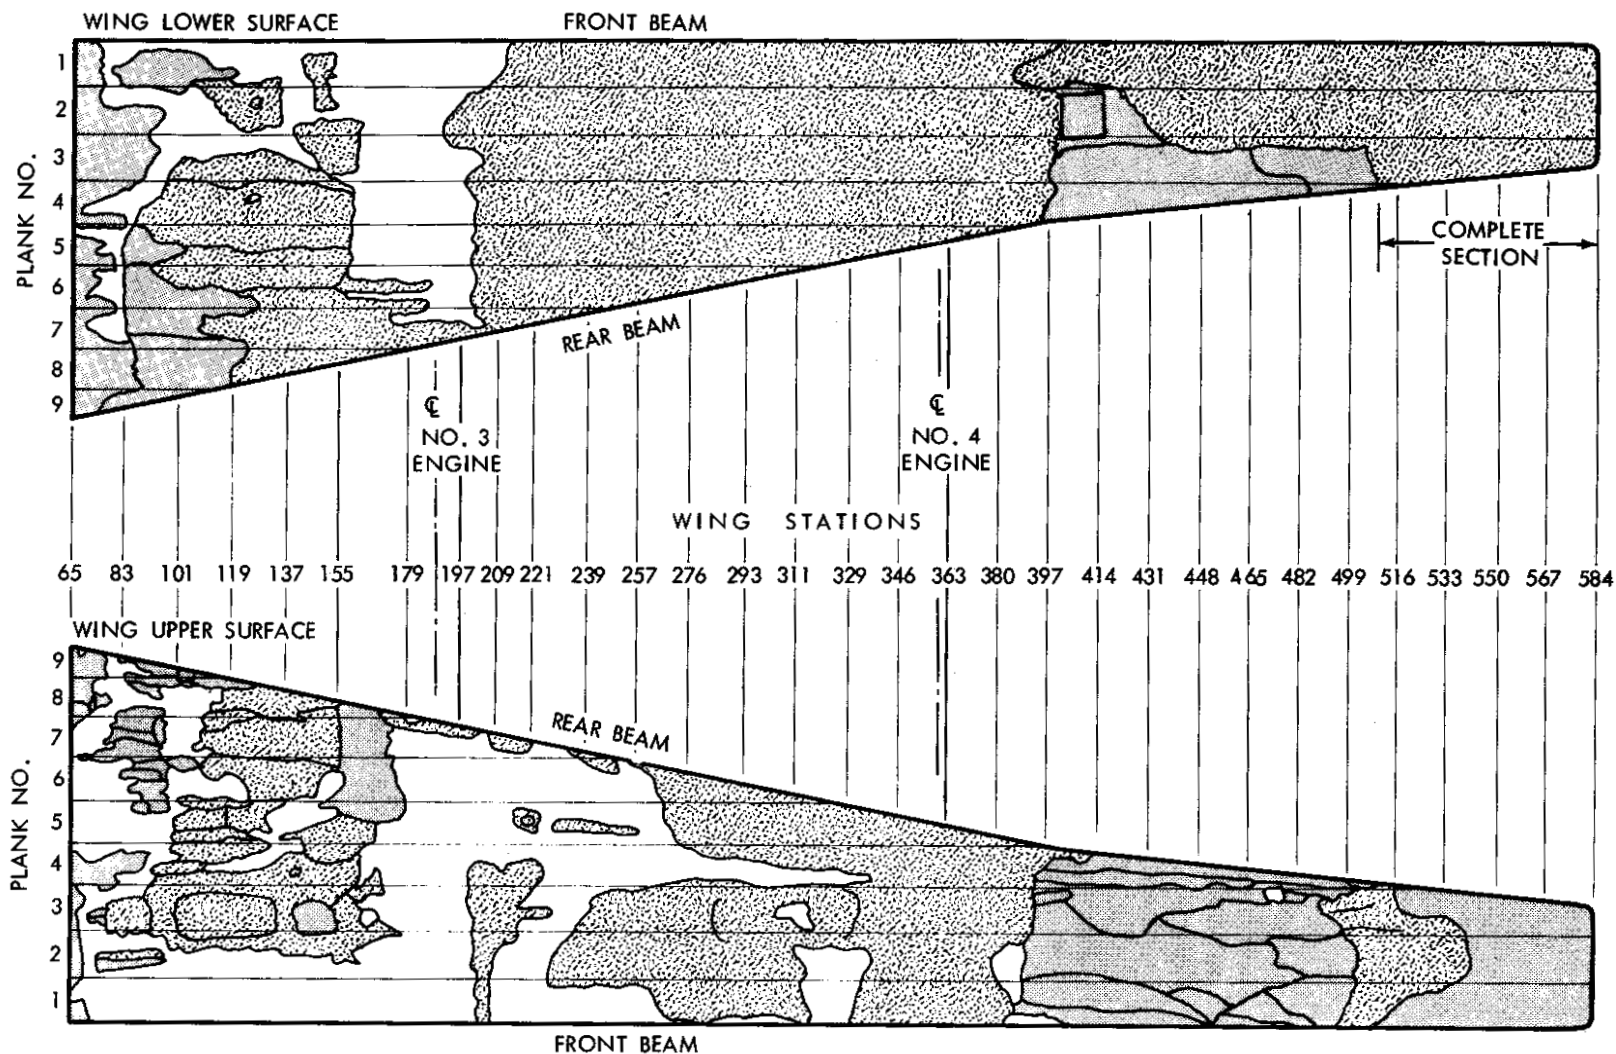
RIGHT WING PLANK LAYOUT

Most of the lower wing planks were recovered and mocked-up. This mockup revealed an irregular chordwise break between WS 70 to 100 and a very irregular diagonal break in planks Nos. 5 to 8. This fracture originated near WS 83 at the forward edge of plank No. 4 and terminated near WS 122 at the rear beam, with a maximum outboard projection nearly to WS 137 along the juncture of planks Nos. 6 and 7.

The failures in the forward half of the wing box section lower planking between WS 83 and 101 were primarily tension failures. Damage in the rear half of the rupture resembled the type of damage which would be produced by torsional loads, with the torsion operating counterclockwise when viewed from the wingtip.
