# The Ladbroke Grove Rail Inquiry

## Part 1 Report

**The Rt Hon Lord Cullen PC**

- 1.1 This Inquiry arises out of the crash at Ladbroke Grove Junction on 5 October 1999 between trains operated by Thames Trains and First Great Western (FGW), which caused considerable loss of life and injuries. Part 1 of the Inquiry is concerned with the investigation of the causes of the crash and the circumstances in which it occurred, lessons which should be drawn from what happened, and recommendations for the improvement of safety in the future.

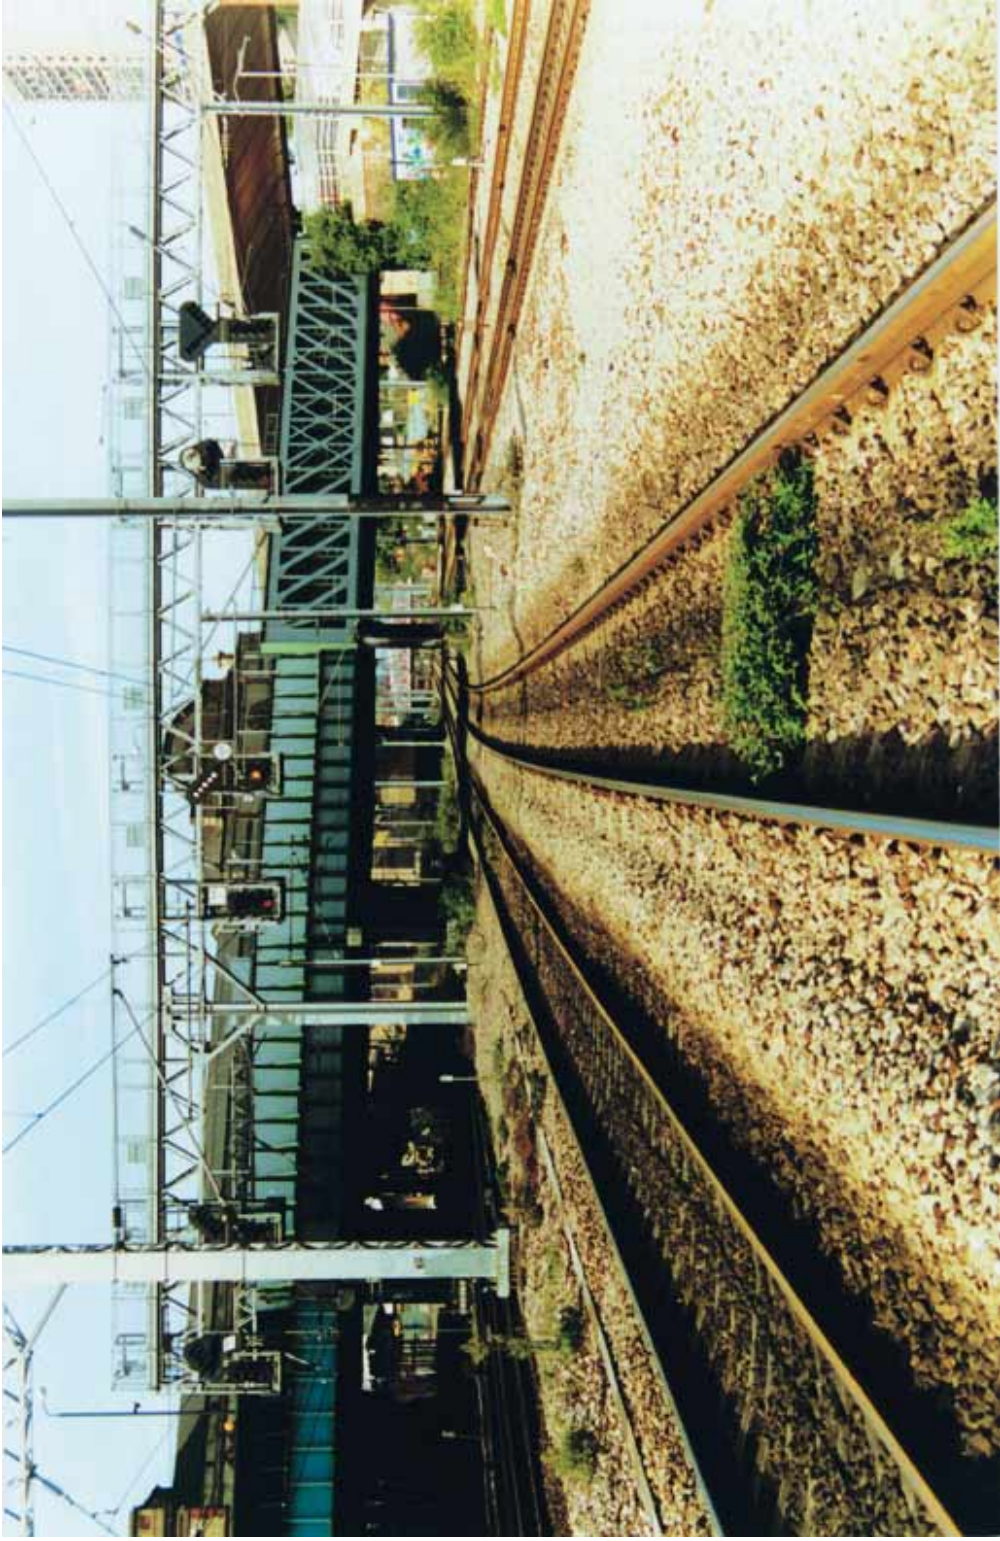
**Plate 1:** Gantry 6 showing, from left to right, signals SN81, SN83, SN85, SN87, SN89 and SN91. Taken from ground level on Line 4, to which SN87 applies.

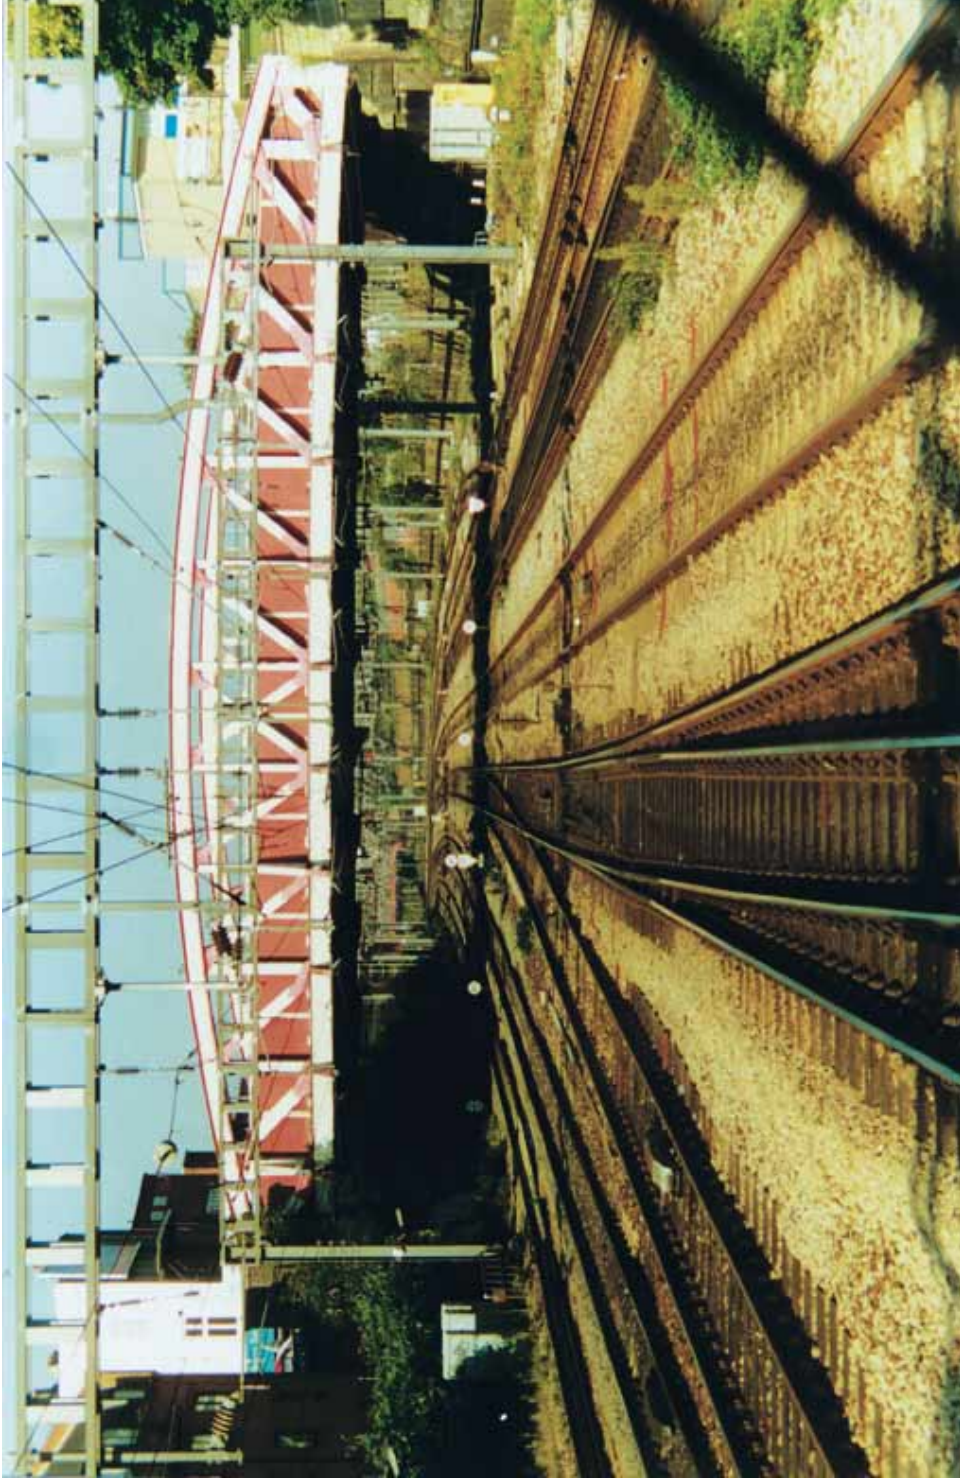
**Plate 2:** Gantry 8 at a distance of 218 metres. Taken from the driver's position in a Class 165 Turbo on the Line 4 to Line 3 crossover. Its signals, from left to right, are SN107, SN109, SN111, SN113 and SN115. SN105 is carried by a post at the trackside.

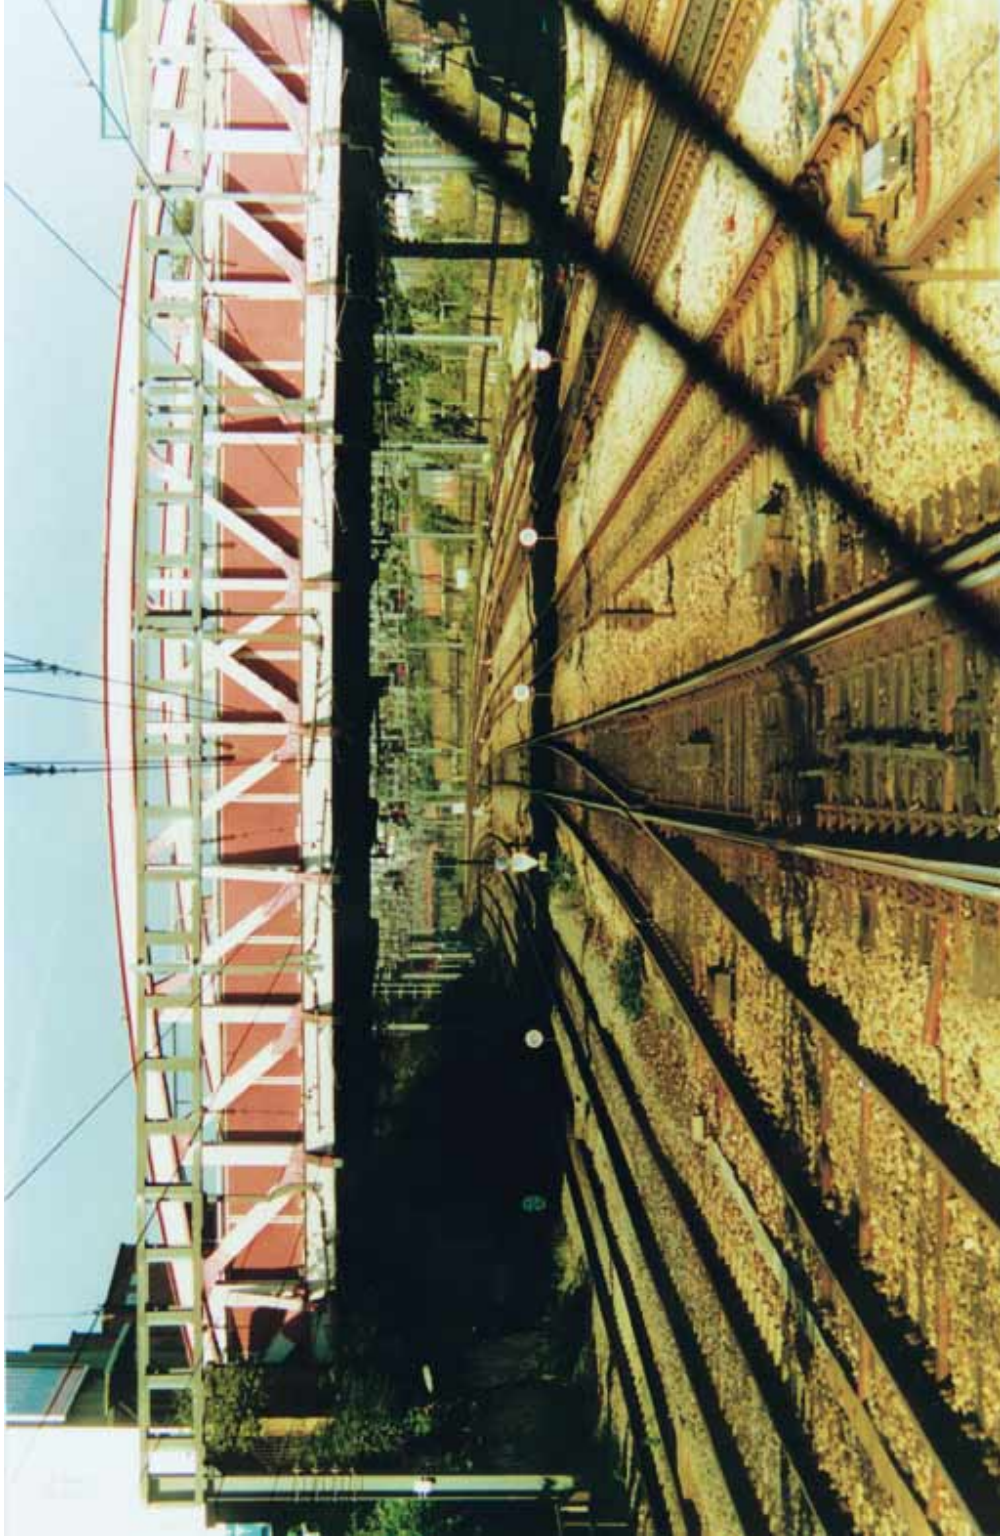
**Plate 3:** Gantry 8 at a distance of 188 metres. Taken from the driver's position in a Class 165 Turbo on the Line 4 to Line 3 crossover.

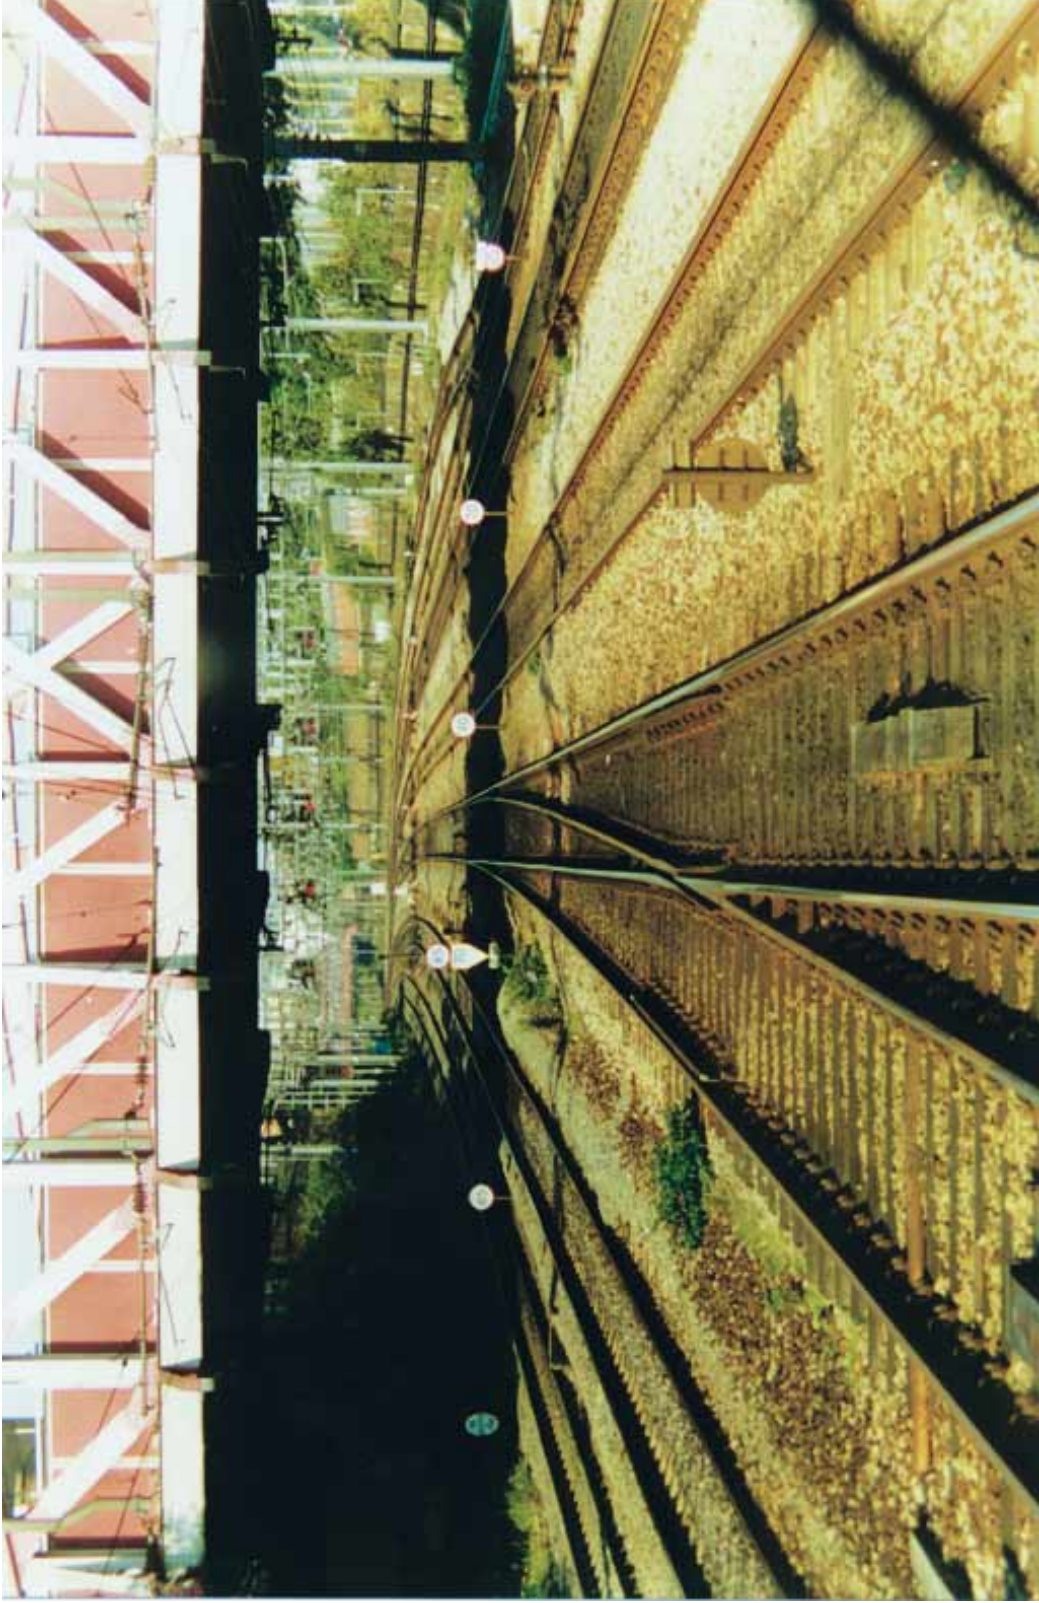
**Plate 4:** Gantry 8 at a distance of 168 metres. Taken from the driver's position in a Class 165 Turbo on Line 3.

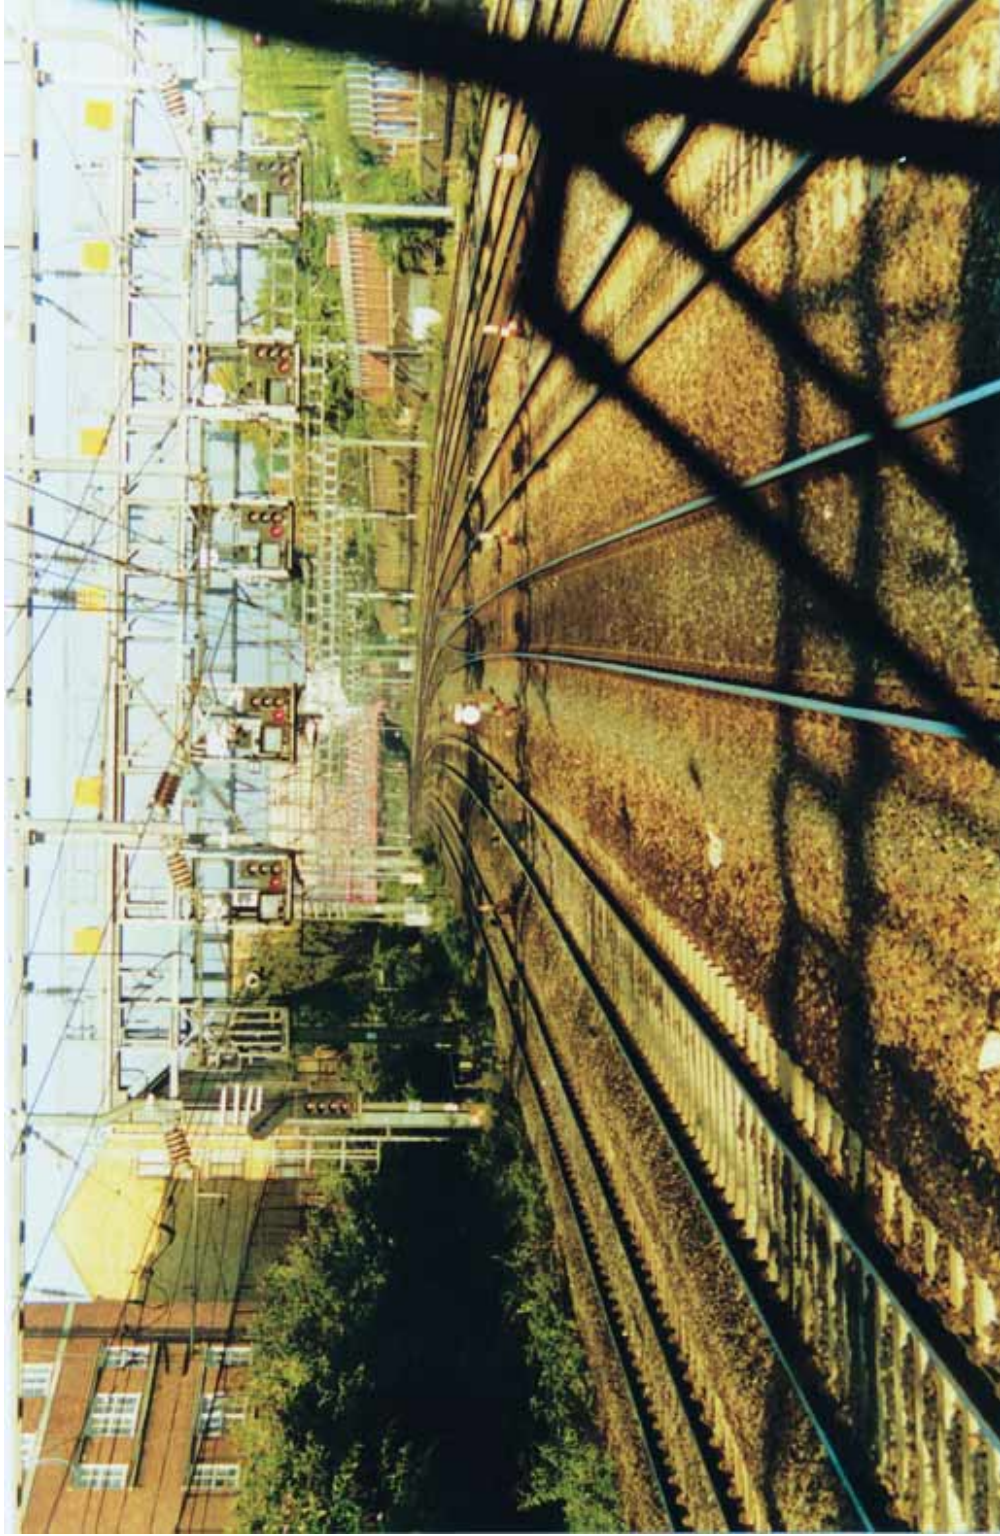
**Plate 5:** Gantry 8 at a distance of 60 metres. Taken from the driver's position in a Class 165 Turbo on Line 3, under conditions of bright sunlight, at 08:51 on 6 October 1999.

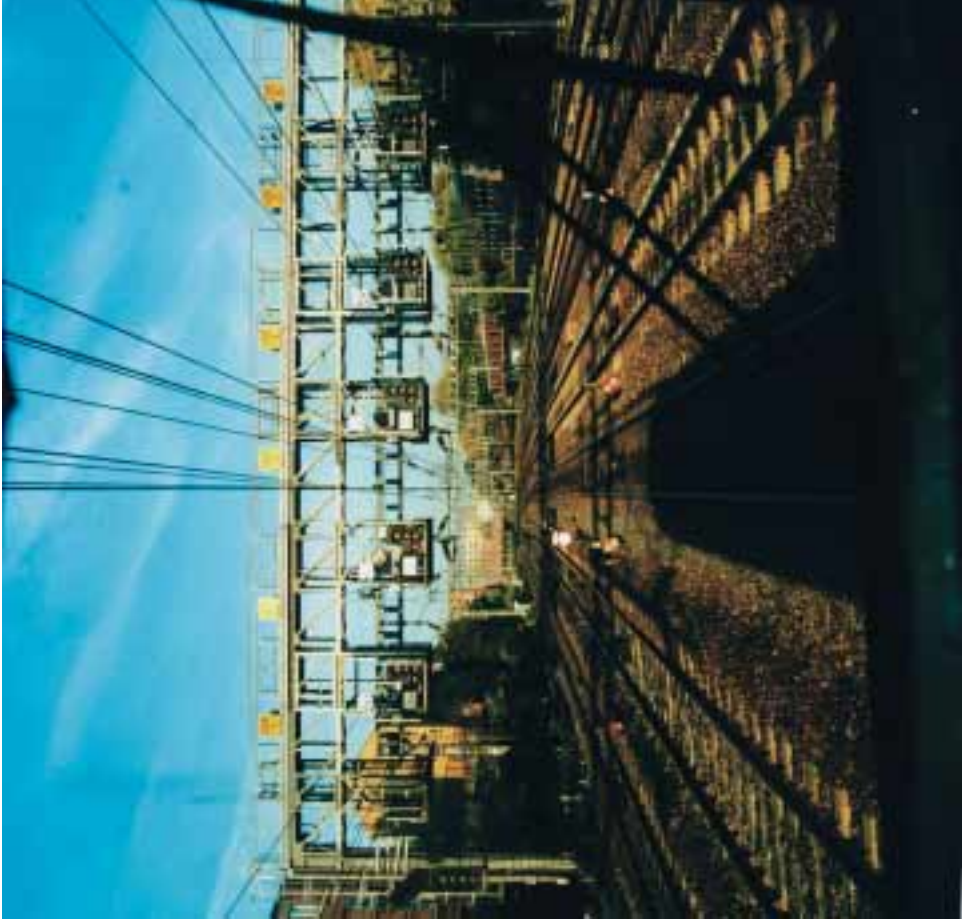
**Plate 6:** Gantry 8 at a distance of 17 metres. Taken from the driver's position in a Class 165 Turbo on Line 3, under conditions of bright sunlight, at about 08:14 on 6 October 1999.

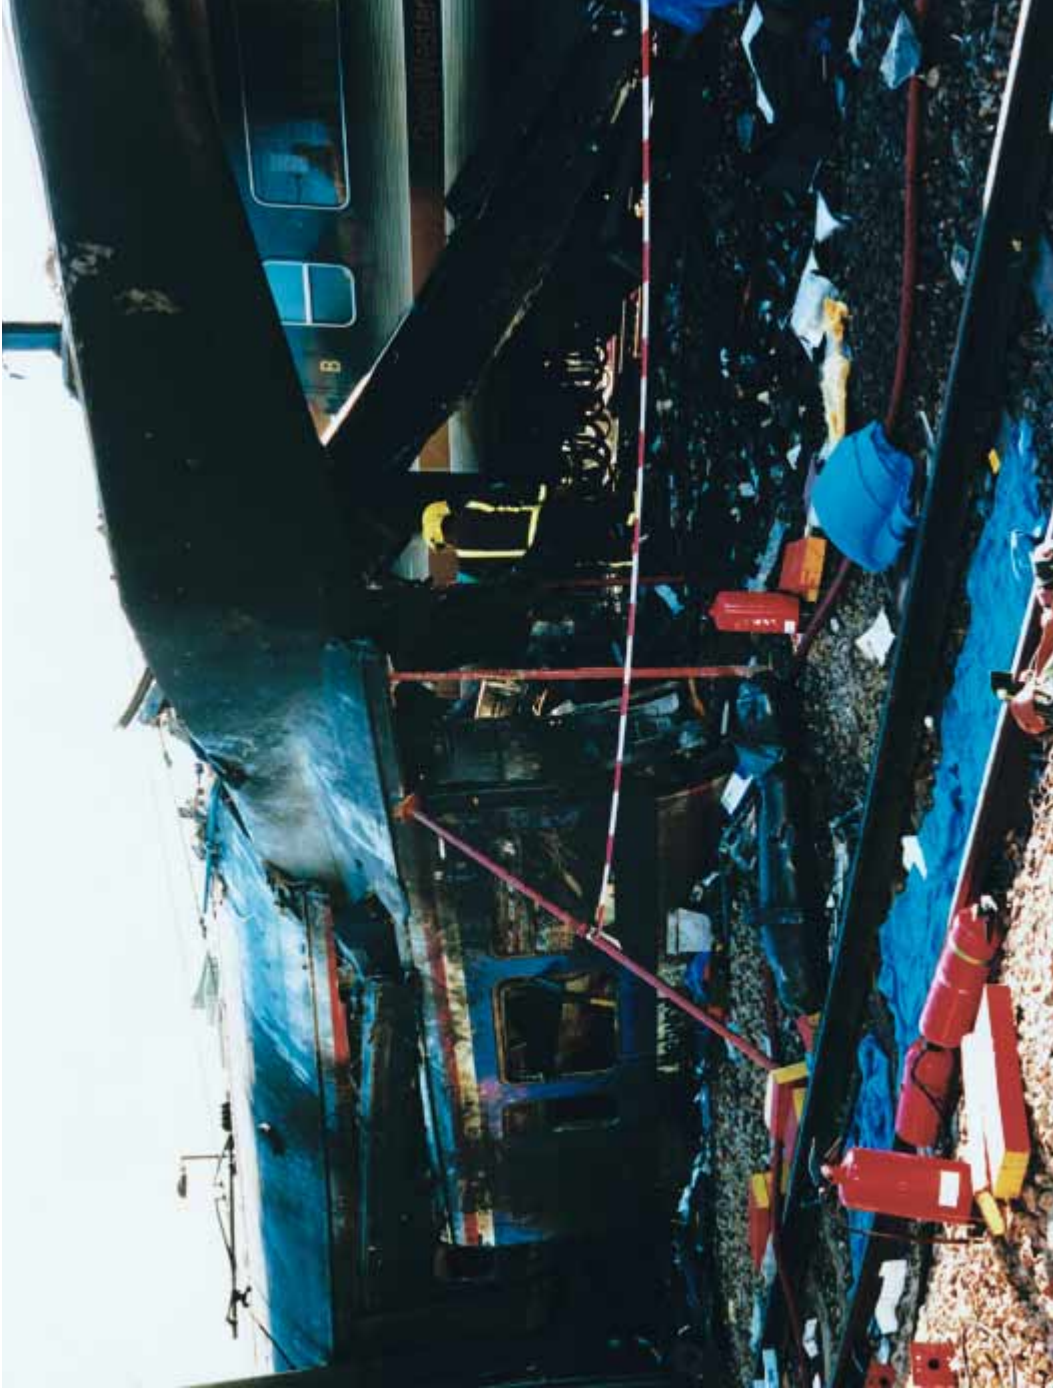
- 4.22 The most striking aspect of the crash performance of the Turbo, as was pointed out by Dr Kirk, was the complete destruction of the front car, failure along welded connections and the general absence of significant plastic deformation in the parent material of the body shells. The Turbos were designed to meet the relevant proof loading requirements and fatigue loads of the time. They were not designed to meet the crashworthy design requirements of the standard to which I have referred above. A requirement for energy absorption was originally specified by British Rail. However, it was only for resisting collisions up to 18 metres per second, and the requirement was in any event subsequently withdrawn with the approval of the HMRI. The reason for the withdrawal was the unknown difficulties and duration involved in complying with the then “untried and underdeveloped” standard which imposed energy absorption. (That standard was overtaken by a simplified version in 1992.) Accordingly British Rail instructed BREL not to proceed with providing cab ends which were capable of being retrospectively fitted with means of energy absorption. The design did not feature crumple zones, shear-out couplers or anti-climbers. However, the total kinetic energy involved in the crash far exceeded that for which vehicle collapse regions are currently designed to cope. As was observed by Professor Sir Bernard Crossland in his report, it has to be recognised that it is impractical to design crush zones which are adequate for such very high energy. It may be noted that the weight of the HST was about 435 tonnes in total, of which 70 tonnes was the weight of its leading power car. The entire Turbo weighed about 113 tonnes.

**Plate 8:** Front and middle cars of the Thames Turbo: view from the north.

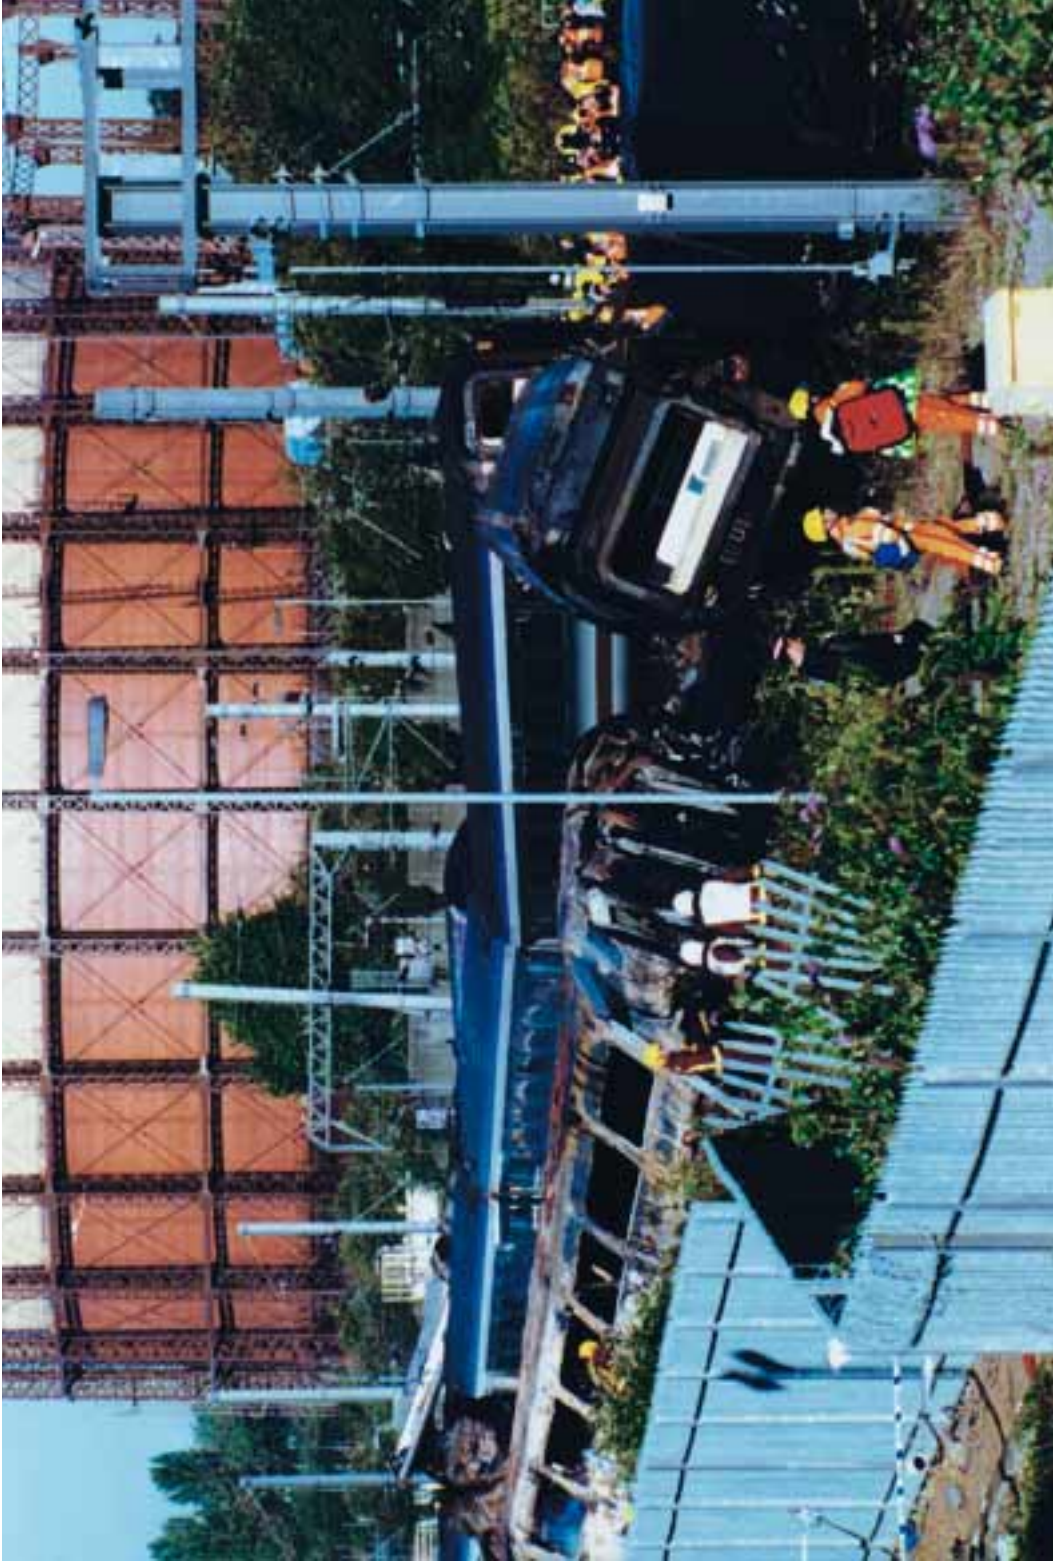
**Plate 11:** Crash site showing coaches F and H of the HST: view from the south-east.

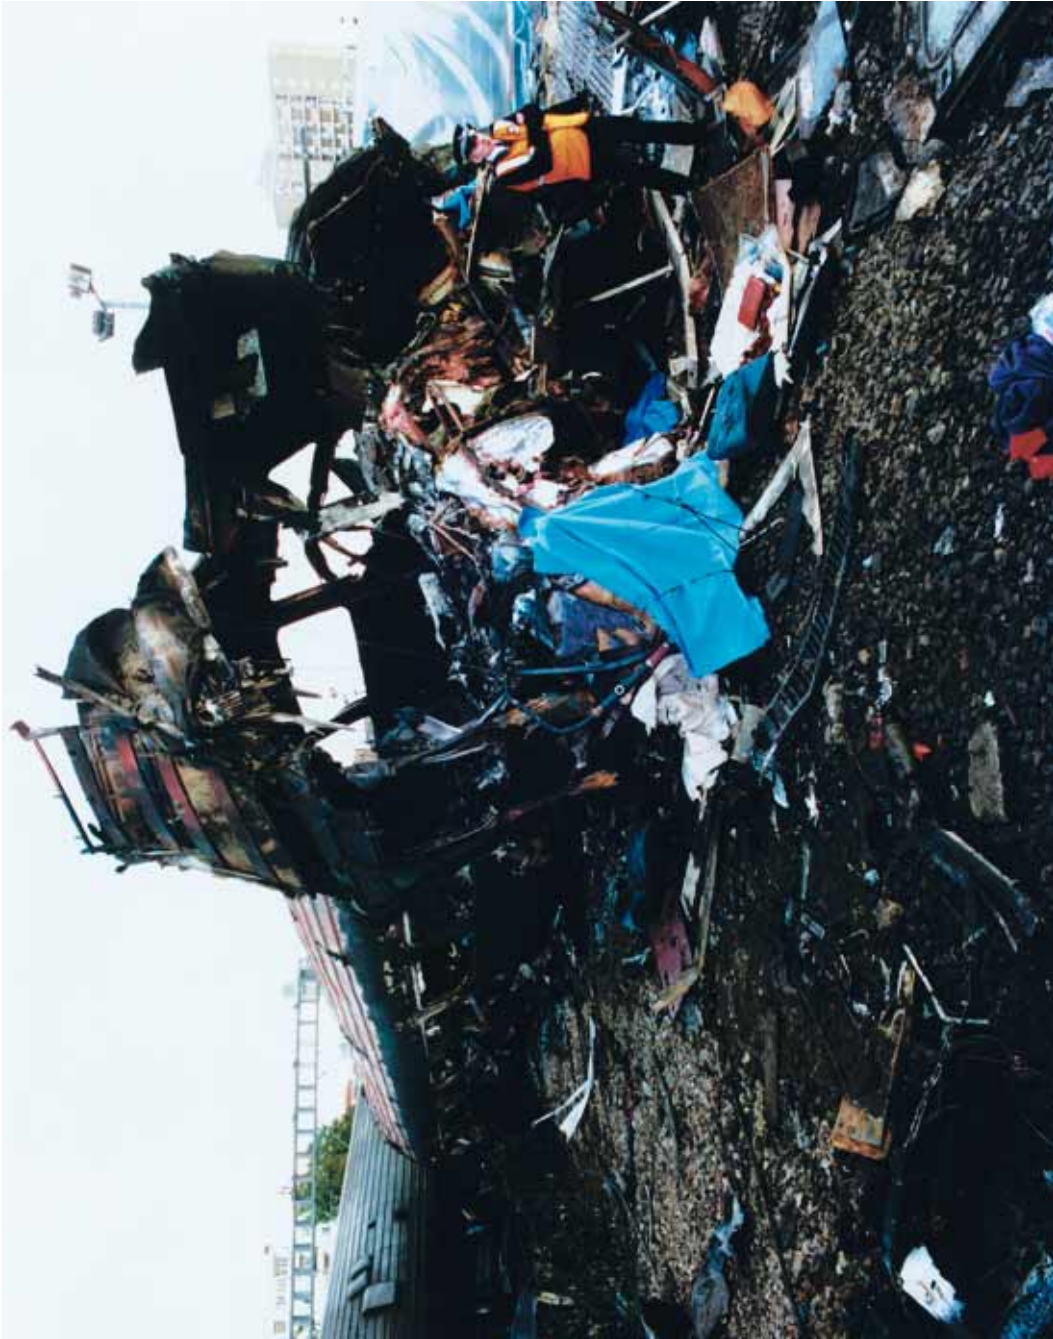
**Plate 13:** Coach H of the HST: view from the west.

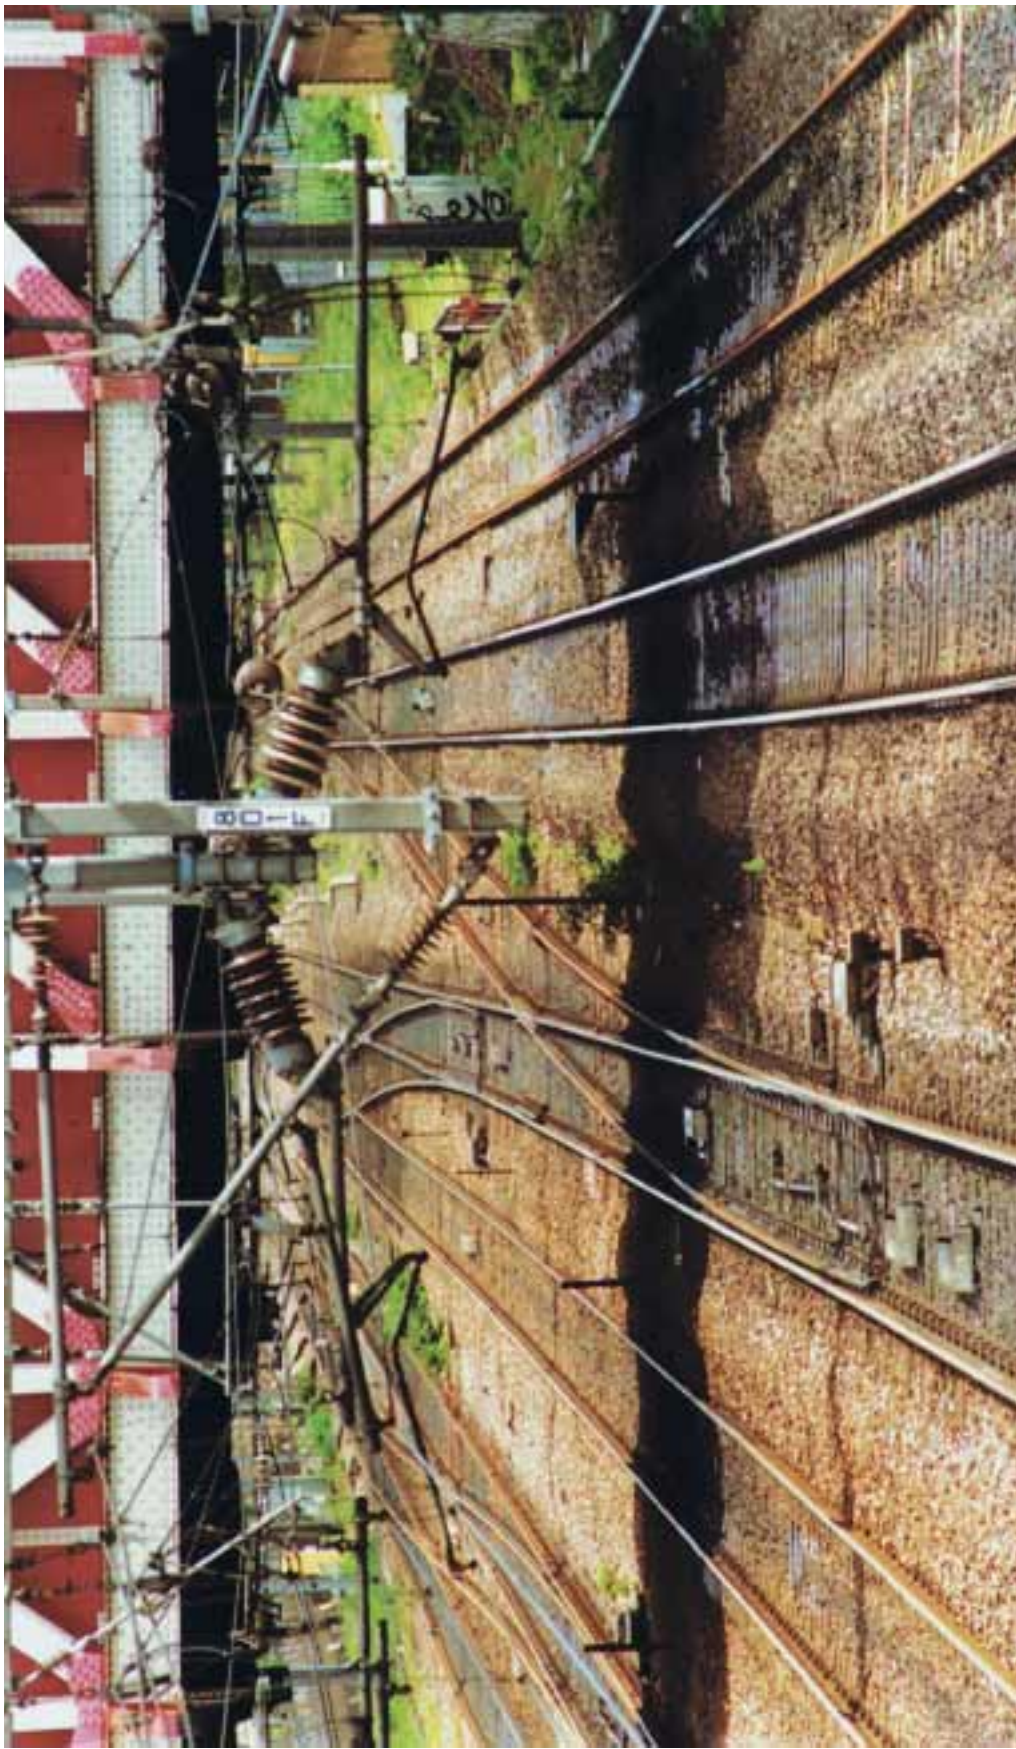
**Plate 14:** View towards Paddington. Taken from Gantry 8 with the camera placed directly above the red aspect of SN109. The lines are numbered 1 to 6 from right to left. SN109 applies to Line 3.
