EFFECT OF THE DENALI FAULT RUPTURE ON THE TRANS-ALASKA PIPELINE

Steve P. Sorensen¹ and Keith J. Meyer²

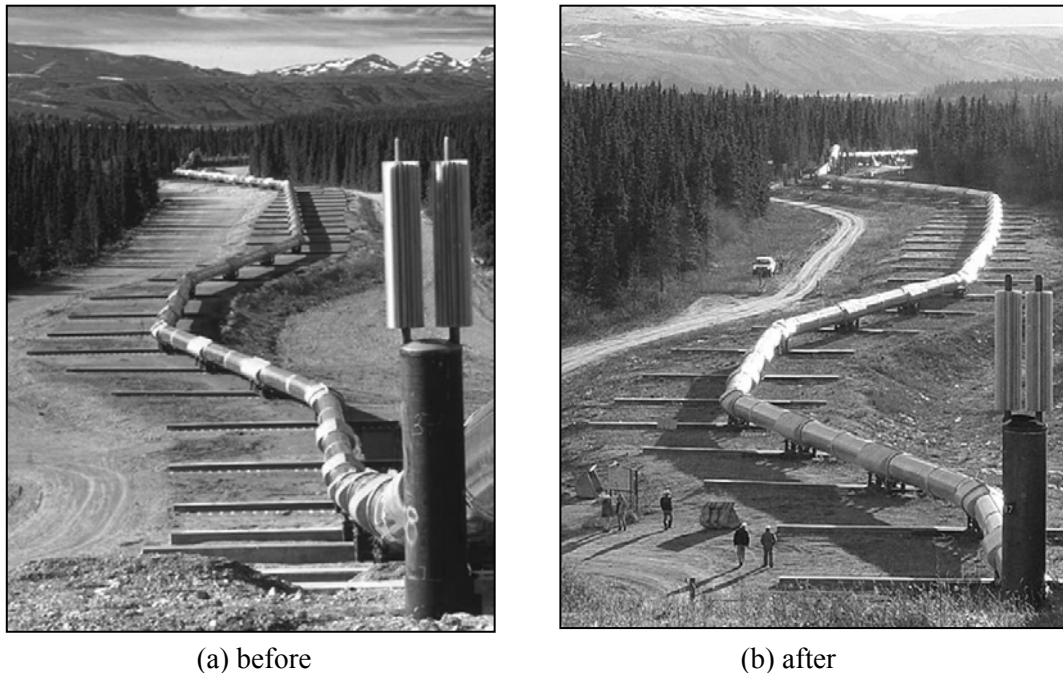
configuration shown schematically in Figure 2. A range of potential locations of fault surface rupture was analyzed during design. From these design studies, the most severe effect on the pipeline was determined to be when surface rupture was postulated at grade beam 7, which is only one bent away from the observed fault trace. Therefore, this event actually represented the near maximum expected movement for the design, as was indeed the observed result. The relative locations between pre-event and post-event pipeline and beam positions are shown in Figure 4.

Figure 4. TAPS crossing of Denali Fault before and after fault slip, looking south. Note movement and bowed segment after fault displacement, which acts to compress the pipeline crossing segment.

Anchors are designed to control longitudinal movement of the pipeline through frictional resistance. Anchors begin slipping at an instantaneous force of 475 kN (105 kips). The anchors north and south of the fault crossing slipped longitudinally and experienced further movement through slippage between the anchor frame and support brackets on the VSMs. Some deformation of the anchor frames was observed via yielding of the slotted bolted connection on the frame itself, but not at the support bracket. During repair operations on the first anchor south of the Denali Fault, the pipe clamps connecting the anchor assembly to the pipeline were released. There was no observed movement of the pipe through the anchor clamps demonstrating that there was no residual compressive stress in the pipeline.

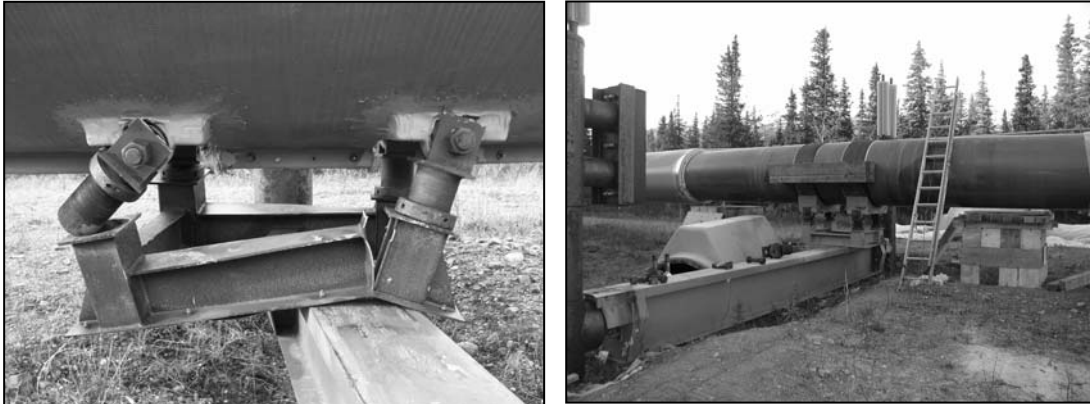
The pipeline support shoe at the first VSM bent (immediately south of the last grade beam configuration) was severely damaged (see Figure 5). This was probably due to the vertical faulting and concurrent violent dynamic shaking both vertically and horizontally. The shoe was replaced during the field repairs after the event, and the

Figure 5. Post-event shoe damage (left) and pre-startup repair (right) on the seismic bent immediately south of the Denali Fault. Note the temporary shoring beneath the pipe used during repairs (right side of picture), the bumper beam on the pipe clamp (center), and the impact absorber on the VSM (far left side of picture).

pipe was thoroughly inspected. Based on documented inspection reports, the pipe itself had no observable damage in this region.

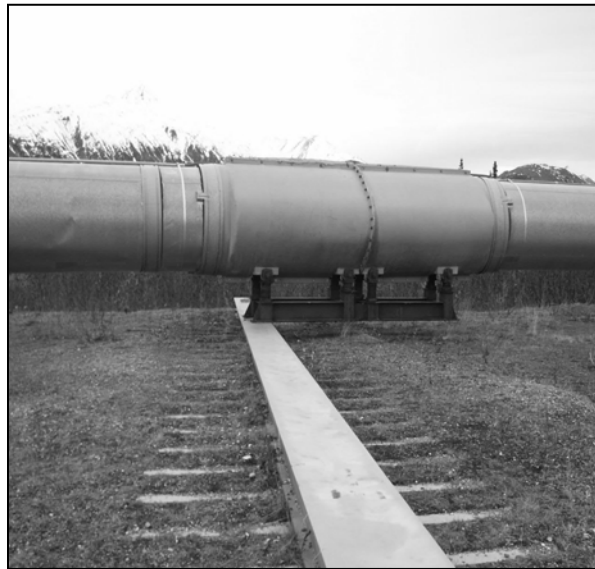
At special configuration locations, ground movement at the grade beams was evident, although no damage to the grade beams, pipe support shoes or the pipe itself was observed (see Figure 6). Slip marks caused by the pipeline shoe sliding across the crossbeams and grade beams during faulting and associated shaking were observed throughout the fault crossing. Some of the grade beams in the near fault area exhibited evidence of minor ground plowing, probably through inertial forces in the beam and/or as a result of sliding friction resistance between the shoe and beam. Pipe shoe movement was often more than the estimated ground fault displacement, and occurred well back from the rupture trace line due to compression and pipe flexure. The final “set” of the pipeline results from friction resistance between the shoe and the cross beam, producing the illusion of residual compression. The observed movement was expected and predicted by the design analysis.

Figure 6. Post-earthquake shoe location on grade beam prior to re-centering.

A total of ten shoes were estimated to have less than 150 mm of remaining overhang after calculating the projected additional fault displacement. One shoe had less than 150 mm of overhang in its post-event position. All eleven of the target shoes were re-centered on the pipeline.
