MARINE CASUALTY REPORT

S/S EXXON HOUSTON

GROUNDING NEAR BARBERS POINT, HAWAII

REPORT NO. USCG 16732/01 HQS 92

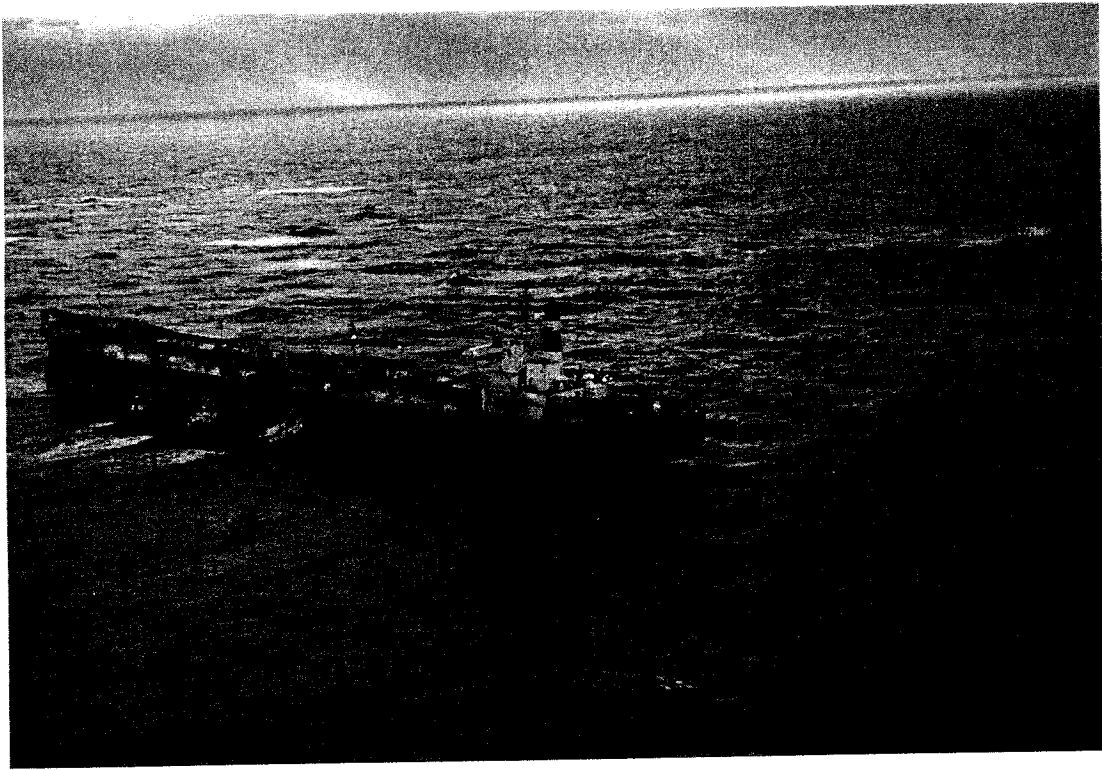
EXXON HOUSTON - AGROUND BARBER'S POINT, 3 MARCH 1989
PHOTO BY - CCGD14(dpa)

Upon grounding of the vessel, the only immediately detectable damage was in the way of the Port Bunker Tank which was leaking bunker oil to the sea and in the engine room double bottoms in the vicinity of the main condenser sea chest. The surveys conducted after freeing the vessel revealed extensive damage in the No. 3 Port Cargo Tank and No. 5 Starboard Cargo Tank. In

addition, several indented areas in scattered areas of the bottom plate with related framing damage was discovered. Based on the age and condition of the vessel, the Exxon Houston was determined to be a constructive total loss.

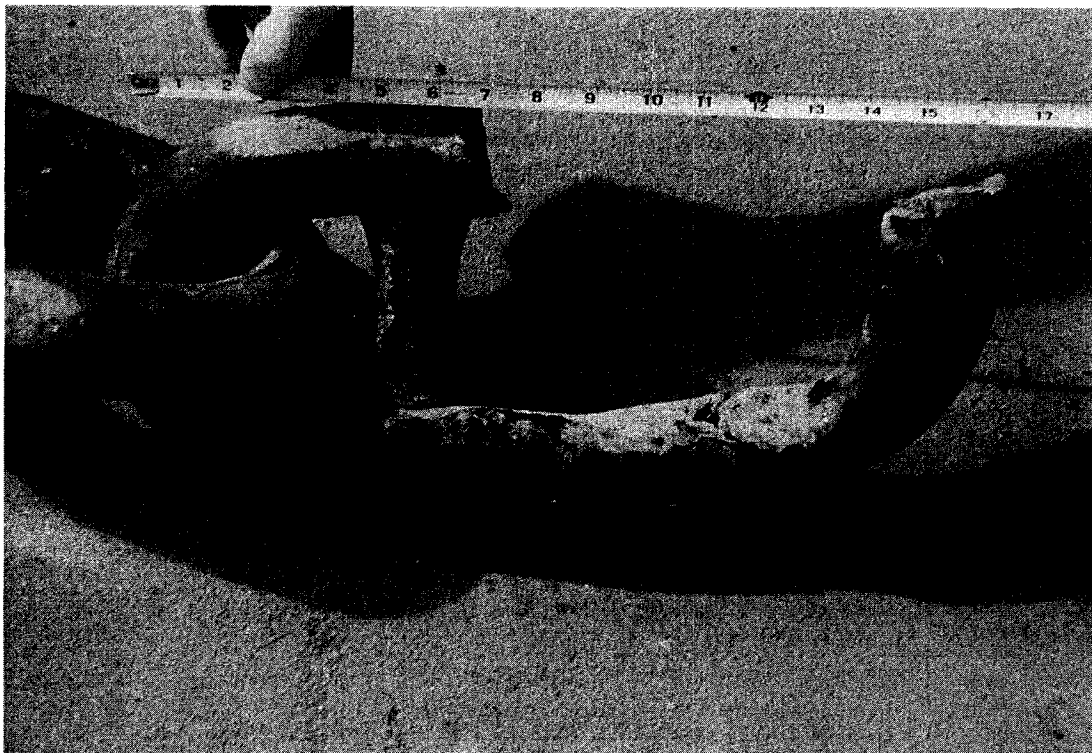
examination of the chain links revealed wear patterns at the end of some of the links which indicated that the chain had experienced a considerable load during service resulting in a mushrooming effect. The bullnose of the Exxon Houston also showed evidence of wear, such as would be produced by a chain link rubbing against the surface.

"It is concluded that the failure of link No. 10 in the mooring chain was due to the defects in the weld and to the poor properties exhibited by the base metal immediately adjacent to the weld. The poor properties of the base metal are attributed to the forging design which caused the material to be loaded, effectively, in the transverse direction. The transverse properties, ductility and strength of steels such as used here are undoubtedly lower than the longitudinal properties measured in the tensile test. The defects left in the weld are caused by inadequate ejection of molten metal during the welding process and suggest that a redesign of the weld cycle is warranted."

LINK NO. 10 OF FAILED CHAFE CHAIN. THIS LINK REMAINED ON BOARD EXXON HUSTON AFTER SEPARATION. PHOTO TAKEN BY LT [REDACTED] ON 5 MARCH 1989. EXHIBIT NO. 41
