## Low Frequency Vibration Measurements on a Compressor Gear Set

The gear set on a critical turbo-compressor was monitored with a standard industrial accelerometer at very low frequencies. Severe vibrations at the hunting tooth frequency were found to be amplified by a compressor surge modulation. Diagnostic evaluation and repair effectively eliminated the surge and hunting tooth vibrations—returning the compressor to proper operation.

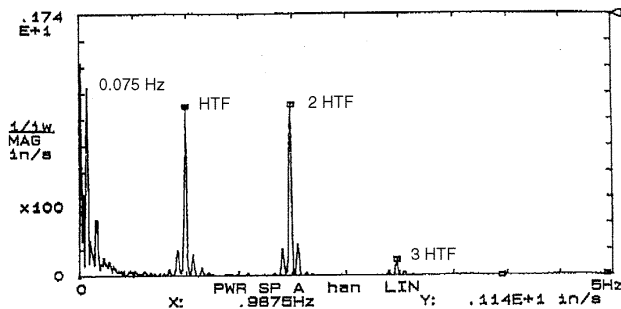
Measurements on the speed increaser indicated significant high amplitude, low frequency vibrations from the high-speed coupled end of the gear box. The spectra shown in figure 1a reveals a very low frequency pulsation at 0.075 Hz (4.5 cpm), and a 1.26 ips vibration at the hunting tooth frequency (HTF) of 0.99 Hz (59.4 cpm). Harmonics of the HTF and sidebands of the pulsation signal are also visible.

Figure 1a. Surge Frequency and Hunting Tooth Harmonics from Speed Increaser Measurement

The HTF corresponds to the rate at which a specific tooth on the gear will contact a specific tooth on the pinion (see table 1); it is due to abnormalities or uniqueness of individual gear and pinion teeth.

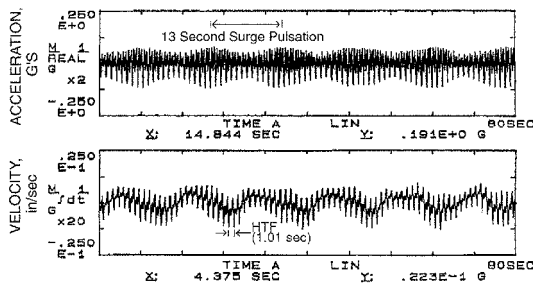
The pulsation produced a beat every 13 seconds (see figure 1b) and was believed to be process related, resulting from surge. The surge was caused by trapped pockets of air in the influent lines of the chiller. The time waveforms and sidebands around the HTF, suggested that the surge pulsation was amplitude modulating the hunting tooth harmonics.

Figure 1b. Time Waveform Showing Modulating Effects of Surge Pulsation

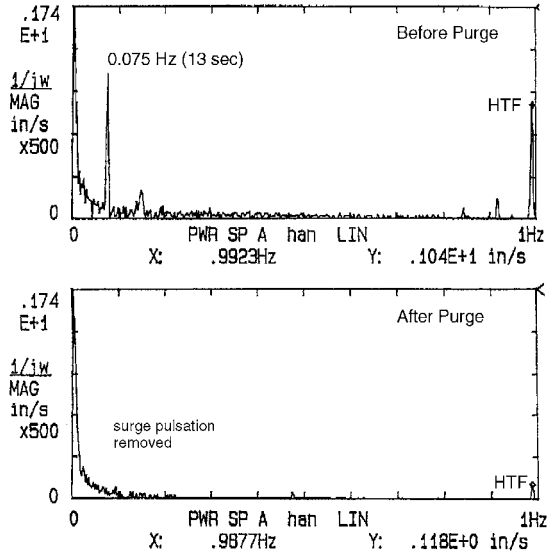
Figure 2a. Surge Pulsation Before and After Purging of Refrigerant

In order to decrease the pulsation, the refrigerant in the delivery system was purged of air. Follow up measurements indicated that purging had completely removed the low frequency surge (see figures 2a and 2b) and substantially reduced the modulated HTF amplitude from 1.16 ips to 0.11 ips.

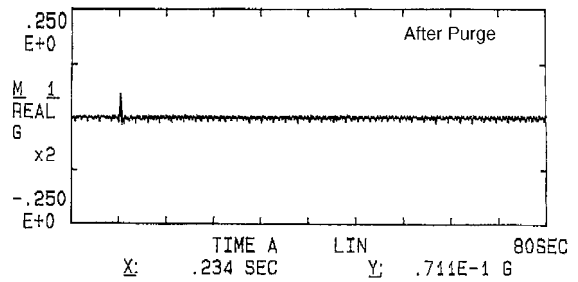
Figure 2b. Time Waveform After Purge

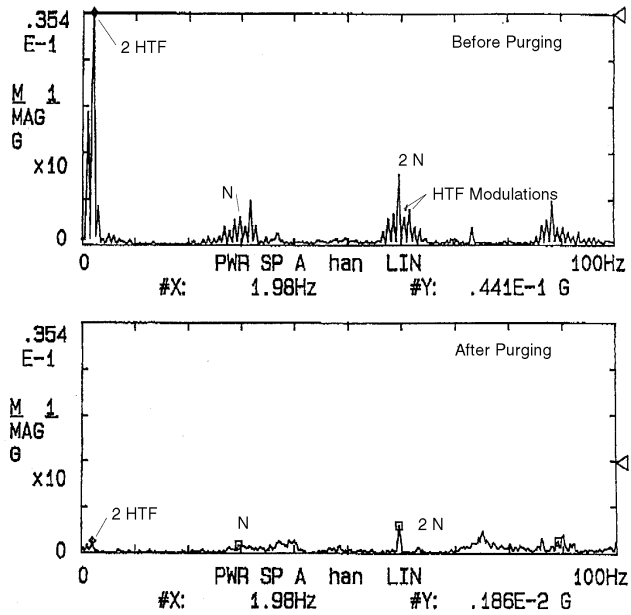
The modulating effects of the HTF upon the gear/motor running speed harmonics were also reduced as shown in figure 3.

Figure 3. HTF Sidebands and Gear Mesh Harmonics Before and After Repair

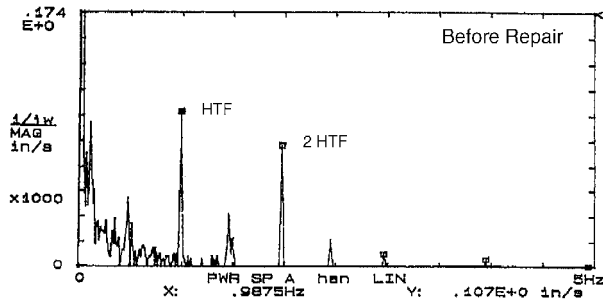
Baseline measurements retaken on the compressor showed the hunting tooth vibration nearly eliminated (see figures 4a through 4d). The final measurement of 0.03 ips at 0.99 Hz was determined to be an acceptable vibration level for this gear set. The compressor was placed on-line without further interruption.

Figure 4a. HTF Reduction and Elimination of Sidebands After Purge (Before Gear Set Repair)

Unfortunately, the HTF component was still prominent and indicated a potential problem with specific teeth on the gear set. Hunting tooth faults can be very difficult to physically isolate and evaluate in terms of reliability. A gear transmission consultant was therefore hired to inspect the gear set. Detailed examination revealed that an indentation had been made on corresponding pinion and gear teeth to mark the phase of assembly when the gear set was rebuilt. The gears were repaired with a fine tooth file and re-installed for start-up.

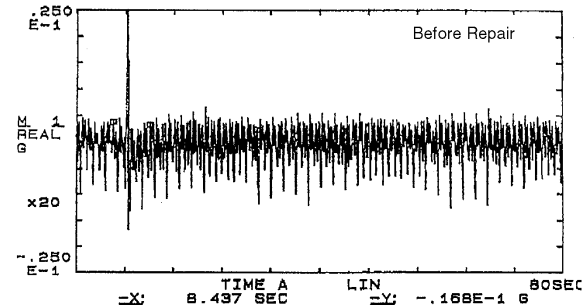
Figure 4b. Time Waveform Before Repair

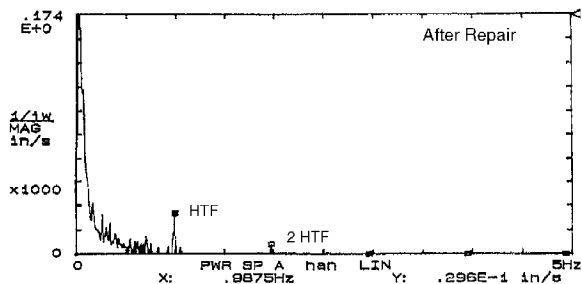
Figure 4c. Hunting Tooth Harmonics After Gear Set Repair

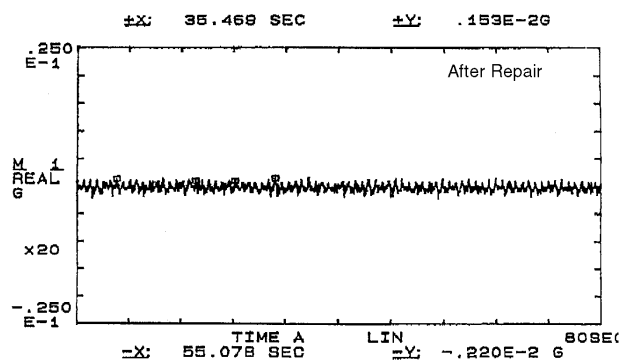
Figure 4d. Time Waveform After Repair
