NATIONAL TRANSPORTATION SAFETY BOARD

AIRCRAFT ACCIDENT REPORT

In-flight Breakup Over the Atlantic Ocean
Trans World Airlines Flight 800
Boeing 747-131, N93119
Near East Moriches, New York
July 17, 1996

**NTSB/AAR-00/03
DCA96MA070
PB2000-910403
Notation 6788G
Adopted August 23, 2000**

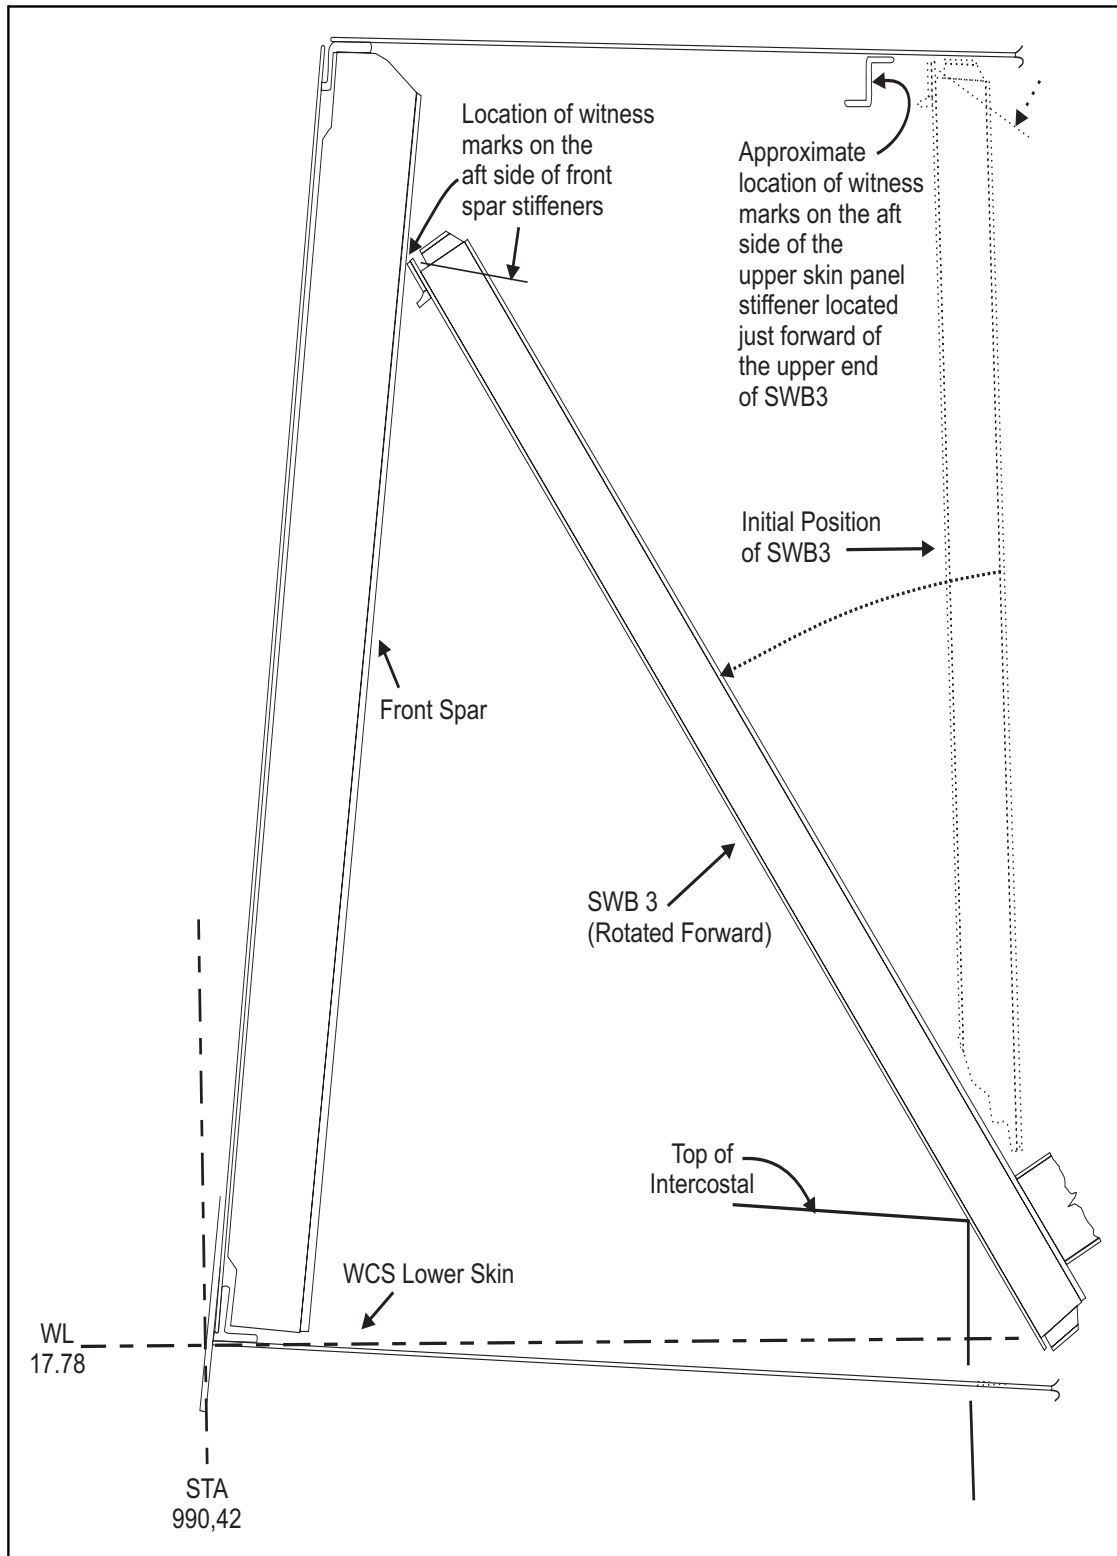
Figure 31. Diagram showing the approximate shape of the upper skin panel stiffener and its location before being struck by SWB3 as the beam rotated forward.

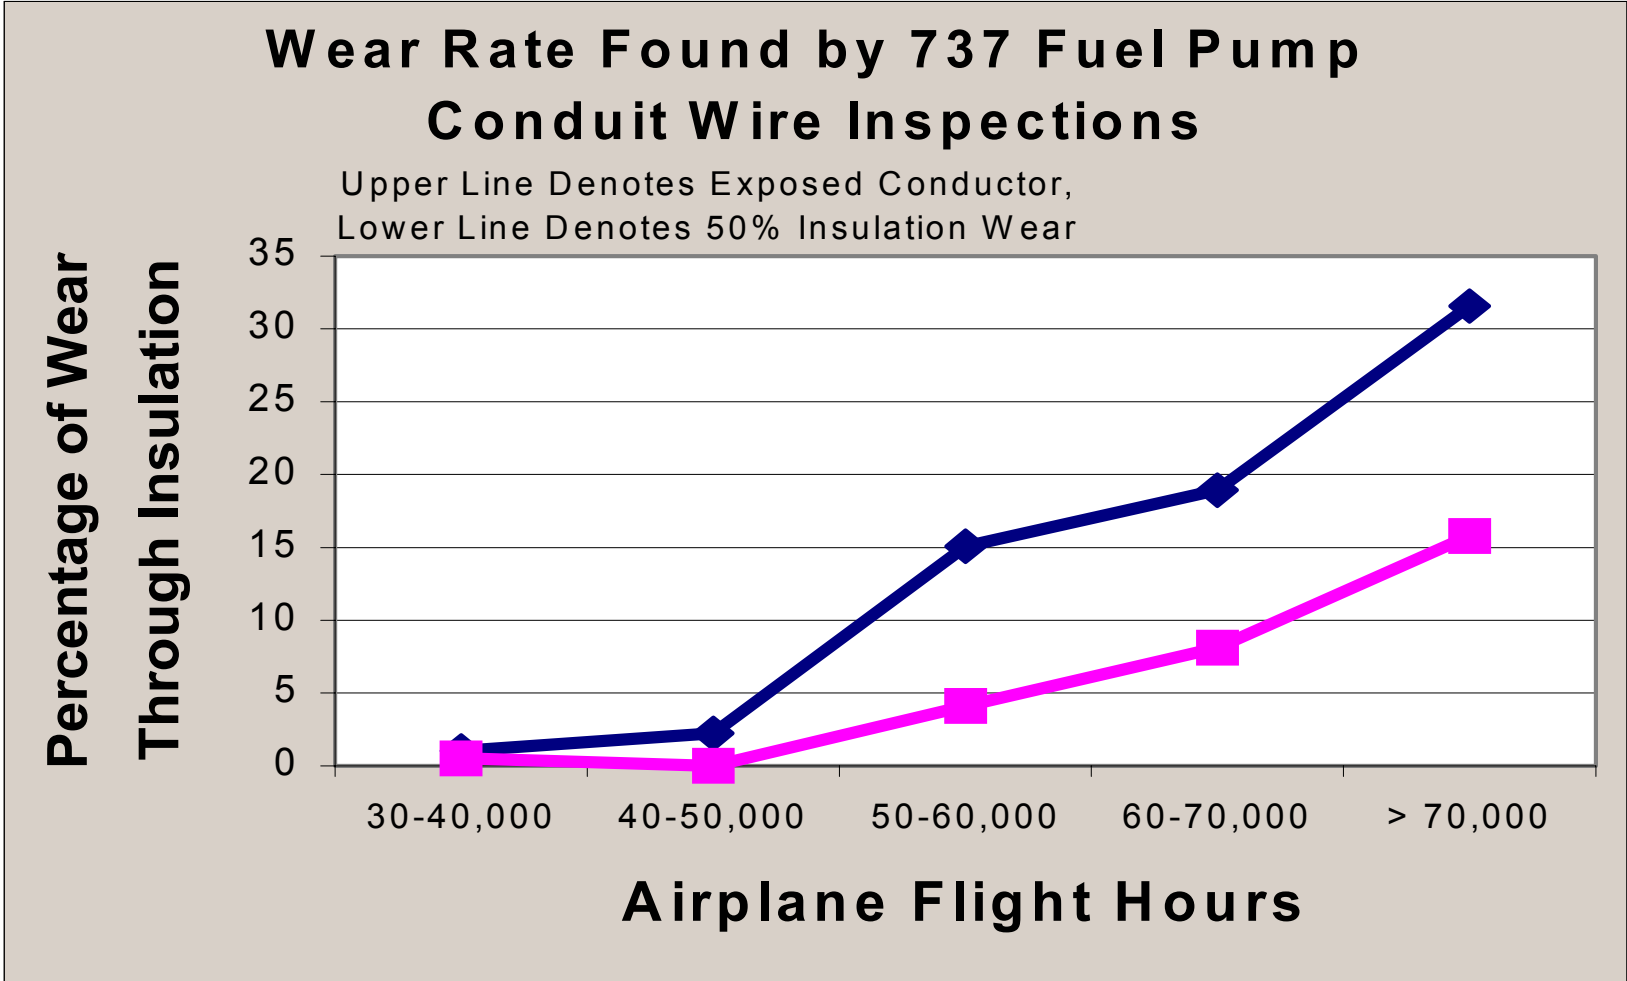
Figure 39. A chart showing the 737 fuel pump conduit wear rate that was identified by the FAA during representative 500 wire inspections.
