OTC 14193

## Failure Analysis of Texas Tower No. 4

Z. Jin, Global Maritime, R. Bea, University of California Berkeley, B.P.M. Sharples, (Formerly with American Bureau of Shipping)

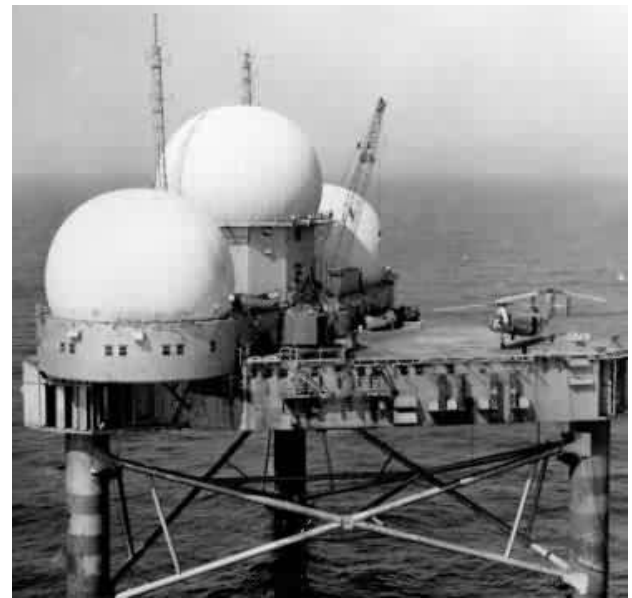
In early 1960, another underwater team was sent down to inspect the structure and found certain pin connections damaged beyond repair. Then a set of above-water X-bracing was manufactured and installed in August 1960 (Fig. 4). According to the contractors and design engineers, original design strength was restored to TT4; it could withstand winds up to 125 miles per hour and breaking waves up to 35 feet high<sup>[1,2]</sup>. Hardly a month later, however, Hurricane Donna (September 12, 1960) whirled in with conditions and forces exceeding the design specifications: 132 mile per hour winds (gust) and breaking waves exceeding 50-foot height. TT4, without evacuation of all personnel (no time for evacuation because of the fast advance of the hurricane), survived Hurricane Donna, but not without first shaking and rocking a great deal from the impact of the hurricane and suffered heavy structural damage. A part of TT4's superstructure was destroyed; worst of all, underwater braces were fractured. Further examination of above and below-water components

Fig. 4 – X-Bracing installed to stabilize TT4 (courtesy TTA)

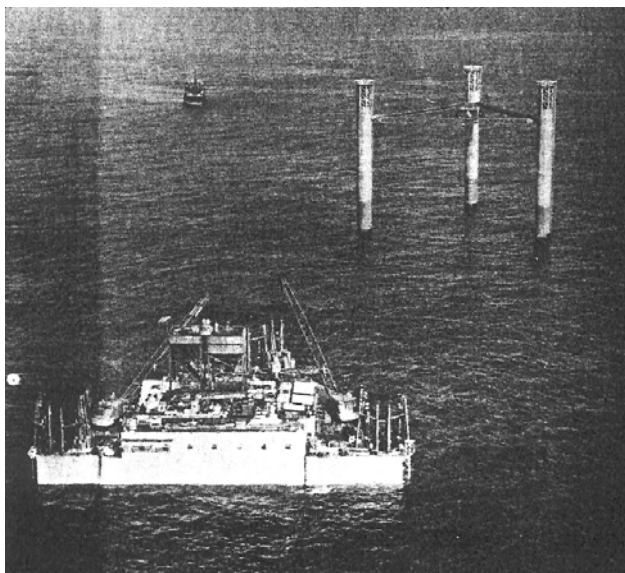
In the process of towing TT4 to site in June-July 1957 (Fig. 3), two diagonal braces, vital to the structural integrity of this huge tripod, were lost in a storm. The contractors, design engineers and the Navy Bureau of Yards and Docks decided to improvise repairs, replacing the lost diagonals at sea rather than return to shore for complete repairs. Consequently, the original design strength was not restored, even though the contractors and engineers thought that the repairs were effective. Later developments demonstrated that the tower structure was actually in a weakened condition due to this improper repair from the very beginning.

Fig. 3 – TT4 deck being towed to jack-up on substructure (courtesy TTA)

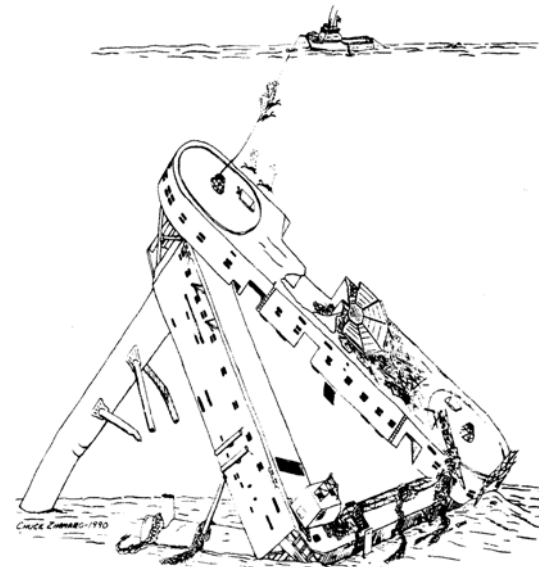
Meantime, a maintenance crew of 28 personnel (14 USAF and 14 contractor repair personnel) were stationed aboard to perform certain repair work. In December 1960, one winter storm struck TT4, causing more damages to all the above and below water bracing on the AB side so that panels of braces between Leg A and B were effectively not functional. Then on 14 and 15 January 1961, TT4 was again caught in a winter storm that battered the tower with winds up to 85 miles per hour and waves up to 40 feet high. The final moments came at about 19:20 PM the night of January 15, when one of its three legs failed; the remaining two thereupon also collapsed, and the platform, with all hands aboard, sank to the ocean's floor (Fig. 5).

Fig. 5 – TT4 collapsed condition (courtesy C. Zimmaro)
