**SECOND ADDENDUM TO**  
**UNITED STATES AIR FORCE**  
**AIRCRAFT ACCIDENT INVESTIGATION**  
**BOARD REPORT**

**F-22A, T/N 06-4125**

**525TH FIGHTER SQUADRON**  
**3RD WING**  
**JOINT BASE ELMENDORF-RICHARDSON, ALASKA**

**LOCATION: JOINT BASE ELMENDORF-RICHARDSON, ALASKA**  
**DATE OF ACCIDENT: 16 NOVEMBER 2010**  
**BOARD PRESIDENT: BRIG GEN JAMES S. BROWNE**  
**CONDUCTED IAW AIR FORCE INSTRUCTION 51-503**

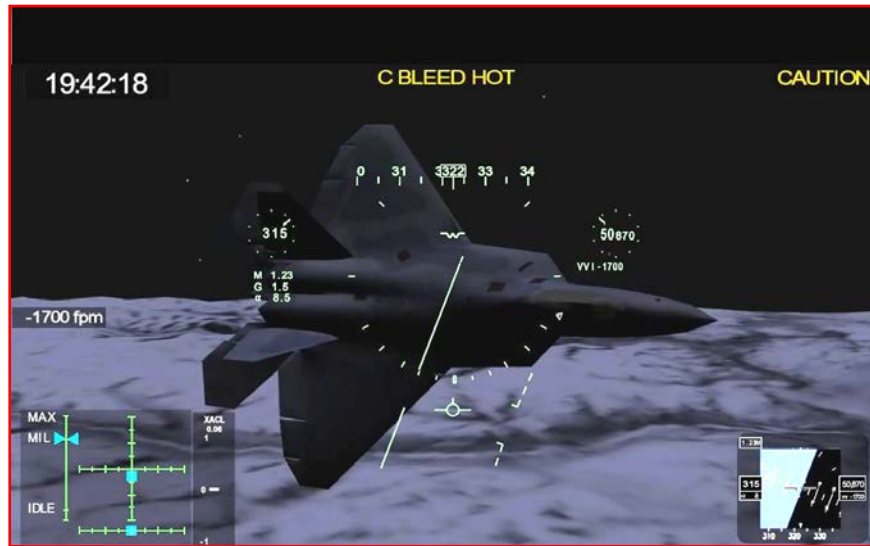
At 19:42:18L, the MA was at 50,870 ft MSL, 315 knots calibrated airspeed (KCAS), 1.23 M, with an attitude of 1-degree nose up, 69 degrees right wing down (RWD), heading 323 degrees, 1.5-Gs, and with a vertical velocity indication (VVI) of -1,700 ft per minute (fpm). (Tab EE-3 and Figure 1) At this time, the fire protection system (FPS) detected a bleed air leak in the center bleed air ducting from both engines. (Tabs J-12, J-42) In response to the FPS, the Integrated Vehicle Subsystem Controller (IVSC) asserted the C BLEED HOT caution ICAW while it requested the Environment Control System (ECS) to isolate the center bleed system. "CAUT" was displayed in the head-up display (HUD) advising the MP of the caution ICAW. (Tab J-12 and Figure 1)

**Figure 1 19:42:18L -- MA parameters at assertion of C BLEED HOT caution ICAW. (Tab EE-3)  
(See Tab Z-10 for a diagram explaining the symbology in the Figures.)**

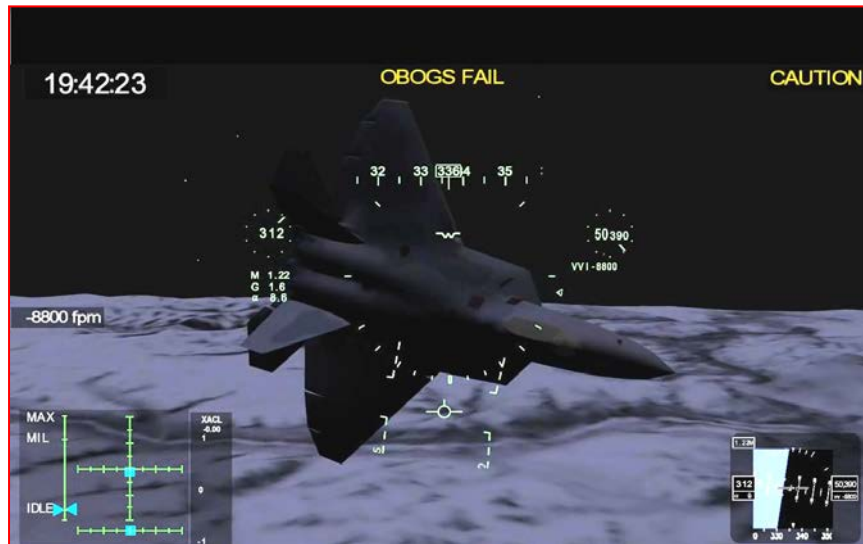
The C BLEED HOT caution ICAW cleared at 19:42:21L after the IVSC commanded the bleed air ducts to the closed position and stopped the flow of bleed air to the ECS. At 19:42:23L, the OBOGS FAIL caution ICAW asserted when the OBOGS output pressure dropped below 10 pounds per square inch (psi). (Tabs J-12, O-13, and Figure 2) The CSMU data showed partial pressure to the MP’s oxygen mask stopped shortly after 19:42:37L. (Tabs J-13 and J-43)

Figure 2 19:42:23L -- MA parameters at assertion of OBOGS FAIL caution ICAW. (Tabs EE-3, Z-10)

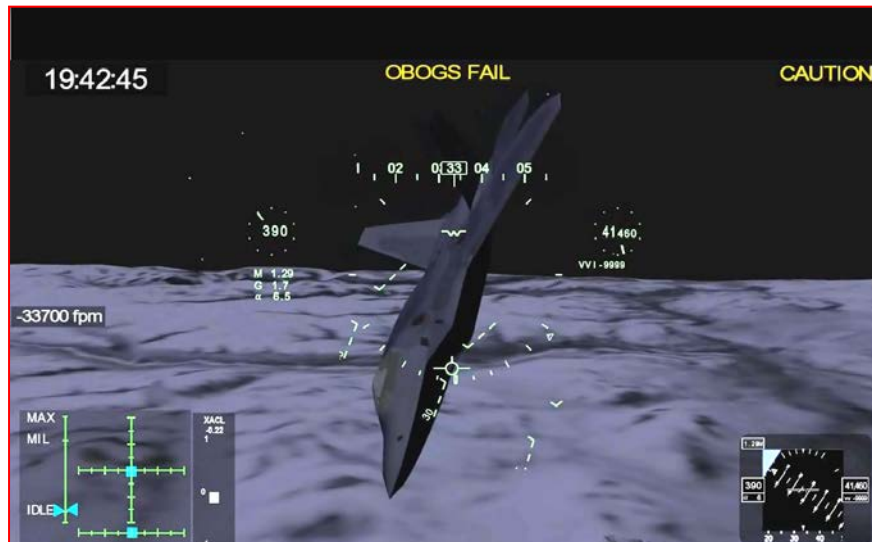
From the assertion of the OBOGS FAIL caution ICAW until 19:42:45L, the MP retarded the throttles to IDLE power and continued a controlled, descending right-hand turn. (Tabs BB-28, BB-29, EE-3 and Figure 3) At 19:42:45L, the MA was at 41,460 ft MSL, 390 KCAS, 1.29 M, 30 degrees ND, 44 degrees RWD, 1.7-Gs, and with a VVI of -33,700 fpm. (Tab EE-3 and Figure 3)

Figure 3 19:42:45L -- MP deliberately flew to a controlled attitude of 30 degrees ND and 44 degrees RWD. (Tabs EE-3, Z-10)

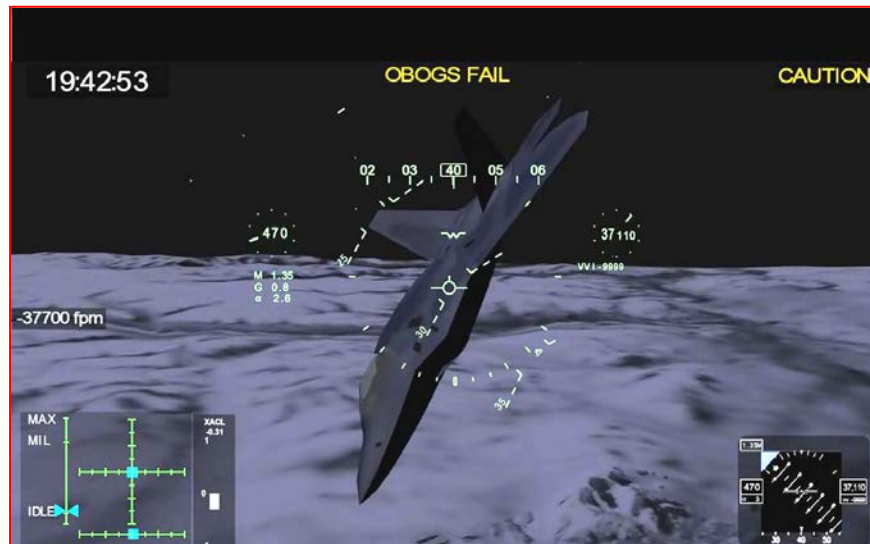
the MA was at 37,110 ft MSL, 470 KCAS, 1.35M, 30 degrees ND, 46 degrees RWD, 0.8-G, with a VVI of -37,700 fpm. (Tab EE-3 and Figure 4)

**Figure 4 19:42:53L -- MA parameters after 8 seconds of zero MP inputs to stick, pedals, or throttles. (Tabs EE-3, Z-10)**

At 19:42:53L, the MP input a combination of right forward stick and right pedal which initiated a 240-degree descending right roll at greater than 45 degrees per second. (Tab EE-3 and Figure 4, above)

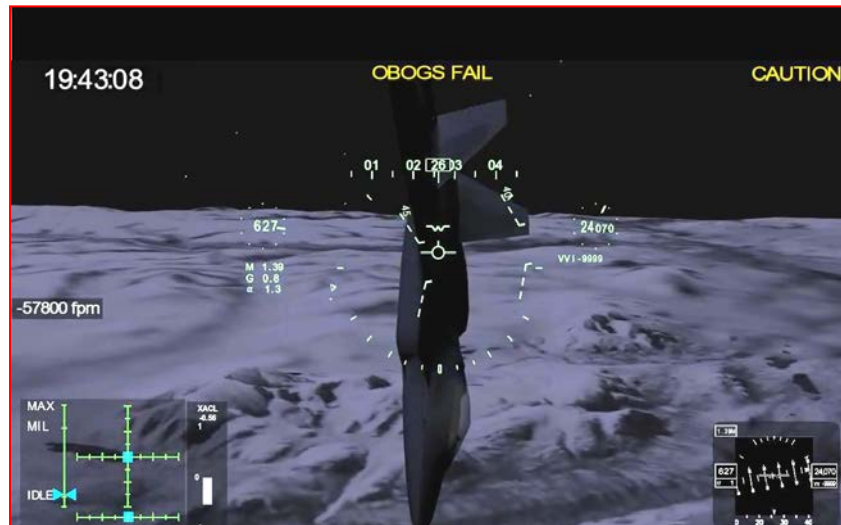
By 19:43:08L, the MA had rolled through inverted flight, experienced less than 1-G of gravitational force, reversed turn direction from RWD to left wing down (LWD), increased ND attitude, and significantly increased the descent rate. The parameters at this time were 24,070 ft MSL, 627 KCAS, 1.39 M, 44 degrees ND, 81 degrees LWD, 0.8-G, with a VVI of -57,800 fpm. (Tab EE-3 and Figure 5)

Figure 5 19:43:08L -- MA parameters after the 240-degree roll. (Tabs EE-3, Z-10)

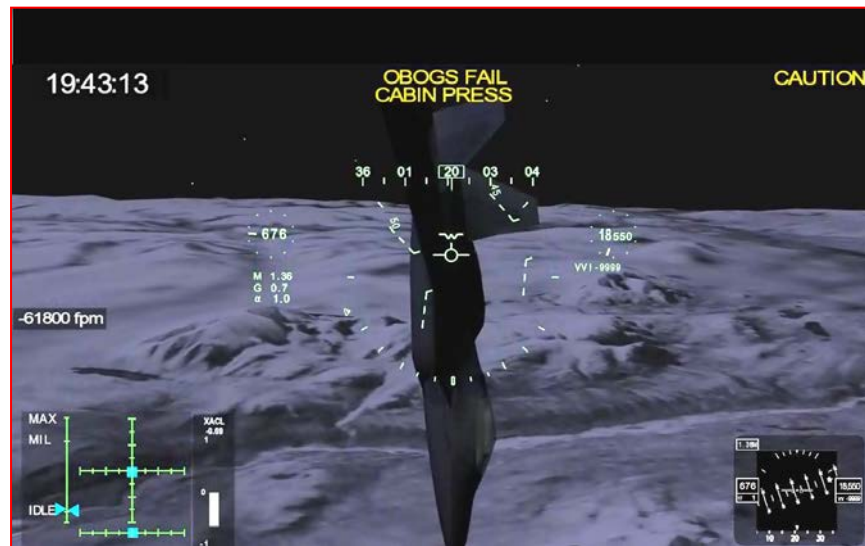
After 19:43:08L, there were no stick inputs and only very minor pedal inputs for the next 15 seconds. During this time, the descent rate of the MA increased to greater than 1,000 feet per second (fps), and at 19:43:13L, as the MA passed approximately 19,000 ft MSL, a CABIN PRESSURE caution ICAW asserted based on cockpit pressurization exceeding its normal schedule. (Tabs J-13, EE-3, and Figure 6)

Figure 6 19:43:13L -- MA parameters at assertion of CABIN PRESS caution ICAW. (Tabs EE-3, Z-10)

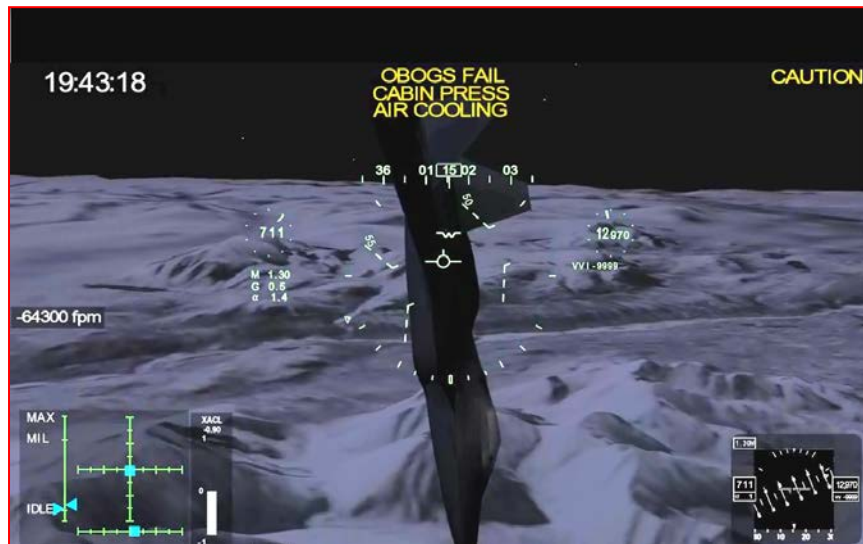
At 19:43:18L, passing 12,400 ft MSL, an AIR COOLING caution ICAW asserted. This AIR COOLING caution ICAW asserted 60 seconds after the C BLEED HOT caution ICAW asserted at 19:42:18L, which meant the MA was not receiving an adequate cooling air source to its avionics. (Tabs J-13, J-28, EE-3, and Figure 7)

Figure 7 19:43:18L -- MA parameters at assertion of AIR COOLING caution ICAW. (Tabs EE-3, Z-10)

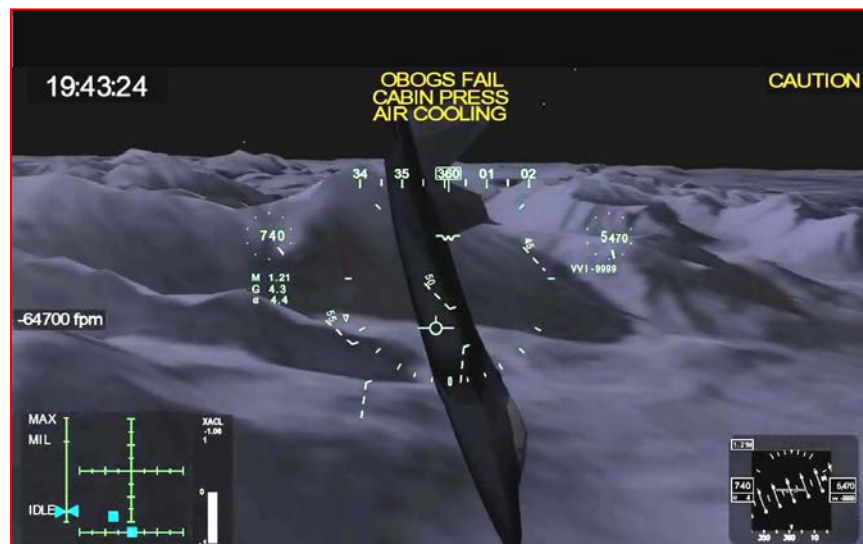
At 19:43:24L the MP performed a dive recovery at 5,470 ft MSL by pulling aft on the stick, producing a 7.4-G pull up maneuver. By this time, the MA had transitioned below the minimum safe recovery altitude. (Tabs J-19, EE-3, and Figure 8) The MA impacted the ground three seconds later, inflicting fatal injuries to the MP and destroying the MA. (Tabs D-3, J-4, J-13, X-3, EE-3)

Figure 8 19:43:24L -- MP initiates full aft stick pull to start dive recovery at 5,470 ft MSL. (Tabs EE-3, Z-10)

IAW the OBOGS FAIL checklist, the MP was in a deliberate and controlled descent to a lower altitude after the assertion of the OBOGS FAIL caution ICAW. (Tab BB-29) However, at 19:42:53L the MP input stick and pedal movements for approximately 15 seconds, causing a 240-degree descending right roll. (Tab EE-3 and Figure 3, above) At the completion of these stick and pedal inputs at time 19:43:08L, the MA had rolled through inverted flight, experienced less than 1-G of gravitational force, transitioned from a RWD to LWD attitude, and significantly increased the descent rate. (Tab EE-3 and Figure 5, above) This increased descent rate shortened the amount of time available to recover the aircraft. The MP did not take corrective actions until approximately three seconds prior to impact. By the time the MP recognized the unusual attitude and applied dive recovery flight control inputs, the MA had transitioned below the minimum safe recovery altitude. (Tabs J-19, EE-3 and Figure 8, above)

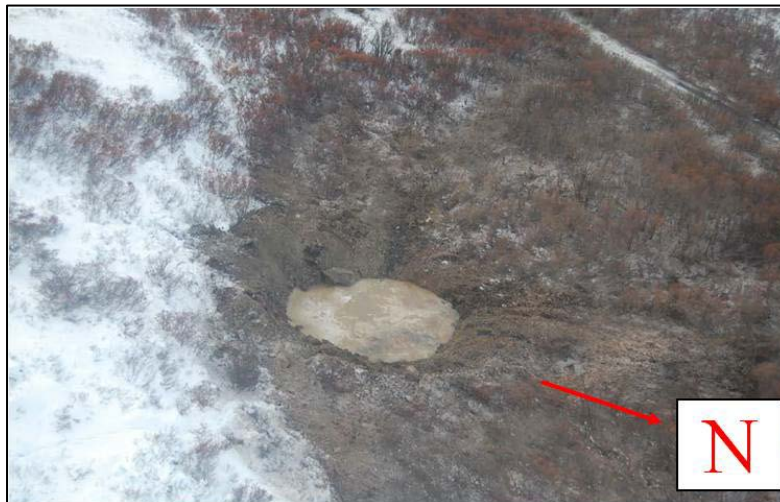
At 19:43:27L, the MA impacted the ground at 735 KCAS, 1.17 M, 48 degrees ND, 48 degrees LWD, 7.4-Gs, with a VVI of -57,900 fpm. The impact site is approximately 120 NM north of JBER, AK, in the Talkeetna Mountain range. The site is approximately 3,100 ft MSL near the edge of a south-west to north-east running valley. The impact crater is located at the valley floor where it begins to slope upwards towards the southeast. The valley floor is approximately one-half mile wide at this point and has a stream running through it approximately 60 yards west of the impact point. (Tabs J-4 through J-6, H-5, EE-3, and Figure 9)

**Figure 9 -- Impact Crater 17 Nov 2010. (Tab S-7)**

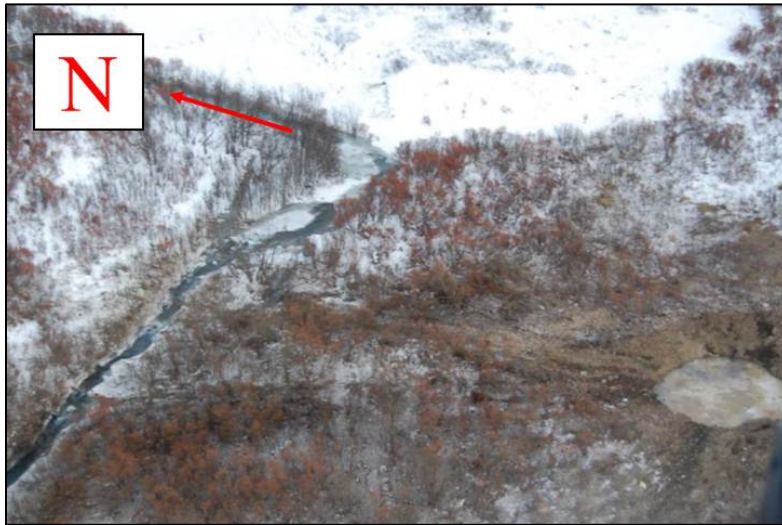
The debris field consisted of small aircraft and engine pieces extending approximately one-quarter mile from the crater. The upslope wall of the crater and aircraft impact angle appear to have focused the debris pattern in a 60- to 80-degree wide arc from west to north. (Tabs J-4 through J-6, and Figures 10 and 11)

**Figure 10 -- Impact Site. 17 Nov 2010. (Tab S-7)**

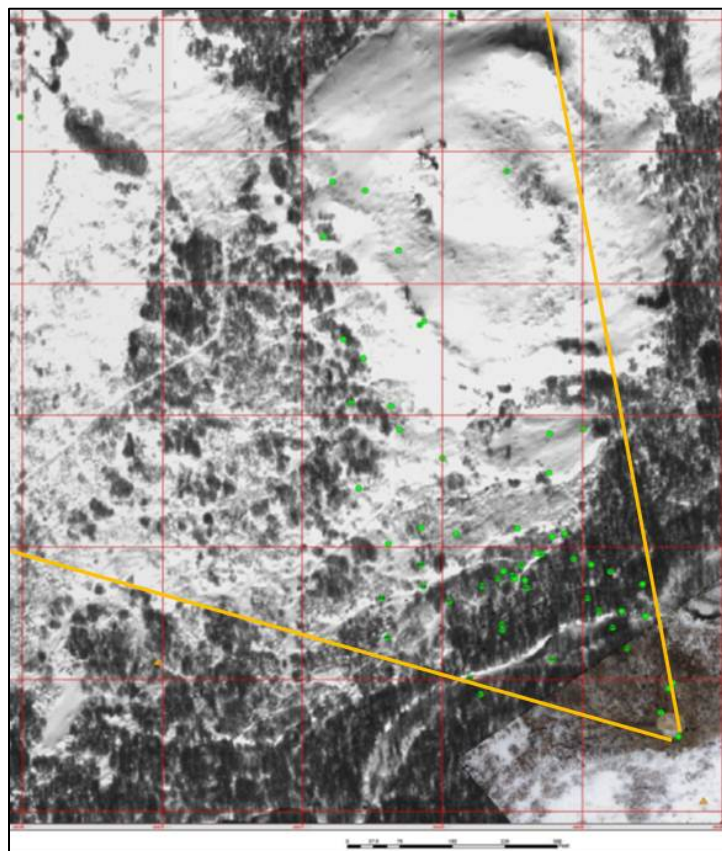
**Figure 11 -- Aircraft Parts Scatter Diagram. Parts represented by green dots. (Tab S-4)**

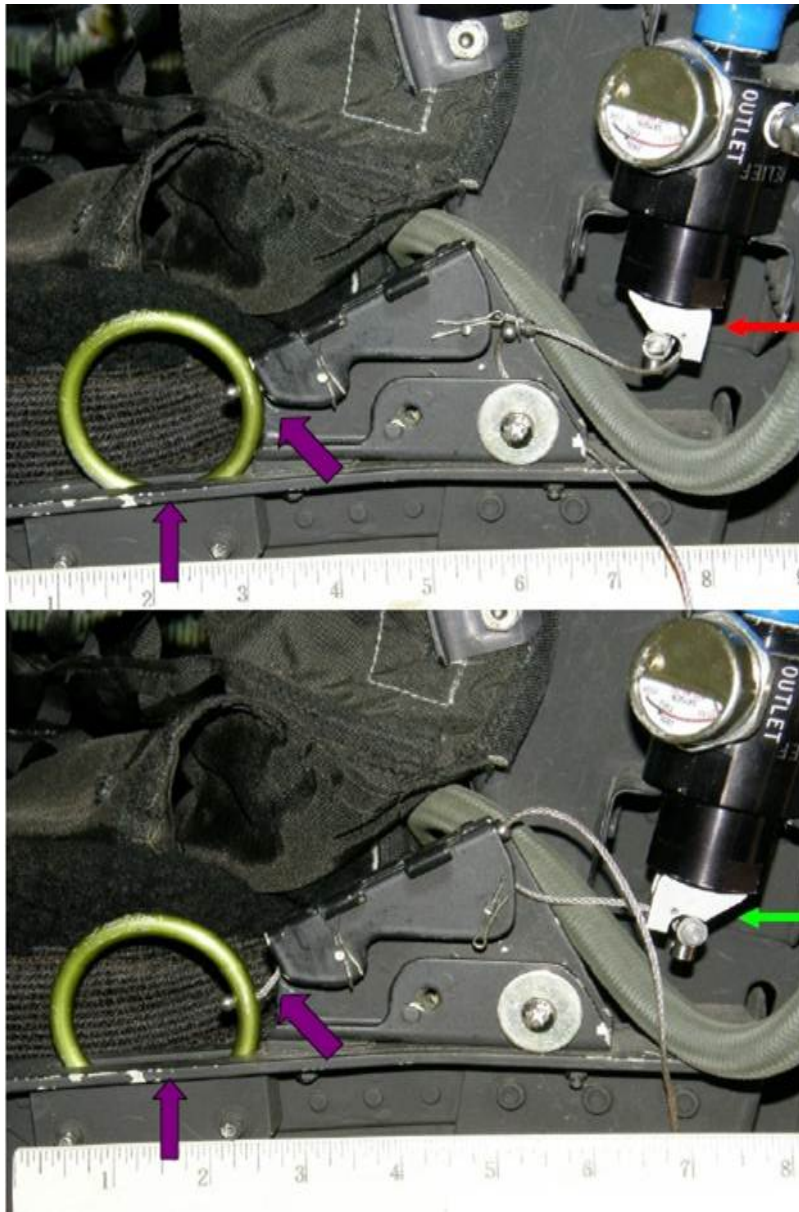
In addition, AFRL/RXSA examined the possibility that the wedge block, which was attached to the EOS activation ring lanyard, was incorrectly installed. This could have been a potential interference with the EOS activation process. (Tab J-72) However, during ground simulation, the AIB pilot advisor was able to manually activate the EOS regardless of whether the wedge block was correctly or incorrectly installed. (Tab U-4 and Figure 15) As such, there is no evidence to suggest the wedge block was a factor in the mishap.

**Figure 15 -- The wedge block installed incorrectly (red arrow) and correctly (green arrow). Notice the position of the EOS activation ring within the seat (purple arrows) based on wedge block position. (Tab Z-6)**

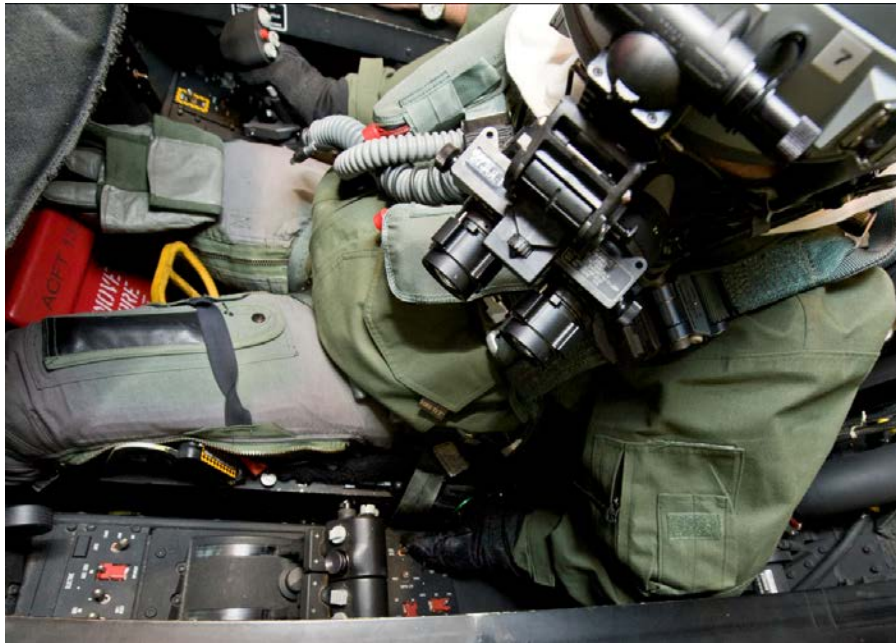
During ground simulation, the pilot advisor successfully manually activated the EOS. The pilot advisor also unseated the EOS activation ring and dropped it between the seat and console prior to EOS activation. This was done to simulate a failed initial pull, which may have occurred. Retrieval of the ring from between the seat and console would be difficult based on the seat position, night environment, CAT III cold weather gear, and NVGs. (Tab CC-5, and Figures 16 and 17)

**Figure 16 -- Pilot advisor pulling EOS activation ring. NVGs interfering with EOS activation ring visualization.  
(Tabs Z-7, CC-5)**

Therefore, there is evidence to suggest that the design, size and location of the EOS activation ring were factors in the mishap.

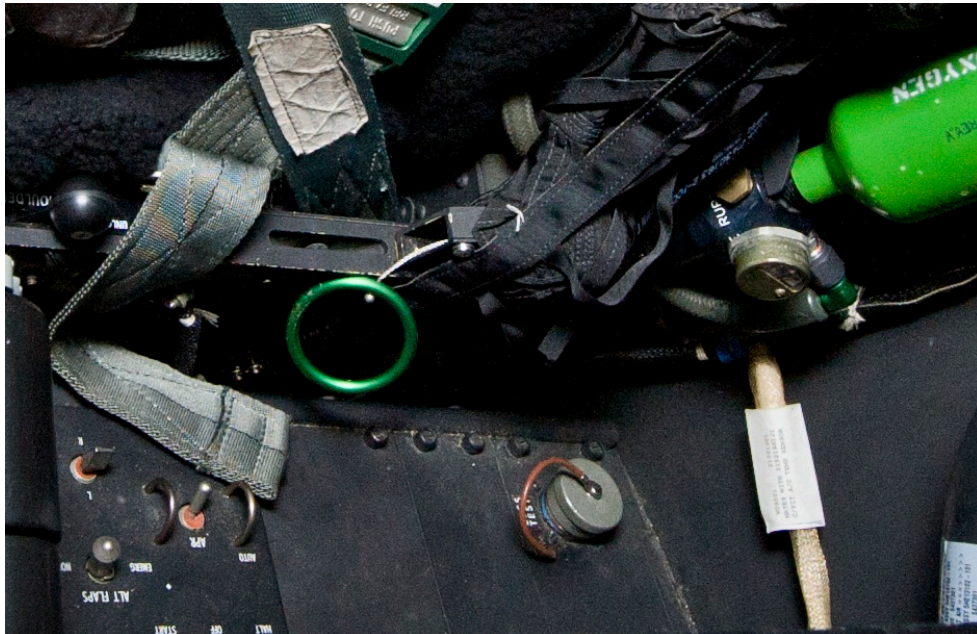
**Figure 17 -- Manual EOS activation ring fallen below lip of seat.  
(Tabs Z-8, CC-5)**
