AIRCRAFT ACCIDENT REPORT

VIEQUES AIR LINK, INC.,

BRITTEN-NORMAN BN-2A-6 ISLANDER, N589SA

NTSB/AAR-85/08

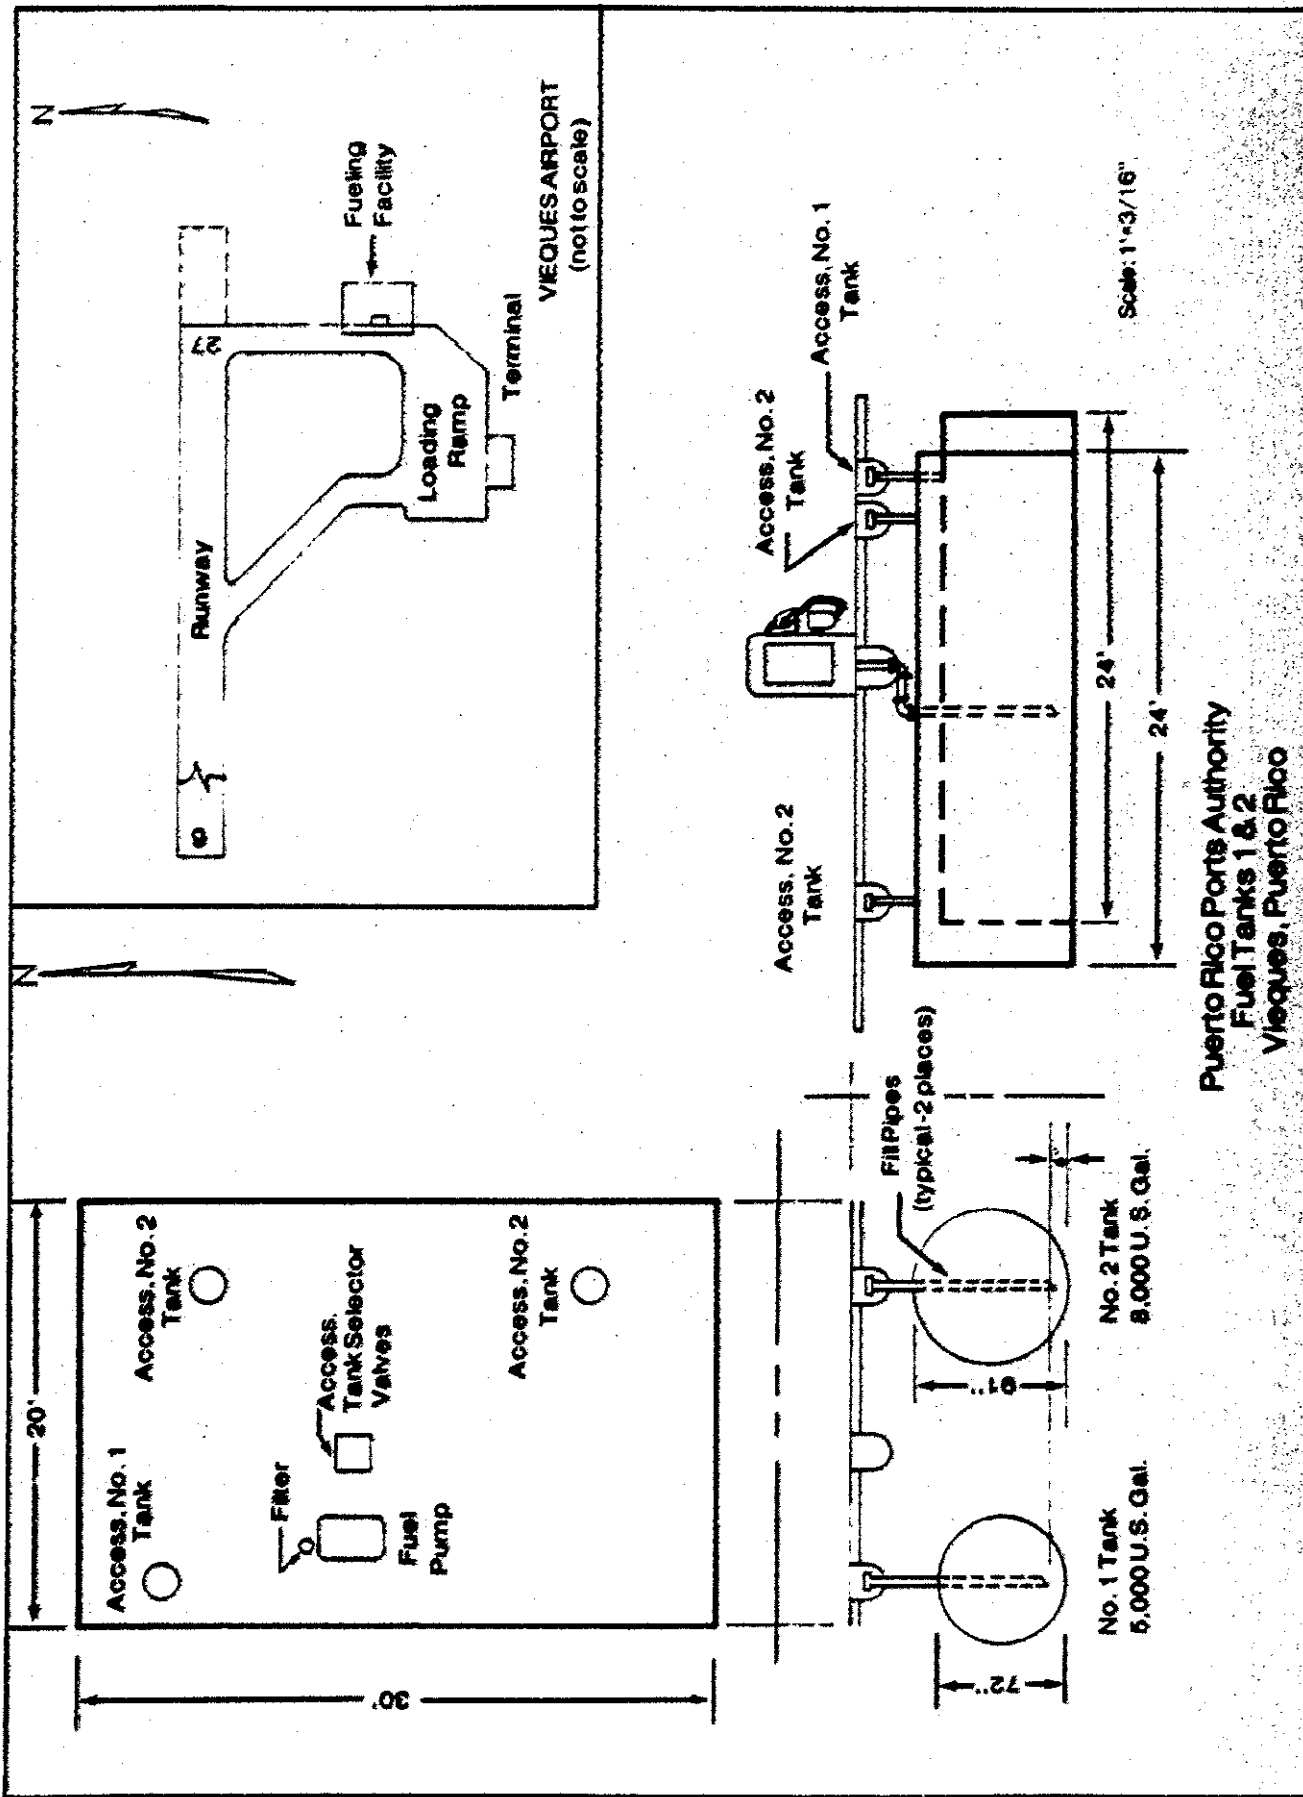
Figure 1.—Fuel facility.

The fueling facility operated by PRPA was located at the east end of the ramp area about 300 feet south of runway 9/27. (See figure 1.) The fueling station consisted of two in-ground steel tanks and one aboveground electric, automotive-type delivery pump.

The investigation revealed that 1 day after the accident the gravel base of the No. 2 fill pipe wells was wet and one of the fill pipe caps was loose on its fill pipe adapter, even though the cam locking levers were down (closed position). The cap could be moved vertically and did not provide an air-tight seal. A portion of the cap's gasket was missing; it measured about 1/4 inch wide in circumference. The outside and inside dimensions of the gasket were different from the gaskets on the other fill pipe caps. The loose gasket was red and the other two were black. The loose gasket was harder than the others and it appeared to have been manufactured locally.

After a very hard rain 2 days after the accident, Safety Board personnel found both fill pipe wells of the No. 2 in-ground tank to be full or partially full of water.
