AIRCRAFT ACCIDENT INVESTIGATION REPORT

Japan Air Lines Co., Ltd.
Boeing 747 SR-100, JA8119
Gunma Prefecture, Japan
August 12, 1985

Aircraft Accident Investigation Commission
Ministry of Transport

June 19, 1987

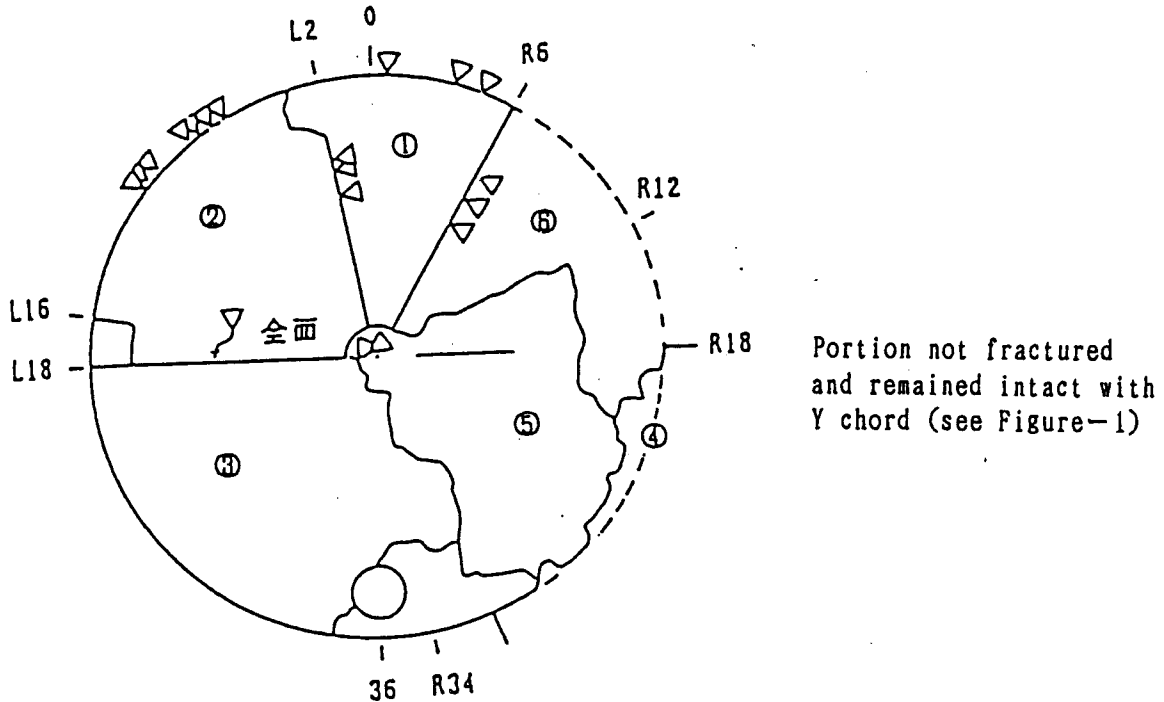
Figure-6 Major Fracture Lines
Major fracture lines, indicate points observed by electron microscope, as viewed from aft of the pressure bulkhead.

Especially along the fracture line of L18 splice, the fracture surface analysis was conducted for overall length directly by scanning electron microscope.

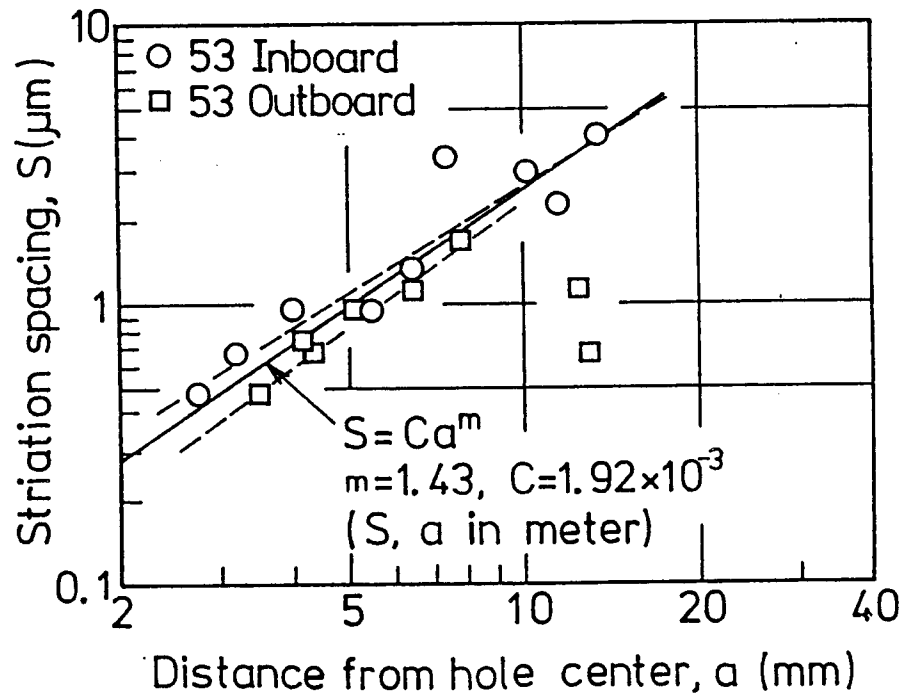
Figure-8 Variation in Striation Intervals
(53rd rivet)

Relationship between the distance from the hole center (a) and the striation spacing (s) is shown in Figure-8, taking as an example rivet hole 53 where striation was clearly observed from a scanning electron microscopic observation on the fatigue fracture surface.

In Table-5 are shown the striation spacing(s) at the distance (a) of 2.5 mm from the hole center, the exponent (m) indicative of relation between (s) and (a), the correlation coefficient (r) indicating the degree to which data are arranged linearly when plotted on the graph as in Figure-8, and the number of striation (N) calculated thereon.

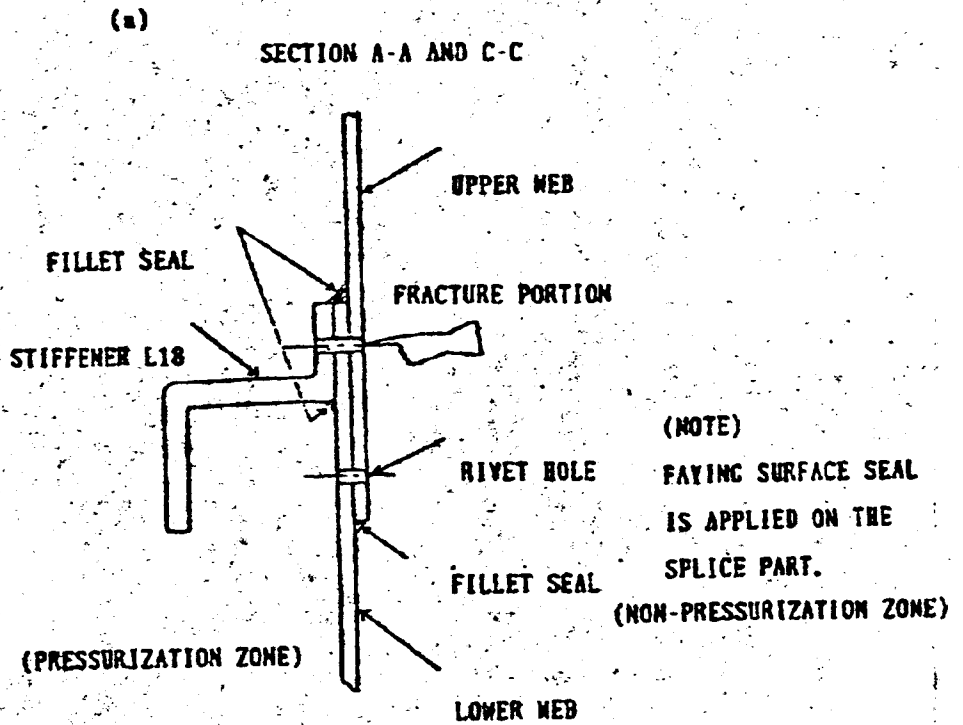
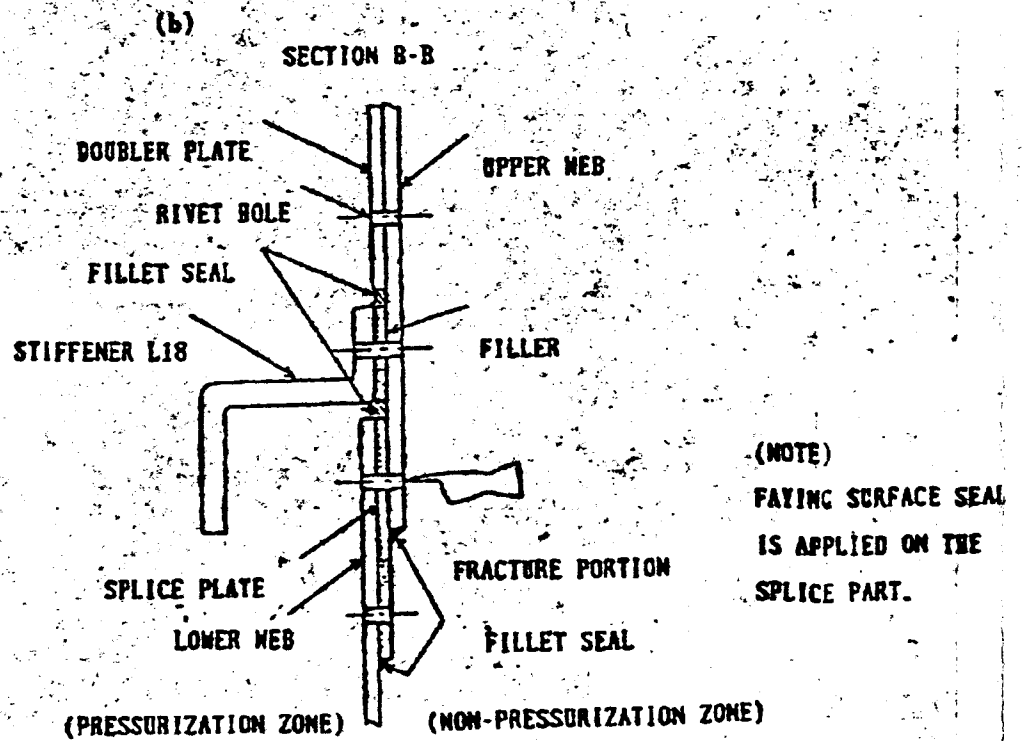
Figure-38 Details of fracture of

(a) Fracture of webs along L18 stiffener

Fracture of the aft pressure bulkhead along L18 stiffener is as shown in Attached Figure-37.

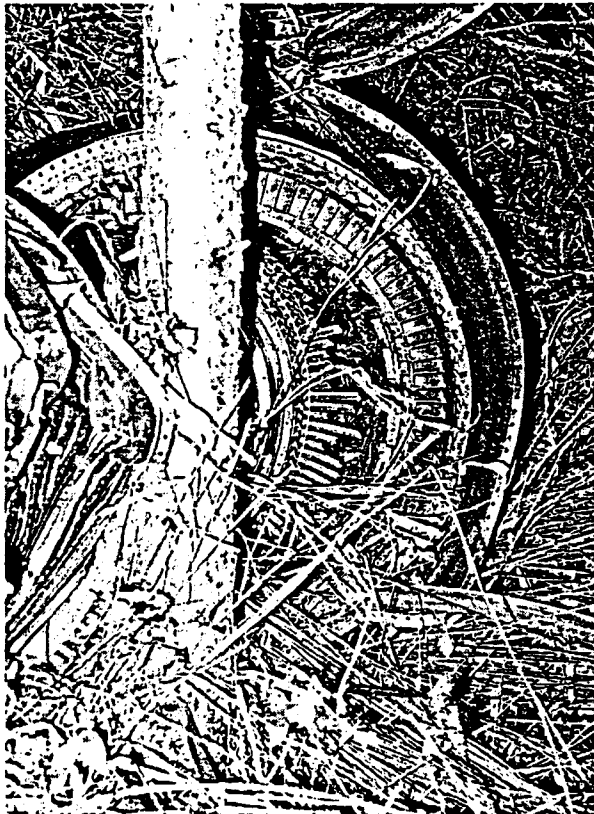
10 Part of No.4 engine

(4) The fan section and core of No.4 engine were destroyed, the fan and the high pressure compressor shaft being severed, and broken into two in the vicinity of stage 9 of the high pressure compressor. The spinner, fan blades, fan case, thrust reverser, engine mounts, gear boxes, combustion chamber, high and low pressure turbine blades, turbine sleeve and plug were torn off and separated (see Photo-10).

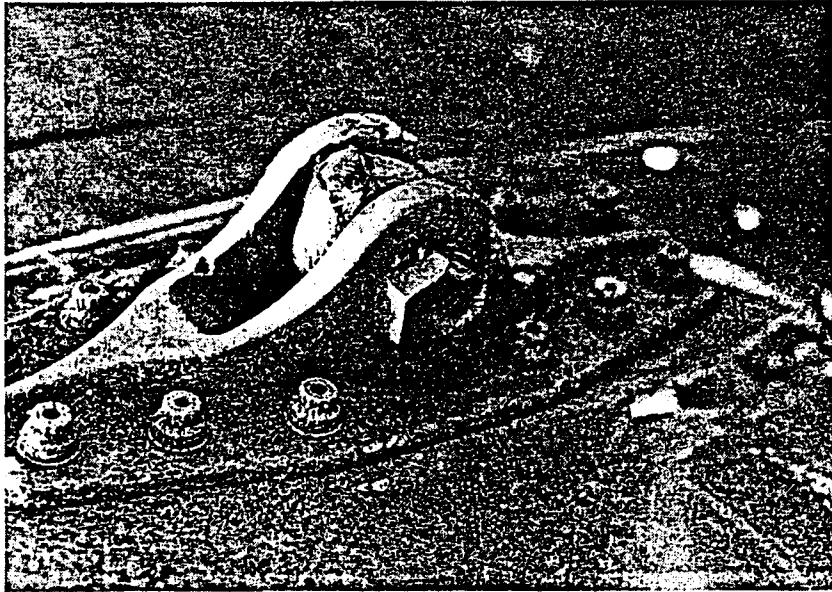
(d) The end fitting at the fuselage side of the tie rod link connecting the vertical fin's auxiliary span with the fuselage was fractured at the neck of an eye bolt, but no evidence of fatigue fracture was recognized on the fracture surface, and the fracture would have been caused by tension. Its end fitting on the auxiliary spar side, including the attaching bracket, was fractured and separated, and has not been recovered.

11 Fractured part of tierod link

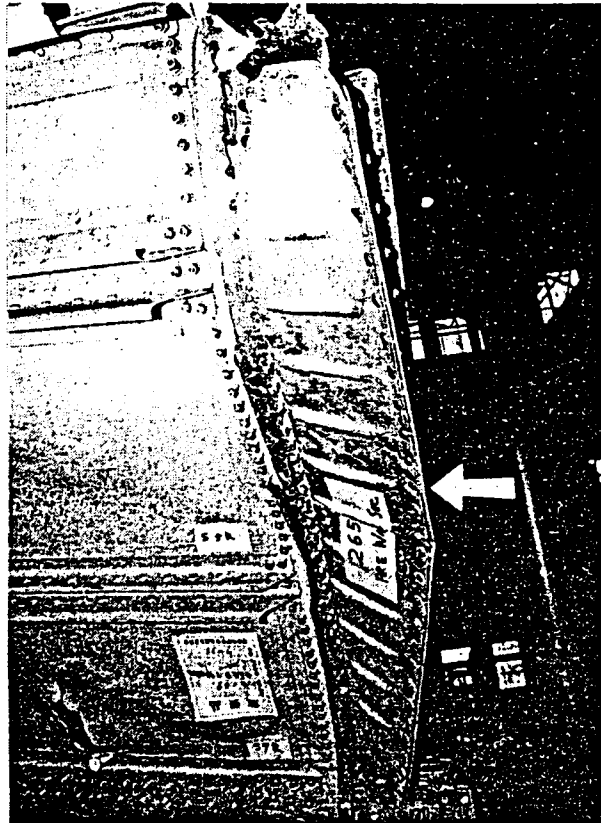
(b) Between 2R and 7R, both angles were partially fractured at the L section's corner (hereinafter referred to as "corner"), but the hinge support channel of the APU air intake duct remained attached.

34 Hinge support channel of APU air intake duct

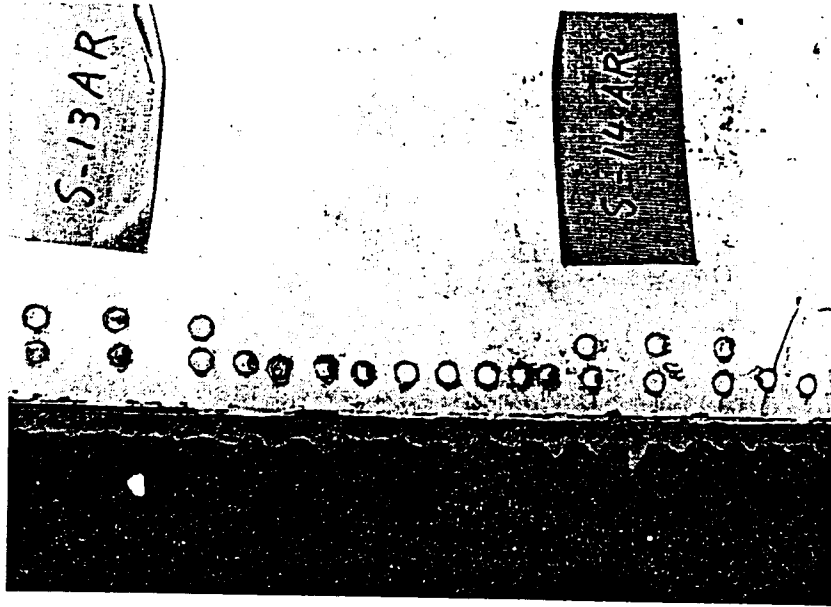
35 Damage of APU firewall installation section at
BS2658 near S14AR

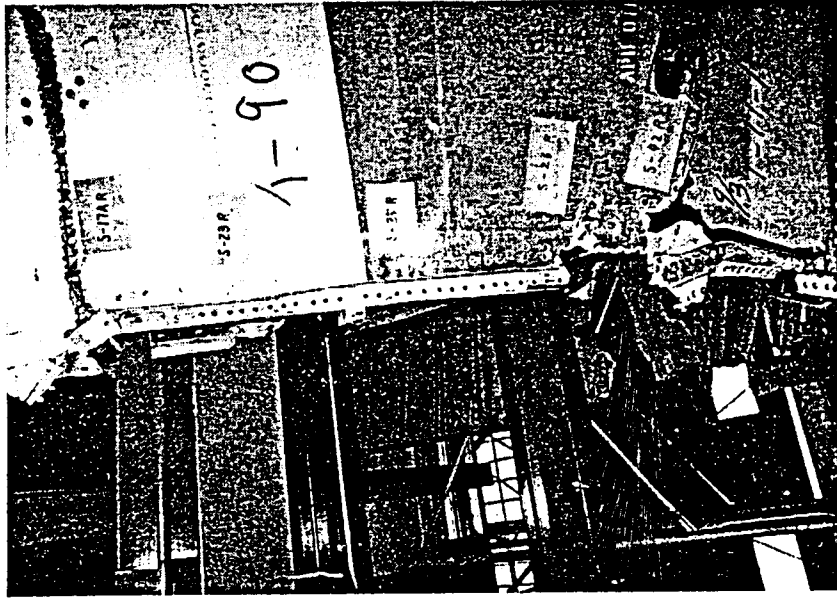
36 Damage of APU firewall installation section at
BS2658 near S23R

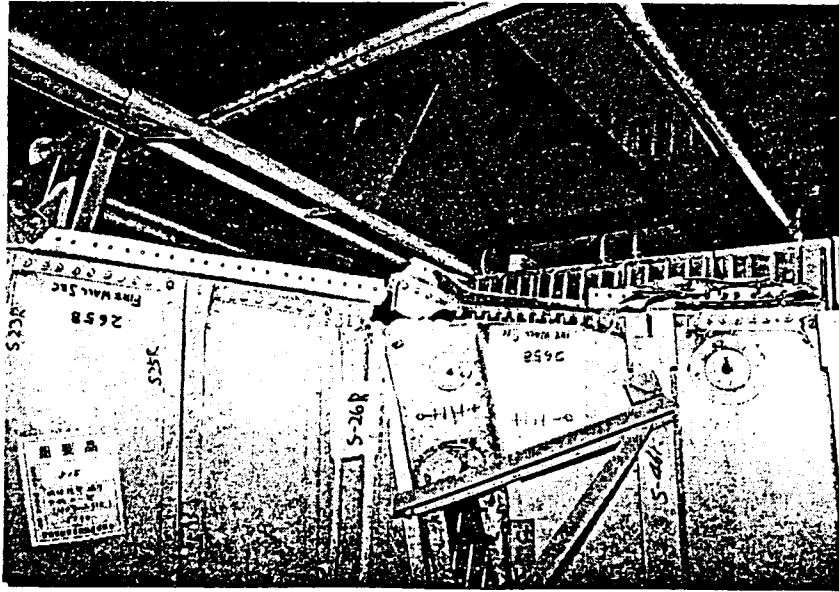
37 Damage of APU firewall installation section at BS2658 near S25R

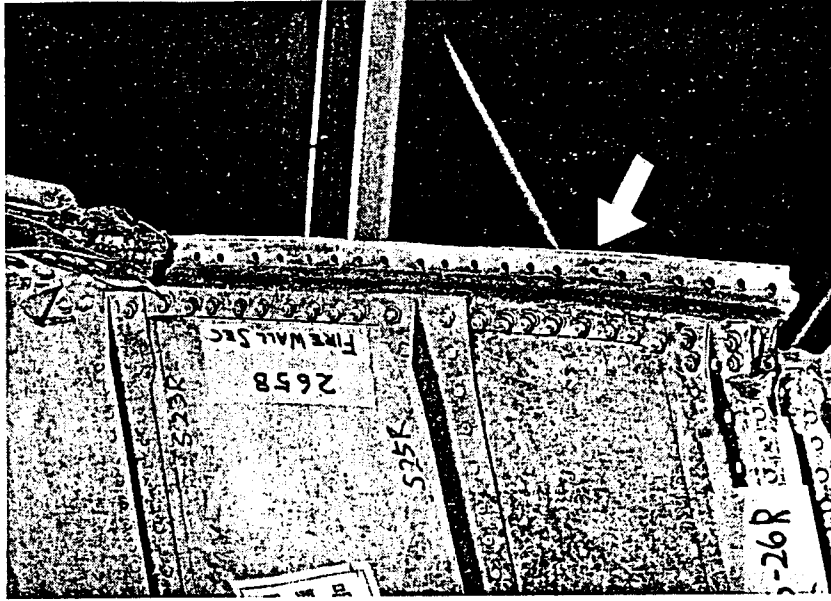
38 Warped doubler in APU firewall installation section at BS2658 near S25R

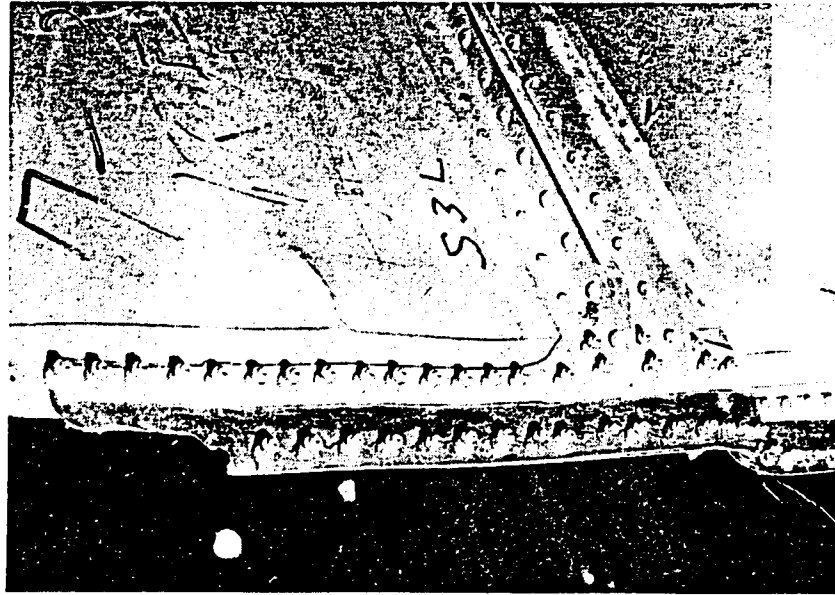
39 Damage of APU firewall installation section at
BS2658 near S3L

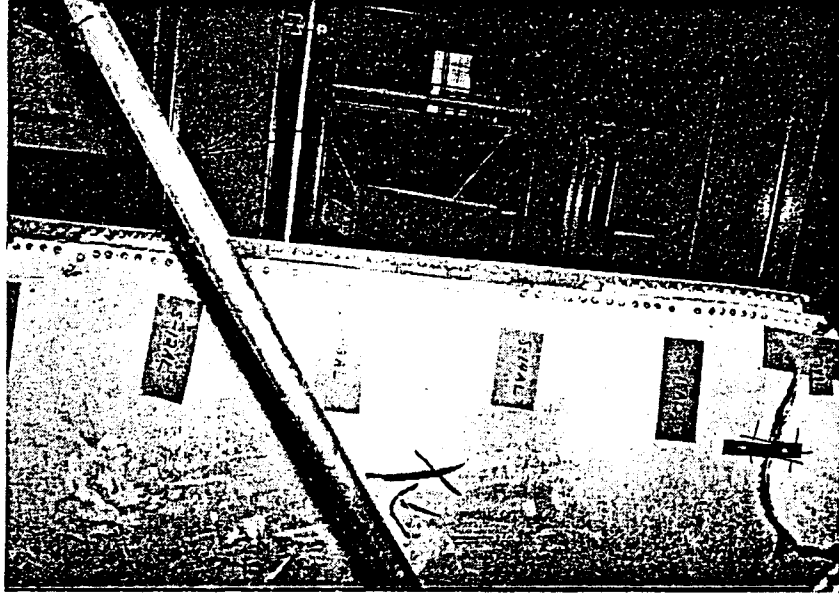
40 Damage of APU firewall installation section at
BS2658 near S14AL

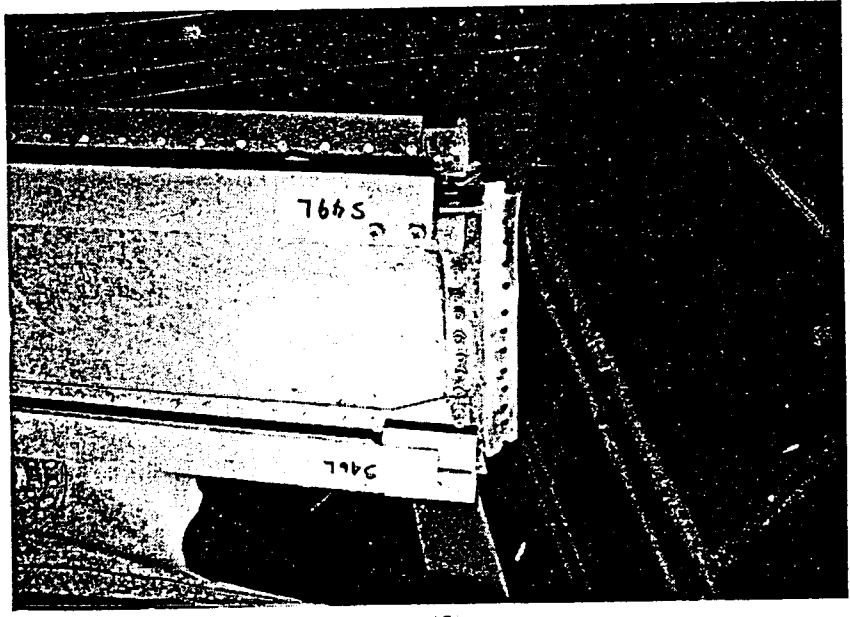
42 Damage of APU firewall installation section at BS2658 between S46L and S49L

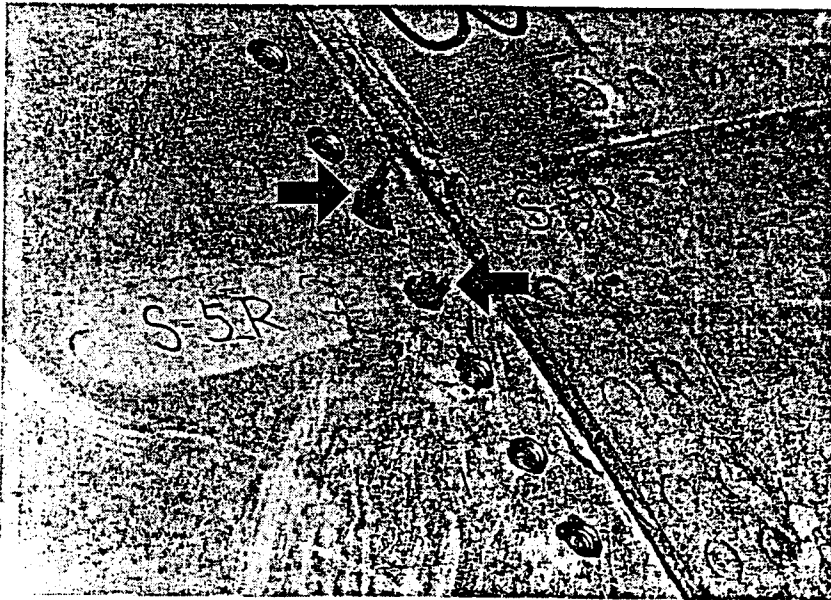
43 Insulation materials that appear to have blown through fastener holes in fuselage skin at BS2638

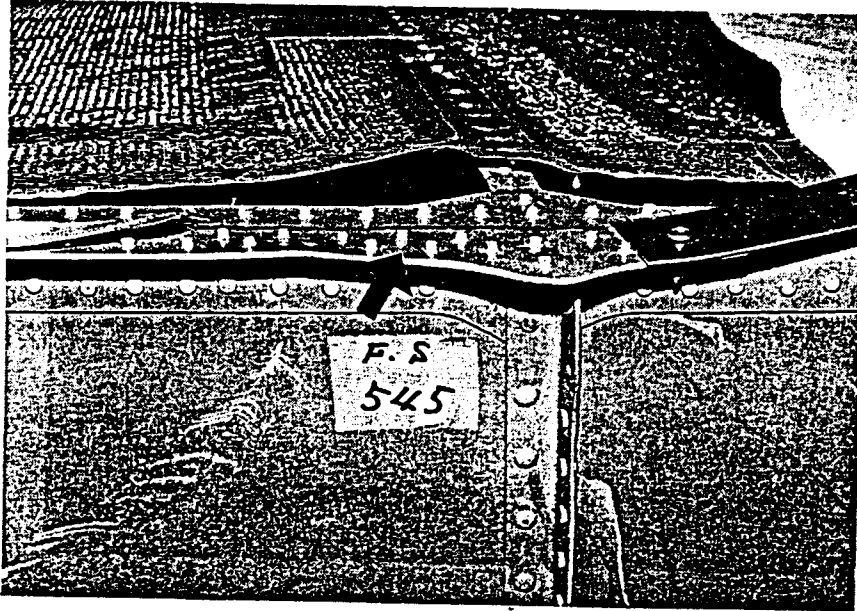
45 Fractured rivets at vertical stabilizer
forward torque box front spar left chord

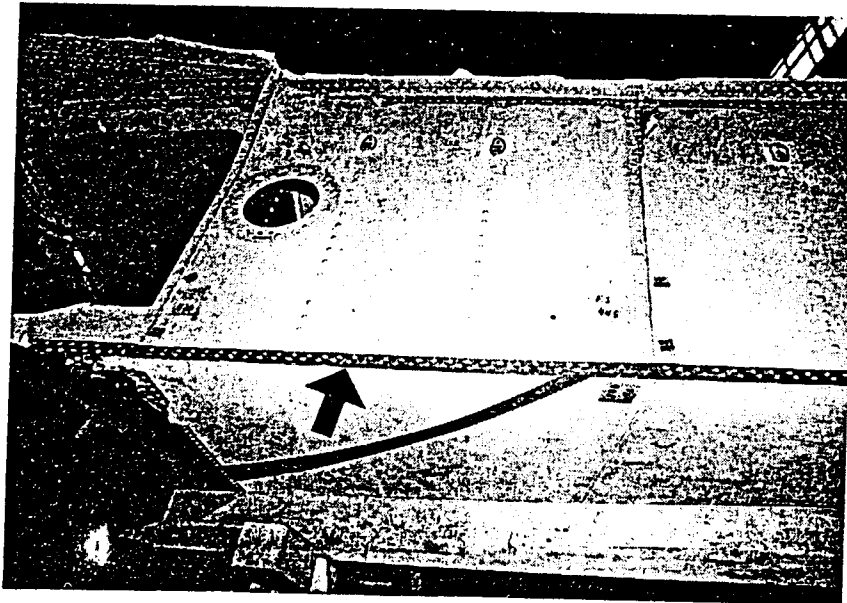
46 Fractured skin at vertical stabilizer forward
torque box front spar right chord

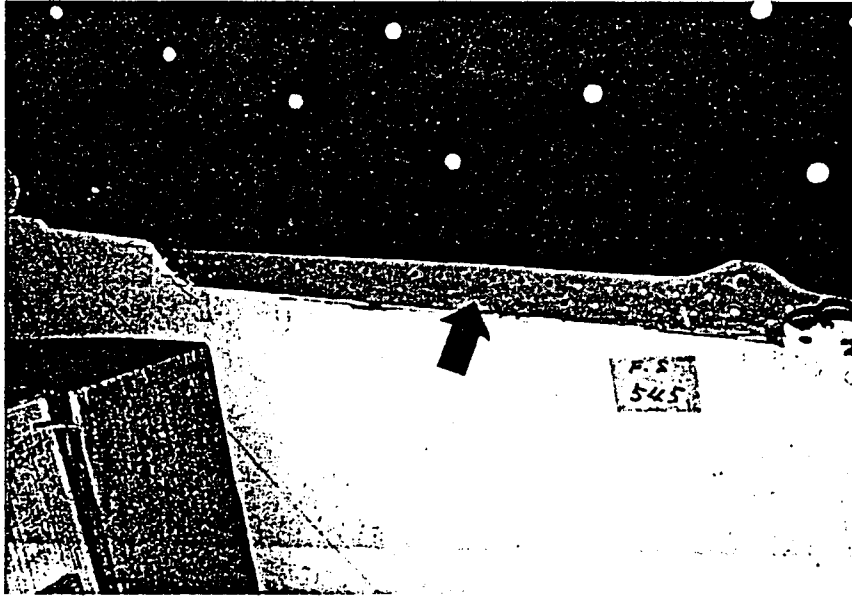
47 Fractured rivets at vertical stabilizer forward torque box spar right chord near FS545

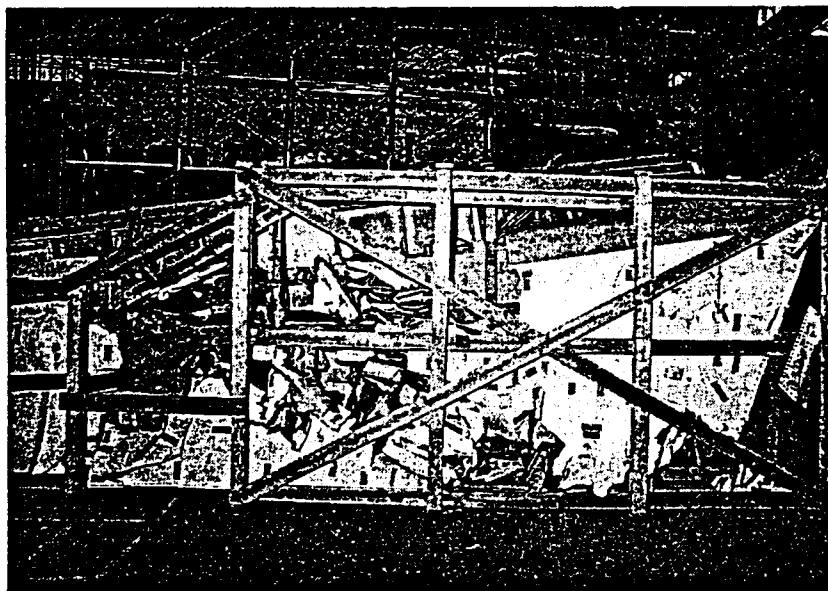
- (4) The horizontal plane was separated from the fuselage, and the left outside elevator was torn off from the stabilizer. A portion of the leading edge of the root of the stabilizer was fractured and separated.
The left leading edge of the horizontal stabilizer's center section and up to the vicinity of SS165.73 was damaged (see Photo-6).

60 Fractured left horizontal stabilizer leading edge

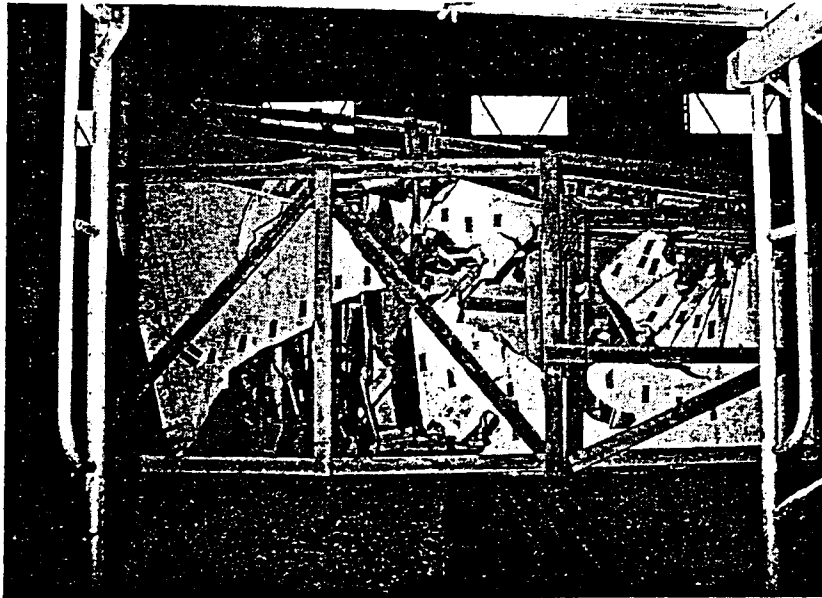
61 Fractured right horizontal stabilizer leading edge

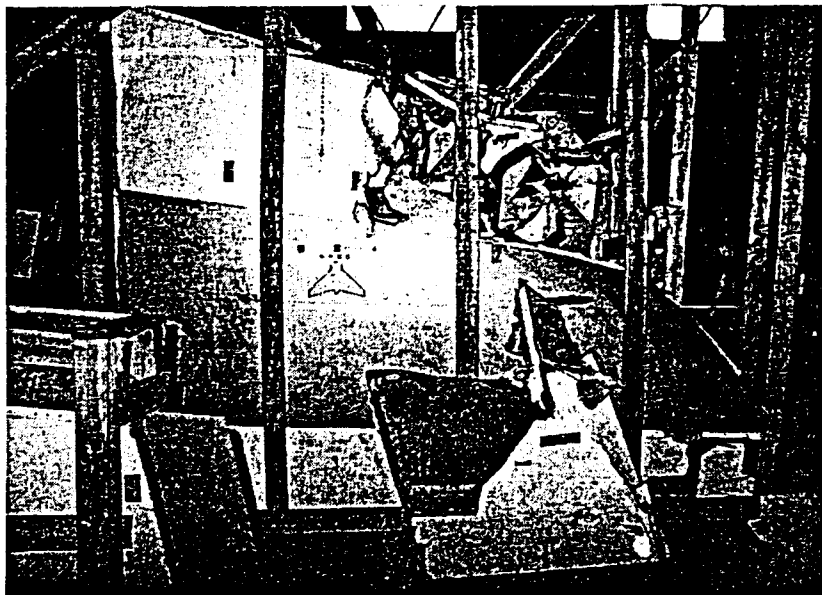
62 Fractured right horizontal stabilizer tip

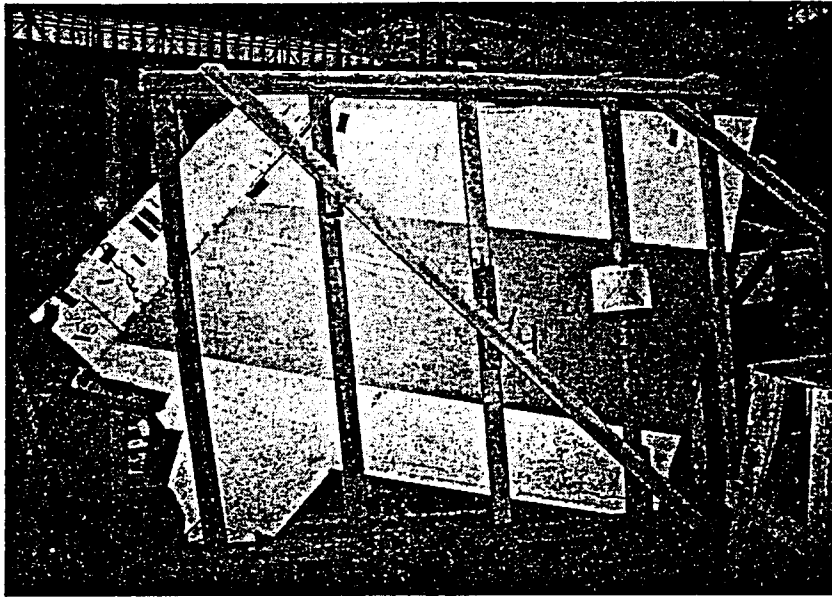
63 Fractured left horizontal stabilizer tip

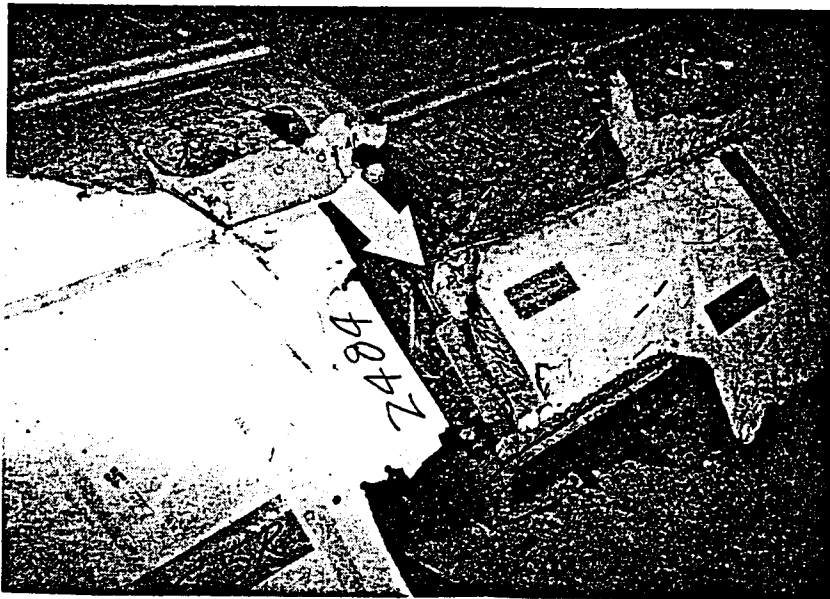
- 95 Fuselage rupture at fuselage to vertical fin joint
(BS2484)

Heat insulation materials found in right skin corner at base of aft torque box.

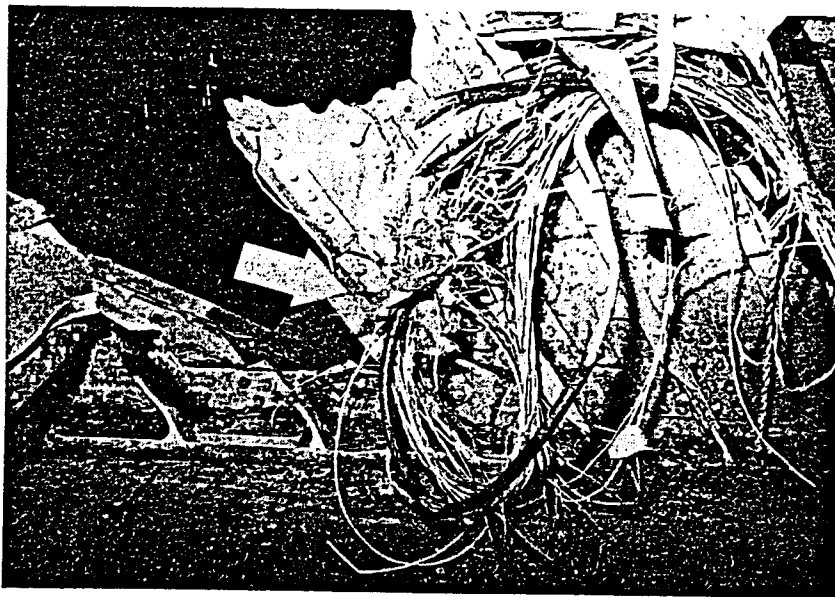
- 96 Vertical stabilizer aft torque box-root of skin on
left side

Film covering heat insulation materials found
tangled in antenna cable, etc.

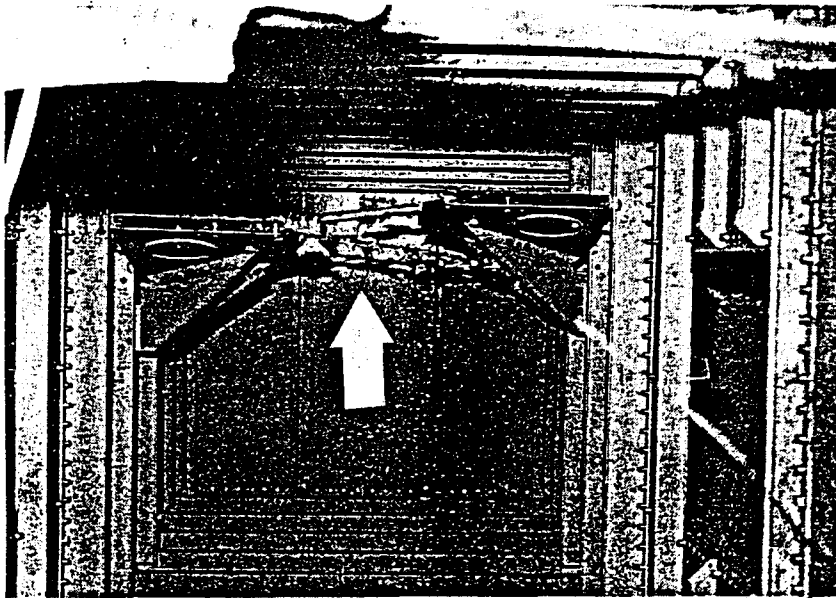
97 Central part of horizontal stabilizer center section

Heat insulation found adhering to control cable inside.

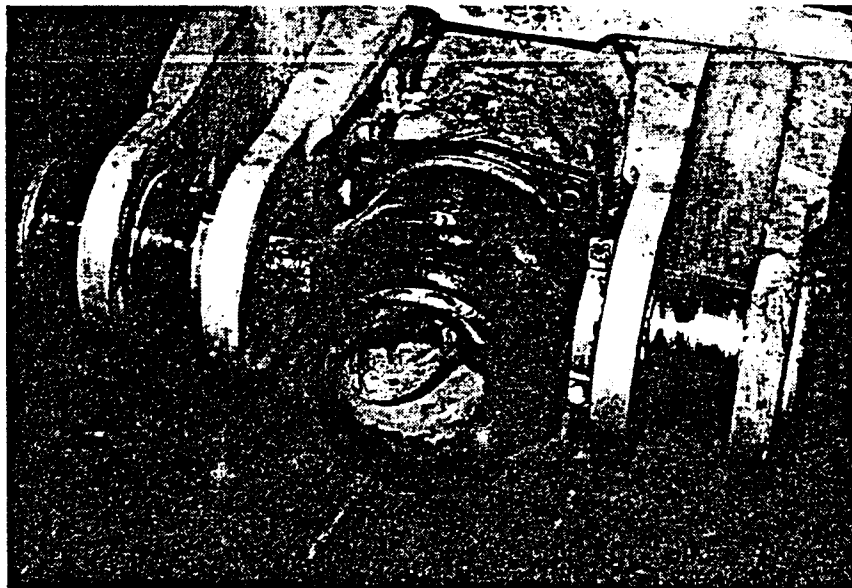
100 Fracture of horizontal stabilizer jack screw
(condition before teardown).

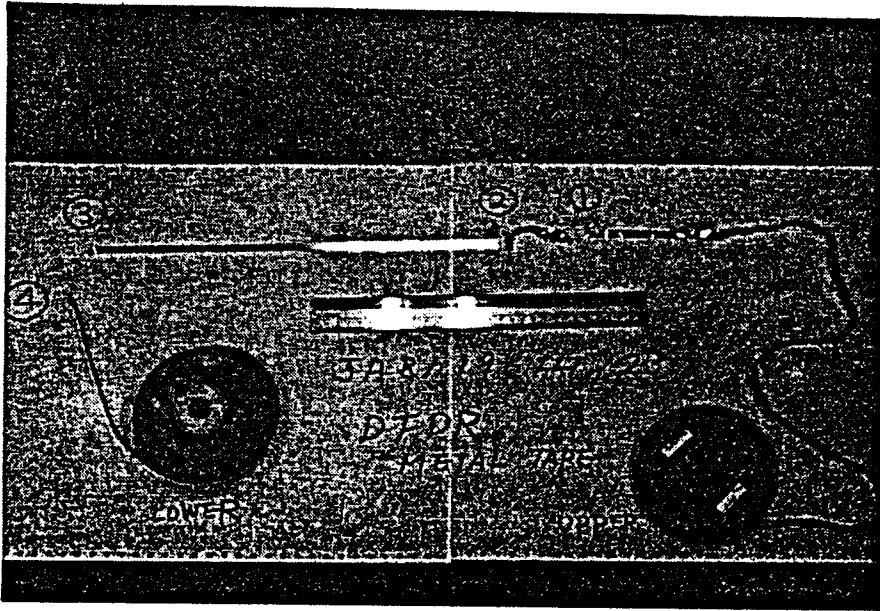
101 Damage to magnetic tape

写真の中の③④は当該飛行以外の記録部分の損傷であり、
また、テープが白くなっている箇所はフラッシュ・ライト
のためである。

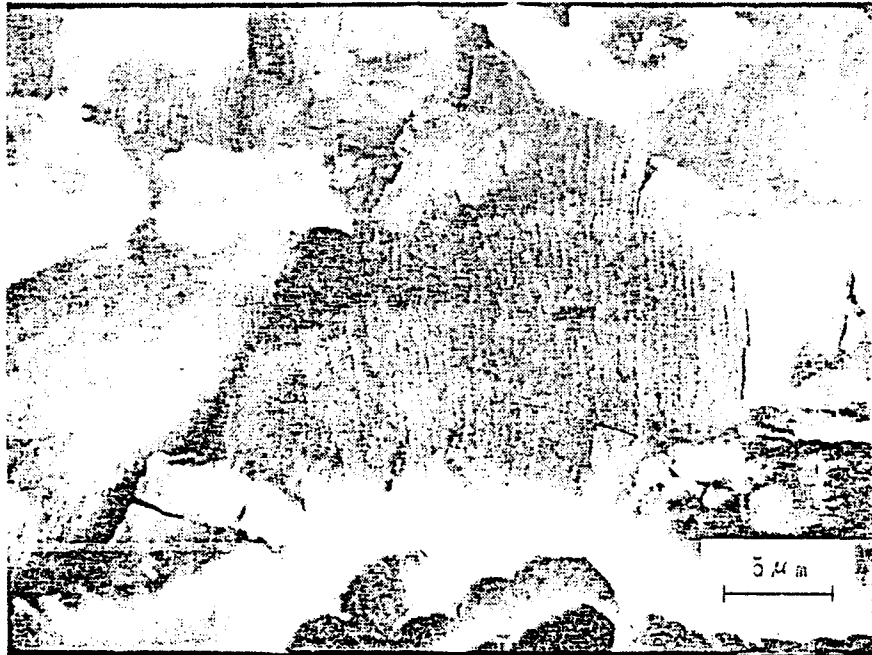
Photo-109 Fracture surface of rivet hole No.34 inboard. Typical fatigue fracture facet. Fine striation patterns show stable crack propagation due to cyclic loading. The spacing of the striation gives the rate of propagation being $0.23\mu\text{m}$ per cycle at this point, 0.28mm from hole edge. Crack grew from left to right on the photo.

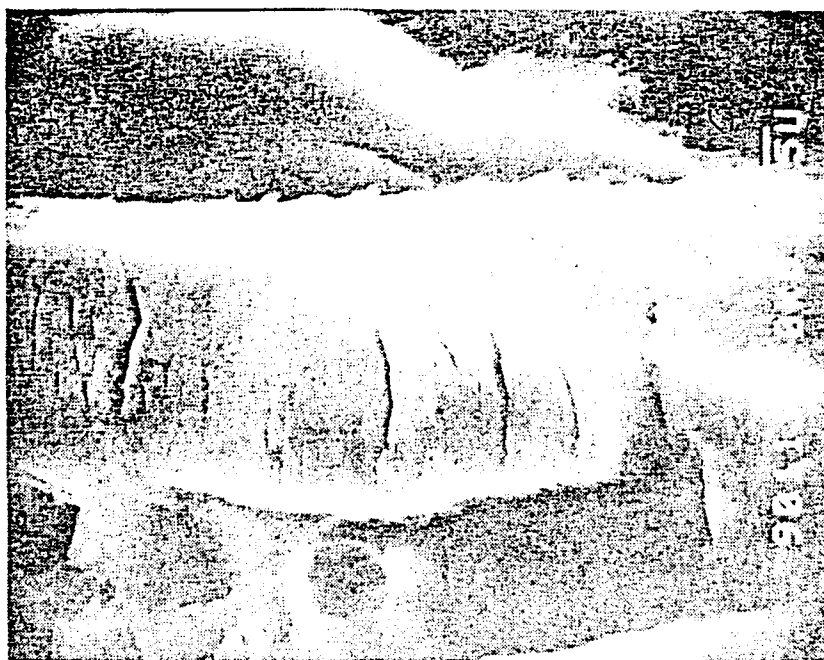
Photo-114 Fracture surface of rivet hole No.90 inboard. Direction of crack growth is from left to right on the photo at 2.60mm from egde of rivet hole No.90 inboard.

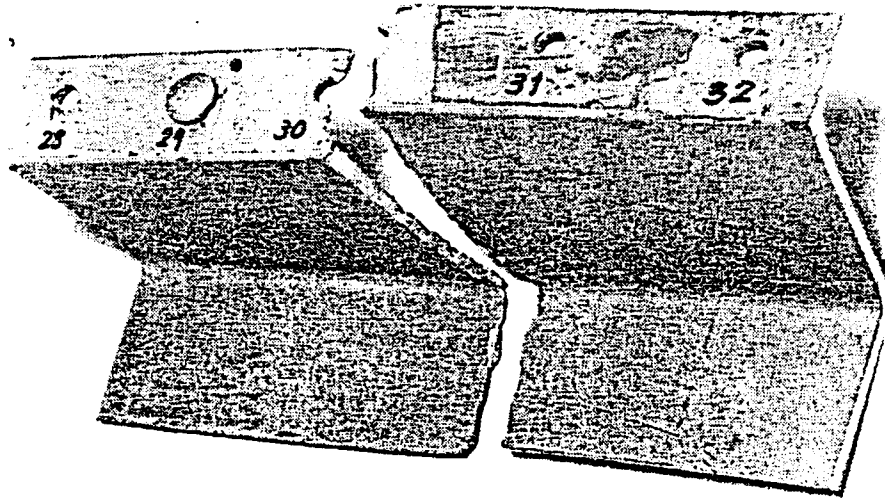
Photo-119 Fracture aspect of stiffener L18, at rivet hole No.30.

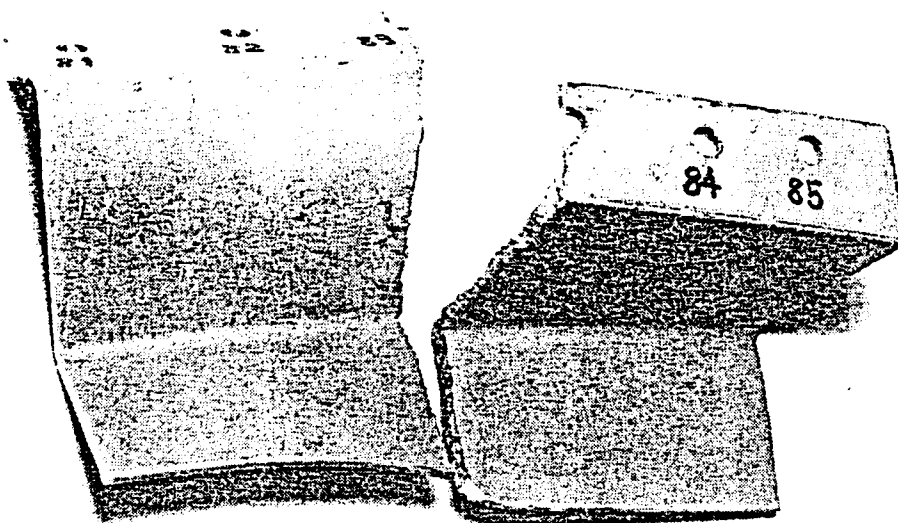
Photo-120 Fracture aspect of stiffener L18, at rivet hole No.83.

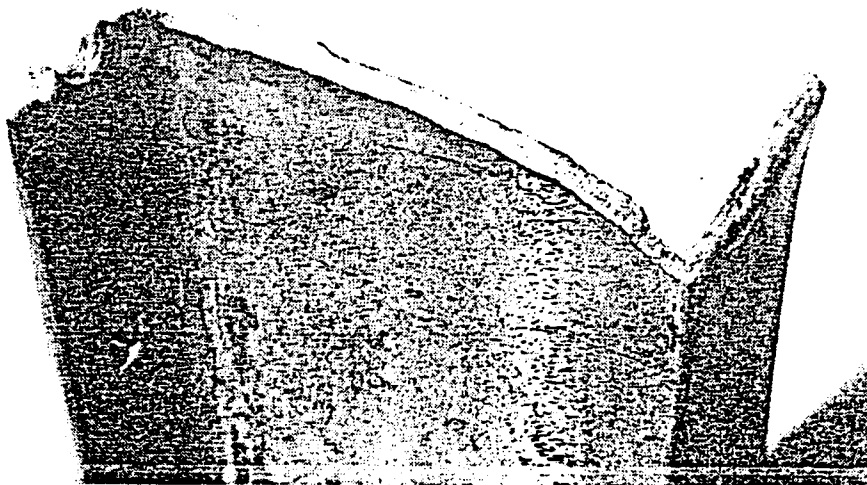
Photo-121 Close-up view of stiffener L18, revealing shear mode fracture, at rivet hole No.30 outboard.

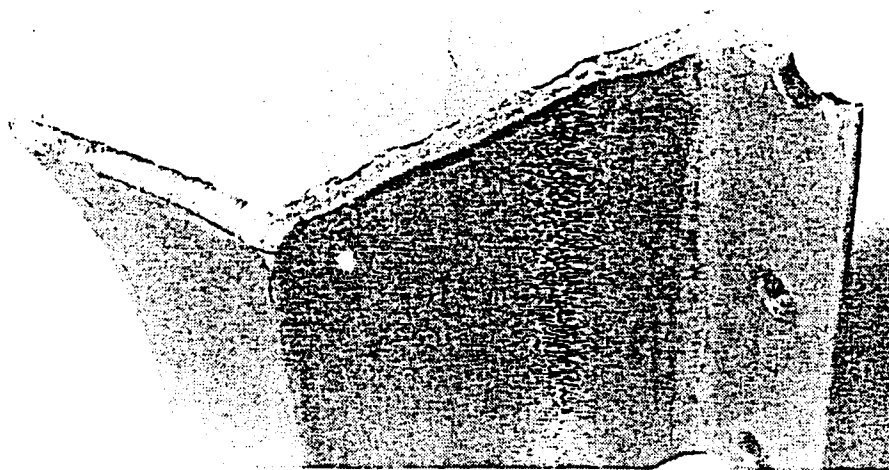
Photo-122 Close-up view of stiffener L18, revealing shear mode fracture, at rivet hole No.83 outboard.
