Tech Notes

MECHANICAL SYSTEMS

Replicating Historic Elevator Enclosures

GUARANTY BUILDING Buffalo, New York

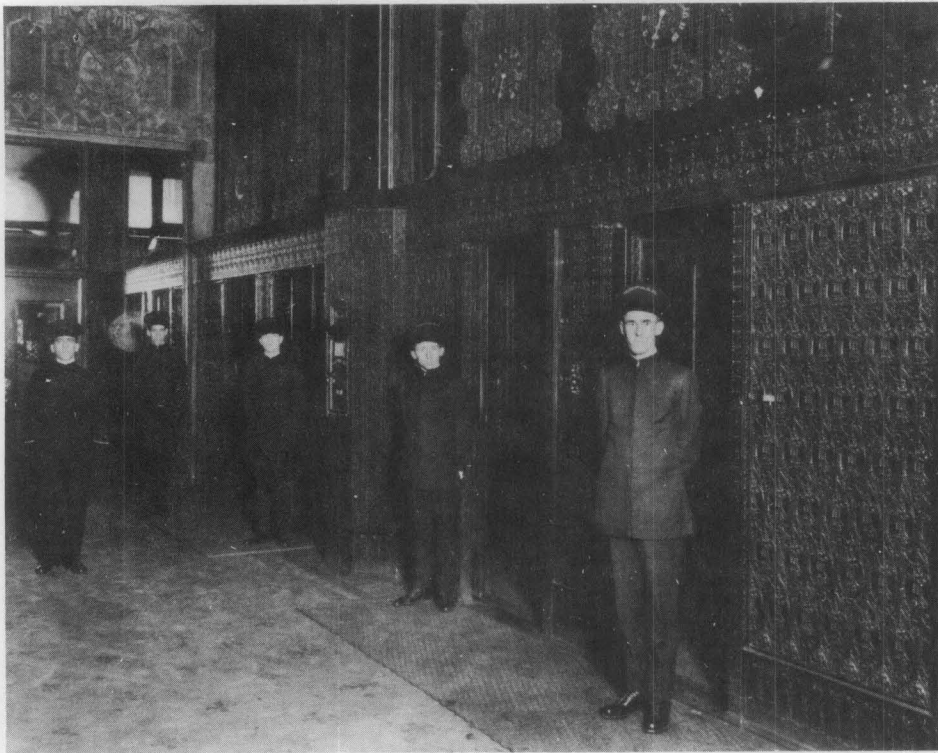
The elevator doors and walls that enclosed the elevator shaft and faced the elevator lobbies were part of a cast iron enclosure assembled from vertical and horizontal members: posts, friezes, cornices, base moldings, and pierced infill grilles. All were detailed with an ornate organic pattern based on the growth and emergence of a germinating seedpod, and finished with electro-plated bronze (see figure 2).

Figure 2. First floor elevator lobby, c. 1897, from northwest. Photo: United Founders Life Insurance Company of Illinois.

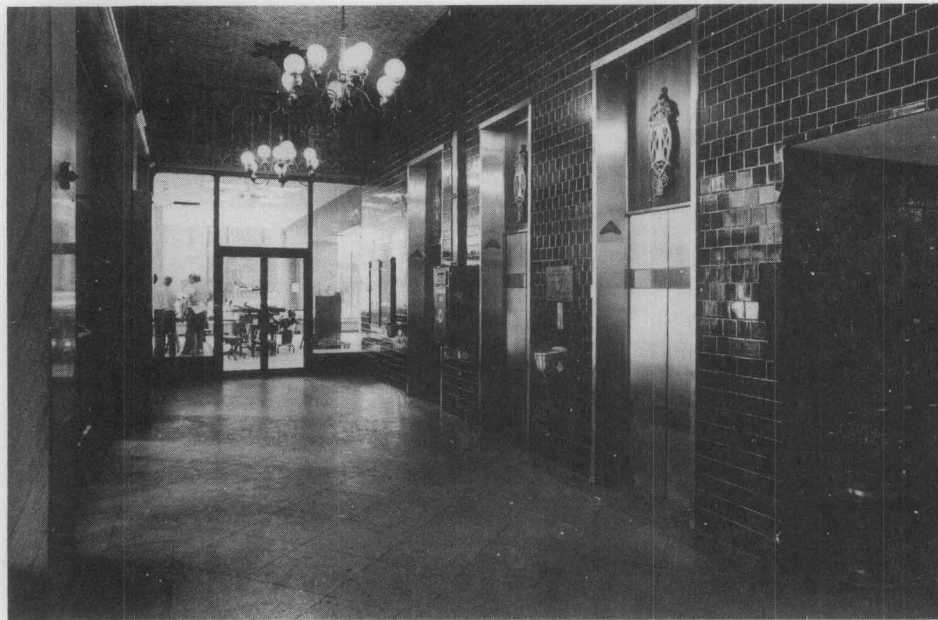
The 1962 changes had a major impact on Sullivan's original design. The four 1903 cabs were replaced with a 3-cab, electrically powered system, with the remaining shaft left vacant for future use. The glazed elevator cabs were replaced with fully enclosed ones, and the open elevator shaft and single stairway were enclosed with two-hour, fire-rated masonry walls (see figure 3). Throughout the building, almost all elevator ornament was removed, leaving only a small piece of the elevator framework exposed within

Figure 3. First floor elevator lobby, c. 1962. Modifications included reduction in number of elevators and addition of masonry enclosure around open elevators and main building stair. Photo: Cannon.

the stair to the west of the elevator bank. Window openings within the elevator shaft were infilled with concrete block, and the shaft's skylight was removed to provide space for a new elevator penthouse.

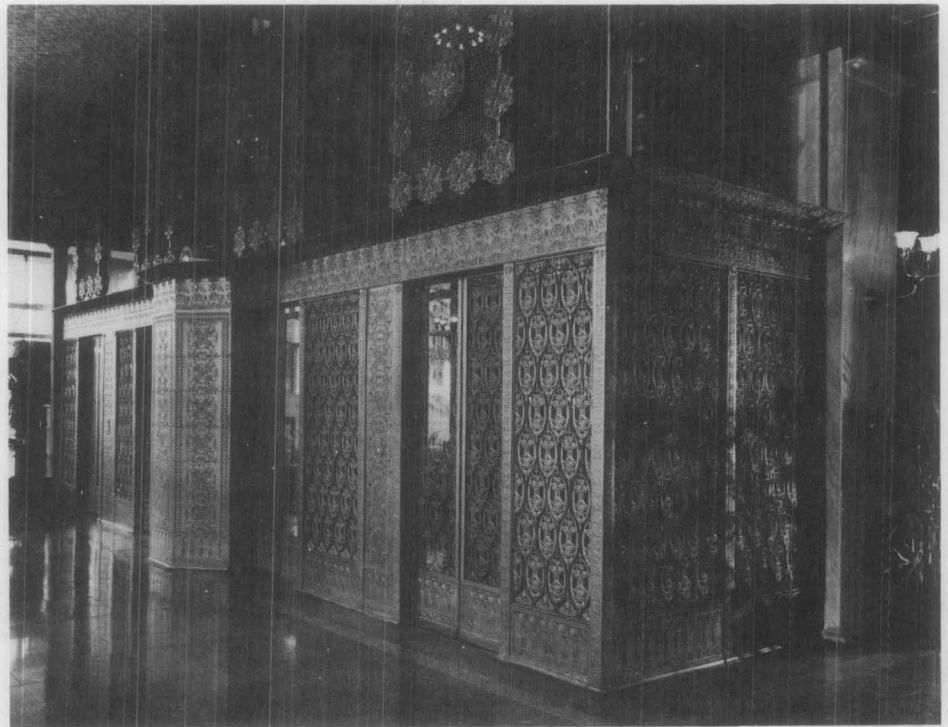
Figure 4. First floor elevator lobby as restored, 1984, showing the replicated cast ornament on the elevator enclosure, with sprinkler heads discreetly placed to protect elevator cabs. The elevator door far left (number 4) is inoperable since the cab and equipment had been removed in 1962. Photo: Patricia Layman Bazelon.

At the first and second floor levels, the elevator enclosures and original lobby floor plans were restored (see figure 4). Replication of all elements comprising the enclosures required the recasting of new elements in molds taken from original samples. Cast iron was used (as had originally been specified by Sullivan), and throughout the casting and finishing processes the architects worked closely with the artisans at the foundry. Only a few surviving elements were able to be refinished and reused.

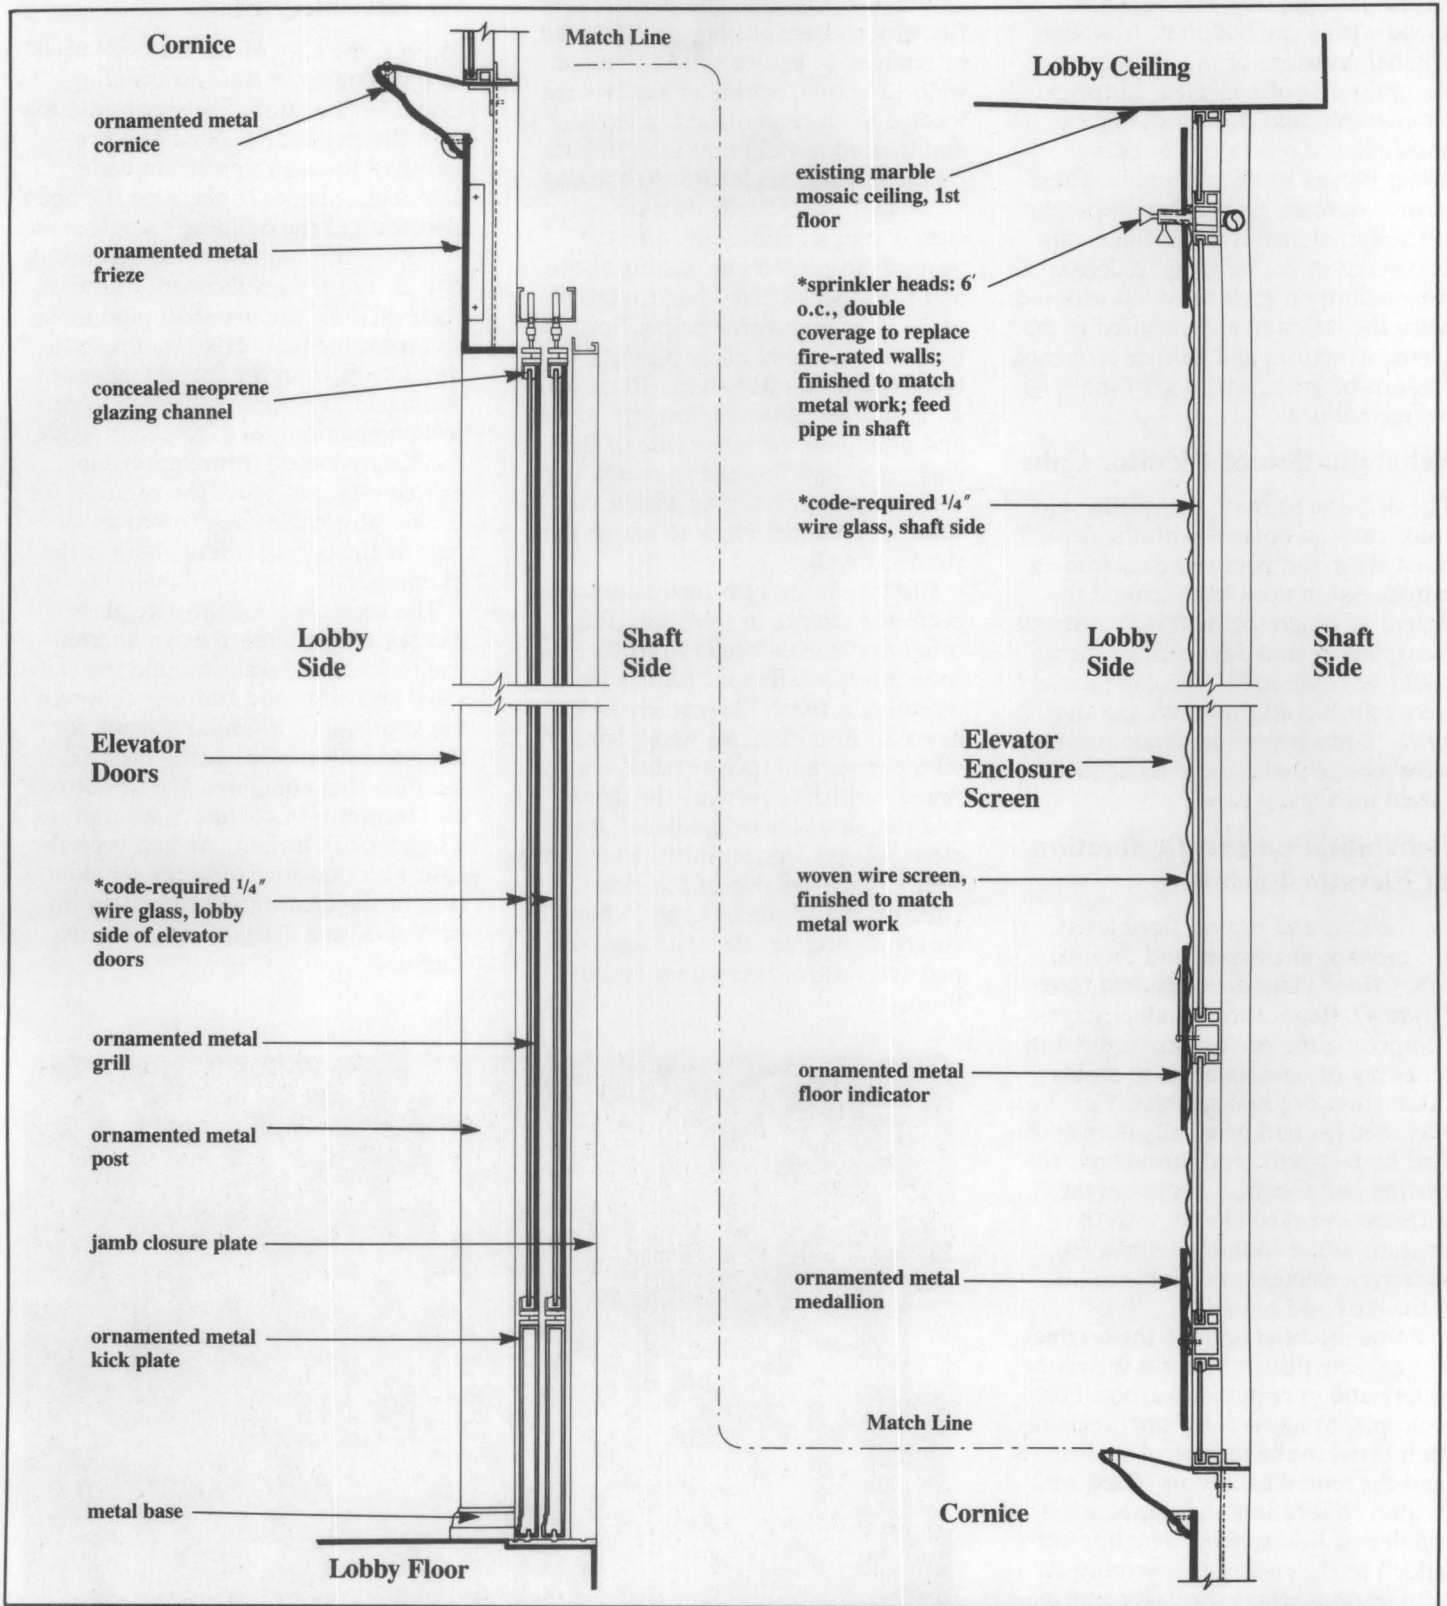
Figure 5. The reconstruction of the elevator enclosures was a complex integration of code-required features (marked by an *) and architectural elements. Wire glass and double-coverage fire sprinklers replaced fire-rated walls while retaining the quality of light in Sullivan's original design. The metal ornament was reproduced in copper-plated cast iron and finished with a tinted varnish to match the original bronze electroplated finish.

Some modifications to the original design were necessary for a variety of safety and operational reasons. For example, to allow for proper registration between the replicated enclosures and the reused cab doors (fixed with respect to location and dimensions), small cast iron spacers were discreetly added to the enclosure assembly. At all locations where the cast metal elevator enclosures was fixed, 1/4" wire glass was installed on the shaftway side with a specially designed, concealed glass gasket. The portion of the enclosure that opened with the elevator doors was double faced with wire glass installed on the lobby side as added protection (see figure 5).

coverage was used at the elevator and first floor where glazing was installed or retained in lieu of solid fire-rated walls (2 hours). Sprinkler heads were located 6' on center (o.c.), selected and located to minimize their impact on the elevator enclosure. At the elevator shaft, two heads were placed at each 6' o.c. location, one directed upwards to protect the glazing above, and the other directed horizontally to protect the lobby area below. Sprinkler heads were connected to piping located in the elevator shaft. To ensure an unobtrusive installation, sprinklers and piping on the lobby side of the enclosure were finished to match the decorative metal; piping within the shaft was painted black to match the shaftway walls.

Electroplating of bronze was not a perfected science in 1897, and the original elements began to oxidize soon after installation. Rather than repeating a finish likely to corrode, new cast iron elements were plated with copper and then finished with a tinted varnish to recreate the depth and patina of the original and aged electroplated bronze finish. Exceptions were at the west side of the elevator enclosure at all upper levels, where the surviving original elements were stripped and refurbished with a liquid bronze.

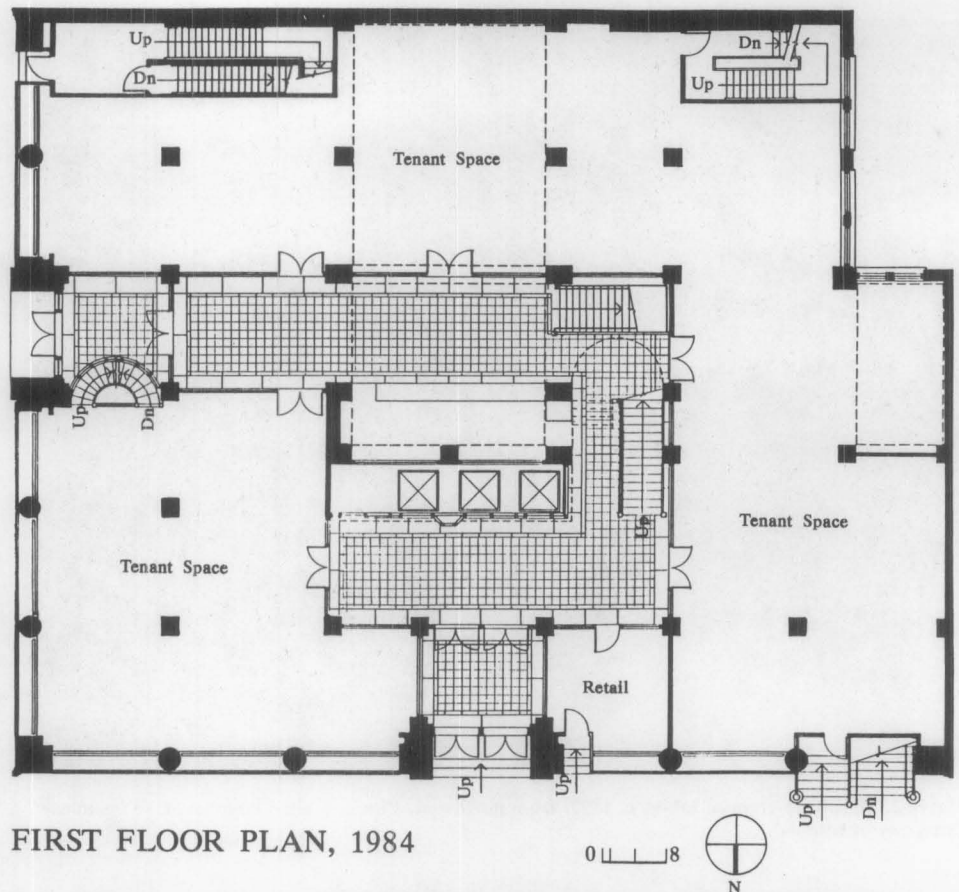
FIRST FLOOR PLAN, 1984

Figure 6. First floor as restored, 1984. With the exception of two new exit stairs added at southeast and southwest corners, the first floor has been faithfully restored to its 1897 appearance, including the 4-bay elevator enclosure. Drawing: Cannon, Javier Salazar.

New stairs exiting directly to the outside were unobtrusively added at the southeast and southwest corners of the building (see figure 6). The stairs at the southwest connected to the building's original open stair; at
