Structures and Mechanics Division

J. A. Smith

December 1989

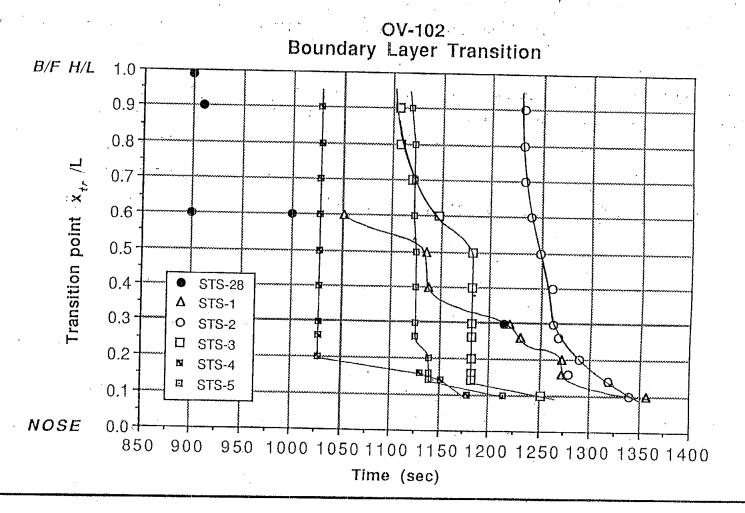
• Transition sometimes occurs at one time over the total vehicle length, while other times it begins at the aft portion of the vehicle and moves forward

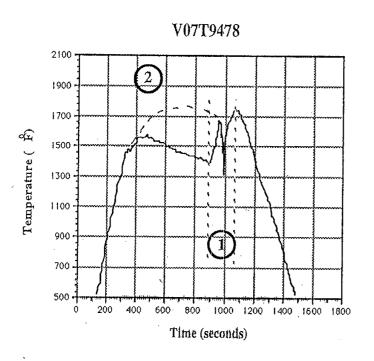
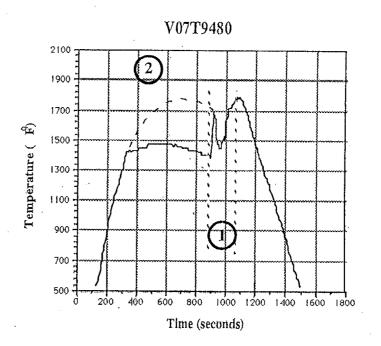
STS-28 Flight Data

- STS-28 (Continued)
 - Questionable "Double Transition" Data and Transition Time (V07T9478, Centerline and V07T9480 port side at same X location) (See Next Page)

- (1) If data is "good" during this time interval, it shows that transition from laminar to turbulent flow occurred at approx. 900 seconds, then went back to laminar flow at 1000 seconds for V07T9478 and 950 seconds for V07T9480, then returned to turbulent flow.

- -May possibly result from protruding AMES gap fillers, causing the first transition to occur; then (after burning out or softening the RTV) the gap filler layed over, allowing return to laminar flow before the final transition to turbulent flow

- OR (2) If the data is "not good", but really reacts as shown by dashes, it negates the first transition time
 - BUT Laminar peak temperatures would be higher than ever recorded in these locations and, Thermal Analysis shows that structural temperatures would not correlate with the higher laminar temperatures

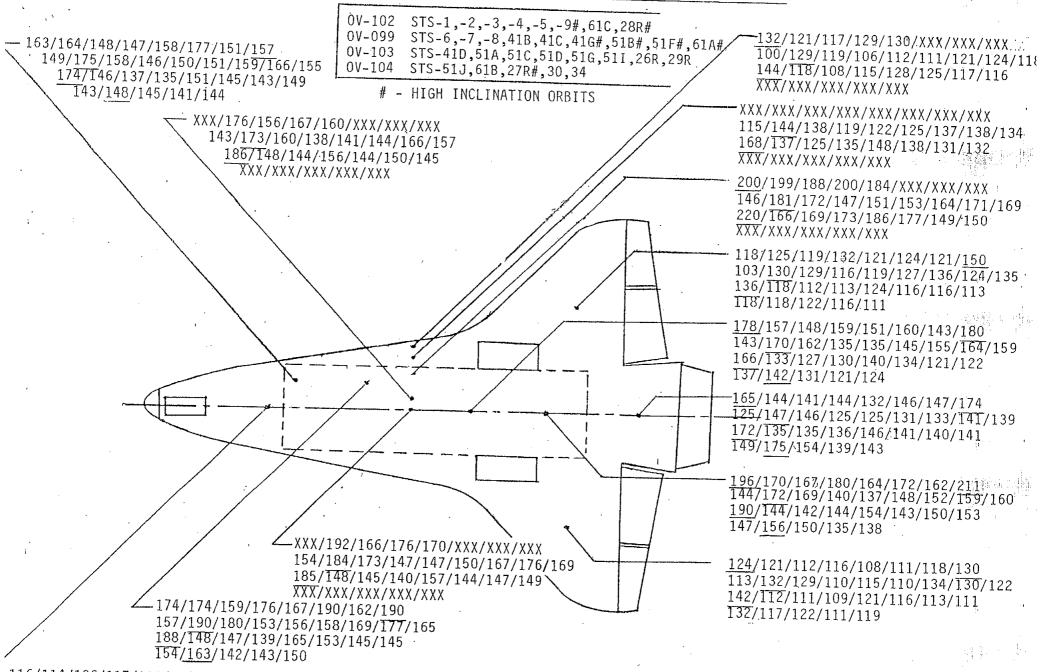
URBITER STRUCTURAL TEMPERATURE RISE DUE TO ENTRY HEATING

- Operational structure temperature measurements (from which structural temperature rise is obtained) did not show any unexplained/unusual values except indications on flights with no surface thermocouple instrumentation, or no data. Noteably:

- The second flight of OV-099 (STS-7)
 - The first flight of OV-103 (STS-41D)
 - The second flight of OV-104 (STS-51J)
