WER'WOLF MKII Mine Protected Vehicle

**India Trial Report
January – June 2000**

Deployment in the Jammu Region

Report compiled by: Johan Dippenaar
With assistance from: Hannes Kögl
Amos van Jaarsveld
Marico Wessels
Report published in: October 2000

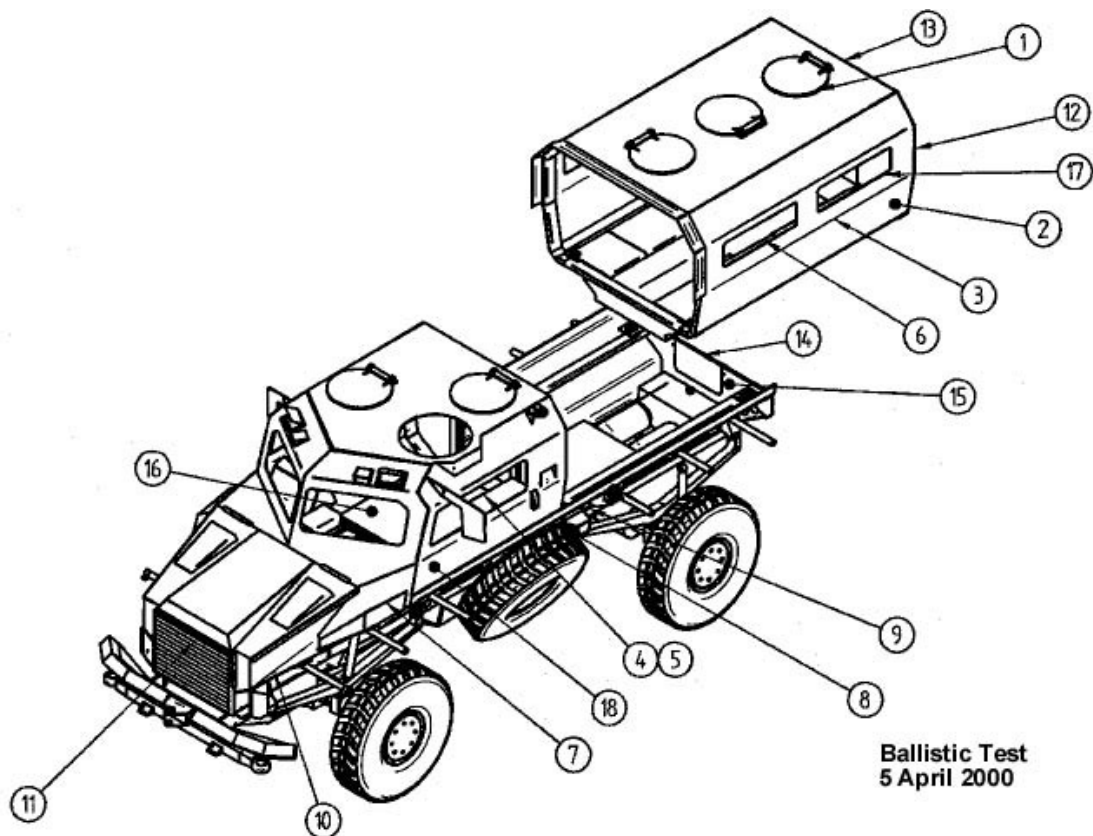
6. **Ballistic tests executed:** all tests are done at a point blank standoff distance of 10 metres with 7,62x39mm AK47, 5,56X45mm INSAS, 7,62X51mm SLR and 7,62X51mm LMG rifles and machine guns using ball rounds.

7. The following tests are done – see the corresponding number on the drawing above for the exact location:
1. 7,62 SLR single shot: roof hatch - shot penetrates fully.

2. LMG burst of 3 rounds – no penetration.
 3. LMG single shot: firing port cover – no penetration.
 4. AK 47 single shot: no penetration.
 5. LMG burst of 3 rounds: side window – cavity forms but no penetration occurs and no bullets are found inside the cabin.

10. INSAS single shot: no penetration.
 11. 7,62 SLR single shot: bullet fragments on impact and 9 shrapnel pinholes are observed in the radiator with another 5 pinholes in the intercooler assembly.

15. 7,62 SLR single shot: RH below number plate – no penetration.
 16. 7,62 SLR single shot: LH windscreen – no penetration.
 17. AK 47 burst: rear window blast reflective mounting buckets – penetration into the mild steel buckets but not into the cabin.

18. LMG burst of 3 rounds: no penetration.

9. After the ballistic penetration test it only takes 35 minutes to have the vehicle fully mobile. Corrective action is focused on plugging the pinhole penetrations in the radiator. This is done using normal Pratley Putty and without replacing the radiator. The vehicle continues to complete the entire trial programme, including automotive performance trials with this repaired radiator.
10. **Test preparation:** the following steps are taken in preparation for the IED side blast test:
 - a. Drive from the ballistic test site to the blast test site.
 - b. Remove the front and rear prop shafts.
 - c. Remove the diesel tank filler cap and replace it with a locally procured galvanised cap.
 - d. Remove and replace the co-driver side window.

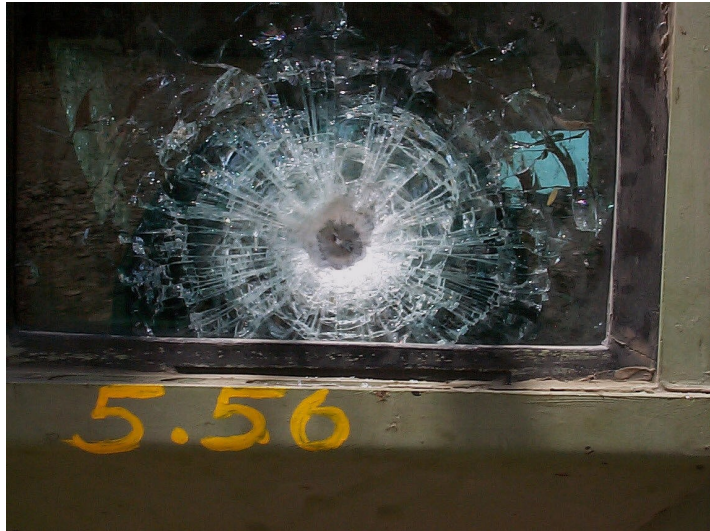
INSAS single shot on left side window.

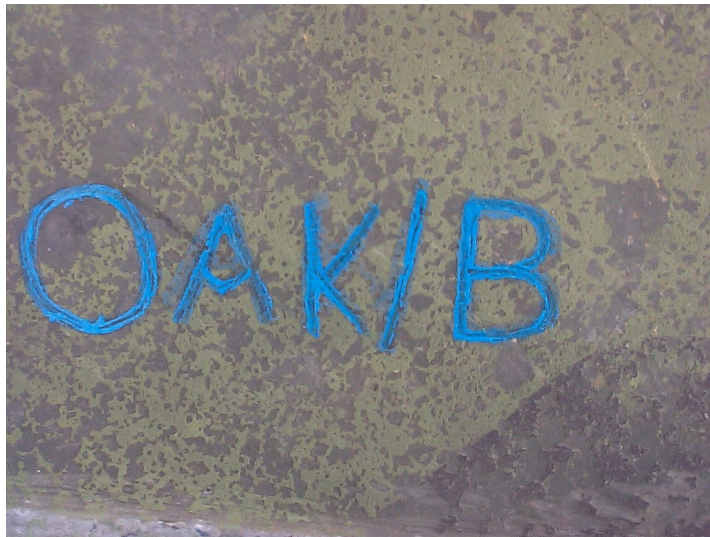
AK 47 burst on hull side.

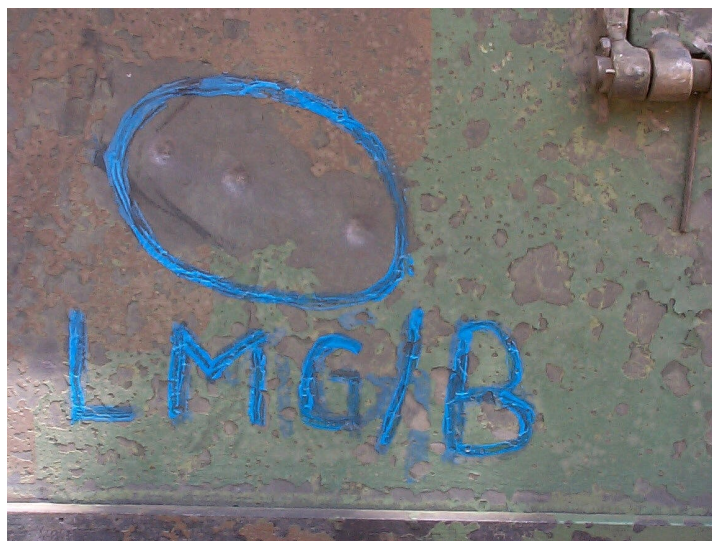
LMG burst on hull side.

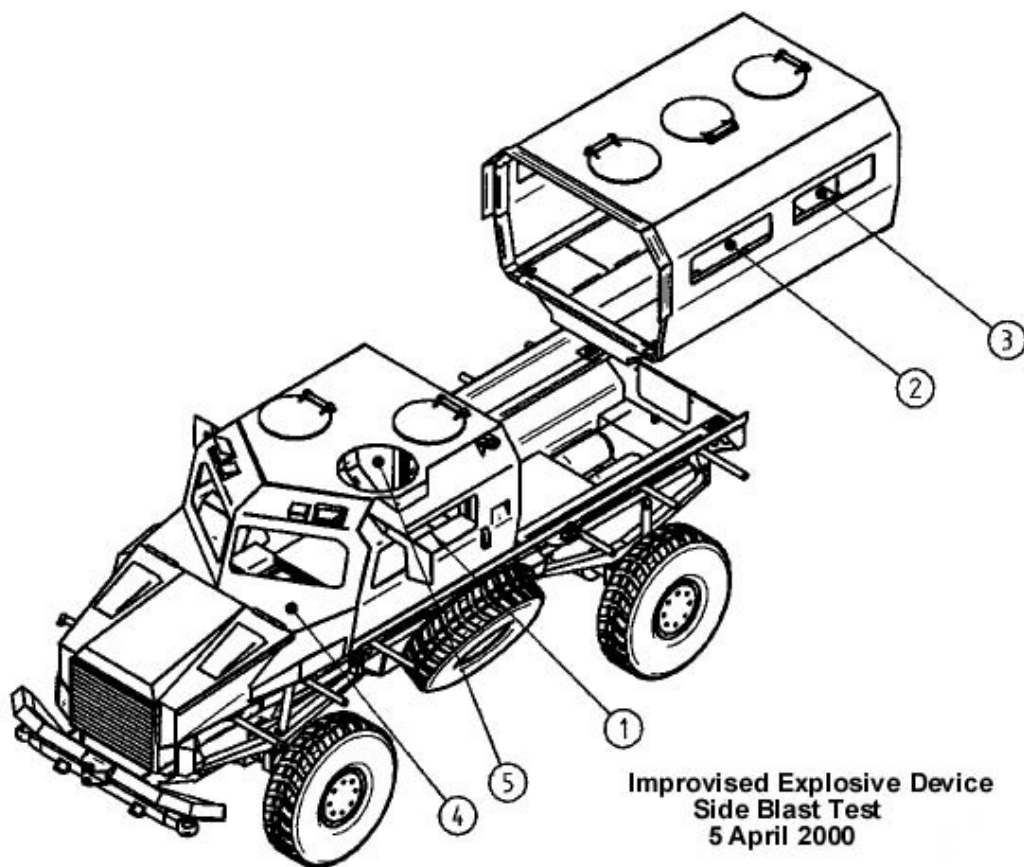
12. **IED side blast results:** the following test results are recorded in respect of the IED side blast test. Please refer to the corresponding number on the drawing above for the exact location of the damage description.

1. Co driver window surface shatters and cracks, but with no penetration or blast intrusion.
 2. Crew compartment side window – as above.
 3. Crew compartment side window – as above.

4. Air intake duct bends.
 5. Two cupola windows are surface shattered.
 6. Complete sandblasting occurs on the left vehicle flank.
13. The vehicle is fully repaired within 30 minutes and is started and driven out of the kill zone. No automotive damage occurs, not even the tyres are damaged or deflated. This test is witnessed by the ADG: WE Trial Director, Colonel AP Singh, who came down from Delhi for the event. Colonel Singh drives with Amos out of the kill zone for an impromptu mobility trial on the test range. The test is a resounding success.

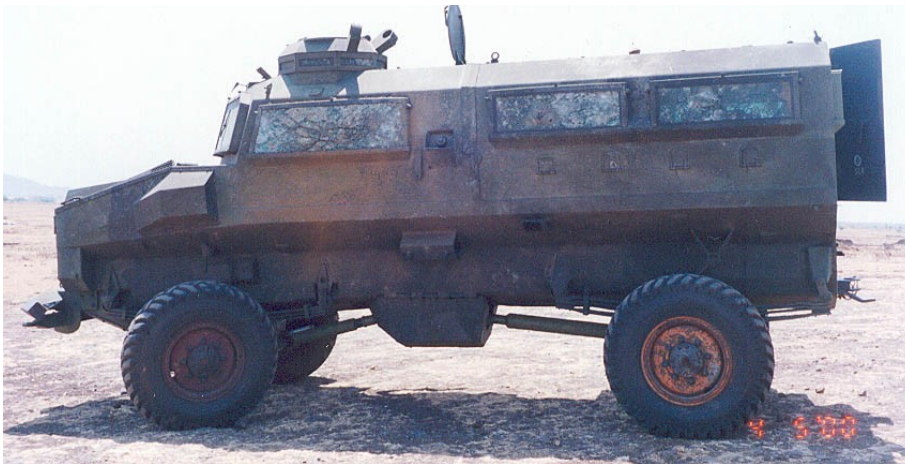
Damage after the MKII IED side blast. No pressure intrusion occurred.

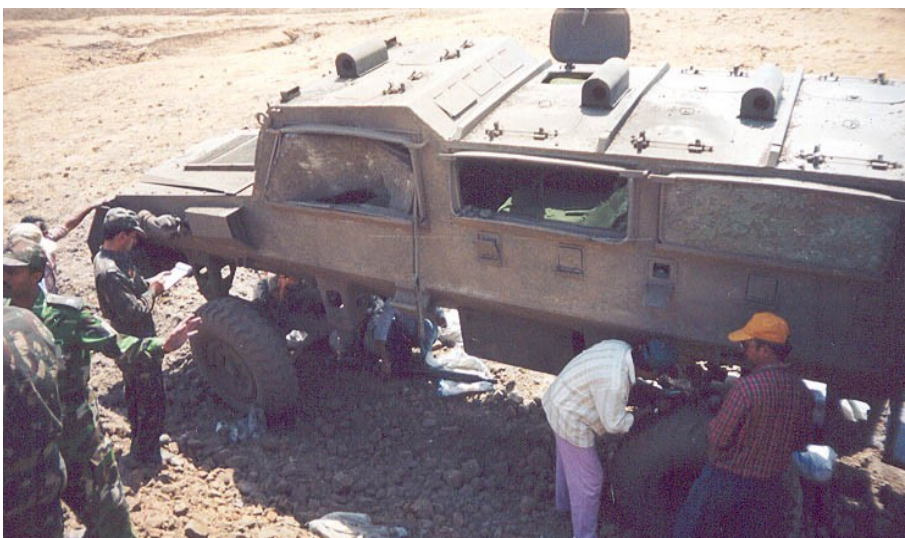
The Medak vehicle after its side blast test. The side windows are completely blown into the cabin. With the resulting pressure intrusion it is doubtful if anyone would have survived this blast.

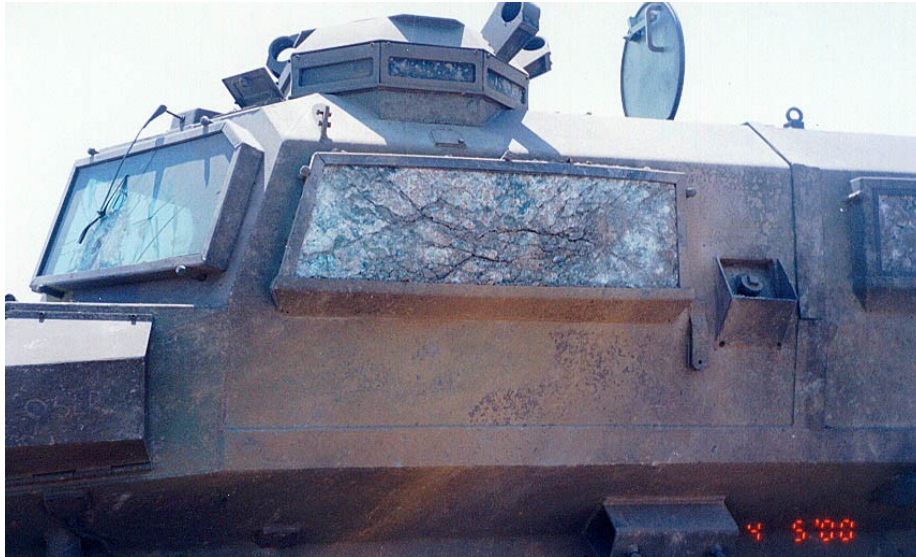
The side blast surface-cracked the windows, but no penetration occurred.

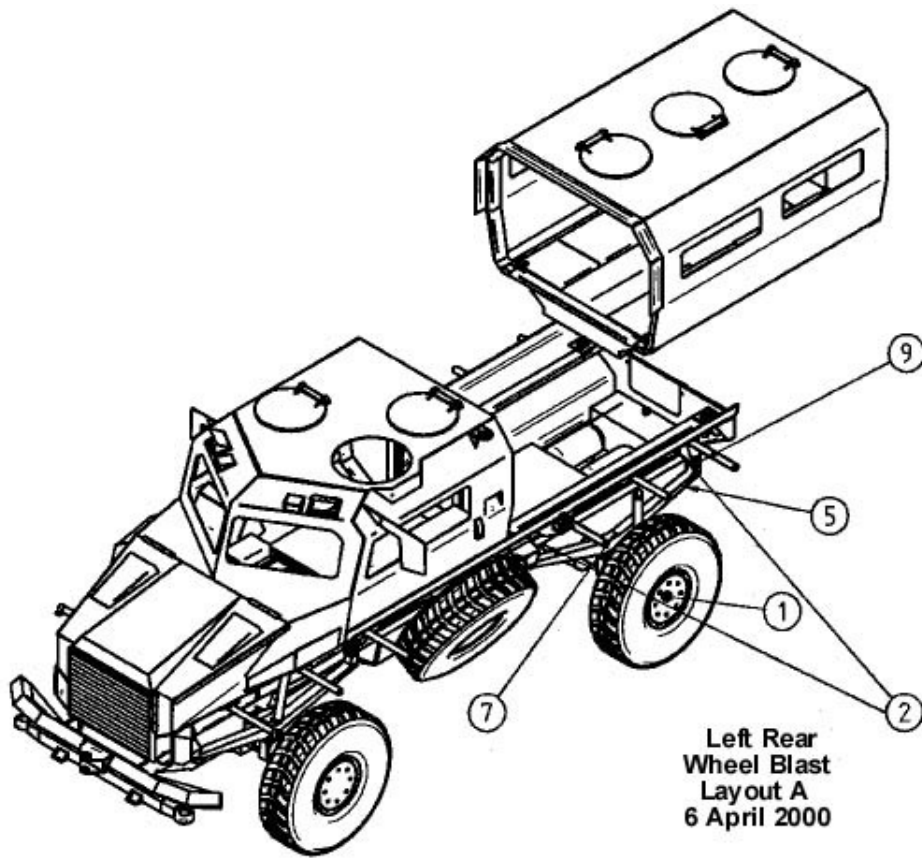
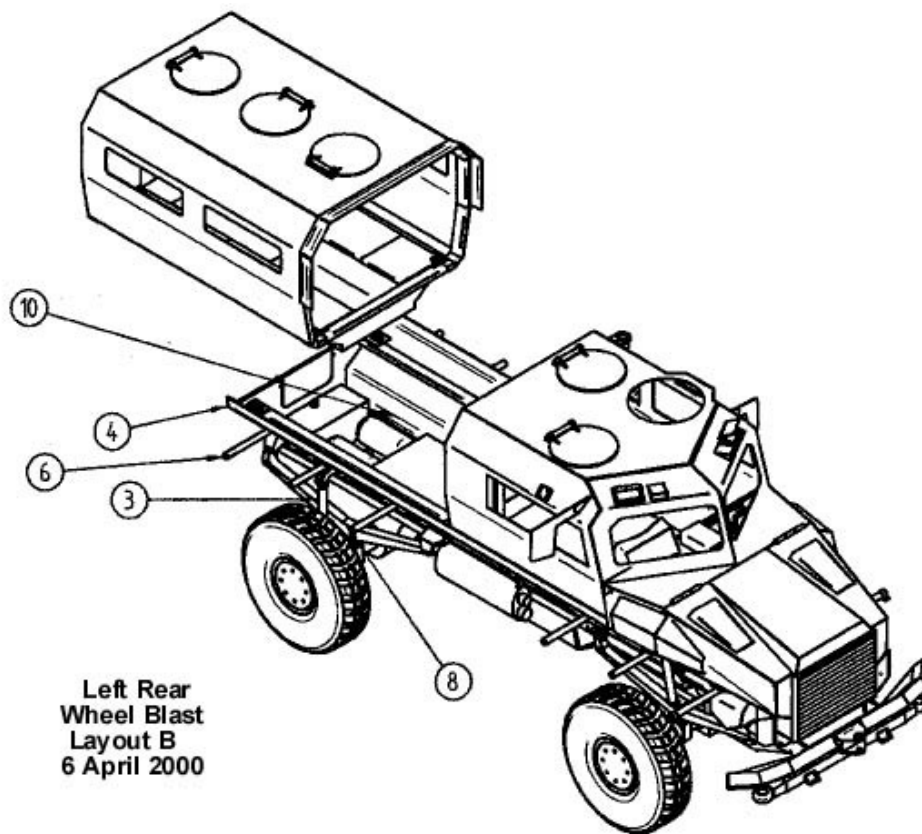
18. **Left rear wheel blast damage:** is recorded as follows:

1. Left rear wheel hub and stub axle assembly blows off. The side shaft is intact. The rim and tyre is destroyed. The LH axle tube assembly is severely damaged.
2. All the spring pack hanger mountings on both rear sides shear off, as designed.
3. RH rear shock absorber is destroyed and is replaced.
4. RH rear light bracket bends, but is repairable.
5. LH spring main blade mounting eye is mildly damaged and is repaired by a roadside blacksmith.
6. RH mudguard bottom mounting caps slide to the outside.
7. LH lower shock absorber mounting bracket is damaged, but repairable.
8. U-bolts that fasten the axle bend, but are fully repairable.
9. LH rear swivel hanger plates bends.
10. 4 – way protection valve housing is damaged and is replaced.

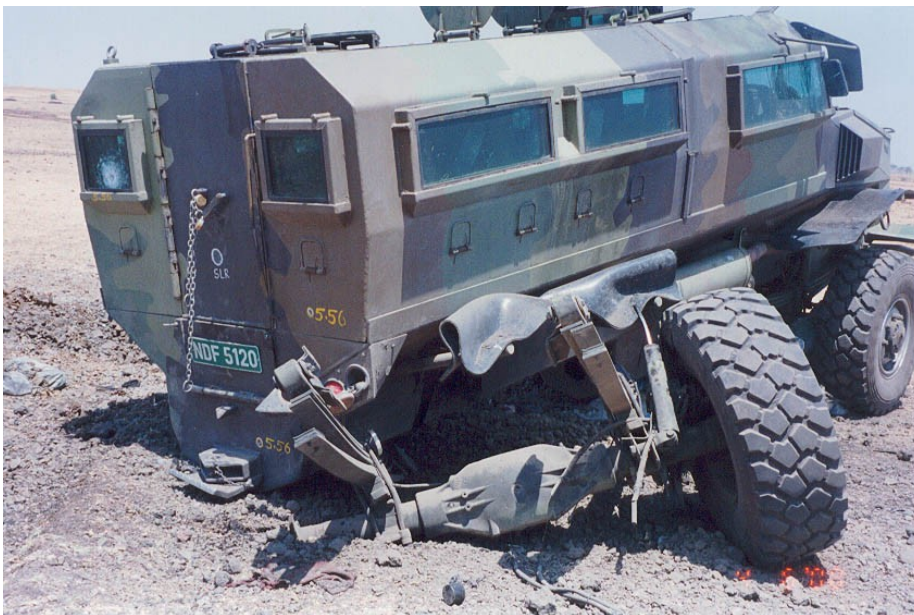
The axle is ripped out to the right rear by the blast force. The vehicle remains field repairable and there is no blast intrusion into the cabin.

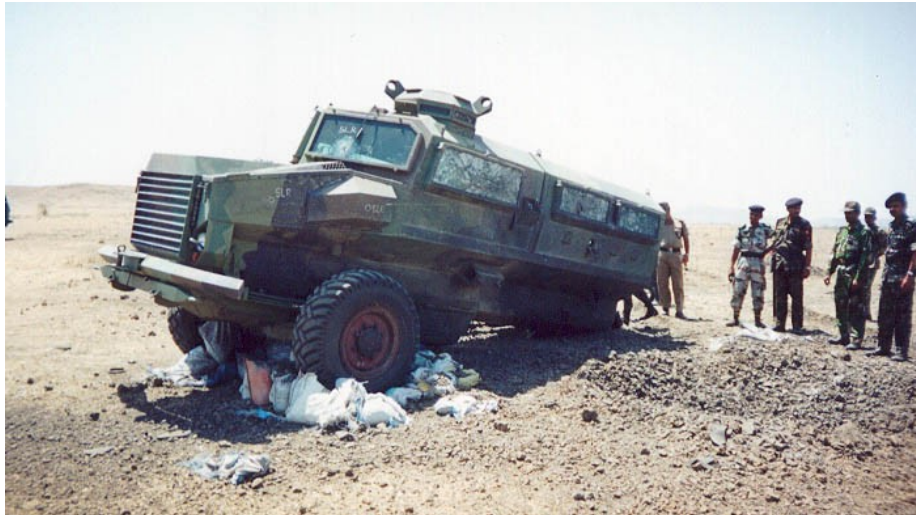
The vehicle is not thrown over by the wheel blast, nor is it moved forward. The rear end is rotated by 30 degrees to the right. Note the blast crater.

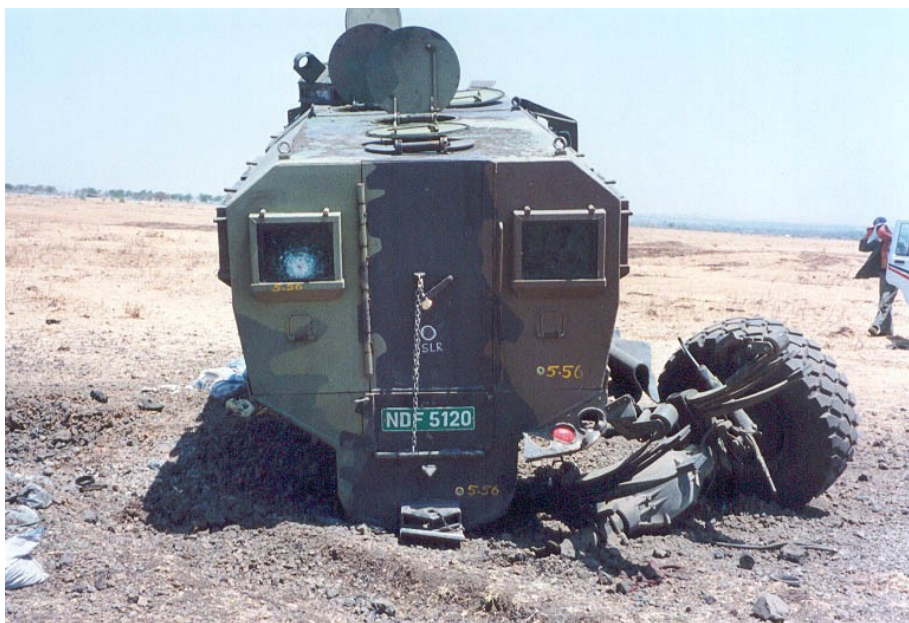
Blast results of an equivalent triple anti tank mine hit.

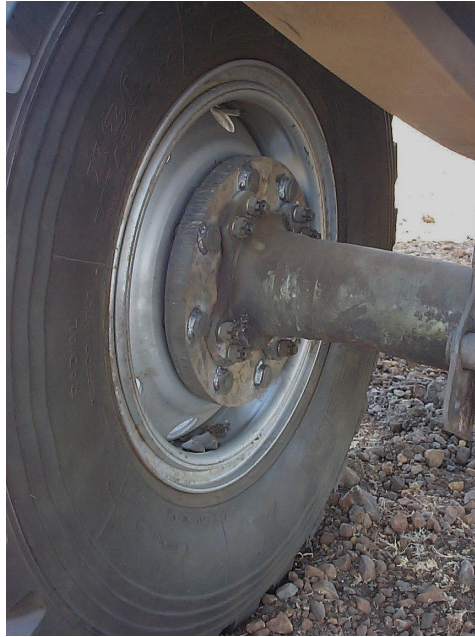
The static axle repair.

21. We improvise however, and we repair the damaged rear axle by welding a flange onto the axle as a dummy hub. The vehicle is still immobile but it can be set up for the last test without the use of any stands.

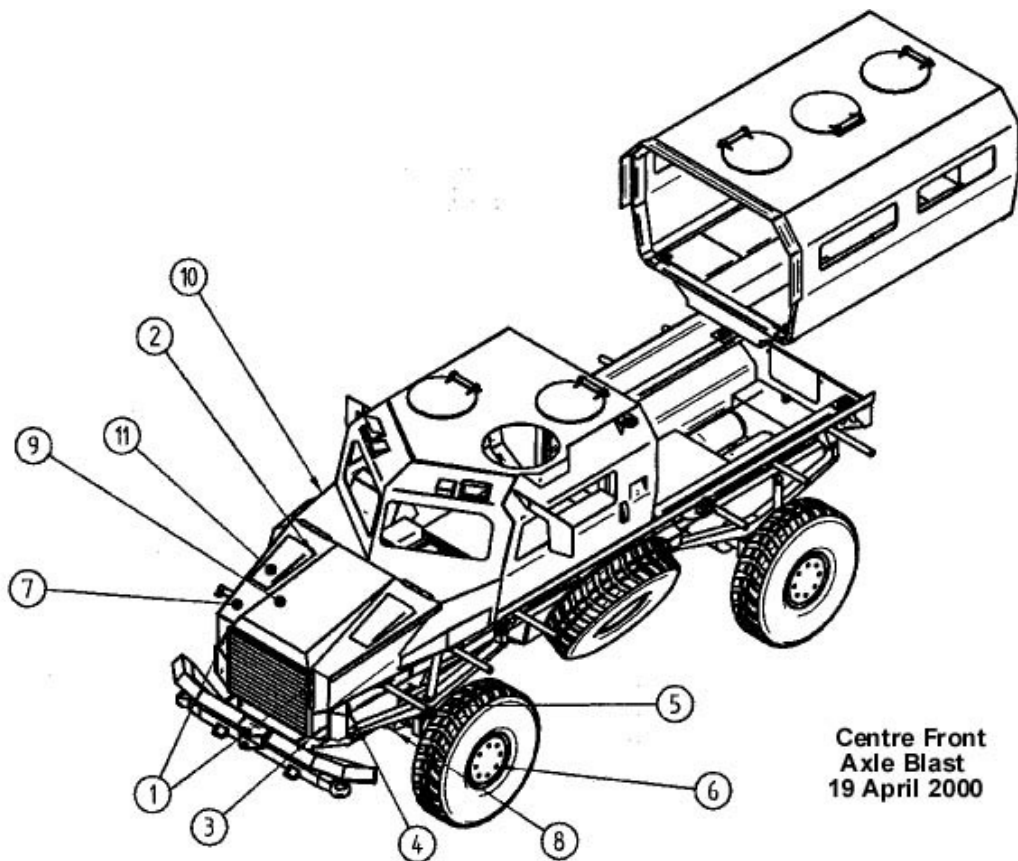
25. **Front axle centre blast damage:** is recorded as the following. Please refer to the drawing above for an exact location of the damage description.
- Both bonnet catches are bent.
 - There is a welding crack on top of the bonnet.
 - One cap screw is sheared off.
 - The LH front spring hanger mounting and one bolt shear off.
 - The tie-rod is bent.
 - Both front wheels are blown off with the hubs bolted on inside. The tyres, rims and hubs are undamaged and are fitted back.
 - Two bolts shear off from the power steering bracket.

8. The axle centre portion is damaged but repairable.
9. One bolt is missing from the engine mounting rail.
10. The flexible portion of the exhaust pipe shear off.
11. The flange of the turbo housing cracks. This is welded up and re-fitted without any negative effect.

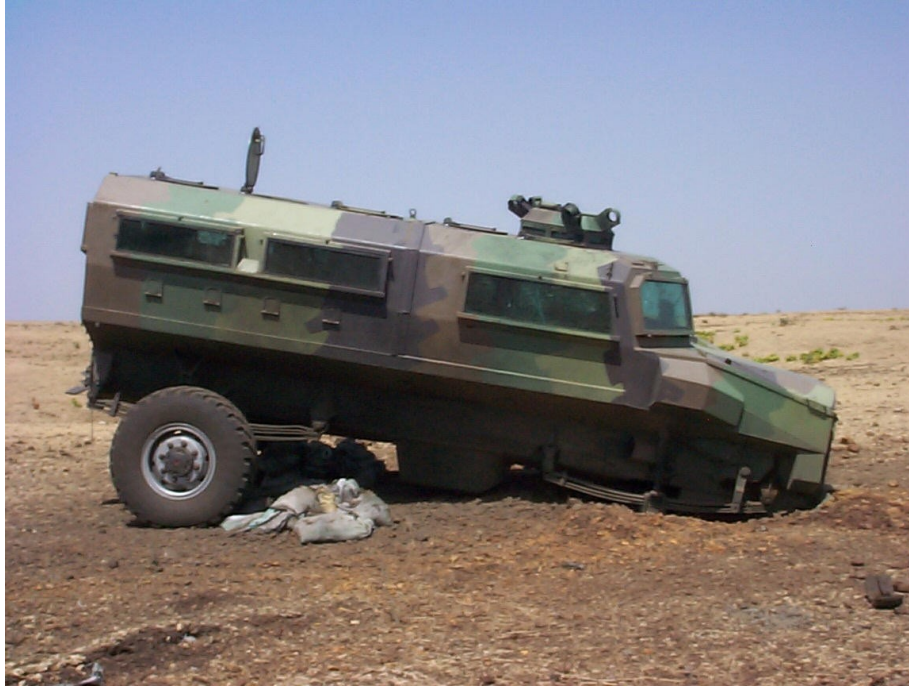
Wer'wolf MKII after the front axle centre blast.

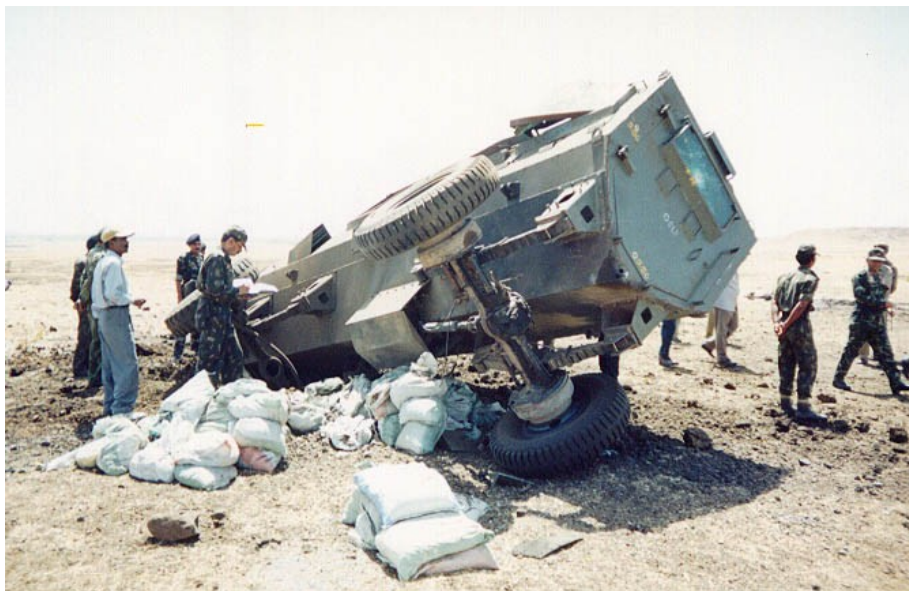
The Medak vehicle after the front axle centre blast.

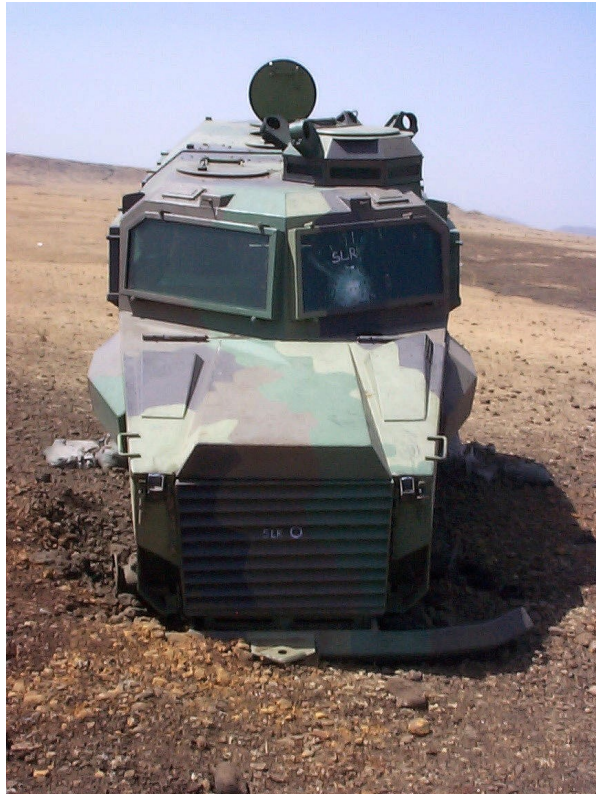
Wer'wolf MKKII lying in the blast crater after the front axle blast test.

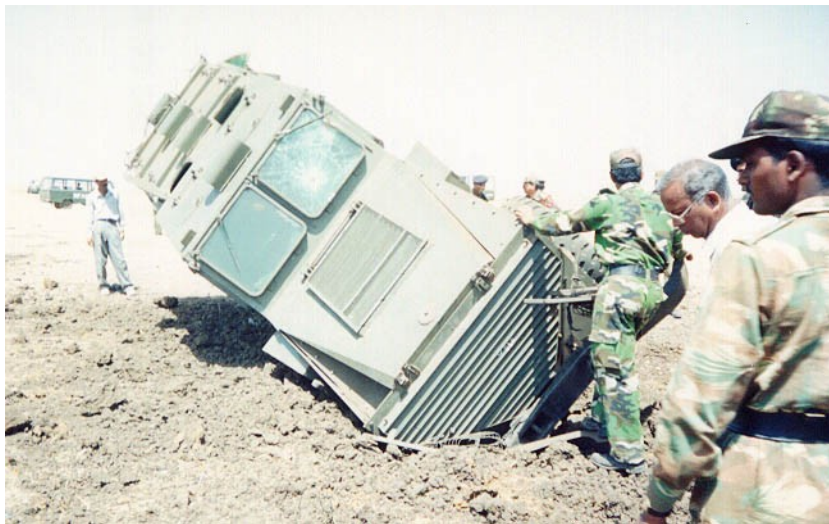
The Medak vehicle lying in the blast crater after the same test.

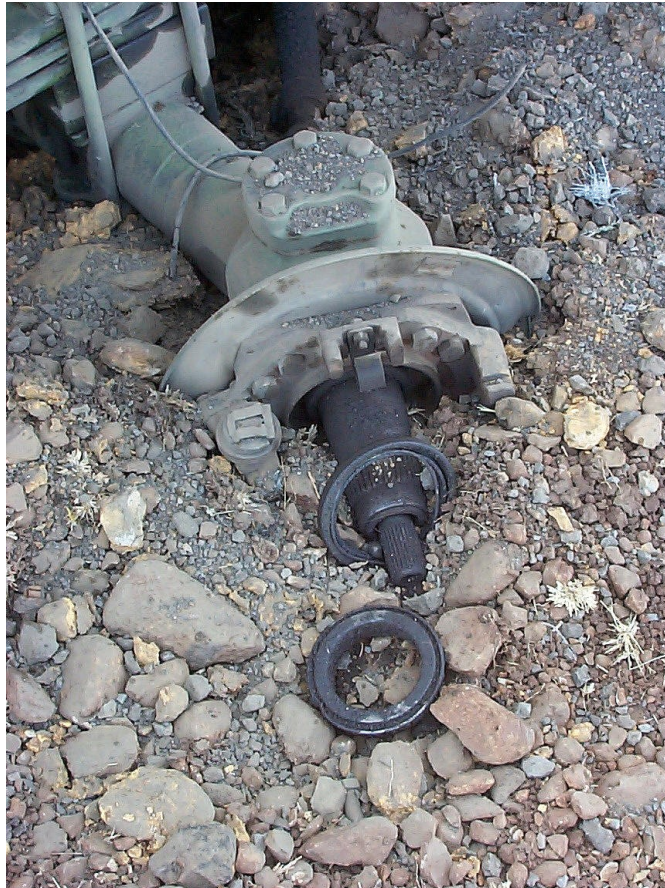
Detail of damage to right front wheel station after front axle centre blast test. The wheel with hub is blown off, but the axle is repairable.

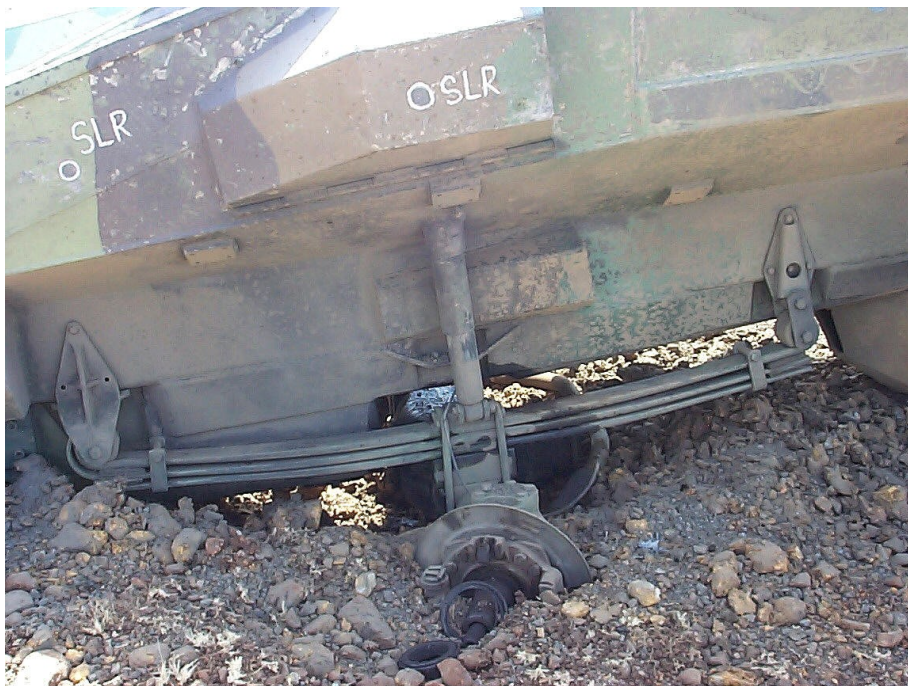
Left front view of damage after the front axle centre blast test. Note virtually no damage to the springs, hanger brackets and shock absorbers.

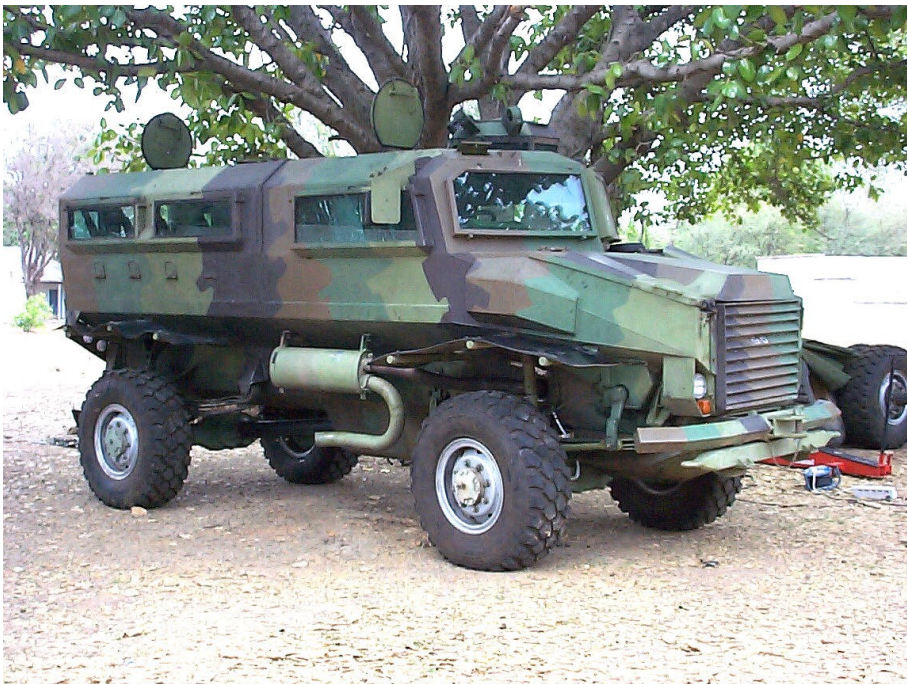
Wer'wolf MKII, field repaired after 9 anti-tank mines were detonated under the vehicle during trials. The vehicle is now ready to proceed for automotive performance evaluation.
