Re: *DIRECTV Enterprises, Requests for Special Temporary Authority*
File No. SAT-STA-20050414-00083
File No. SAT-STA-20050427-00091
File No. SAT-STA-20050517-00104

Background on "Tin Whisker" Failures

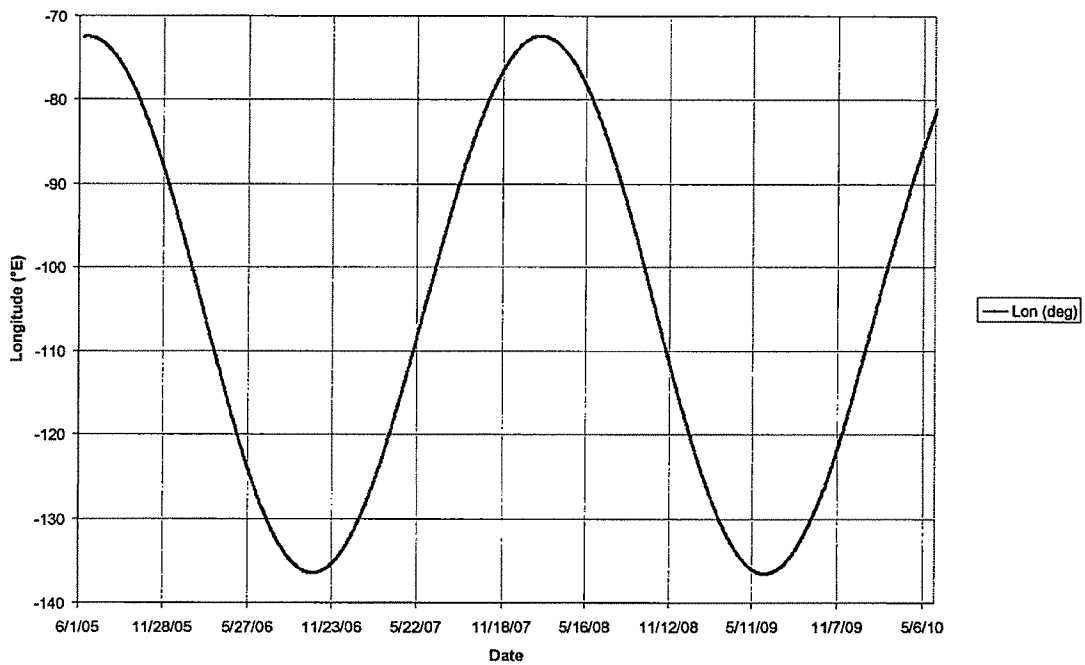
**Figure 1. Longitude vs. Time
(5 years)**

If both SCPs on a satellite become disabled, it is no longer possible to control the satellite position. Figures 1 through 4 show the change in orbit longitude (east-west) and inclination (north-south) and apogee/perigee (radial) over time for such a case, assuming the failure occurred at 72.5 WL. The possibility of contact with another satellite diminishes over time. Figure 2, which is an expansion of the data in Figure 1, shows that although the eccentricity and therefore east-west longitudinal movement begins immediately, the satellite is still within the 0.05 degree station keeping constraints shown by the horizontal lines for about three weeks. This, interestingly, is one advantage of moving a satellite susceptible to SCP failure away from a crowded orbit position such as 101° WL, where six satellites currently operate. As Figure 3 depicts, the inclination of the orbit is also growing linearly at about one degree per year and the apogee and perigee

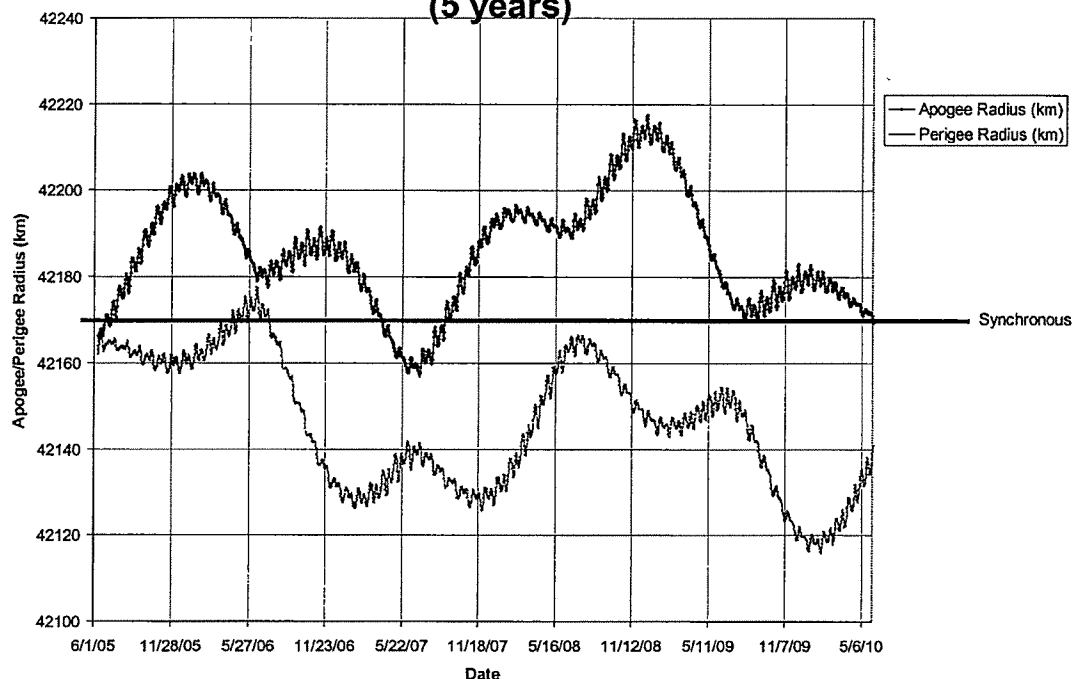
**Figure 4. Apogee and Perigee vs. Time
(5 years)**

also diverge from synchronous as shown in Figure 4. The three measures of position (east–west, north–south, and radial) all diverge from the geosynchronous arc, and although the satellite will pass through the equatorial plane, the crossings are displaced from the geosynchronous arc. This is somewhat analogous to a satellite in transfer orbit passing through the equatorial plane. Therefore, although the satellite would remain near the geosynchronous arc, it is clear that as time passes the chance of contact with another satellite diminishes.
