## LONDON AND SOUTH-WESTERN RAILWAY.

Board of Trade (Railway Department),  
8, Richmond Terrace, Whitehall, London, S.W.,  
November 8th, 1900.

I HAVE the honour to report for the information of the Board of Trade, in compliance with the Order of the 11th October, the result of my enquiry into the collision that occurred on the 7th idem at Twickenham Station on the London and South-Western Railway.

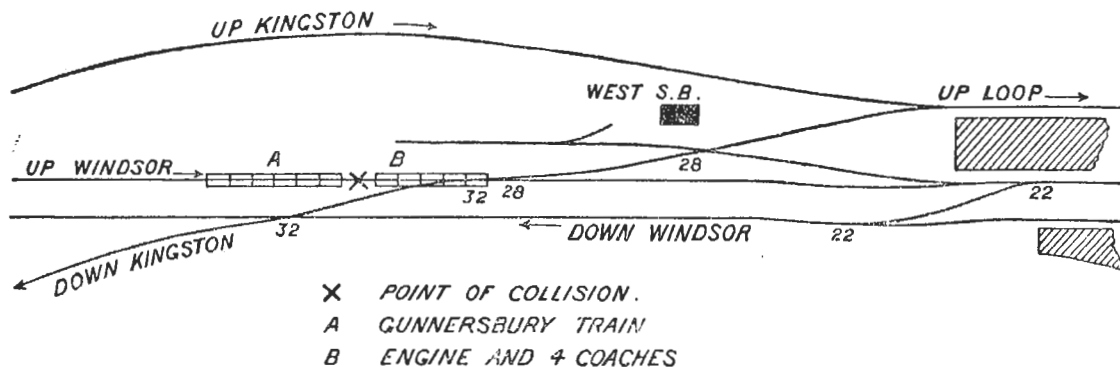
This collision occurred about 160 yards west of Twickenham Station on the up Windsor line. There are three lines passing through the station, viz., the up loop, the up Windsor, and the down Windsor, their direction being approximately east and west. Twickenham is the junction between the Windsor lines and the Kingston lines; the down

Kingston line diverges from the down Windsor at a point about 210 yards from the west end of the place, while the up Kingston line crosses the Windsor lines by an over-bridge 400 yards west of the station, and joins the up loop line at the back of the up platform. At the west end of the station there is a cross-over road between the up and down lines with trailing points on each line, which are worked by No. 22 lever in the signal-box, and about 175 yards further west there is another cross-over road worked by No. 32 lever. Between these two cross-over roads there is a facing connection worked by No. 28 lever on the up Windsor line leading into the up loop line.

The west signal-box, from which these points and the signals relating to them are worked, is 66 yards west of the up platform on the north side of the Windsor lines, and between it and the loop line. The up signals both for the Windsor and loop lines are carried on a bracketed post which is 225 yards from the signal-box, and 185 yards from the site of the collision. I annex a small diagram (not to scale) which renders the arrangement of the place easier to understand. The points and signals are properly interlocked.

The signalling at Twickenham Station appears to be out of date. The up home signals are 360 yards from the station and about 230 yards from No. 28 facing points, which distances are far greater than is desirable. And there are no disc signals for controlling the shunting of trains through cross-over road No. 32. I believe it is contemplated by the Company to carry out a rearrangement of the whole place, and it is to be hoped that this work will be put in hand with as little delay as possible.
