EMBRAER E190-100LR

AIR ASTANA / P4-KCJ

ACCIDENT
SAFETY INVESTIGATION
FINAL REPORT

[08/ACCID/2018]

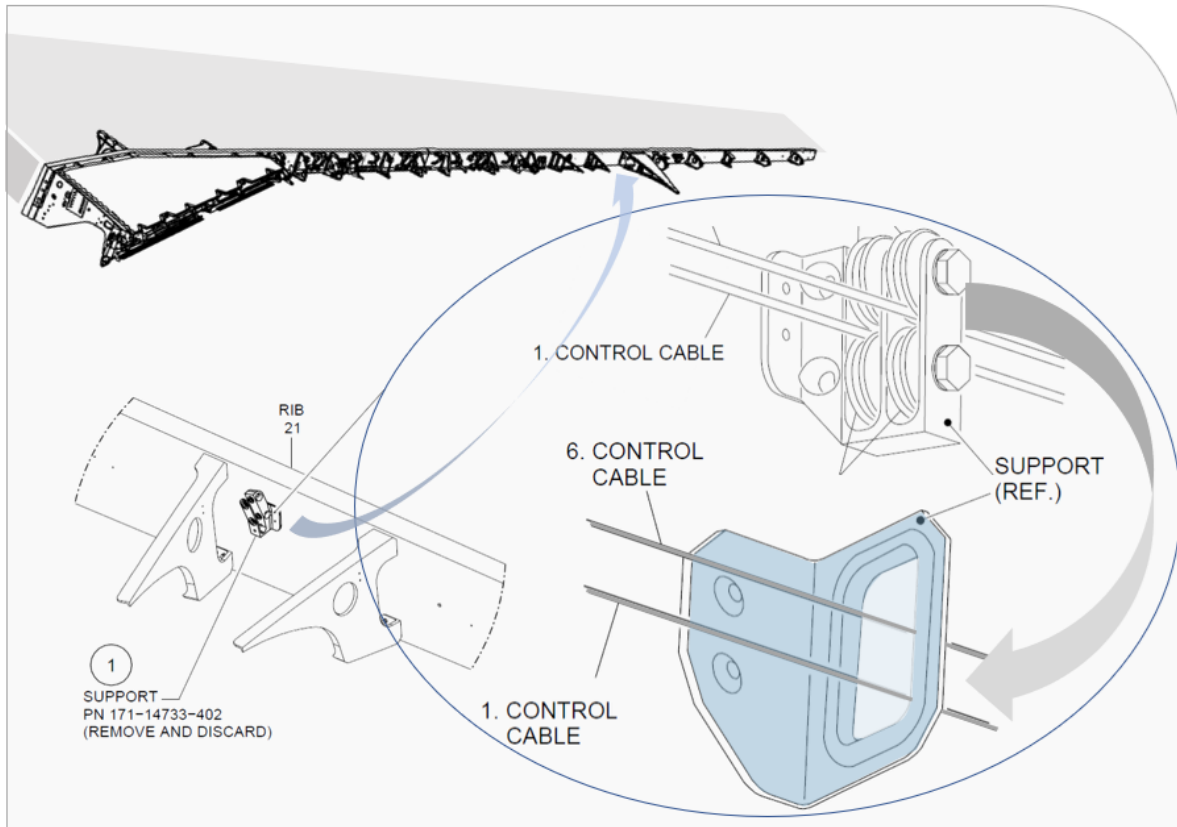
Figura 1 || Figure 1

On OCTOBER 09th 2018, with the aircraft already de-energized, a service bulletin (SB190-57-0038R2) was initiated, which changed the type of routing of the ailerons' control cables, with the replacement of pulleys and respective structural supports by a non-contact support, aiming to reduce the control cable friction on that area (figure 1 below).

Ilustração da modificação aos suportes dos cabos (SB190-57-0038R2)

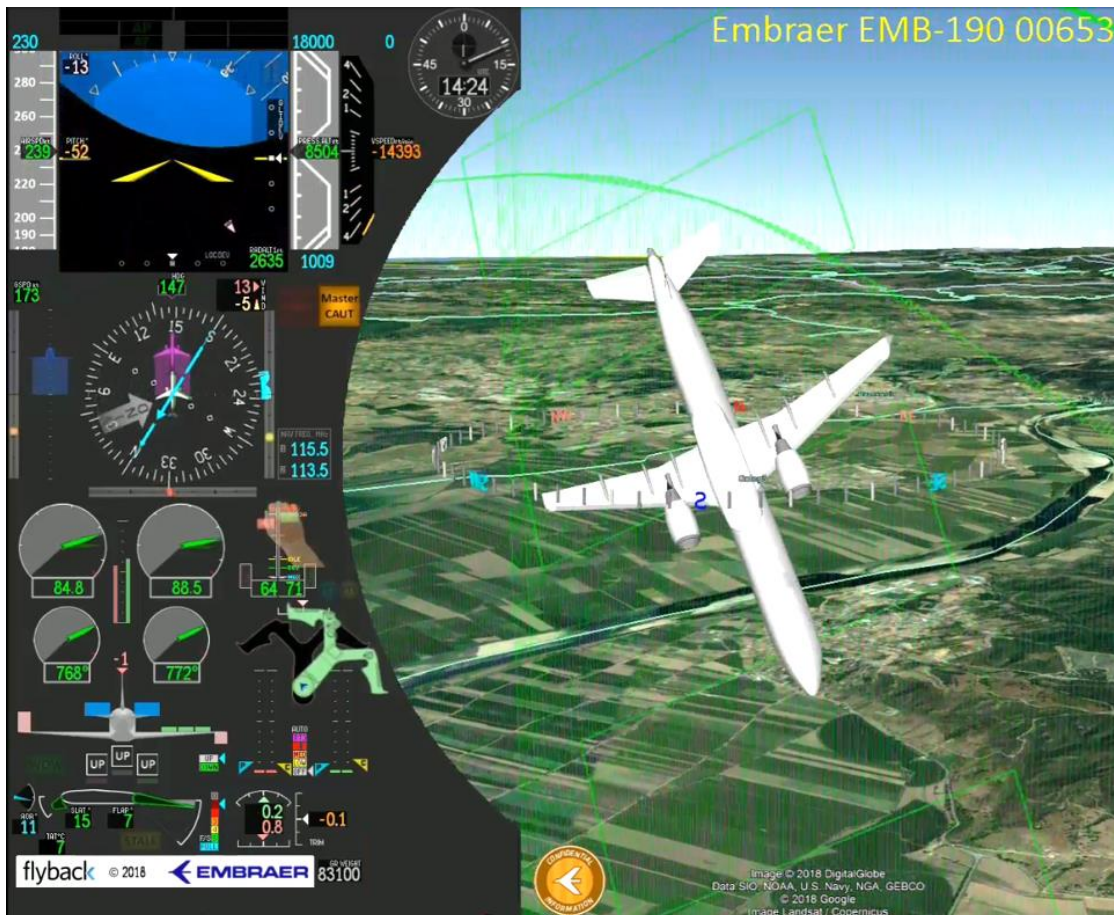
Figura 2

Atitude anormal da aeronave – Exemplo FDR
 Fonte: flyback Embraer

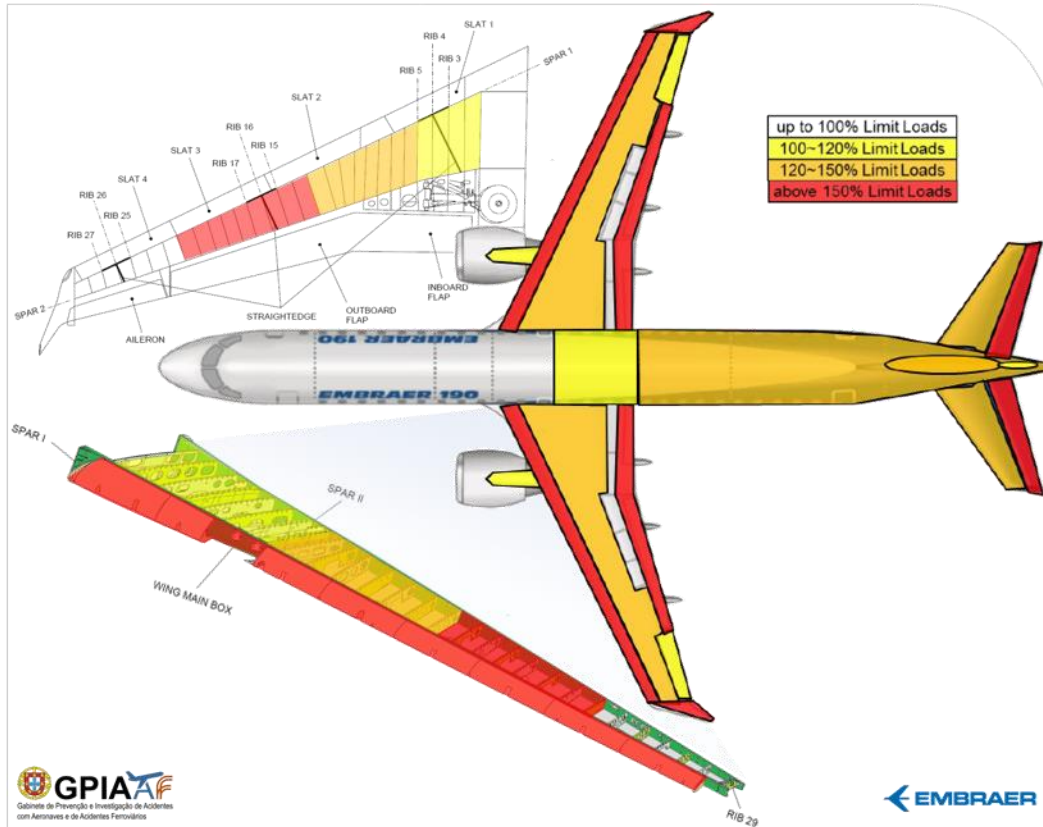
Figura 4 || Figure 4

All wing fixed leading edges were found wrinkled. The damage geometry was found sharper on forward and aft regions, and smoother on inboard and outboard regions, indicating that the damage was caused by wing bending around the wing chord direction.

Áreas da aeronave afetadas e cargas limite aplicadas durante o voo do evento

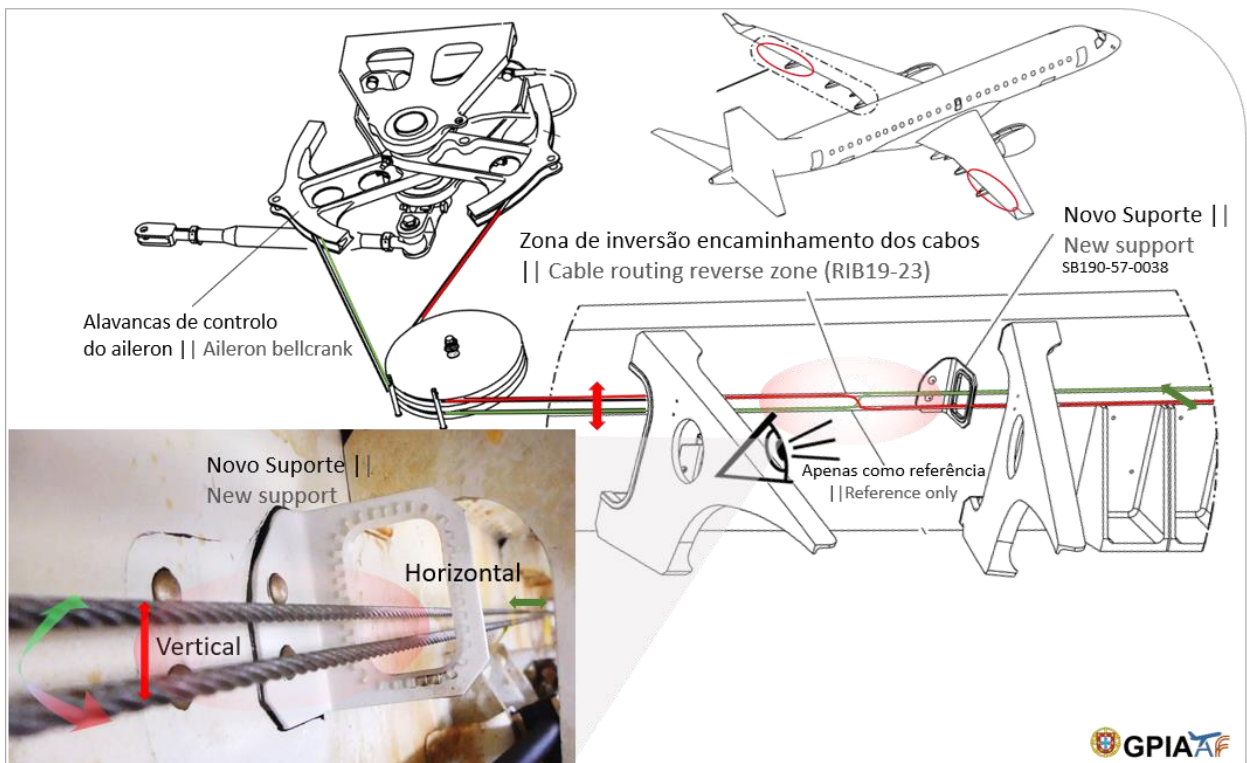
Figura 14 || Figure 14

The inversion of the aileron control cables through their terminals was verified in both quadrants.

Visualização do encaminhamento dos cabos de comando conforme encontrado após o voo do acidente

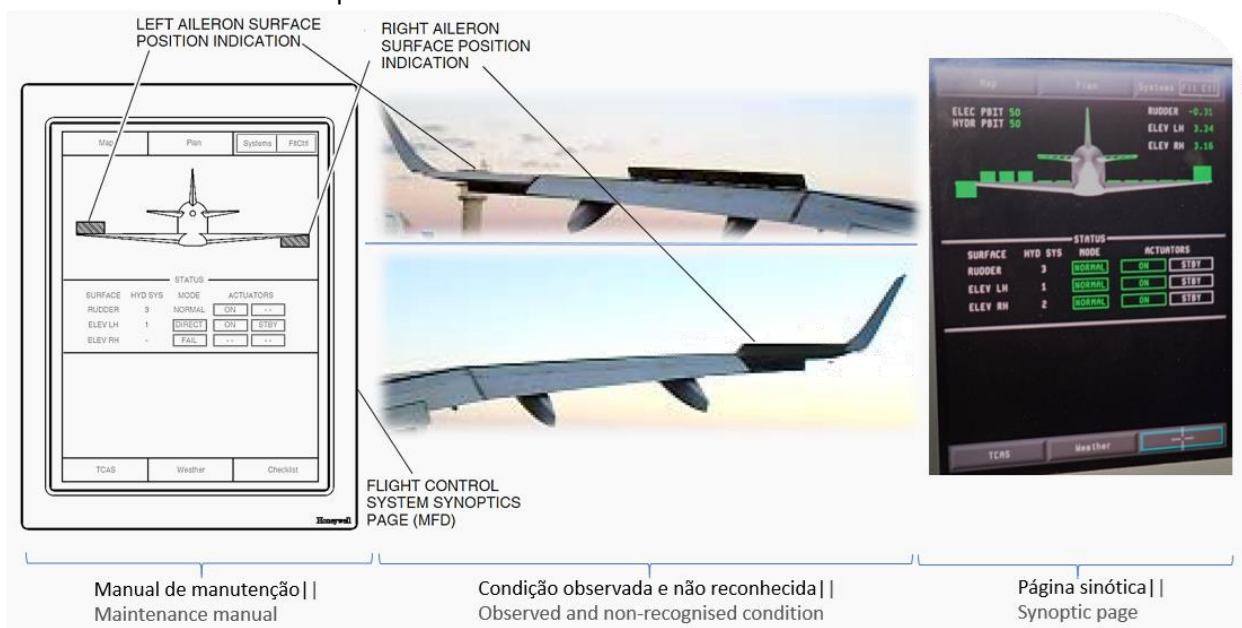
Figura 16 || Figure 16

As the aircraft was in this configuration without applied power, the operational tests to check the ailerons correct operation were not immediately performed after completing the cable replacement task, as required in the SB.

After the aircraft power-up and during the operational checks, a FLT CTRL NO DISPATCH was triggered due to a failure in the FCS. However, due to the non-detected aileron control cables inversion, it was not possible to fully perform the reset cycle on the flight controls return to service procedure, exercising the five CBIT of the ailerons control systems and cleaning the NVMs on the FCMs.

Ilustração da posição física dos *ailerons*, conforme tarefa de manutenção à data do evento

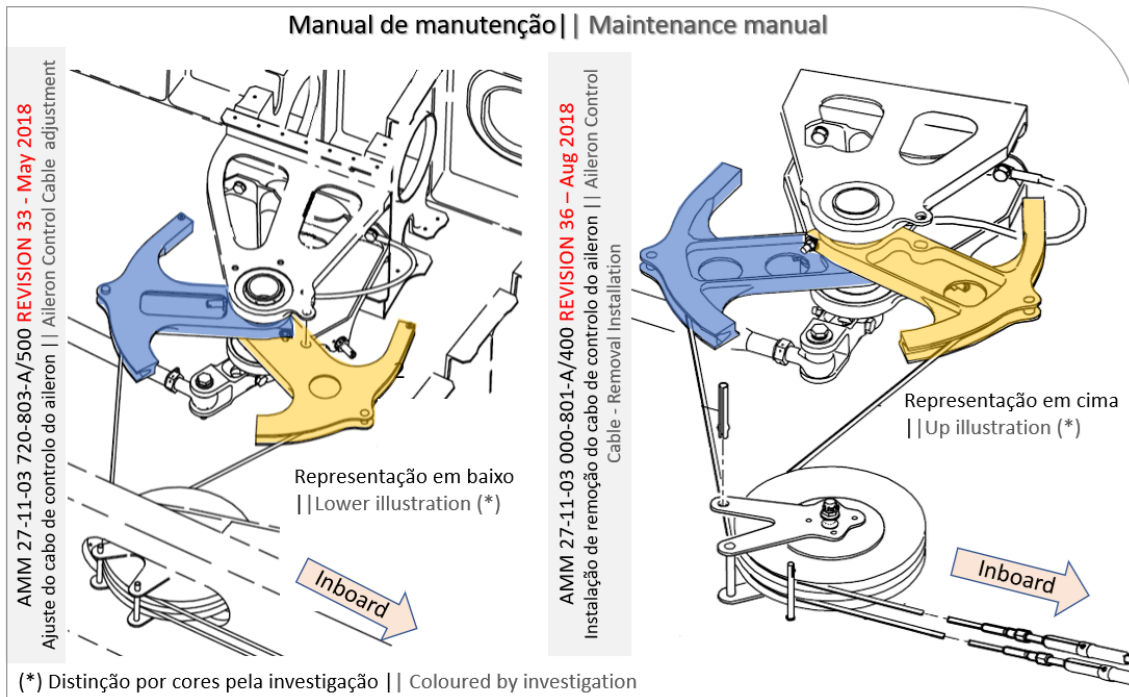
Figura 18 || Figure 18

referenced figures contained in the cables installation task contained correct components representation, however with presenting format limitations.

Diferenças de representação técnica de componentes
Fonte - AMM

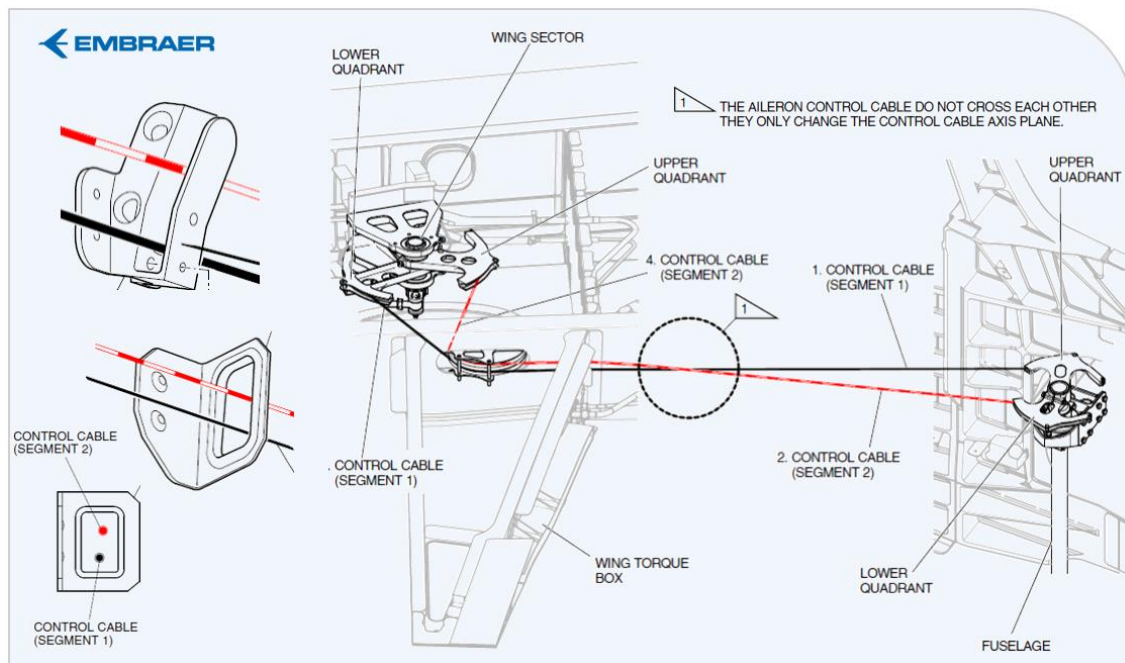
Figure 19
 Illustrative picture with changes in the revised cable replacement maintenance task
 Source – AMM 27-11-03 Rev. Out 2019

After the event and during the investigation, the OEM made important changes to the approved instructions and procedures, such as changing aileron control cables replacement task adding clearer instructions and using figure colouring on SB 190-57-0038 aileron control cables - fairleads and grommet replacement related instruction, the SB for cable material replacement and also on the operational task to check the ailerons position.

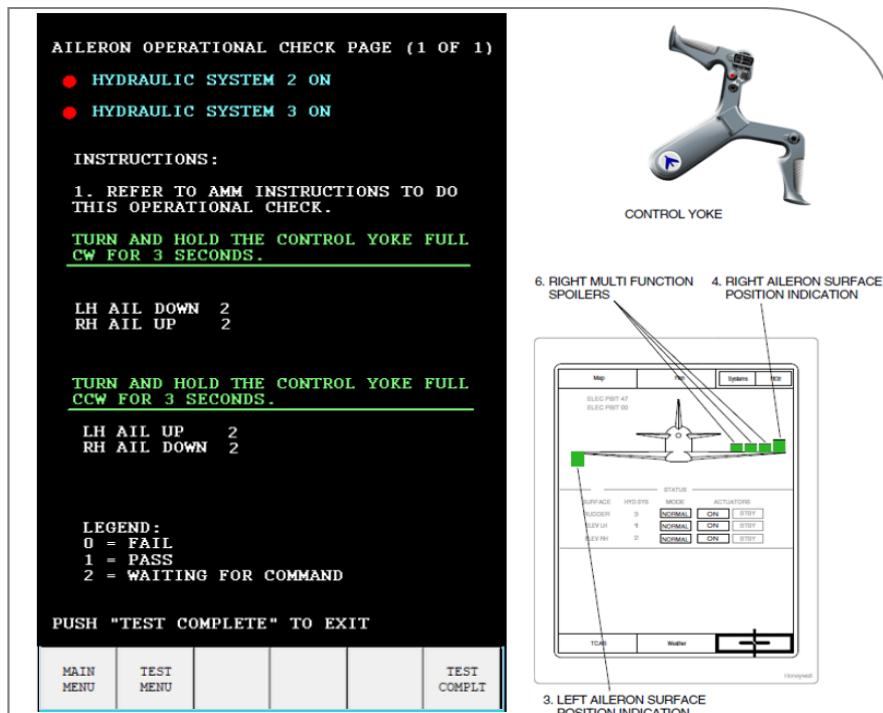
Figura 20

Nova página CMC de verificação operacional dos *aileron*s
 Fonte – Nova revisão do AMM

The solution uses "low-level" programming software (software used in maintenance only), and therefore, without the certification process requirements, through the code 0 for "Failure"; code 1 for "Pass" and code 2 for "Waiting for Command", informs the technician of the ailerons position in relation to the control column command.

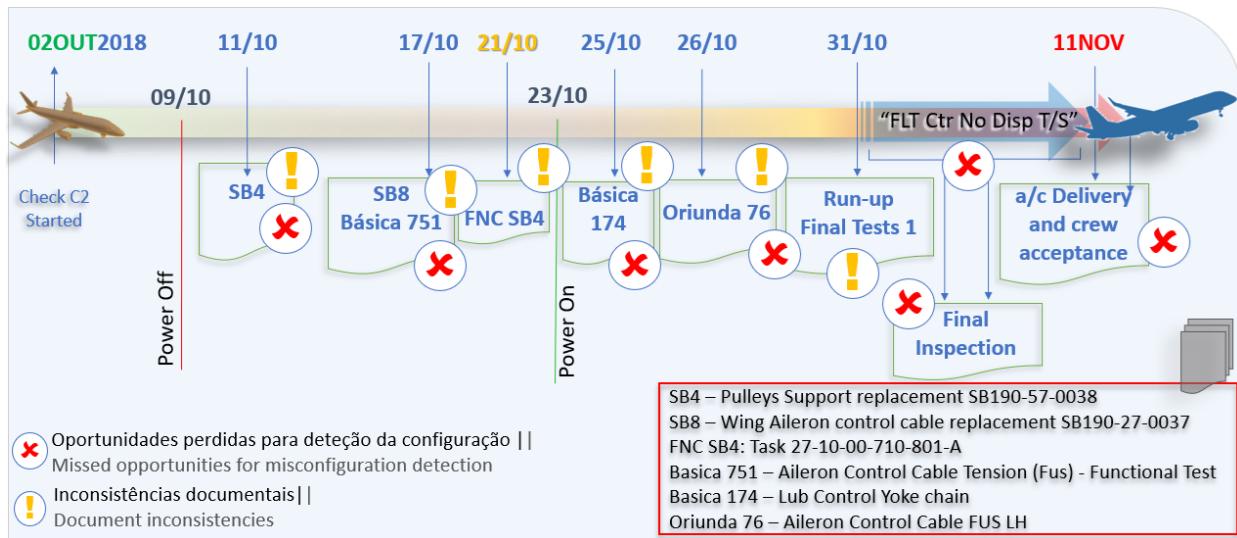
Figura 23 || Figure 23

Sequência de oportunidades perdidas de deteção do erro de configuração
