UNITED STATES COAST GUARD

REPORT OF INVESTIGATION INTO THE ALLISION OF THE COSCO BUSAN WITH THE DELTA TOWER OF THE SAN FRANCISCO-OAKLAND BAY BRIDGE IN SAN FRANCISCO BAY ON NOVEMBER 7, 2007

MISLE ACTIVITY NUMBER: 3095030

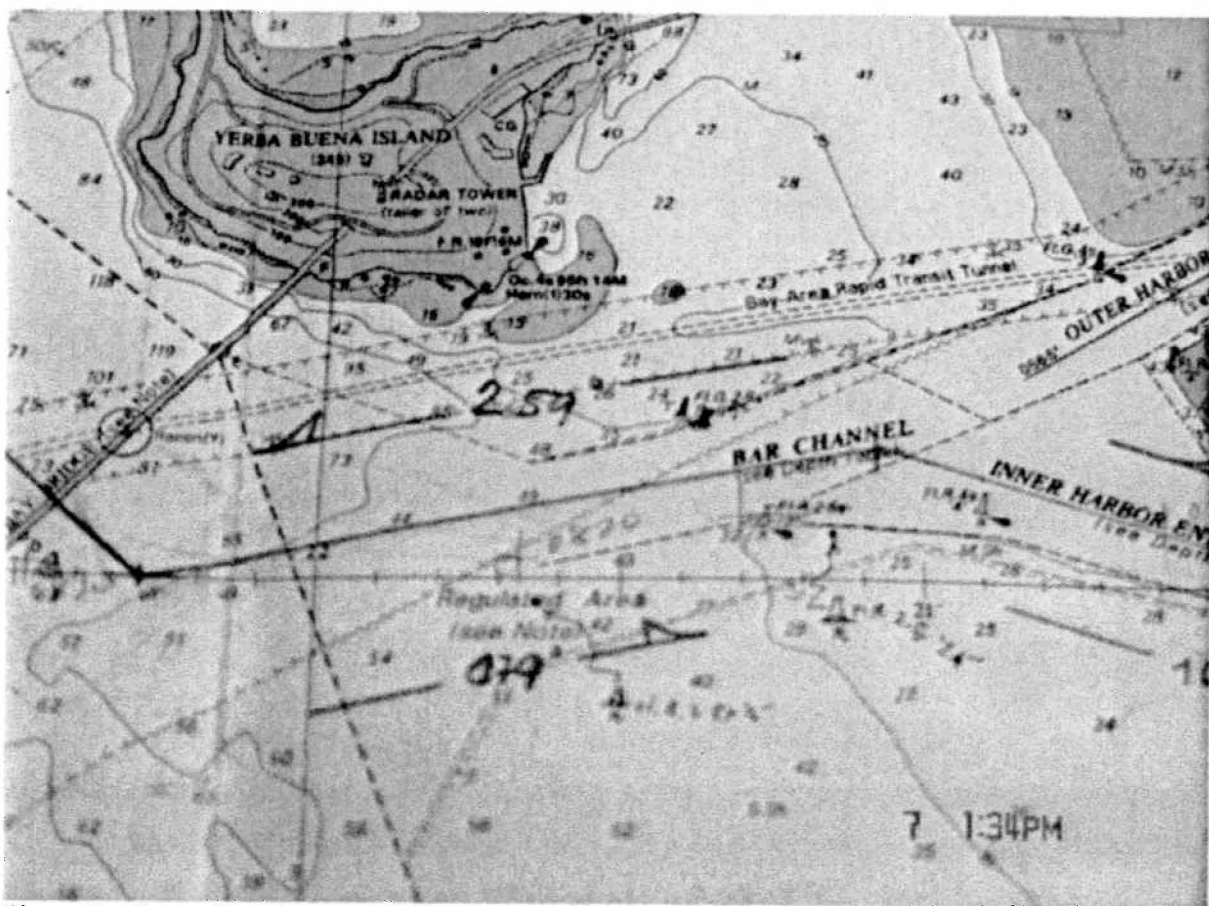
Figure 1. Coast Guard photo of the navigation chart from the M/V COSCO BUSAN. Note the "X" and "0820" (near the center of the photo) and "0830" notations, which are GPS positions plotted by the Third Officer while underway. This photo was taken before the Third Officer erased these positions after the casualty.

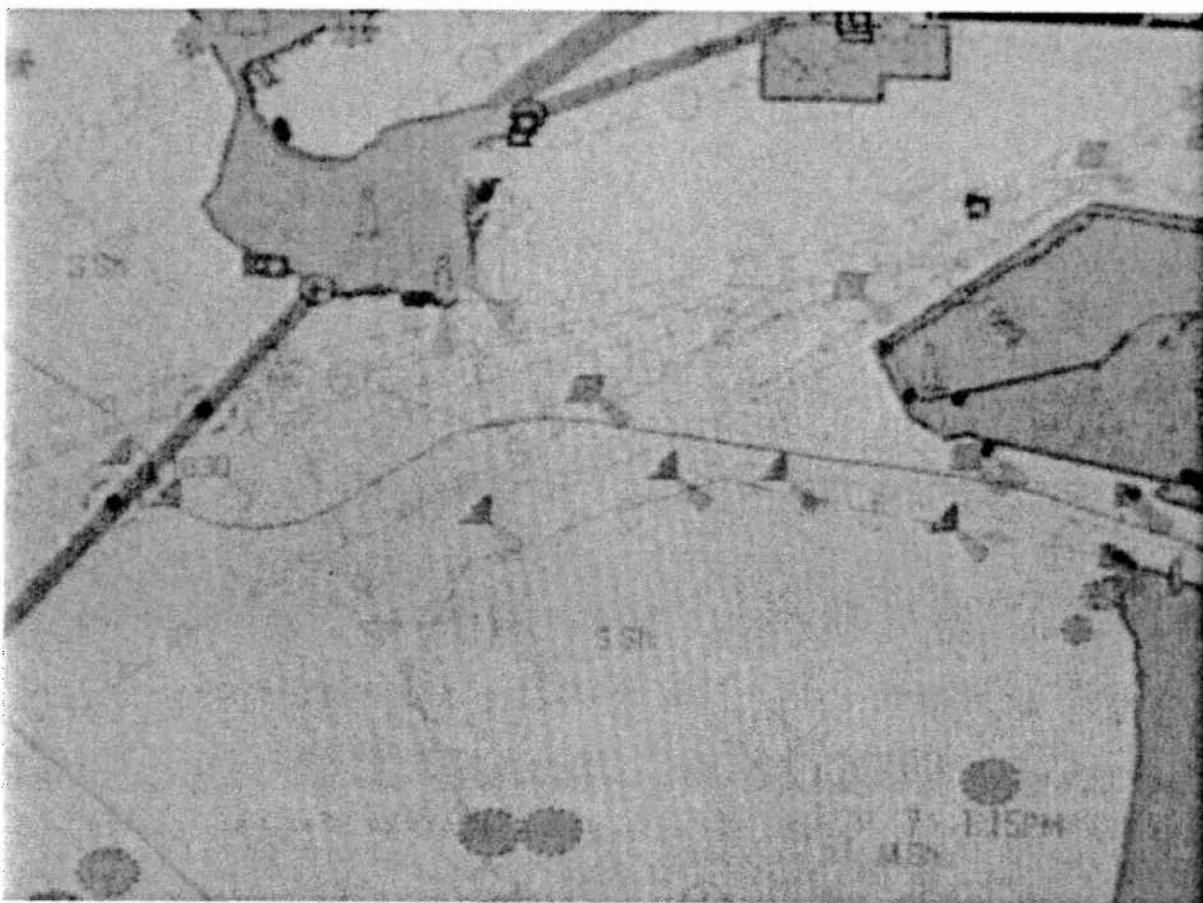
Figure 2. Coast Guard photo of the ECDIS display of the M/V COSCO BUSAN. Note the red triangle symbols with teardrops indicating lighted aids to navigation, and two red triangle symbols on either side of the Delta Tower Island, representing the buoys marking the Tower Island. The racon symbols (dark circles with magenta broken halo) on the bridge are also clearly visible. The blue trackline is the vessel's AIS course.

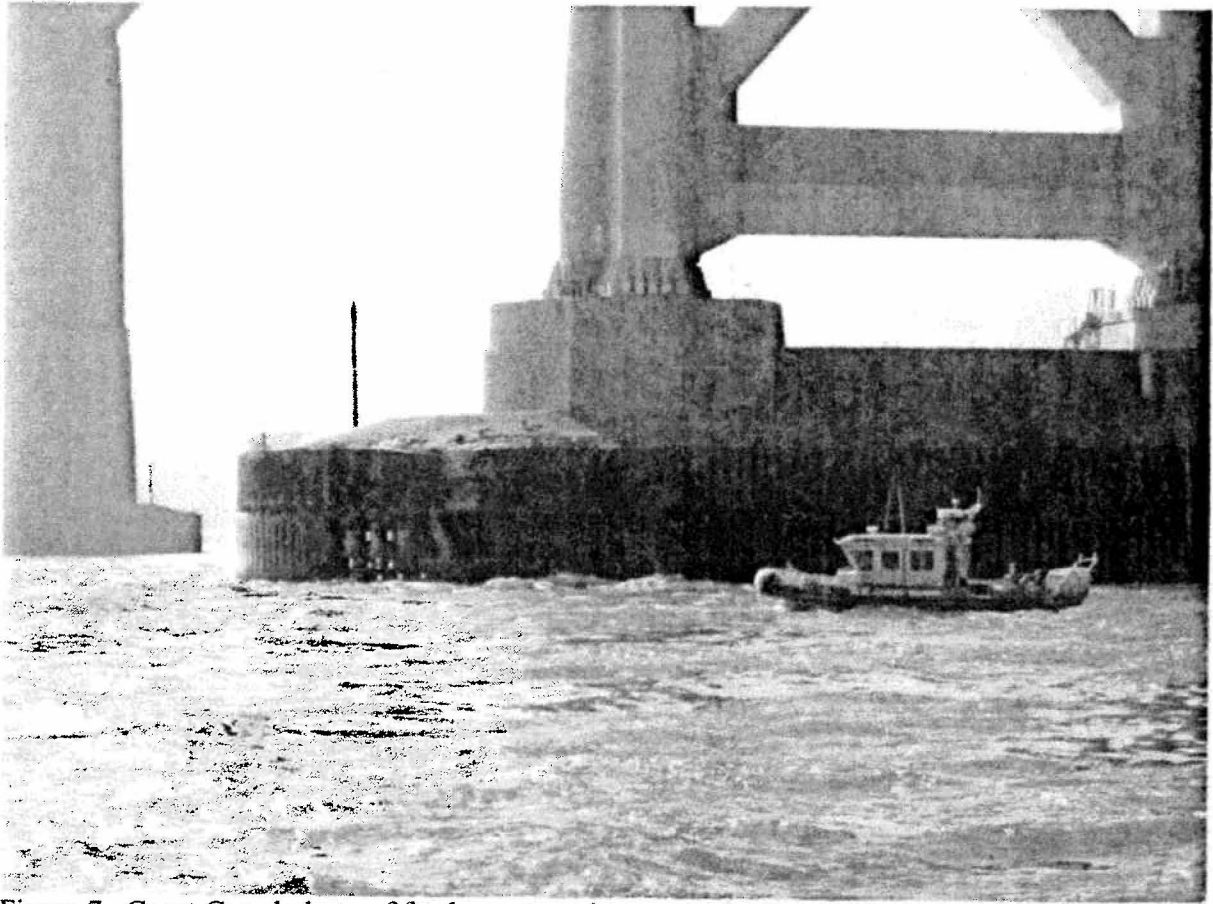
The Bay Bridge sustained damage to the wood and plastic fender system and concrete tower support (ECN 3095030 #044 [REDACTED]). Some fender material that fell into the water was recovered by the Army Corps of Engineers (ACOE), and some washed up on beaches in the days following the casualty. The bridge was inspected by the California Department of Transportation (CALTRANS) and found structurally sound. The estimate for repairs to the fender system was \$1.5 to \$2 million (See Figure 7, with additional photos located in ECN 3095030 #022 [REDACTED]).

Figure 7. Coast Guard photo of fender system damage to the Bay Bridge

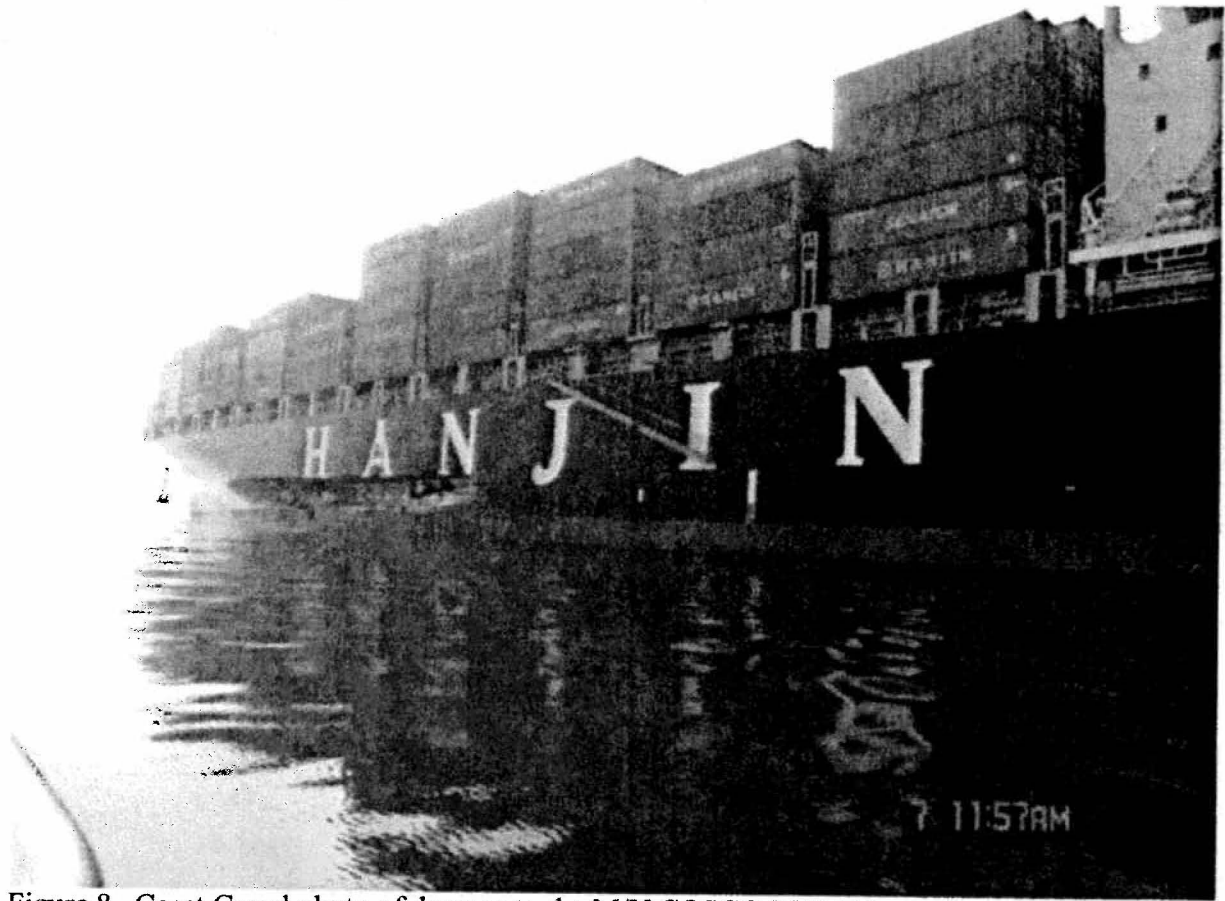
The COSCO BUSAN sustained significant structural damage to the port side shell above the waterline between frames 128 and 150. The hull was breached to a height of three meters, and inboard to the longitudinal bulkhead, which was buckled and punctured in way of cargo hold #2. All associated internals were completely destroyed (ECN 3095030 #001 [REDACTED] and ECN 3095030 #013 [REDACTED]). Temporary repairs were completed in San Francisco at an estimated cost of \$1 million (ECN 3095030 #038 [REDACTED]). Permanent repairs were completed outside the U.S., at an estimated cost of \$1.5 million (See Figure 8, with additional photos located in ECN 3095030 #023 [REDACTED]).

The side shell of the COSCO BUSAN was damaged in way of the #2 water ballast tank, #3 wing

fuel oil tank and #4 wing fuel oil tank. The fuel oil level in the #3 tank was below the lower edge of the damage, and thus it is unlikely that there was a substantial flow of oil, if any, from the #3 fuel oil tank. The #4 fuel oil tank discharged an estimated 53,653 gallons of Intermediate Fuel Oil (IFO 380) (ECN 3095030 #009 [REDACTED]). Based on calculations by the Coast Guard Marine Safety Center (MSC), the majority of the discharge occurred in a period estimated at less than 10 seconds (ECN 3095030 #009 [REDACTED]). One witness reported that a "substantial flow of oil" was pouring out of the after part of the damaged area as late as 0852 (ECN 3095030 #055 [REDACTED]).

Figure 8. Coast Guard photo of damage to the M/V COSCO BUSAN
