AIRCRAFT ACCIDENT REPORT

CONTROLLED FLIGHT INTO TERRAIN
KOREAN AIR FLIGHT 801
BOEING 747-300, HL7468
NIMITZ HILL, GUAM
AUGUST 6, 1997

NTSB/AAR-00/01
PB00-910401
Notation 6952B
Adopted January 13, 2000

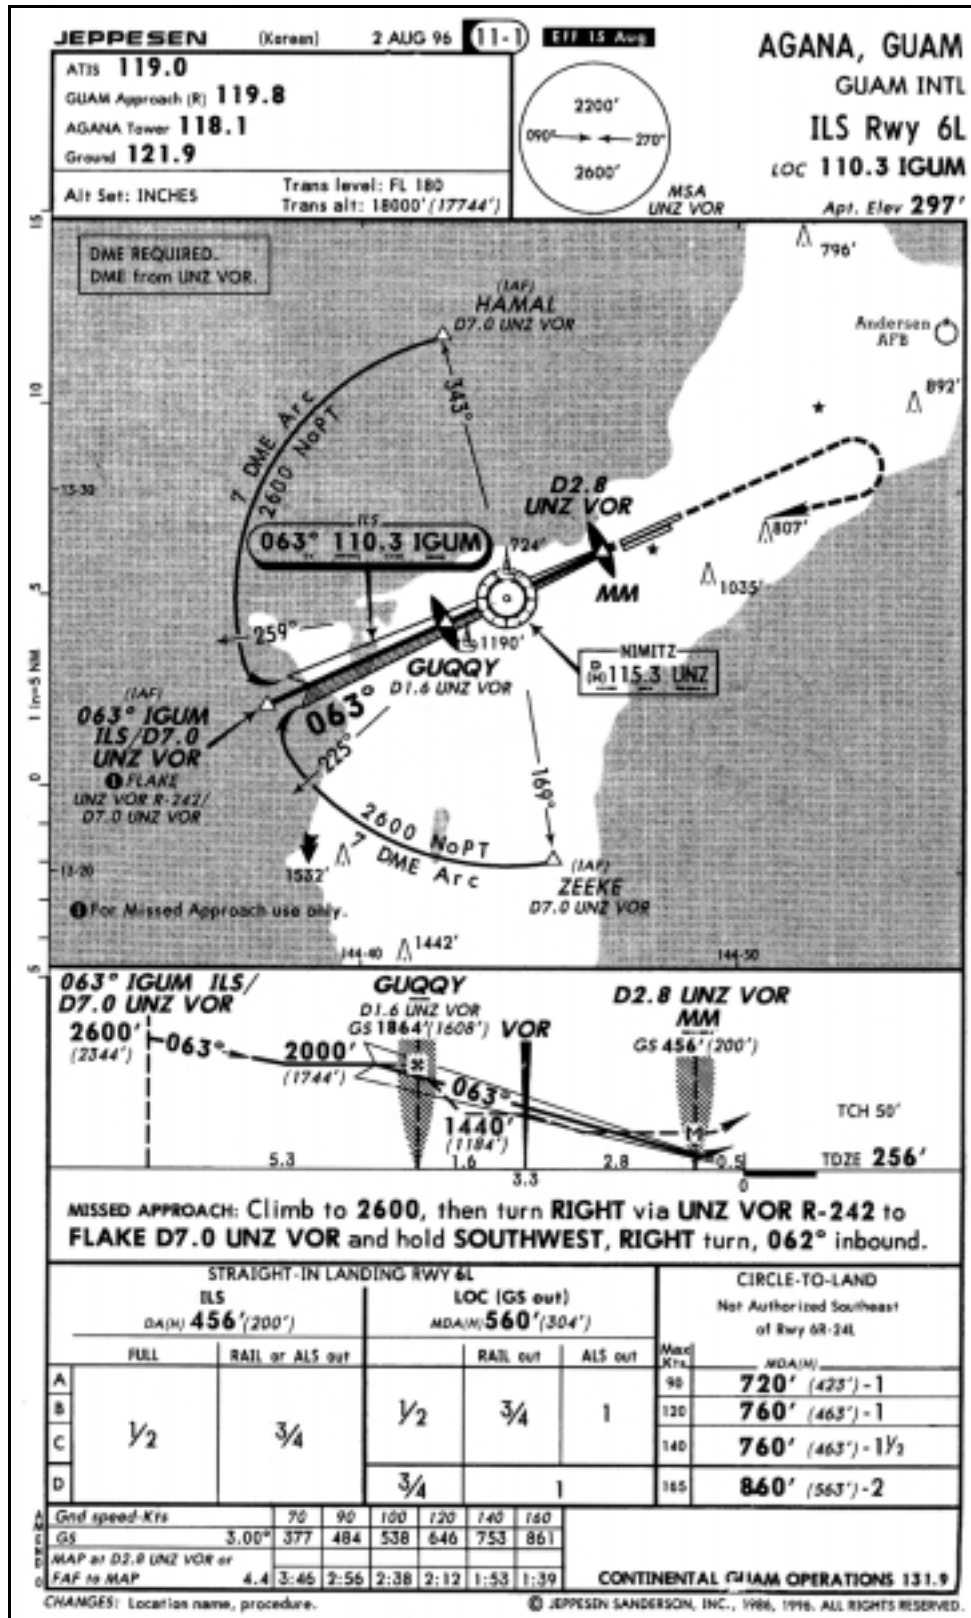
¹⁶ ATIS information Uniform noted the Notice to Airmen (NOTAM) for runway 6L, which stated that the ILS glideslope was “out of service until further notice.” See section 1.7.1.

Figure 1. Instrument approach chart for the Guam International Airport runway 6L ILS procedure.

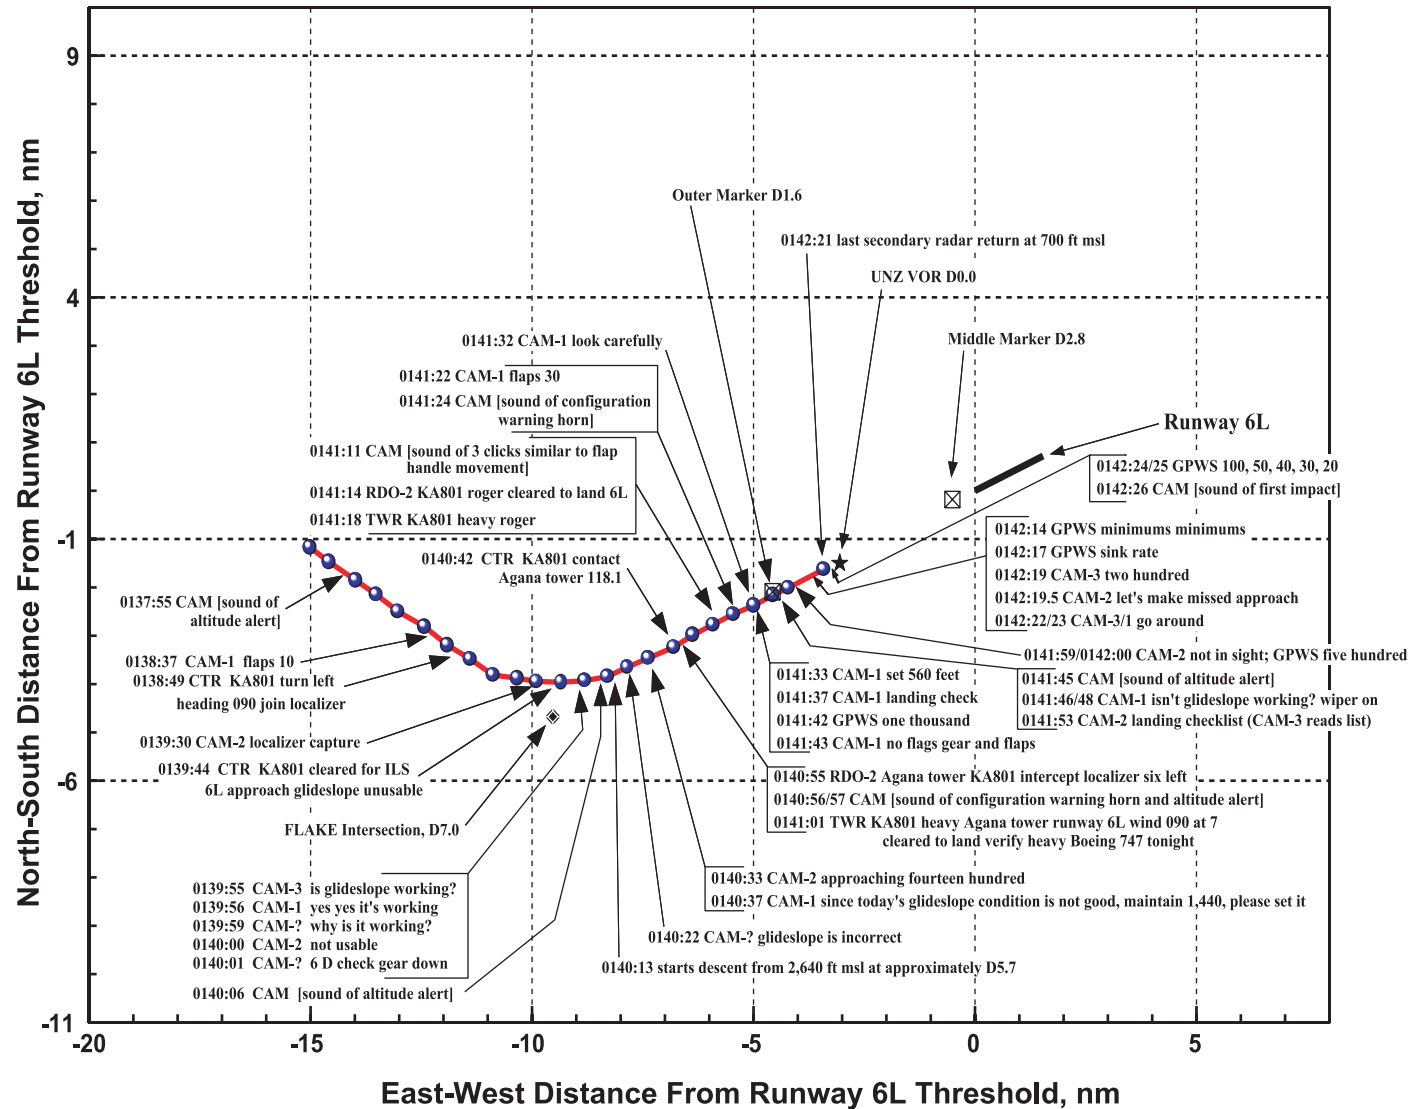
Figure 3. Overhead view of FAA radar data with selected ATC and CVR communication excerpts.

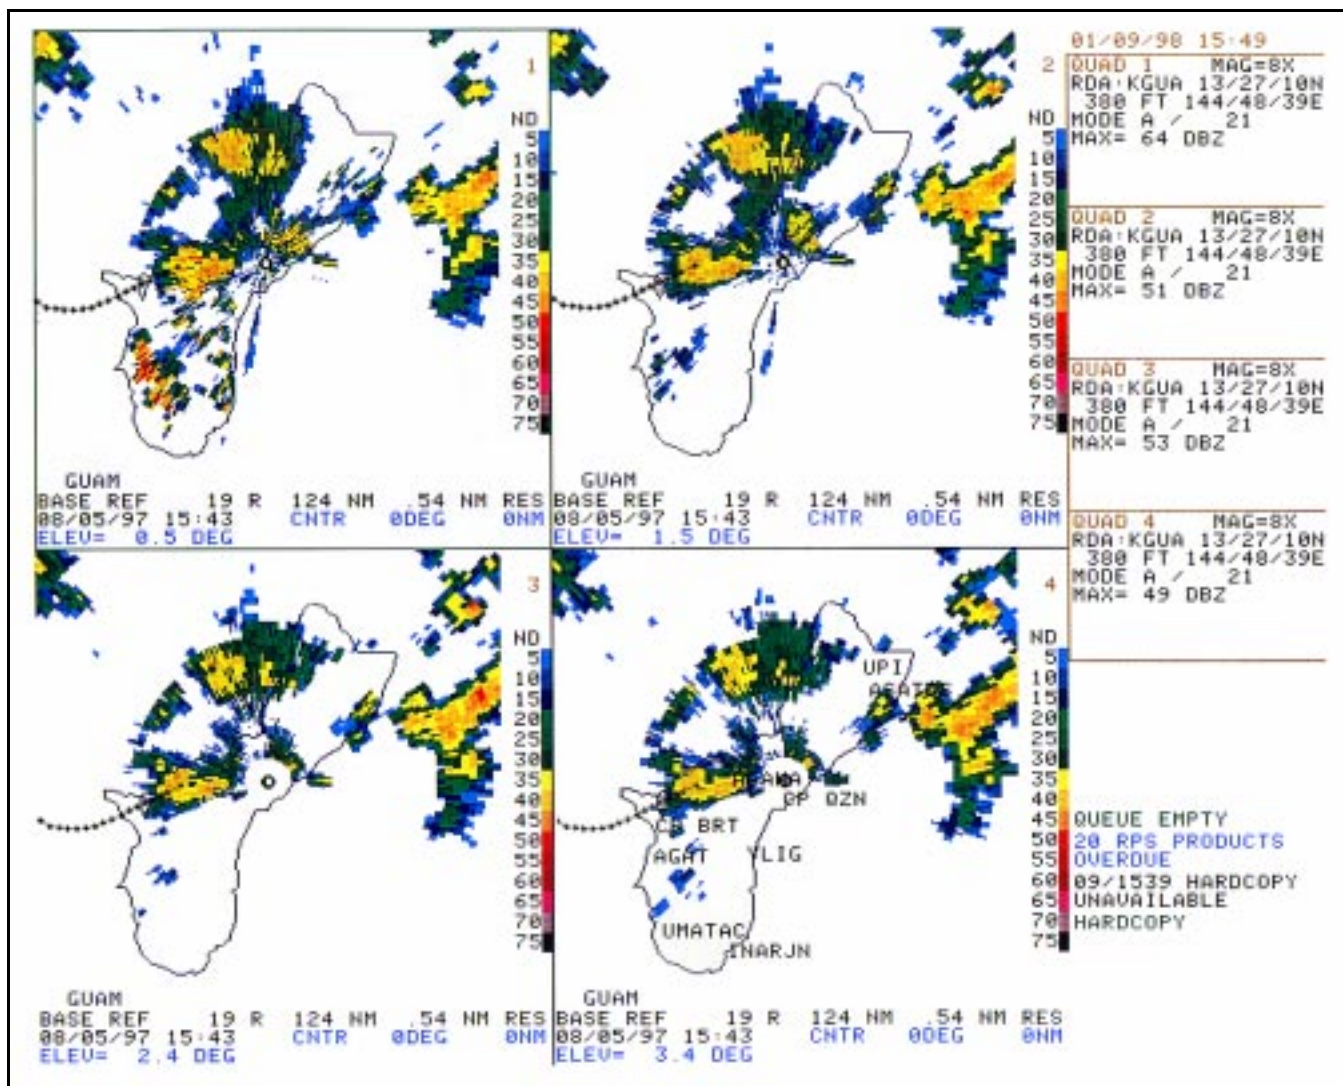
Figure 6. WSR-88D four-panel base reflectivity product for Guam.

The CERAP controller stated that he did not advise the flight crew or the Agana tower controller that he had observed the precipitation on radar while flight 801 was on the approach course to the airport. The controller said that he had assumed that the flight crew was using cockpit radar because they had asked him twice for deviations around weather. The controller stated that the airplane's cockpit radar was more accurate and more precise than the radar he was using at the CERAP. The controller further stated that he did not observe (on radar) the airplane entering the precipitation.

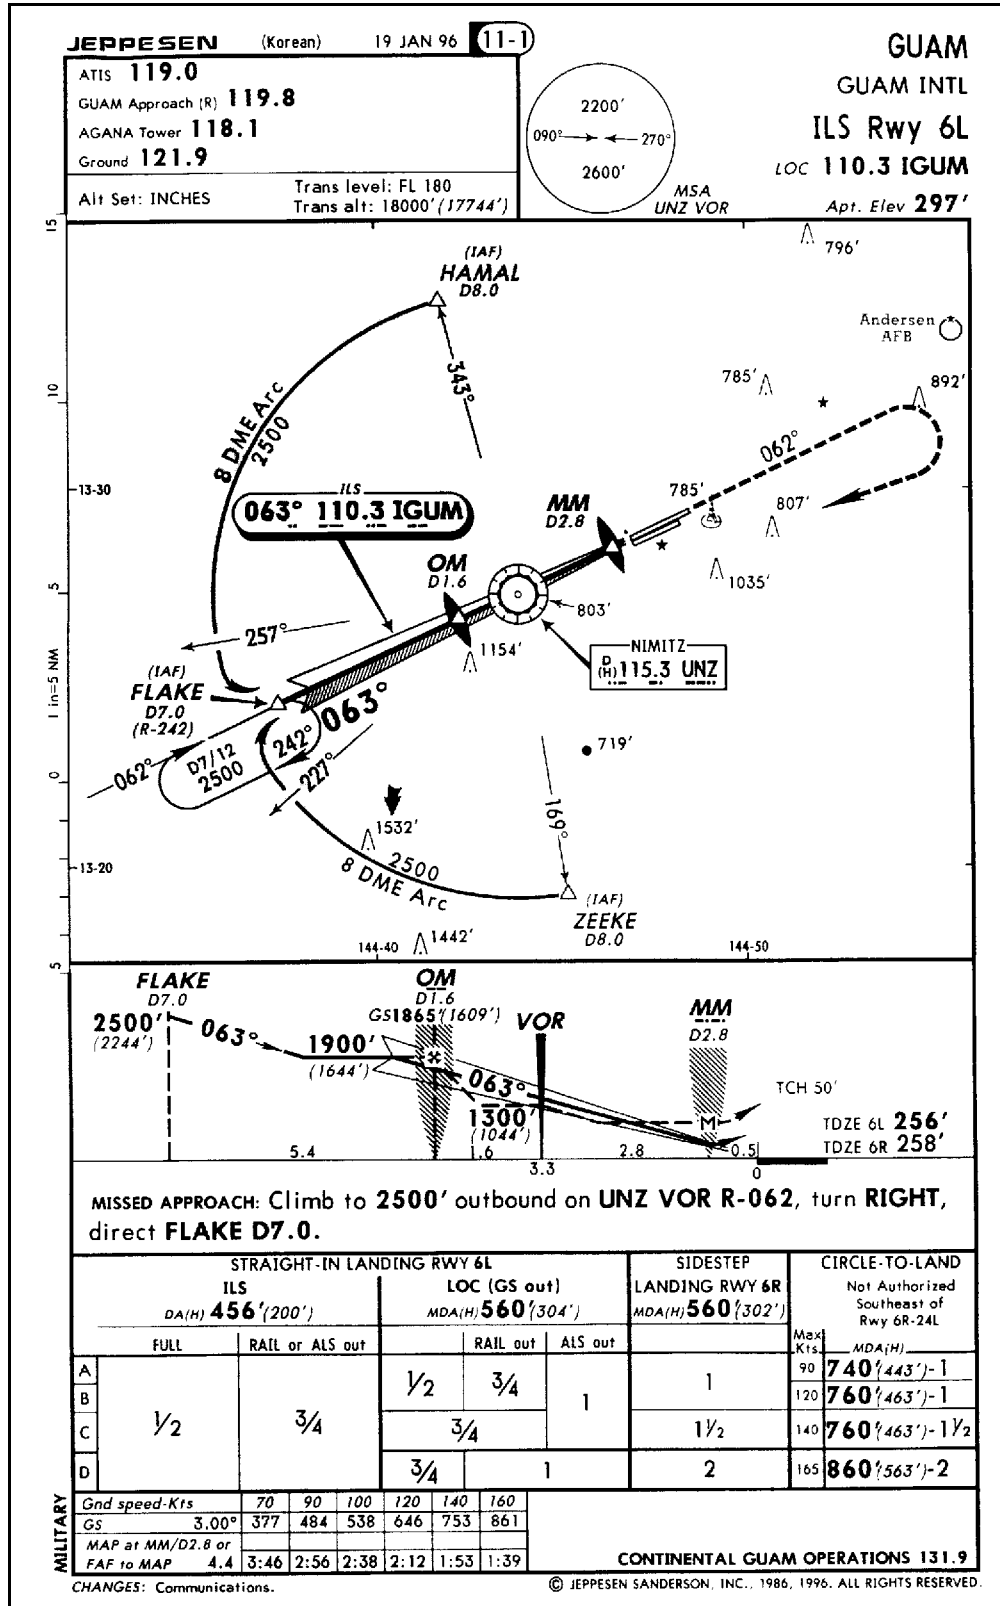
Charts 11-1 and 13-2 were found side by side and were visible through one face of the plastic sleeve. Chart 16-1 and the blank side of an approach plate were visible through the opposite face of the plastic sleeve. Chart 11-1, which is shown in figure 7, had the following items highlighted with a green fluorescent tint:⁶²

Figure 7. The January 19, 1996, 11-1 ILS runway 6L instrument approach chart.

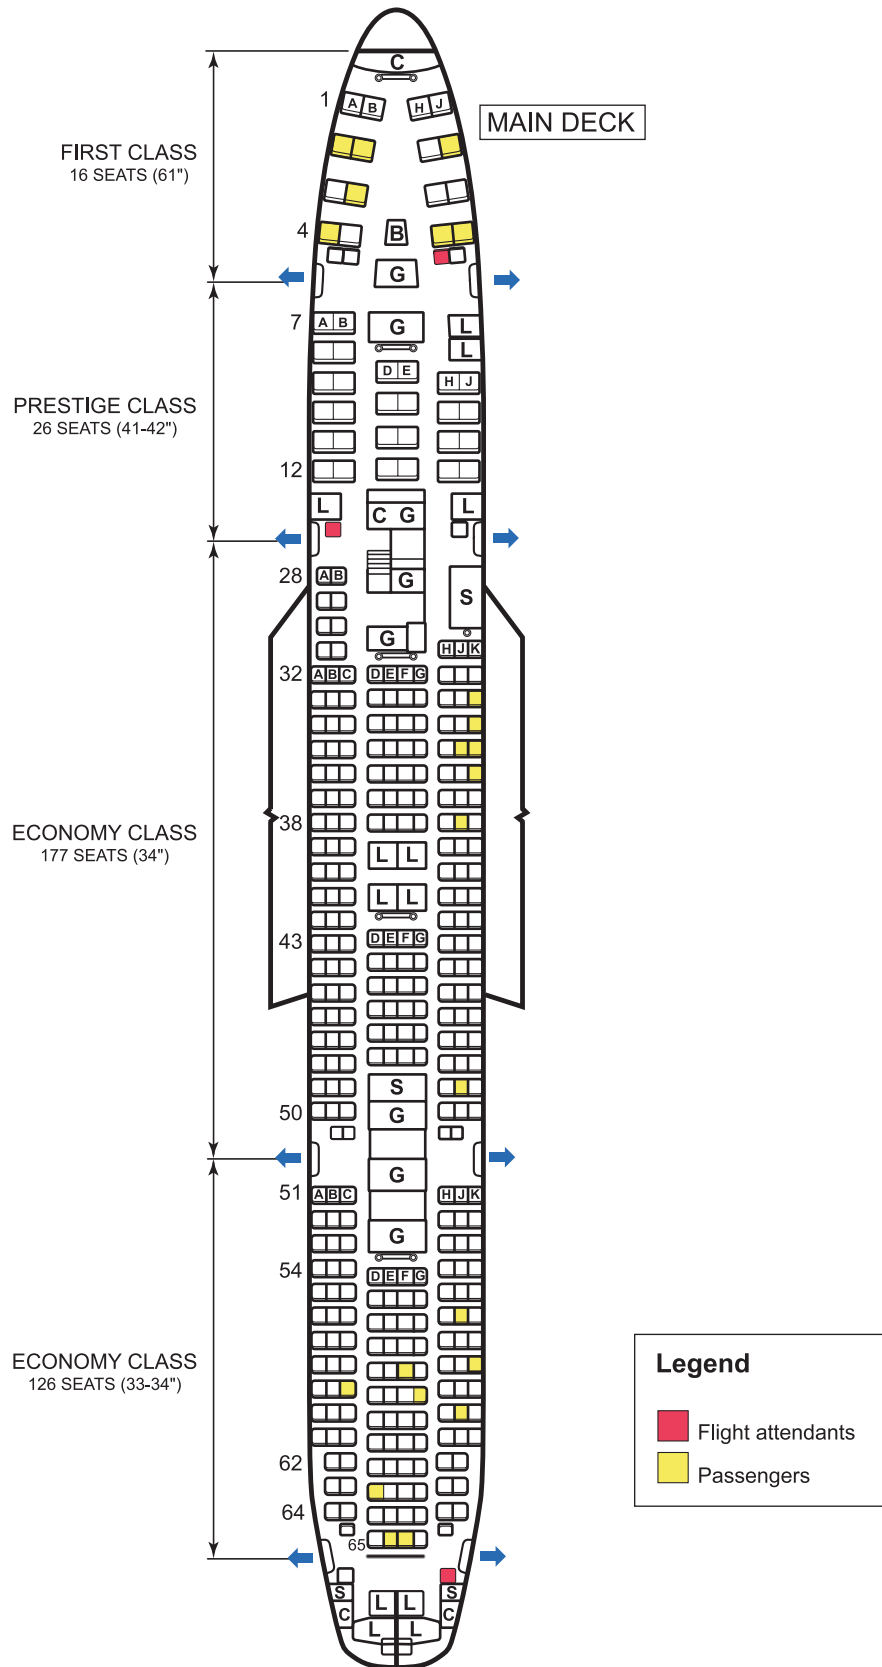
Of the 26 survivors of the accident, 7 passengers and 1 flight attendant were seated in the first class section, 1 flight attendant was seated in the prestige class section, 7 passengers were seated in the forward economy class section, and 9 passengers and 1 flight attendant were seated in the aft economy class section. Two of the surviving flight attendants and 13 of the surviving passengers were seated on the right side of the airplane; 6 of these 13 passengers were seated over the right wing. Figure 9 shows the 747-300 cabin configuration and the survivor seat locations.

Figure 9. Korean Air flight 801 cabin configuration and survivor seat locations.

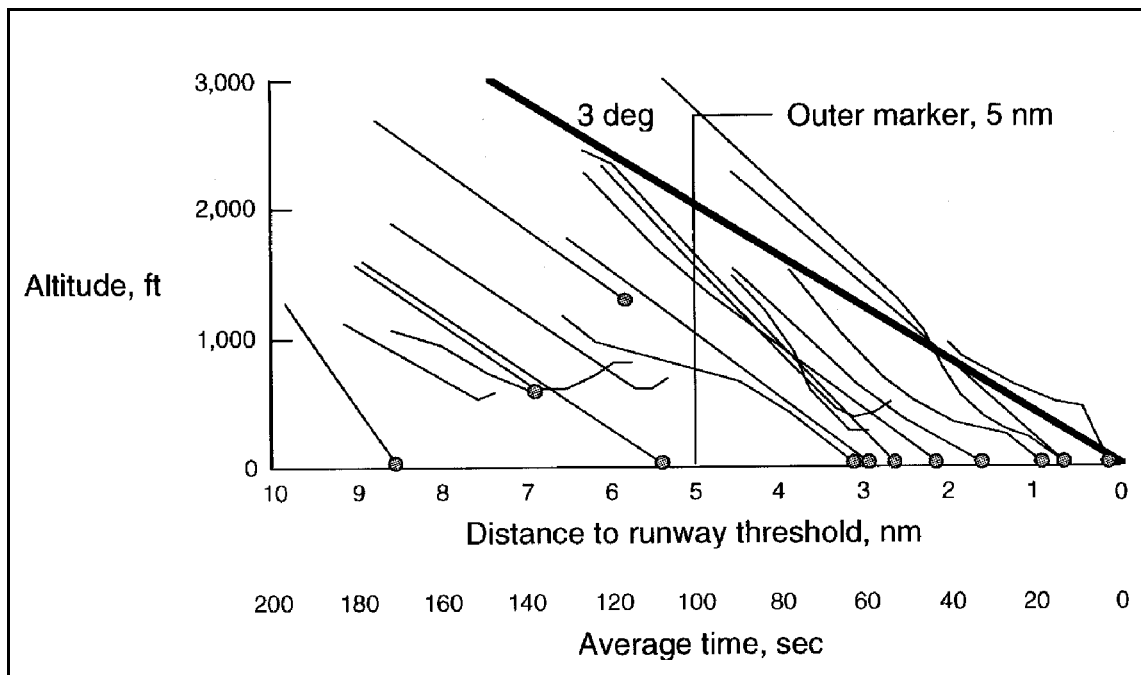
The captain stated that 70 percent of the CFIT accidents occurred on final approach and that most of these aircraft were “...in line with the runway.” The captain also stated that “...many accident aircraft [were] underneath the three-degree glideslope [of a precision approach].” Figure 10 shows vertical profile information that was available from the 40 CFIT accidents and incidents that occurred between 1986 and 1990, as prepared by Boeing and provided by the FSF’s CFIT Awareness Task Force.

Figure 10. Vertical profile information from the 40 CFIT accidents and incidents between 1986 and 1990.
