Descent Below Visual Glidepath and Impact With Seawall
Asiana Airlines Flight 214
Boeing 777-200ER, HL7742
San Francisco, California
July 6, 2013

NTSB/AAR-14/01
PB2014-105984

Aircraft Accident Report

Descent Below Visual Glidepath and Impact With Seawall

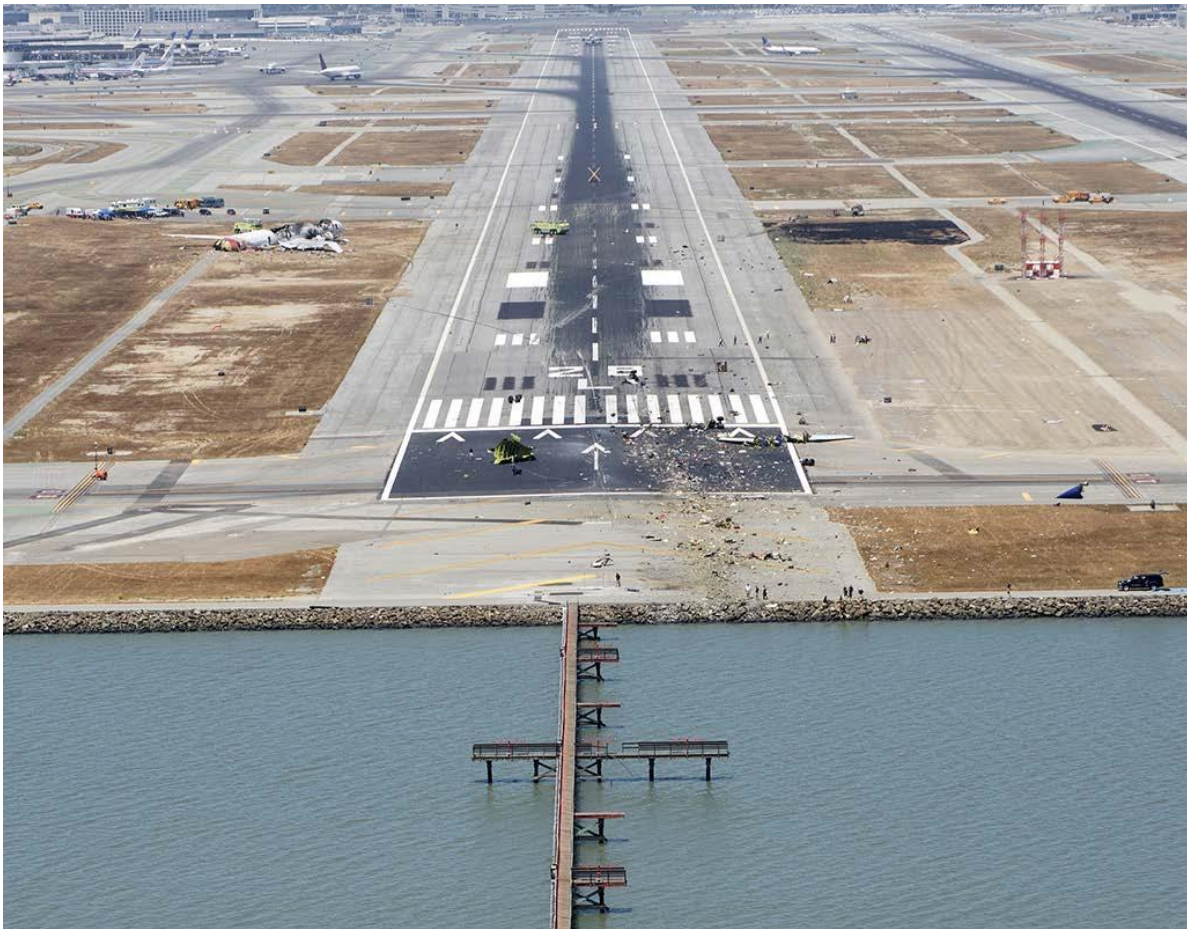
Figure 5. Aerial view of the flight 214 wreckage.

The left and right engines separated cleanly from their respective wings during the impact sequence as per design specifications.⁵⁴ The left engine came to rest about 600 ft north of the main wreckage in the grass on the opposite side (right) of the runway. The engine exhibited fan blade airfoil fractures opposite the direction of rotation consistent with high speed fan rotation at the time of impact.

The right engine came to rest against the right side of the fuselage near door 2R, lying on its right side. The exterior surfaces of the left side of the engine, which was facing up, and the bottom of the engine, which was facing the fuselage, exhibited thermal damage and sooting. The oil tank located on the left side of the engine was partially melted, and the areas around the tank were heavily sooted and thermally damaged. The engine exhibited fan blade tip bending opposite

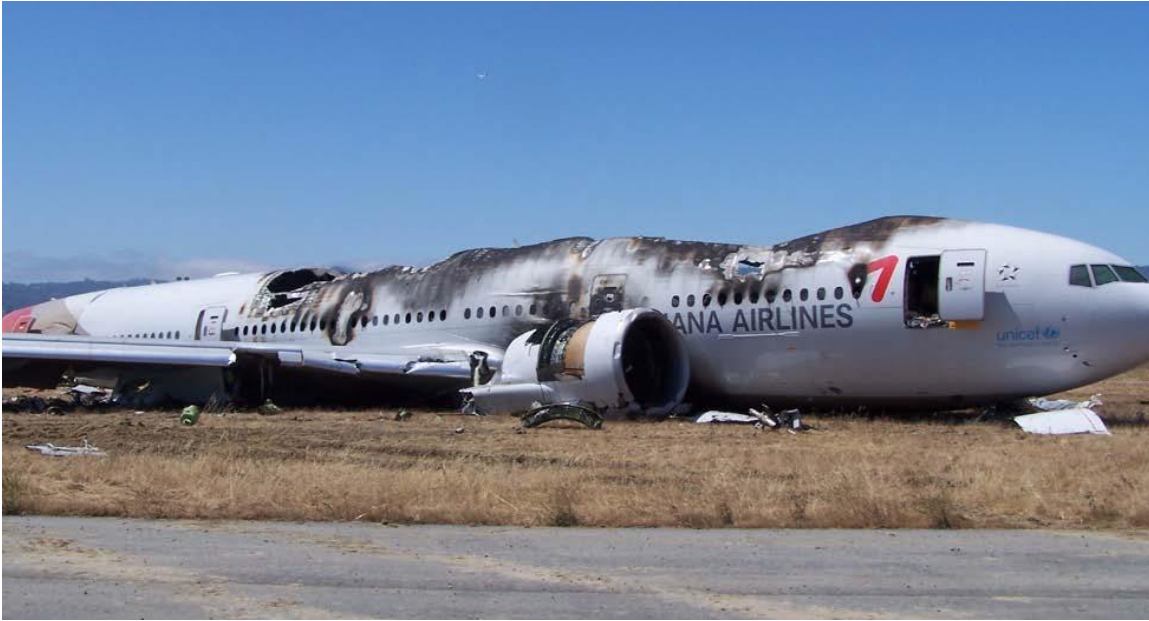
Figure 11. Fire damage to the fuselage of flight 214.

A fire erupted during the accident sequence and destroyed sections of the airplane before being suppressed by firefighting personnel. Portions of the fuselage crown structure above the window belt were burned through from about body station⁶¹ (BS) 358 aft to about BS 1434. The cabin interior above the passenger floor from about the cockpit door aft to about BS 1434 was partially consumed by fire. Figure 11 shows fire damage to the airplane.

Examination of the accident site and the airplane's fuel tanks showed no evidence of postcrash fire involving fuel. As previously noted, the right engine's oil tank was breached and partially melted; thermal damage signatures around the oil tank were consistent with an oil-fed fire. The fuselage in the area where the right engine came to rest (BS 825 to 867) showed severe heat damage but no penetrations other than rivet holes and minor cracks. The door 2R external skins were burned away, but the fire did not penetrate internal insulation and mechanisms into the cabin. However, below the cabin floor in the cargo bay, severely burned ducts, thermal acoustic insulation, and composite floor beams were found between BS 755.5 and 888 behind the cargo compartment liner. The path of the fire was traced from this area, up the environmental control system riser duct bay between BS 825 and 846 and into the overhead area.

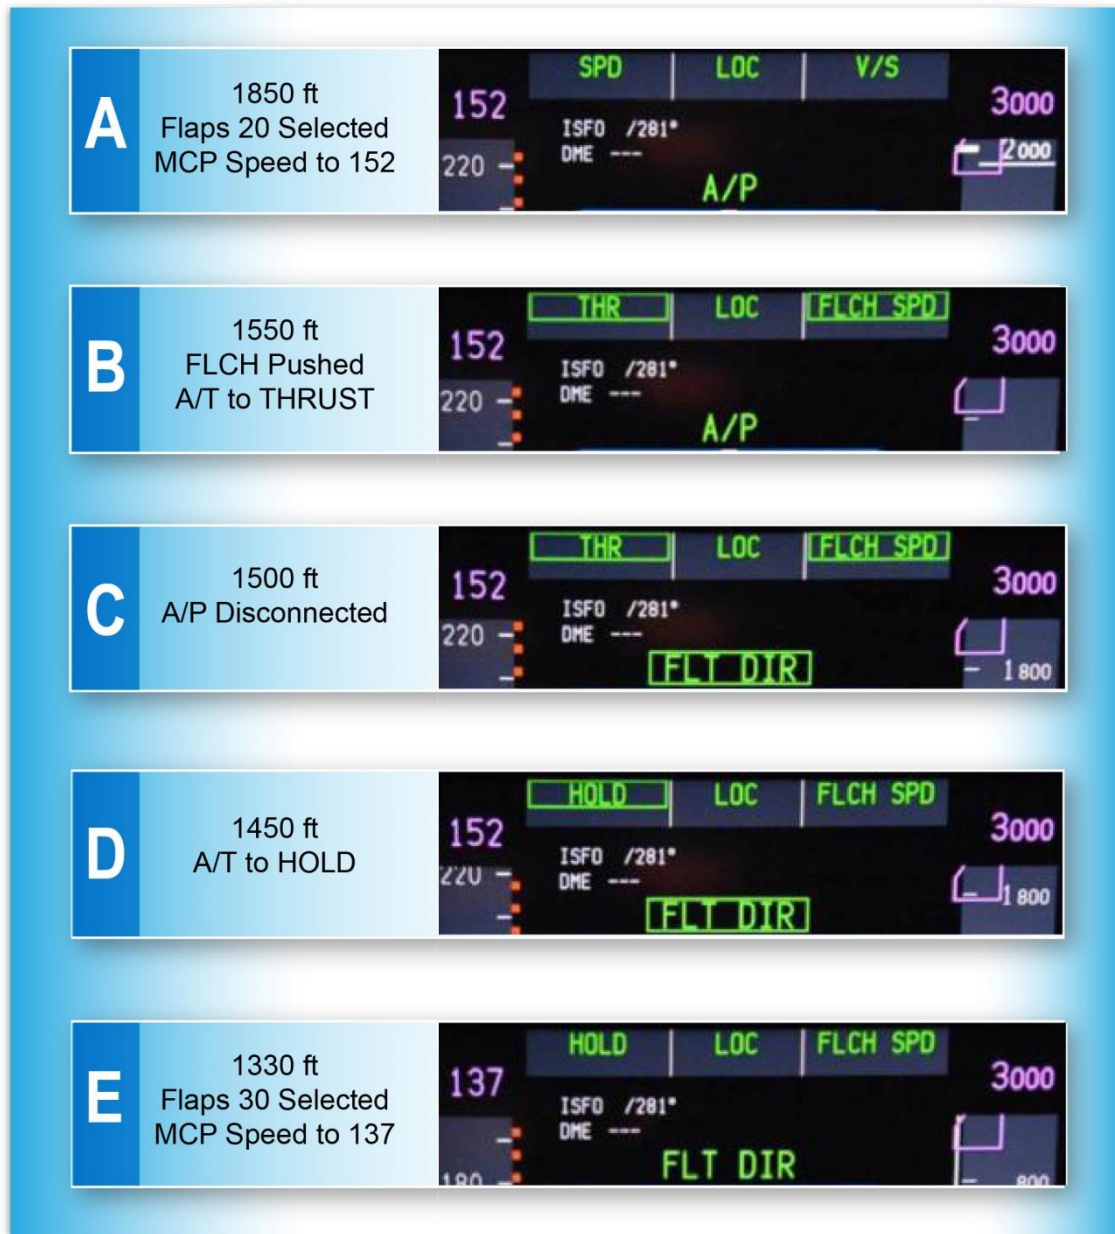
Figure 14. Automation sequence from 1,850 to 1,330 ft msl.

The flight crew's difficulty in managing the airplane's vertical path continued as the approach progressed. The PF was aware of the need to lose excess altitude and attempted to do so using FLCH SPD pitch mode, which initiated a sequence of events that had the unintended consequence of deactivating automatic airspeed control. The changes on the FMA that occurred during the airplane's descent from 1,850 to 1,330 ft msl, when it was between about 4.5 and 3.0 nm from the runway threshold, are shown in figure 14 and discussed below.

After passing the DUYET waypoint, the PF called out and set the MCP altitude to 3,000 ft, the planned altitude in the event of a go-around. After passing the 5 nm point, the PF commanded flaps 20; the PM moved the flap lever to the flaps 20 position; and the PF set the MCP speed to 152 knots (panel A of figure 14), the target speed for flaps 20.⁹³ The PF then commanded flaps 30, but the PM delayed setting them to the flaps 30 position because the airspeed had not yet slowed to below the flaps 30 limit speed.

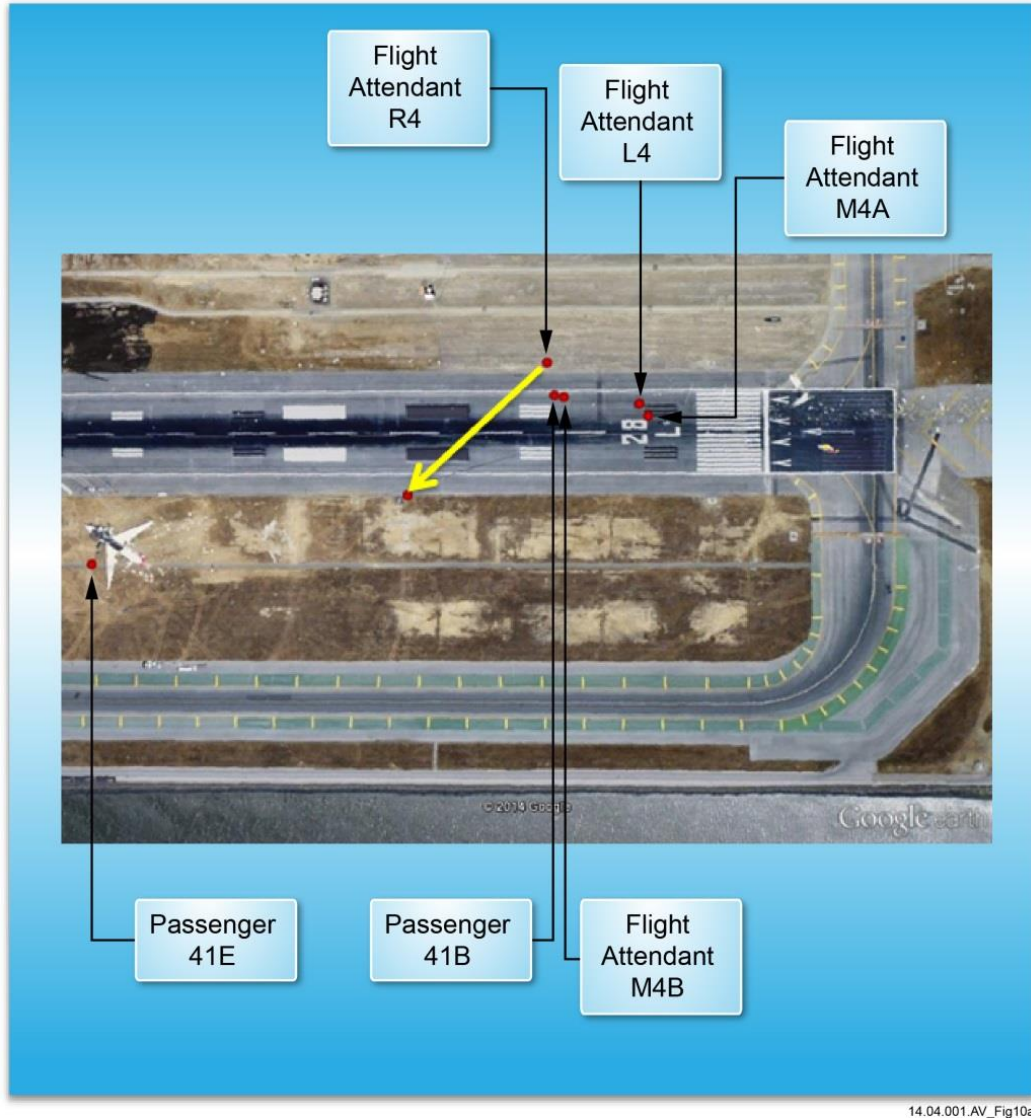
Figure 15. Location where ejected occupants were found.

Passenger 41B,⁵⁵ a 16-year-old female, was found on the right side of the runway about midway between the seawall and the main wreckage. An autopsy was performed by the San Mateo County Coroner's office, and the cause of death was determined to be "multiple blunt injuries" and the manner of death to be "accident." The autopsy report described skull fractures, as well as extensive contusions and abrasions to the torso and extremities.

Passenger 41E, a 16-year-old female, was found about 30 ft in front of the airplane's left wing and about 50 ft from the left side of the fuselage. An autopsy was performed by the San Mateo County Coroner's office, and the cause of death was determined to be "multiple blunt injuries" and the manner of death to be "accident." The autopsy report noted that there was a moderate amount of dirt and plant material on the outside and inside of passenger 41E's clothing. The autopsy report described skull fractures, a lacerated aorta, a fractured pelvis, and extensive contusions and abrasions of the extremities and anterior torso as well as open fractures of the right humerus and left wrist and closed fractures of the left humerus and left femur.

¹⁰⁴ In postaccident interviews, students seated in the same row as passenger 41E reported that she was not wearing her seatbelt for landing. Flight attendants and passengers reported that at least two flight attendants performed prelanding seatbelt compliance checks in C-zone and were "very diligent" in ensuring compliance with seatbelt regulations.
