AIRCRAFT ACCIDENT REPORT: NATIONAL
AIRLINES, INCORPORATED, DC-10-10,
N60NA, NEAR ALBUQUERQUE, NEW MEXICO,
NOVEMBER 3, 1973

National Transportation Safety Board
Washington, D. C.

15 January 1975

1. Report No. NTSB-AAR-75-2		2. Government Accession No.	
4. Title and Subtitle Aircraft Accident Report - National Airlines, Inc., DC-10-10, N60NA, Near Albuquerque, New Mexico, November 3, 1973		5. Report Date January 15, 1975

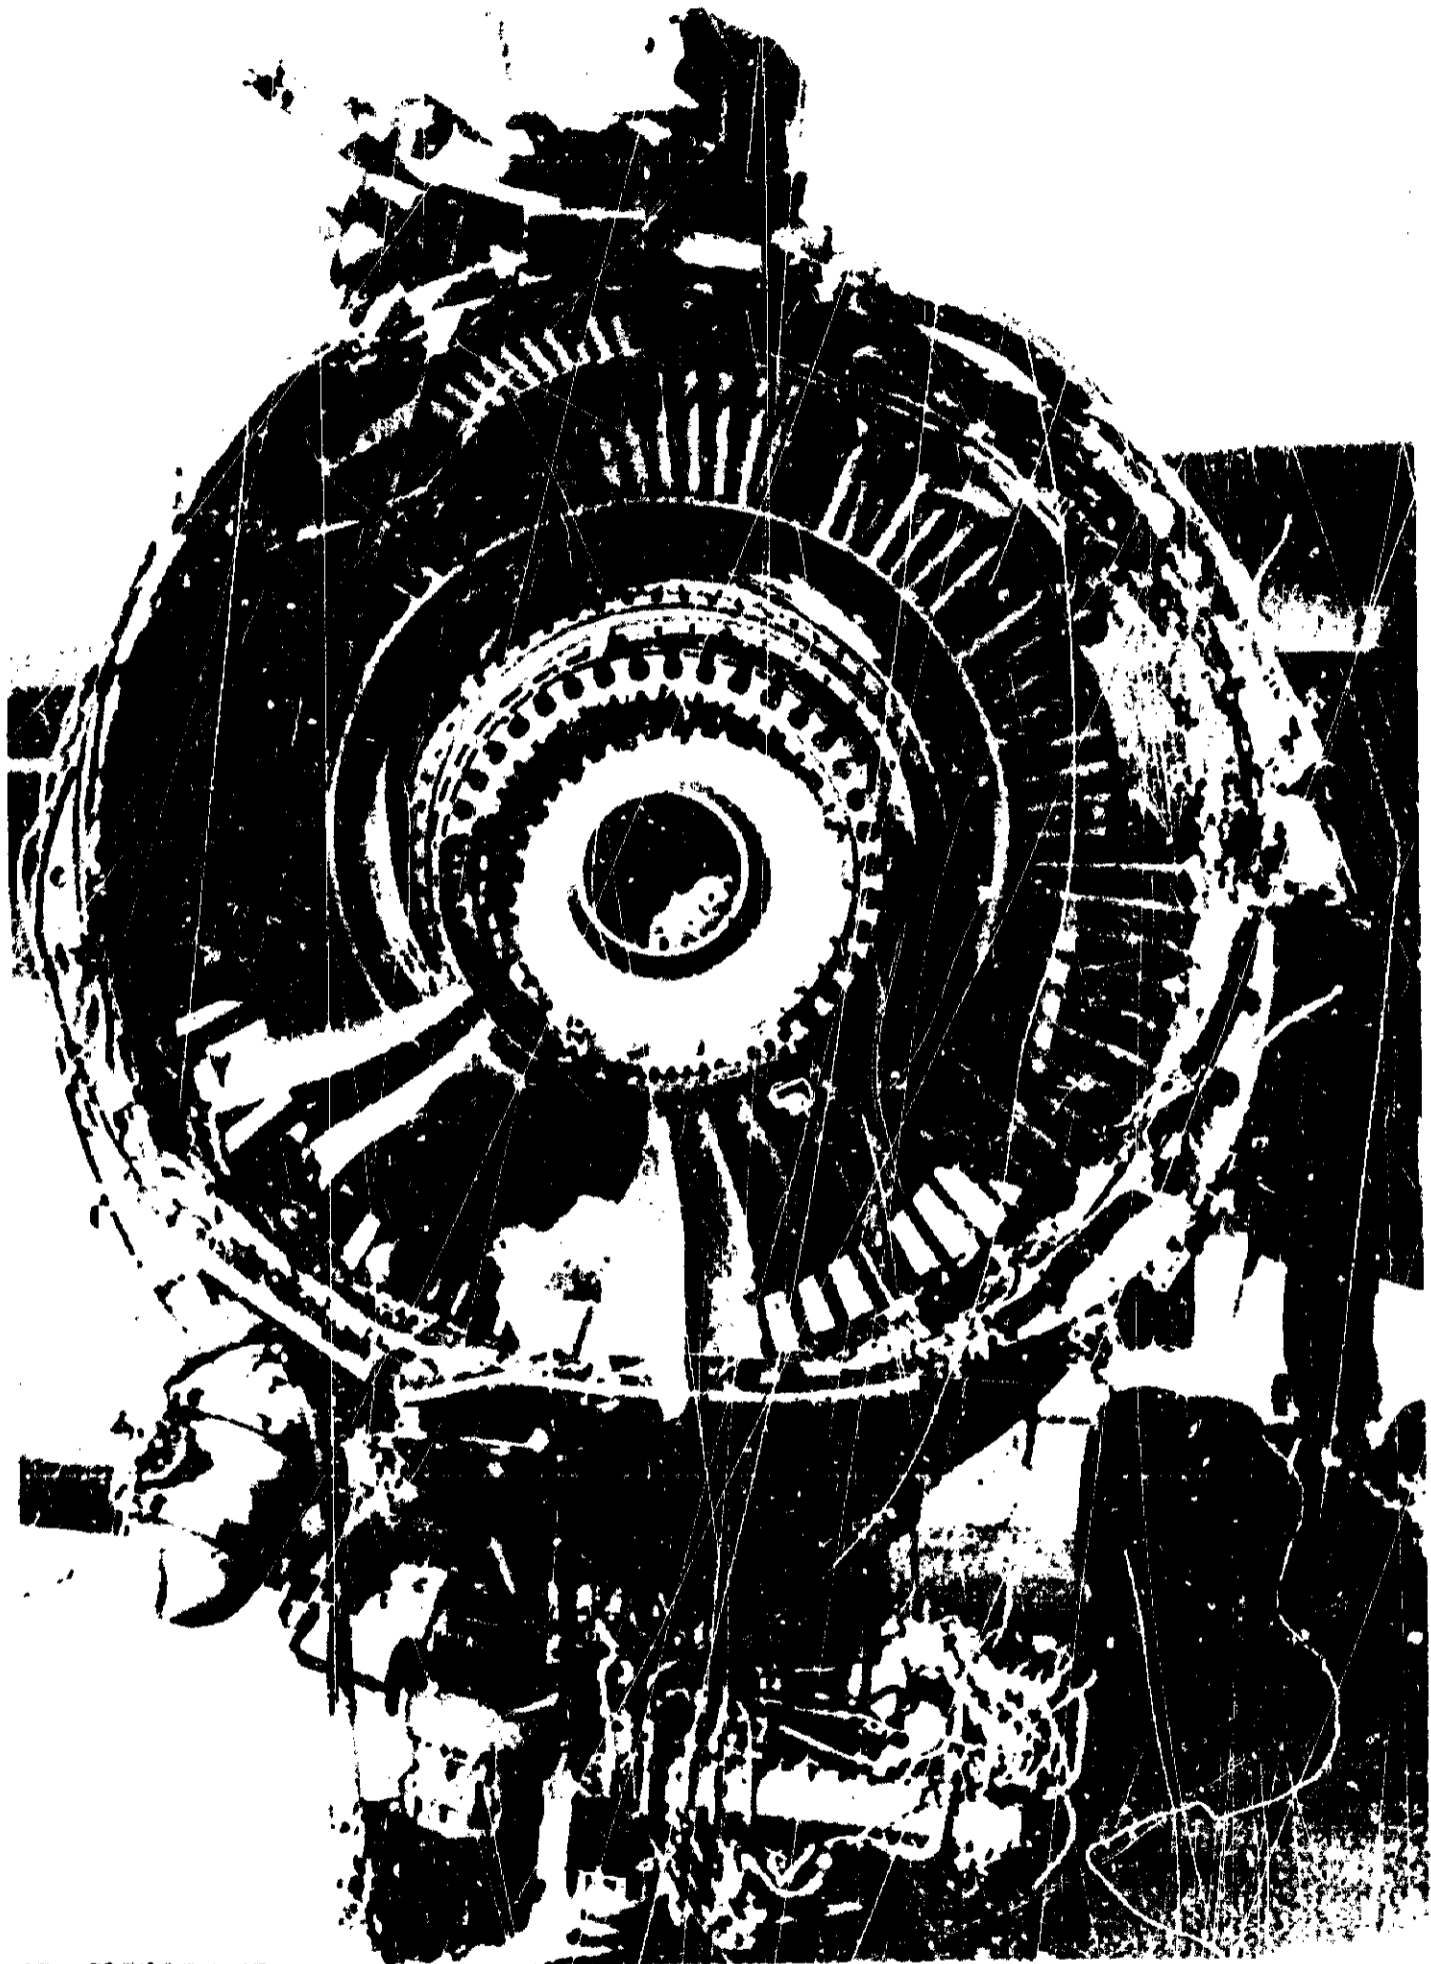
Front View No. 3 Engine

The nose cowl (inlet duct) was intact. It had broken away along the aft attach area, and the aft portion had been crushed on ground impact. Numerous blade fragments had penetrated through the inner barrel of the cowl. The outer barrel was punctured in eight locations.

The fan blade containment ring was recovered in an opened-up and twisted configuration. It separated at the 7:00 position, and the entire ring appeared torn and distorted, with considerable abrasion along the inner surface of the ring. Of the 12 bolts that attach the nose cowl to the containment ring, only portions of 5 bolts were recovered. The fracture surfaces of the bolts showed evidence of failure in shear. The 12 attachment bolt holes had deformed in various directions. The predominant forces, however, as shown on both the nose cowl and the containment ring, were in the direction of engine rotation.
