NATIONAL TRANSPORTATION SAFETY BOARD

AIRCRAFT ACCIDENT REPORT

EASTERN AIR LINES, INC.,
BOEING 727-225, N8838E
RALEIGH, NORTH CAROLINA
NOVEMBER 12, 1975

NTSB/AAR-83/06
(SUPERSEDES—NTSB-AAR-76-15)

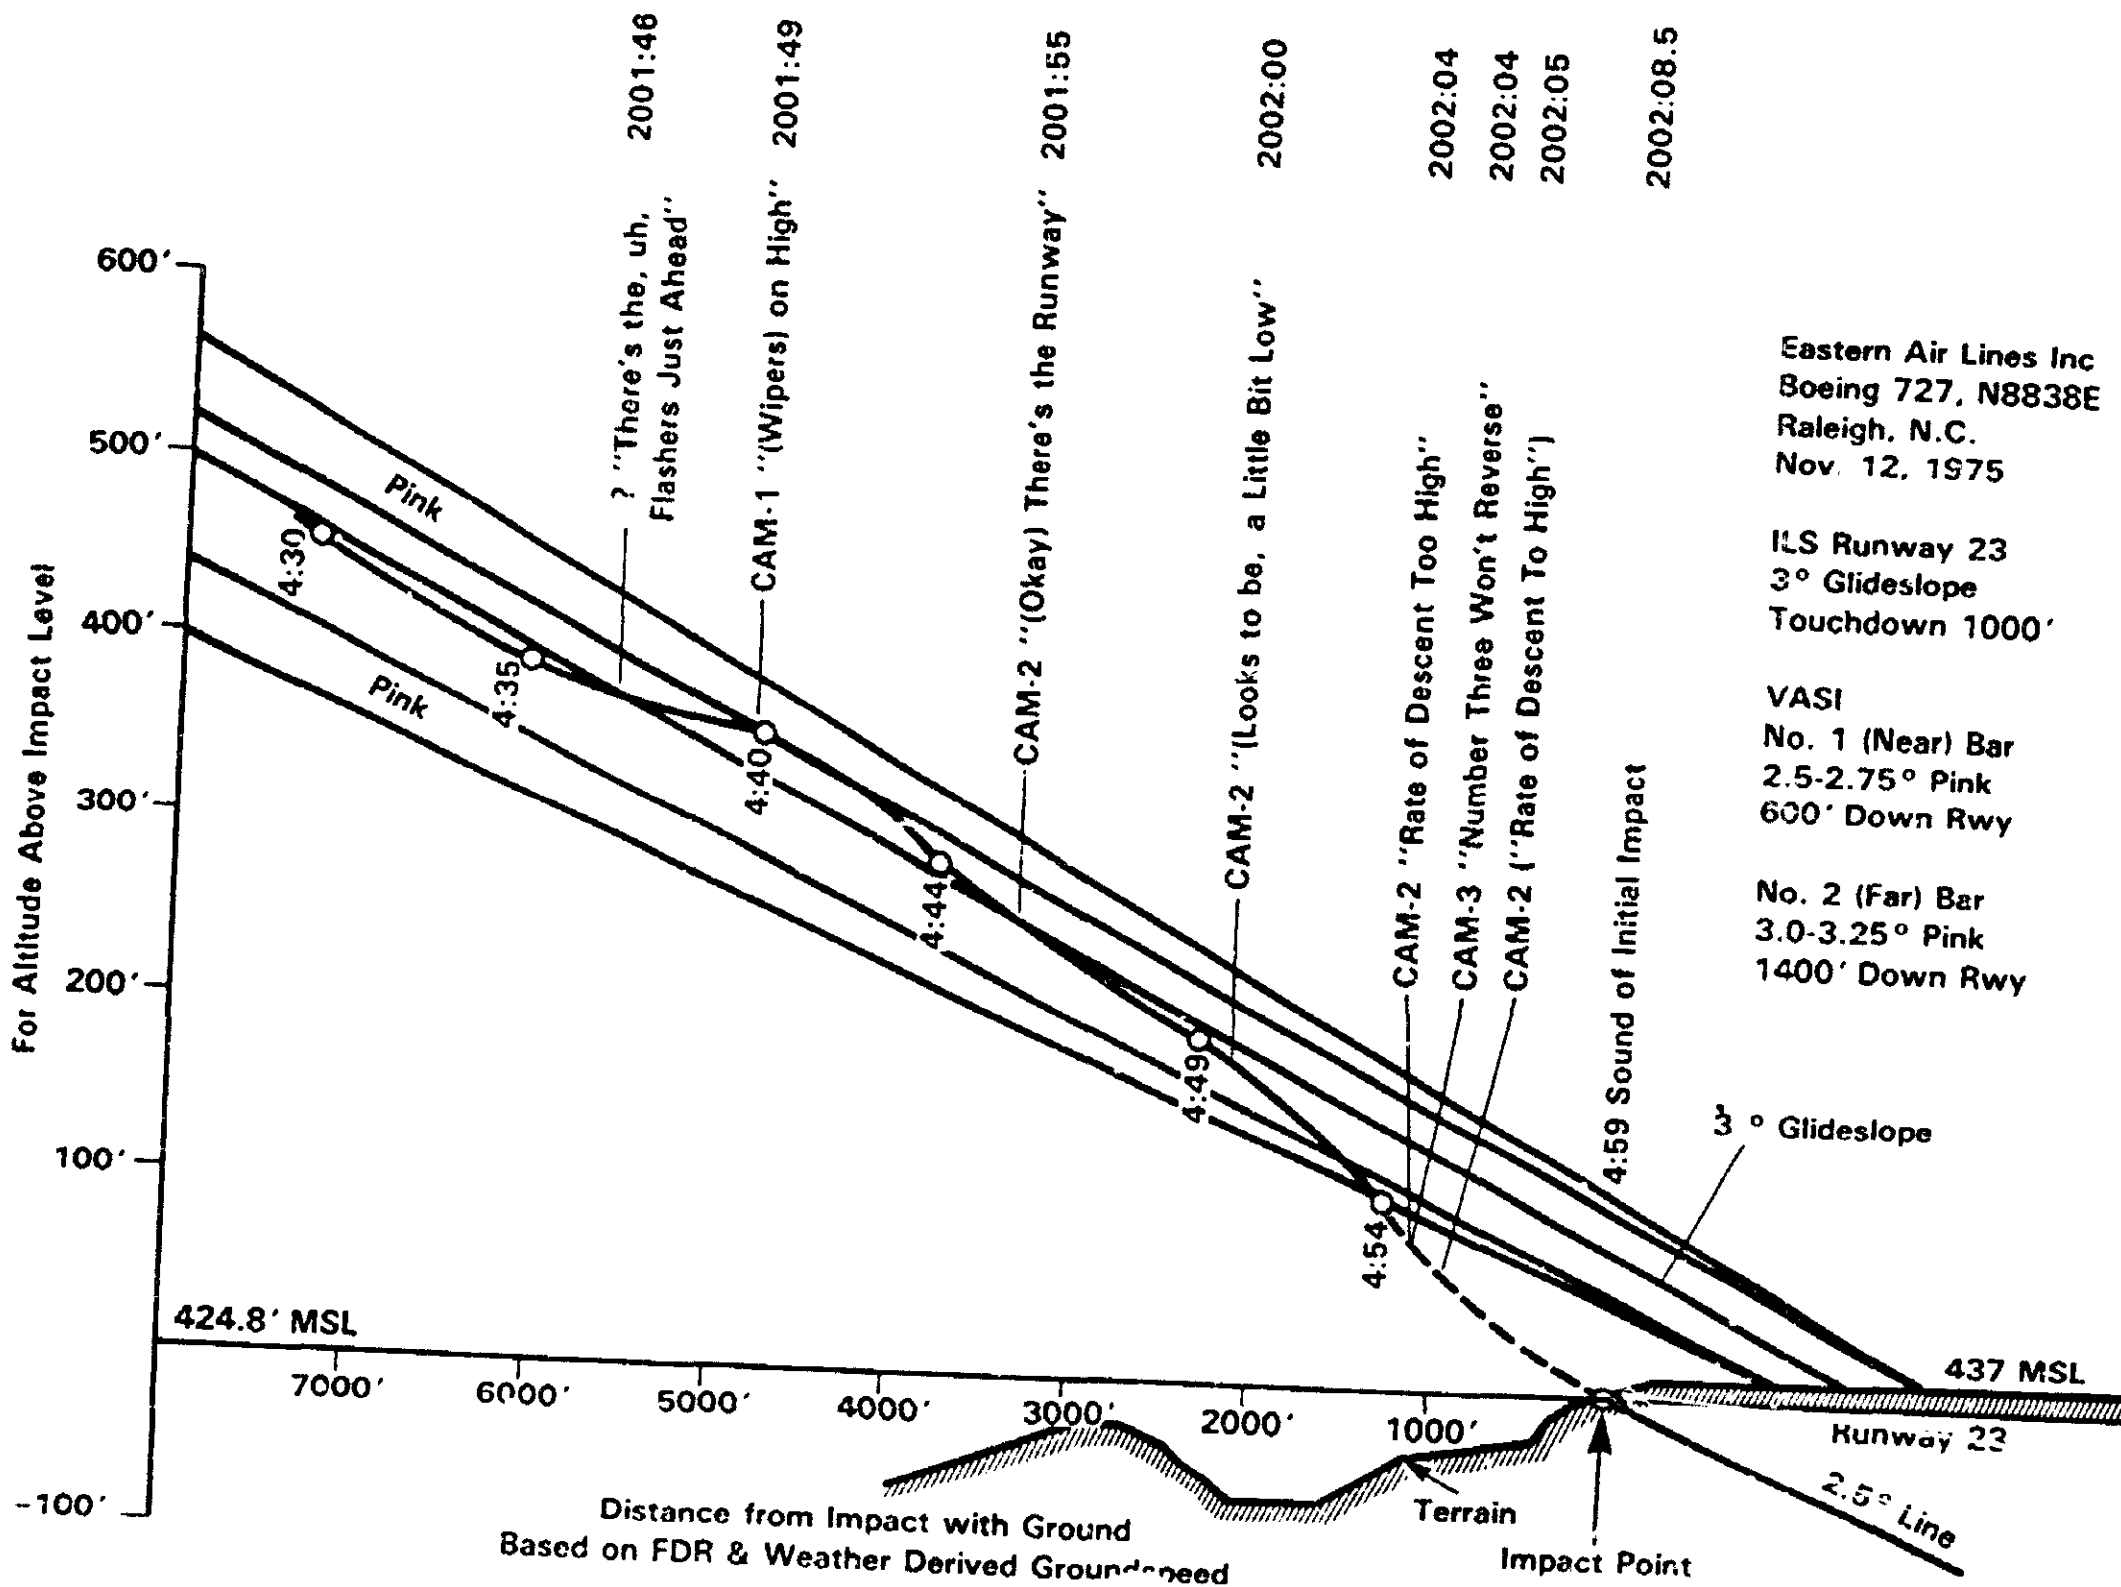
DESCENT PROFILE

The FDR showed that the airspeed on the final approach varied from 140 knots to 145 knots until about 300 feet and had increased to about 147 knots at initial impact. The rate of descent remained fairly constant at between 650 fpm and 700 fpm until about 100 feet. During the 5 seconds before impact, the FDR showed that the average rate of descent was 1,260 fpm, with an airspeed of 145 knots. This airspeed and descent rate equalled a flight path angle of about 5°. Ground damage and marks on the ILS glide slope shack indicated a glidepath angle of about 2.5° at impact. This angle could be produced by a rate of descent of 640 fpm at 145 knots.

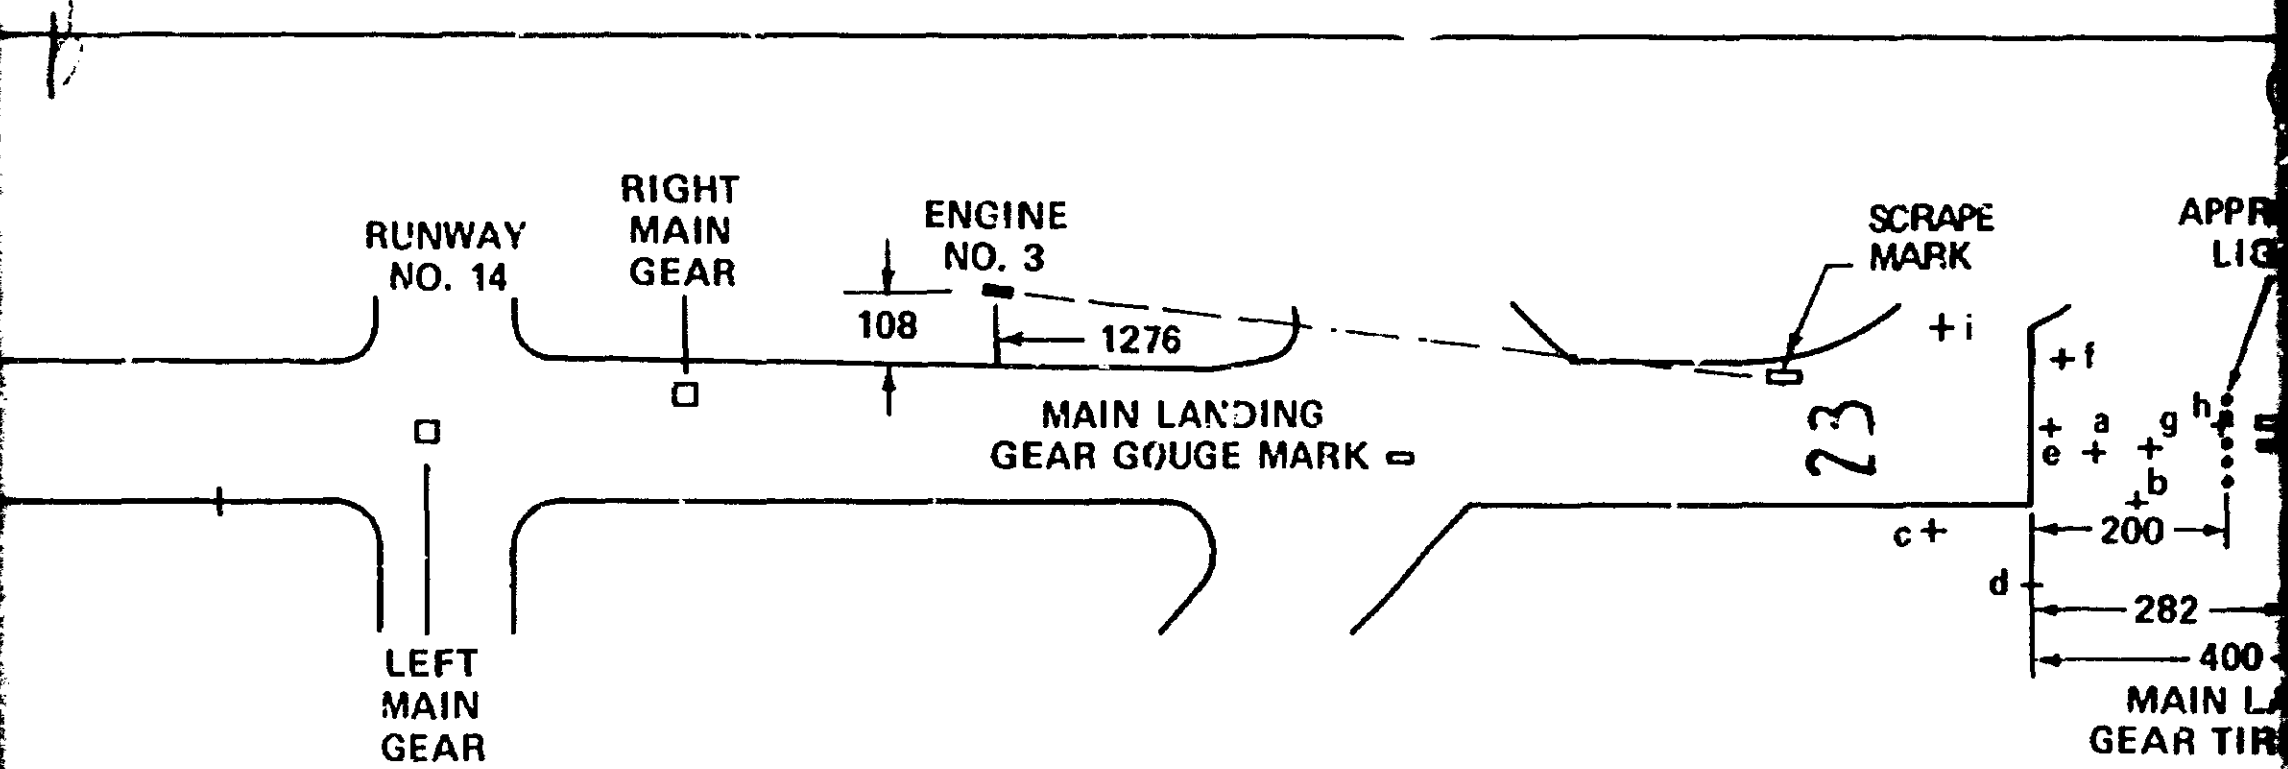
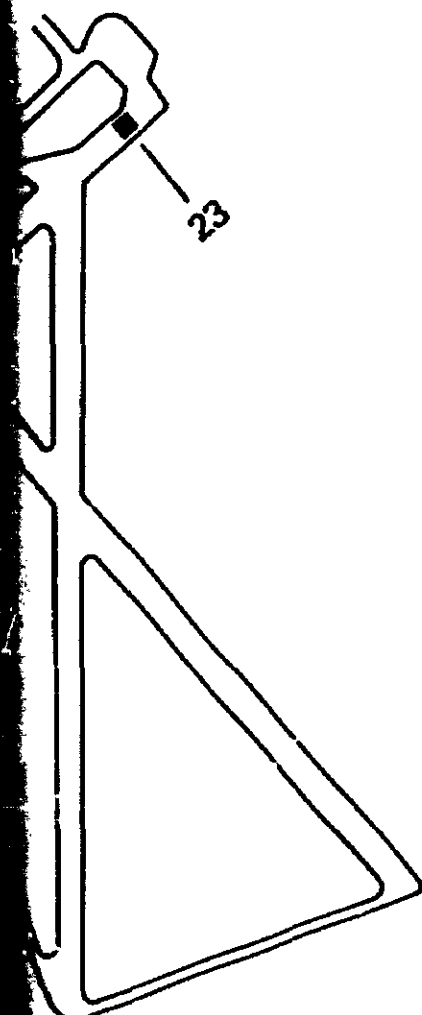
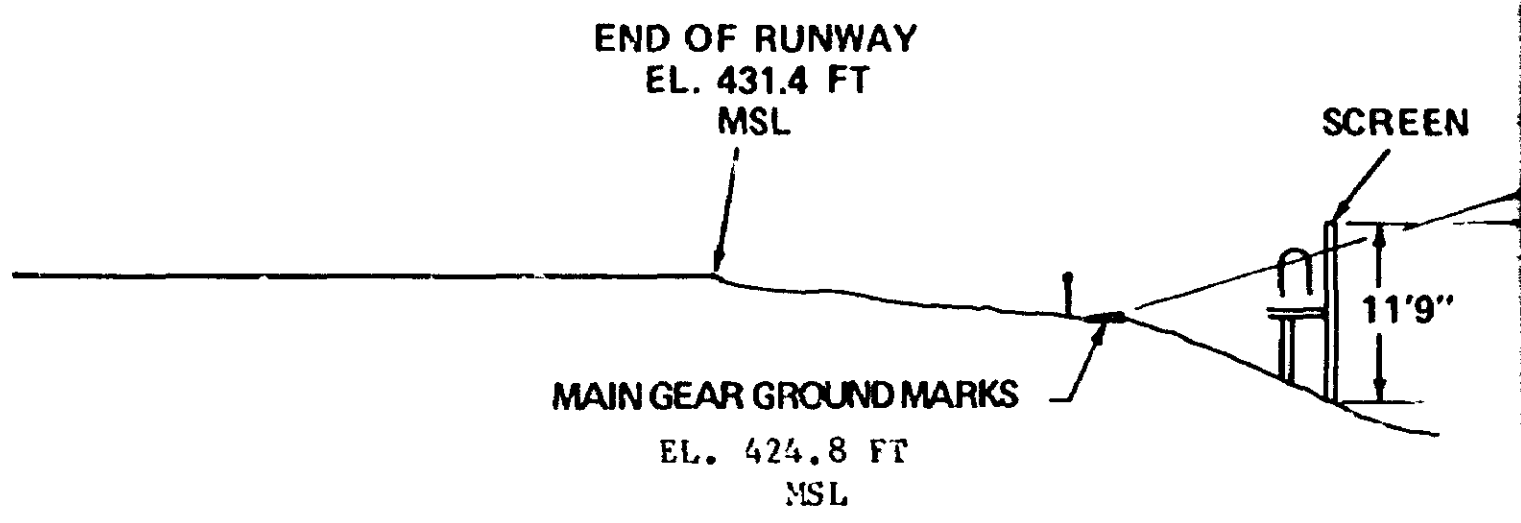
WRECKAGE DISTRIBUTION
 EASTERN AIRLINES FLIGHT 401
 Raleigh-Durham N.C.
 12 November 1975

The airplane first struck the ILS localizer antenna screen for runway 05, which is located 400 feet before the threshold of runway 23. The top 2 feet of the parallel antenna screen wires were severed. The elevation of the top wire was about 430 feet m.s.l., about 1.5 feet below the runway threshold elevation, and about 5 feet below the touchdown zone elevation. An antenna dome was also damaged. (See appendix E.)

The main landing gear tires hit the ground first—about 282 feet short of the runway 23 threshold. The elevation of the ground marks was about 425 feet m.s.l. about 3.5 feet below the elevation of the runway threshold, and about 6 feet below the elevation of the touchdown zone. The airplane's angle of descent between the broken ILS localizer antenna domes and the ground marks was about 2.5°.

The nose landing gear remained on the airplane; the tires were flat. Portions of both main landing gear support structures, the left inboard, mid-inboard, and the mid-trailing edge flaps; the airstair handrails; and airstair control access panel were found between the point of the first ground contact and the runway threshold.
