AIRCRAFT ACCIDENT REPORT

ALOHA AIRLINES, FLIGHT 243
BOEING 737-200, N73711;
NEAR MAUI, HAWAII
APRIL 28, 1988

NTSB/AAR-89/03

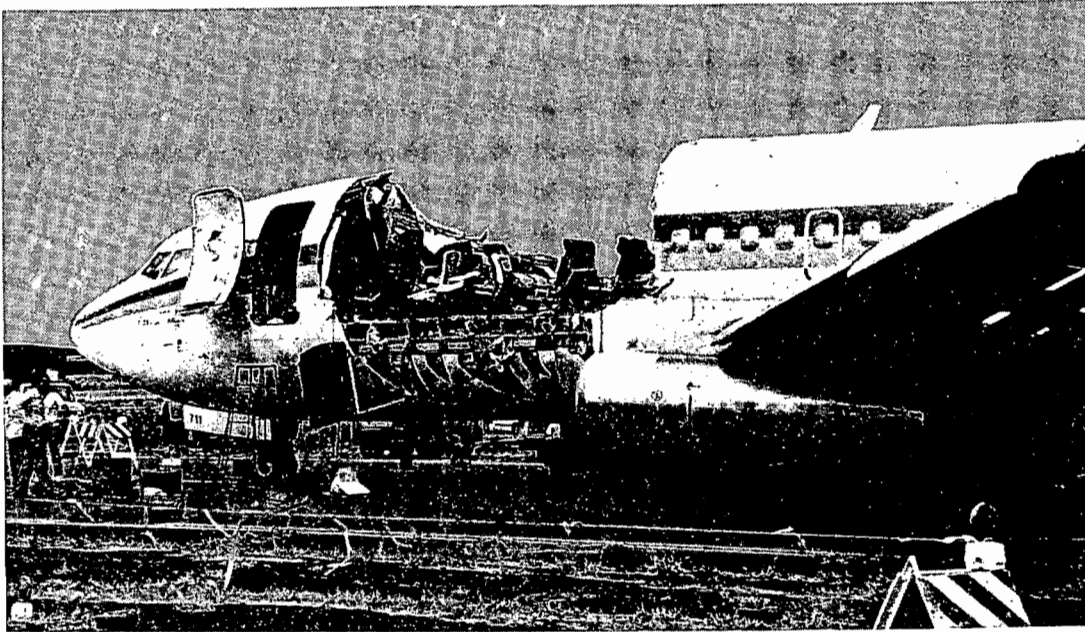
A major portion of the upper crown skin and structure of section 43 separated in flight causing an explosive decompression¹ of the cabin. (See figures 1 and 2.) The damaged area extended from slightly aft of the main cabin entrance door, rearward about 18 feet to the area just forward of the wings and from the left side of the cabin at the floor level to the right side window level.

Figure 2a.--General view, left side of forward fuselage, N73711

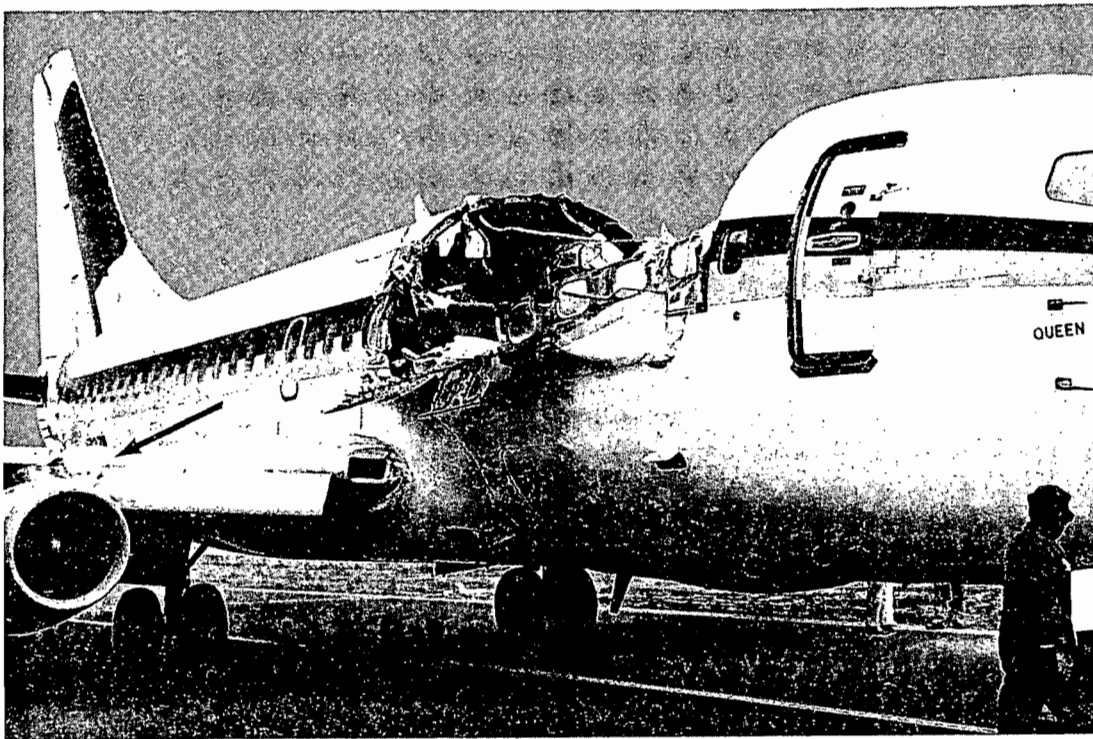
Figure 2b.--General view, right side of forward fuselage, N73711. Arrow marks fragments of S-4R lodged in the leading edge flap.

A fuselage section from BS 365 to BS 420 between S-4R and S-8R was trapped between the leading edge flap and inboard side of the right engine strut. This was the only significant piece of structure from the damaged

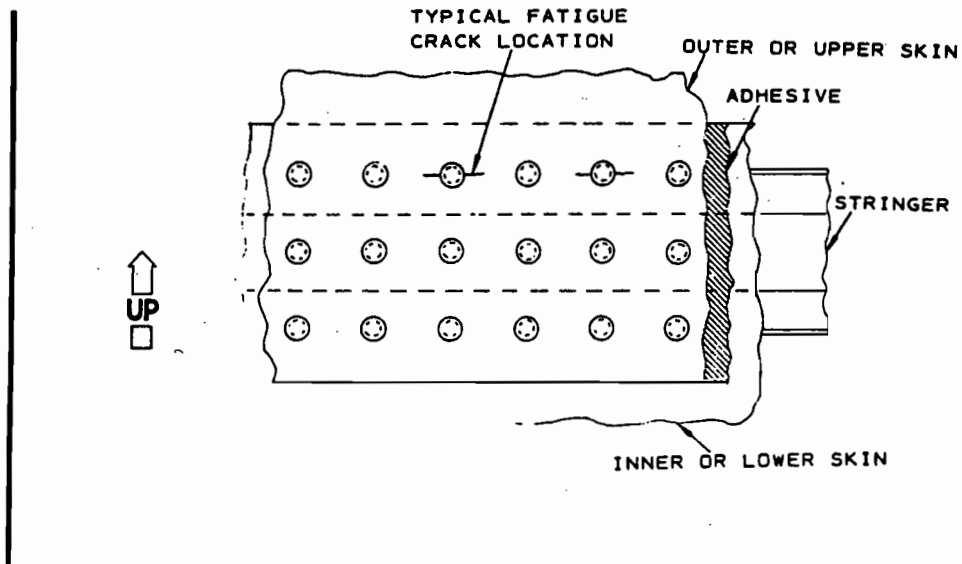
FIGURE 5. FATIGUE CRACK LOCATION
