## **AIRCRAFT ACCIDENT REPORT**

**RUNWAY COLLISION INVOLVING  
TRANS WORLD AIRLINES FLIGHT 427  
AND SUPERIOR AVIATION CESSNA 441  
BRIDGETON, MISSOURI  
NOVEMBER 22, 1994**

**Adopted: August 30, 1995  
Notation 6519B**

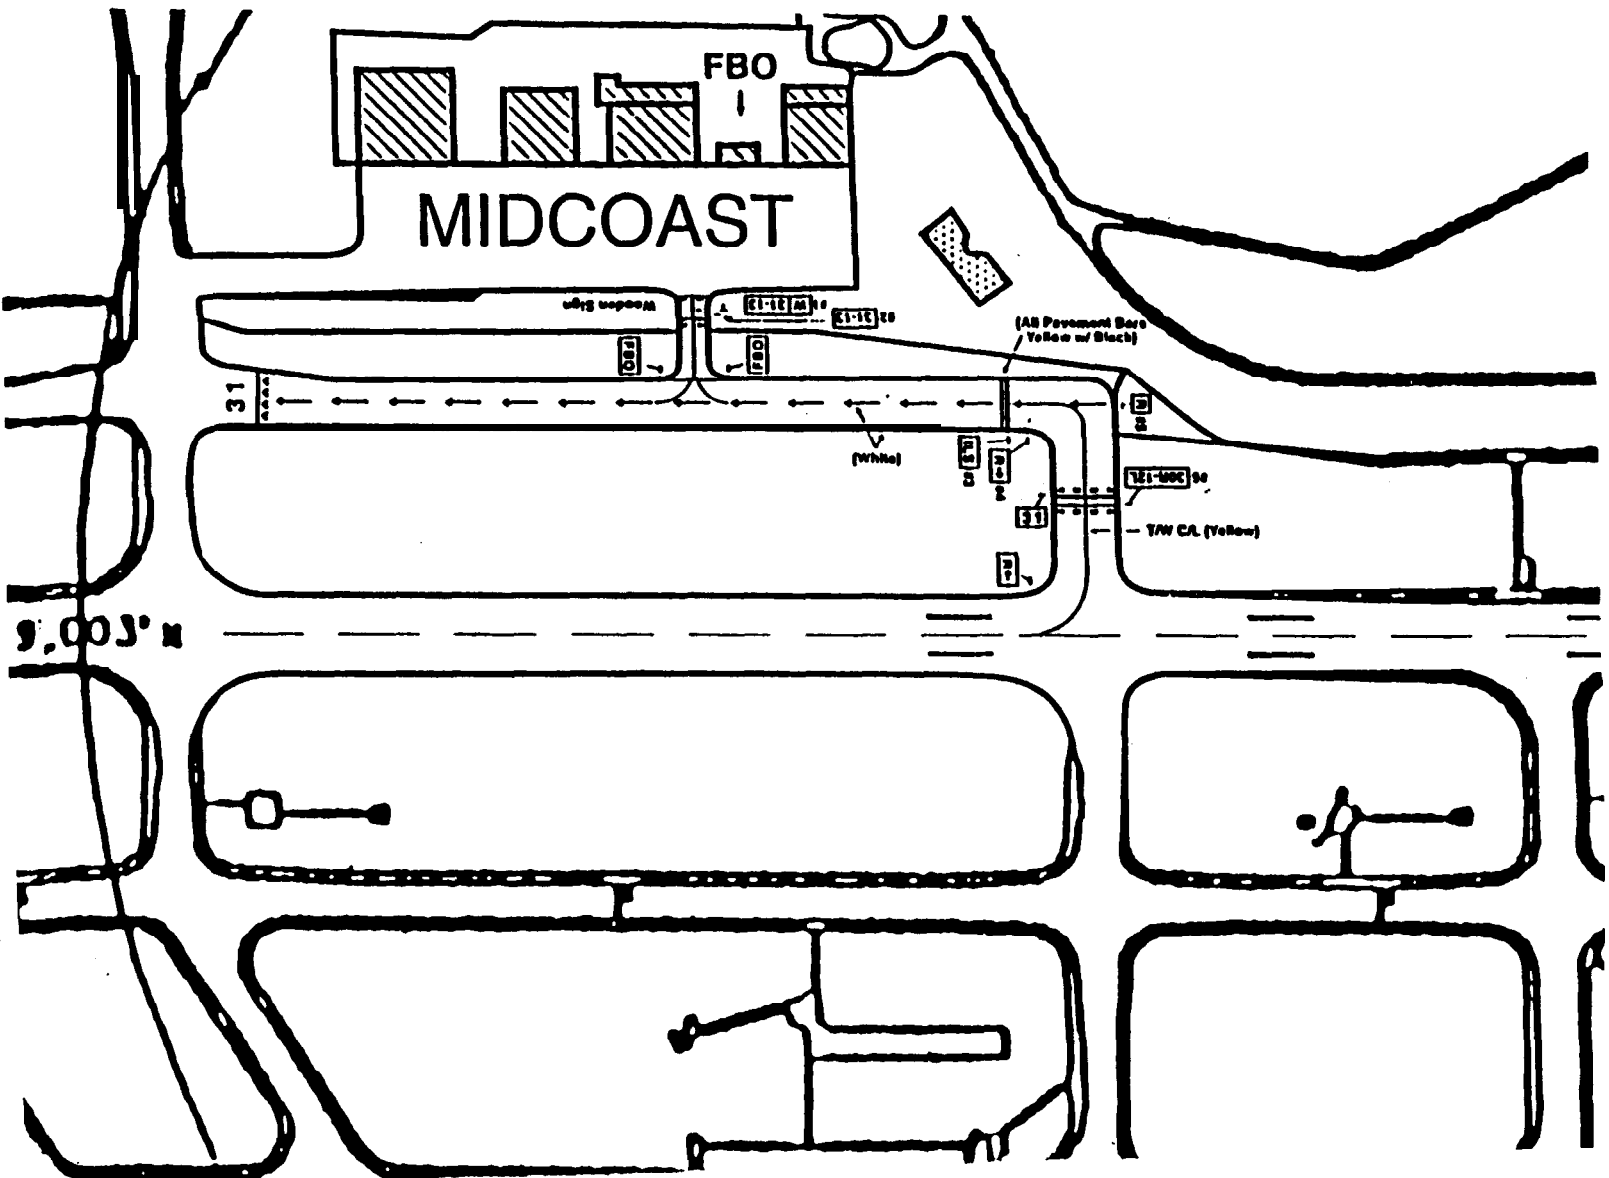
Figure 3--Airfield Signs Near and Along Midcoast Ramp and Taxiways Whiskey and Romeo

The Safety Board's examination of the airfield signs, markings, and lighting near and along the taxi route taken by the Cessna 441 revealed that they conformed to FAA standards. The Safety Board noted that upon exiting the **Midcoast** ramp area, there were **three** signs indicating runway 3 1 on the left side of the entrance to **taxiway** Whiskey. The furthest sign on the left side of the **taxiway** was installed in compliance with the FAA's revised (July 31, 1991) **signage** requirements, but was not yet in full service and was not lit. Behind this sign and slightly to its left was the in-service hold position sign. To the right of the two hold position signs was a wooden sign that read "ACTIVE RUNWAY CONTACT TOWER 121.9." (See Figure 3.)

Airport personnel told Safety Board investigators that the hold position signs for runway 13/3 1 were observed to be not internally illuminated during the hours following the accident: one sign had an inoperative light bulb, and one sign hadn't been hooked up to power. To simulate the **signage** conditions that the pilot of the Cessna 441 may have encountered the night of the accident, the Safety Board observed the signs at night, without internal illumination. Investigators noted that the three signs were clearly visible in the ambient light from the **Midcoast** ramp flood lights.

Investigators also noted that all **taxiway** markings, hold position markings, and displaced threshold markings for runway 3 1 were visible as they traveled from the **Midcoast** ramp to runway 3 OR, via **taxiway** Romeo. The yellow hold position markings on **taxiways** Whiskey and Romeo were highlighted in black to enhance the visibility of the markings. The runway 12L/30R hold position sign at **taxiway** Romeo had one inoperative light bulb on the right side of the sign. Investigators noted that the sign was clearly visible.'

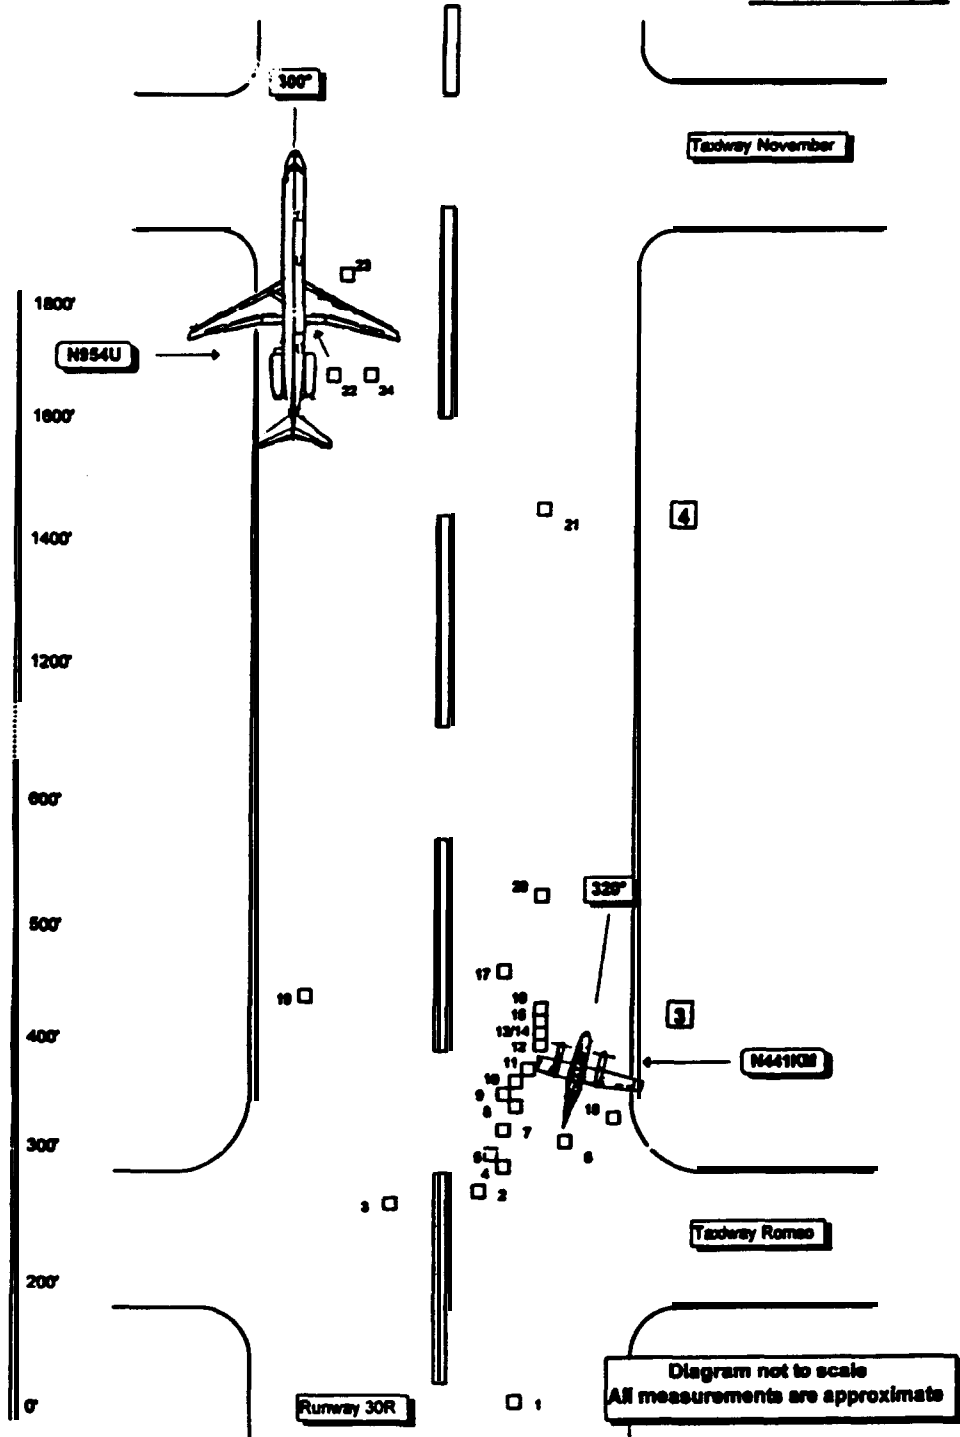
Figure 4--Wreckage Diagram

23. [N441KM] Left outboard wing section (fractured 7.5 feet outboard of the number one engine nacelle) found wrapped around right main gear of N954U
24. [N441KM] Wreckage from N441KM in N954U right wing leading edge
