MARINE ACCIDENT REPORT

**SS EDMUND FITZGERALD
SINKING IN LAKE SUPERIOR**

NOVEMBER 10, 1975

REPORT NUMBER: NTSB-MAR-78-3

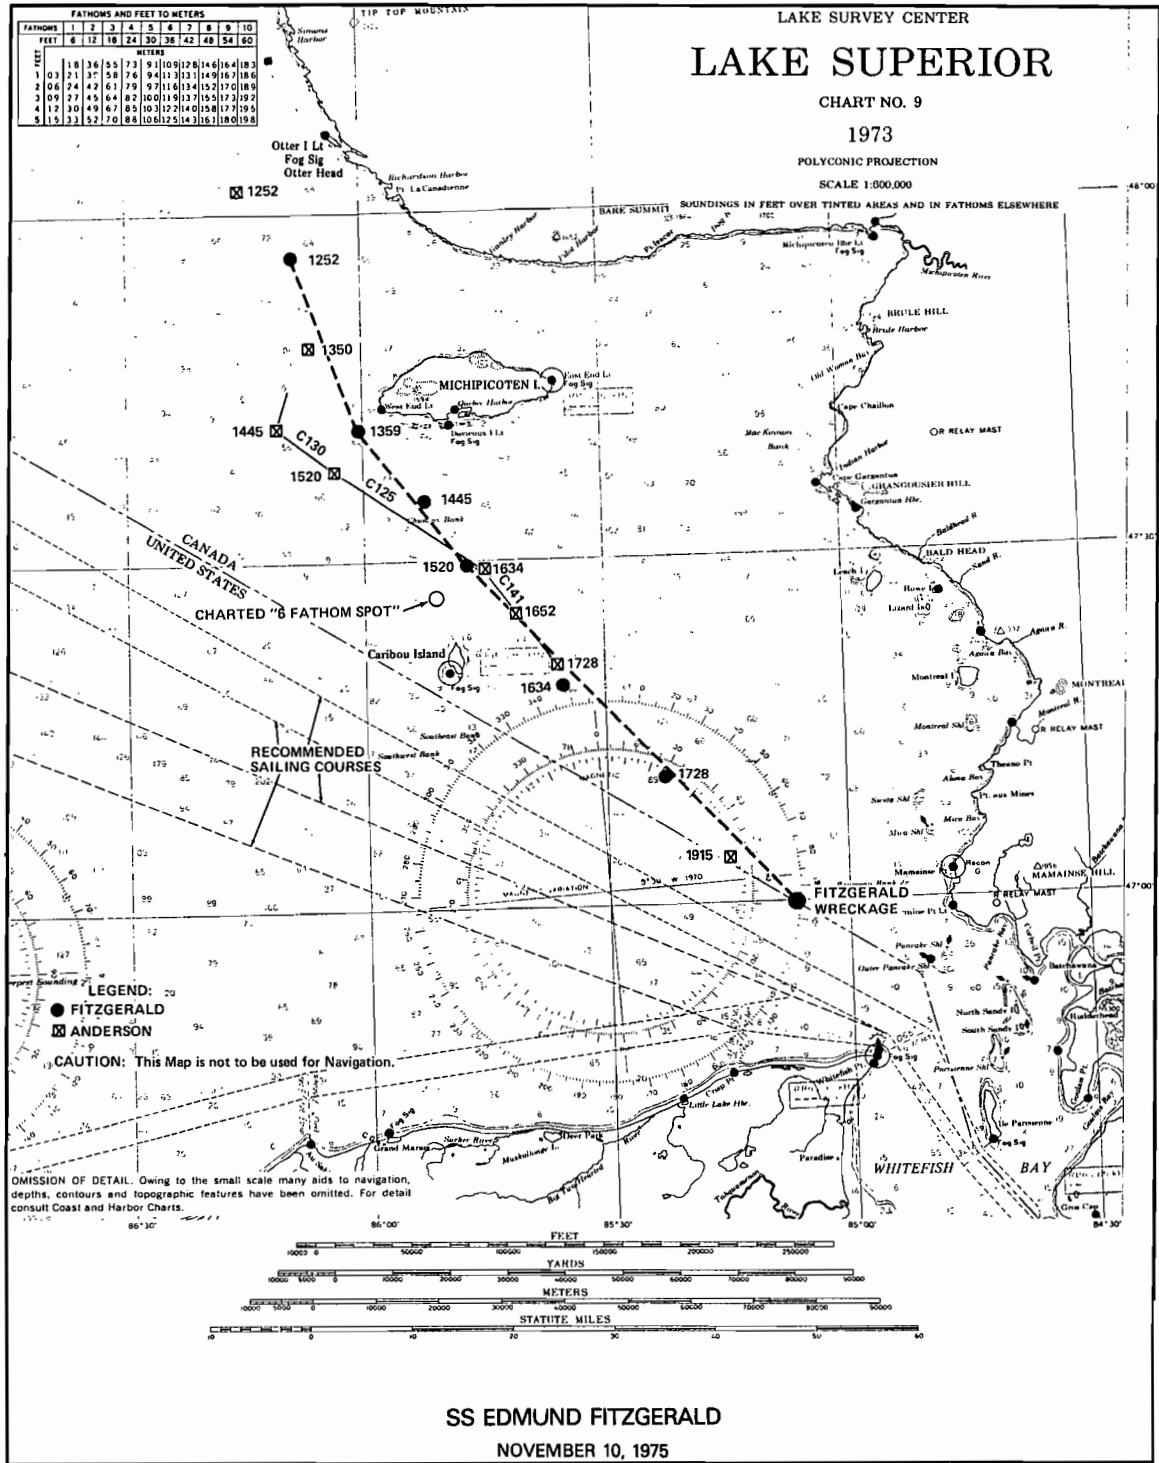
Figure 1. Probable tracklines of SS EDMUND FITZGERALD and SS ARTHUR M. ANDERSON on November 10, 1975.

Based on radar data observed by the ANDERSON, the FITZGERALD's position at 1350 (1359), 1445, 1520, 1652 (1634), 1701 (1728), and 1915 correlate with the 141° T course reported by the FITZGERALD and the Safety Board's calculated speeds. (See figure 1.)

The trackline of the FITZGERALD lies 2.75 miles east of Chummy Bank and 2.5 miles east of the 10-fathom curve outlining the shoal area north of Caribou Island known as North Bank. Some testimony placed the FITZGERALD closer to North Bank; however, the course of 141° T from West End Light to Whitefish Bay is well known to Great Lakes navigators and this was the intended track of both the ANDERSON and the FITZGERALD. The ANDERSON was navigated to return to this trackline at 1634 for the final leg of her voyage. At this time the FITZGERALD was observed to be almost dead ahead of the ANDERSON when her heading was 142° T.

10. The most probable trackline of the FITZGERALD, from west of Michipicoten Island to the position of her wreckage, lies east of the shoal areas north and east of Caribou Island; therefore, damage from grounding would have been unlikely.

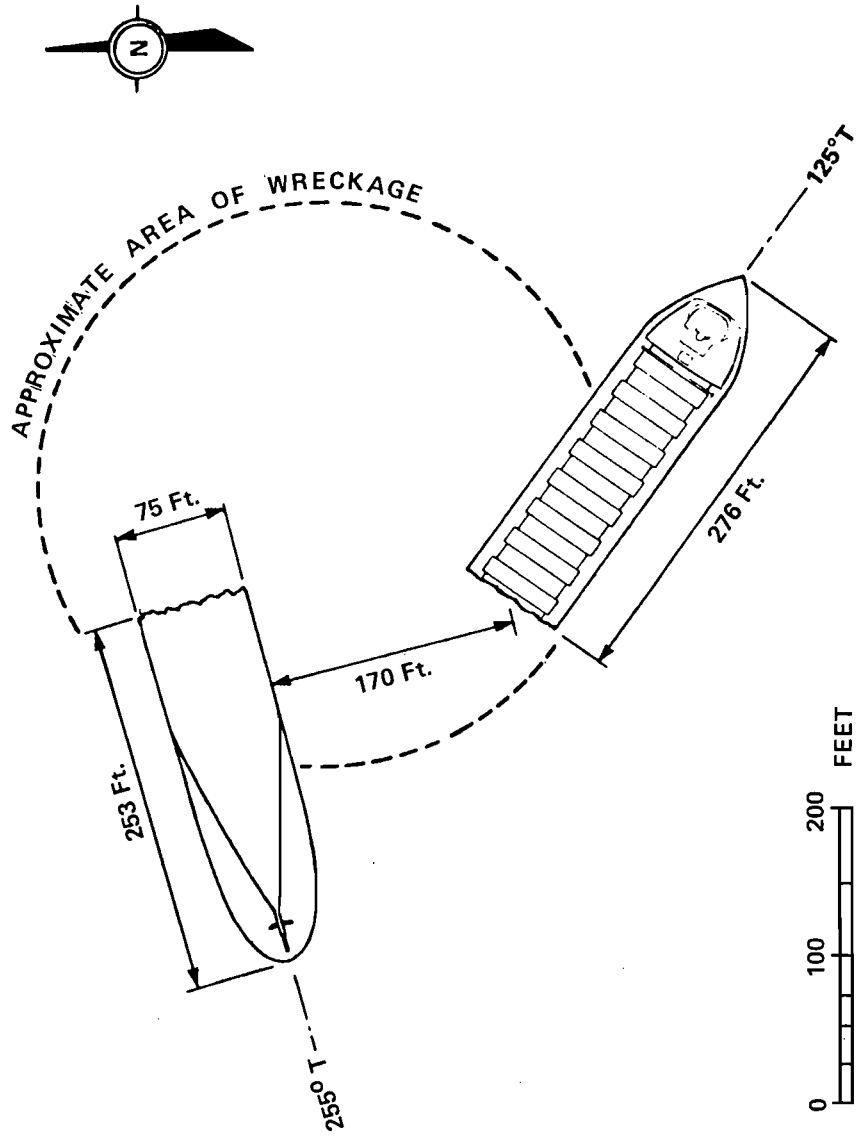
Figure 3. Sketch of relative positions of bow and stern section.

The wreckage lies approximately 17 miles northwest of Whitefish Point, Michigan. The wreckage consists of an upright bow section, an inverted stern section, and debris from a missing 200-foot midship portion. The bow section is 276 feet long, inclined 15° to port from the upright, extends from the stem to a location between hatches Nos. 8 and 9, and is buried in mud up to the 28-foot draft mark.

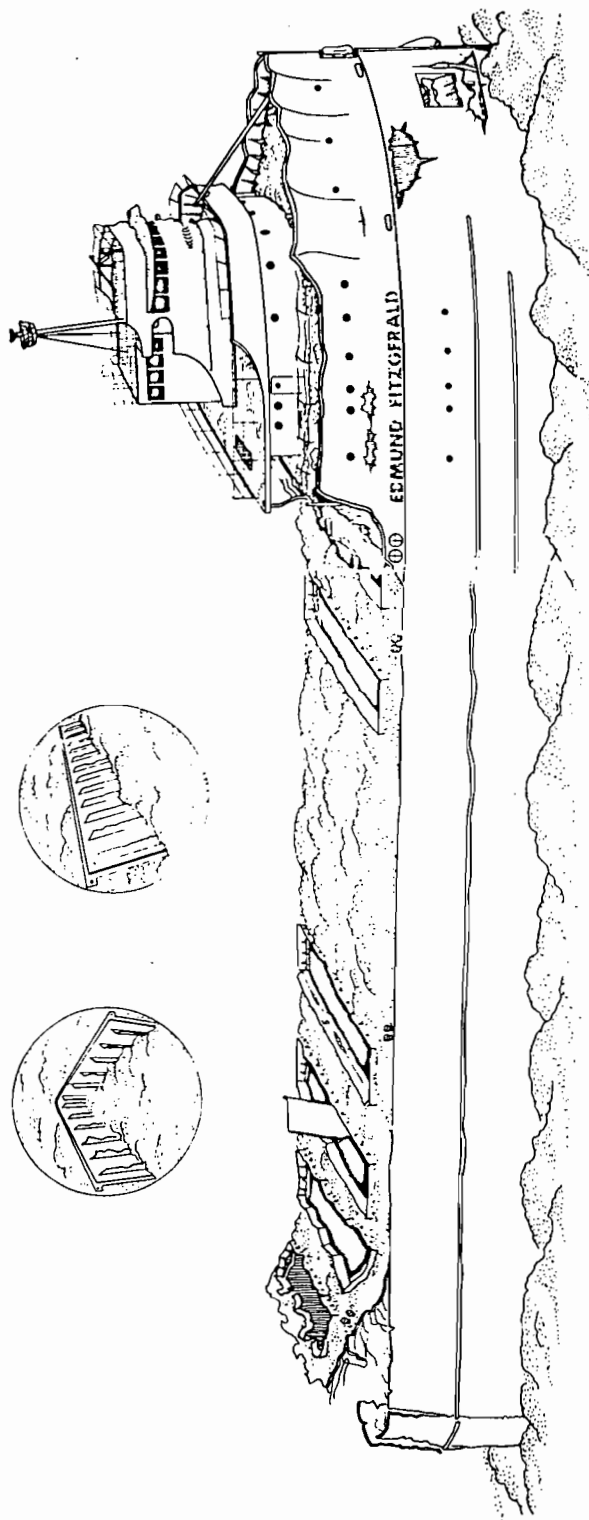
Figure 4. Sketch of bow section from starboard.

There was extensive damage to the forward deckhouse and there were several holes in the bow shell plating. The rest of the shell plating extending back to the rupture was intact. The No. 1 hatch cover was entirely inside the No. 1 hatch and showed indications of buckling from external loading. Sections of the coaming in way of the No. 1 hatch were fractured and buckled inward. The No. 2 hatch cover was missing and the coaming on the No. 2 hatch was fractured and buckled. Hatches Nos. 3 and 4 were covered with mud; however, one corner of hatch cover No. 3 could be seen in place. Hatch cover No. 5 was missing. A series of 16 consecutive hatch cover clamps were observed on the No. 5 hatch coaming. Of this series, the first and eighth were distorted or broken. All of the 14 other clamps were undamaged and in the open position. The No. 6 hatch was open and a hatch cover was standing on end vertically in the hatch. The hatch covers were missing from hatches Nos. 7 and 8 and both coamings were fractured and severely distorted. The bow section abruptly ended just aft of hatch No. 8 and the deck plating was ripped up from the separation to the forward end of hatch No. 7.

A few of the deck vents on the starboard side of the bow section could be seen above the mud. One vent near hatch No. 5 was torn away from the deck, leaving an opening in the deck at the base of the vent pipe. The vents on the port side of the bow section were covered with mud. Neither the spare propeller blade nor the hatch cover crane was visible and they have not been located.

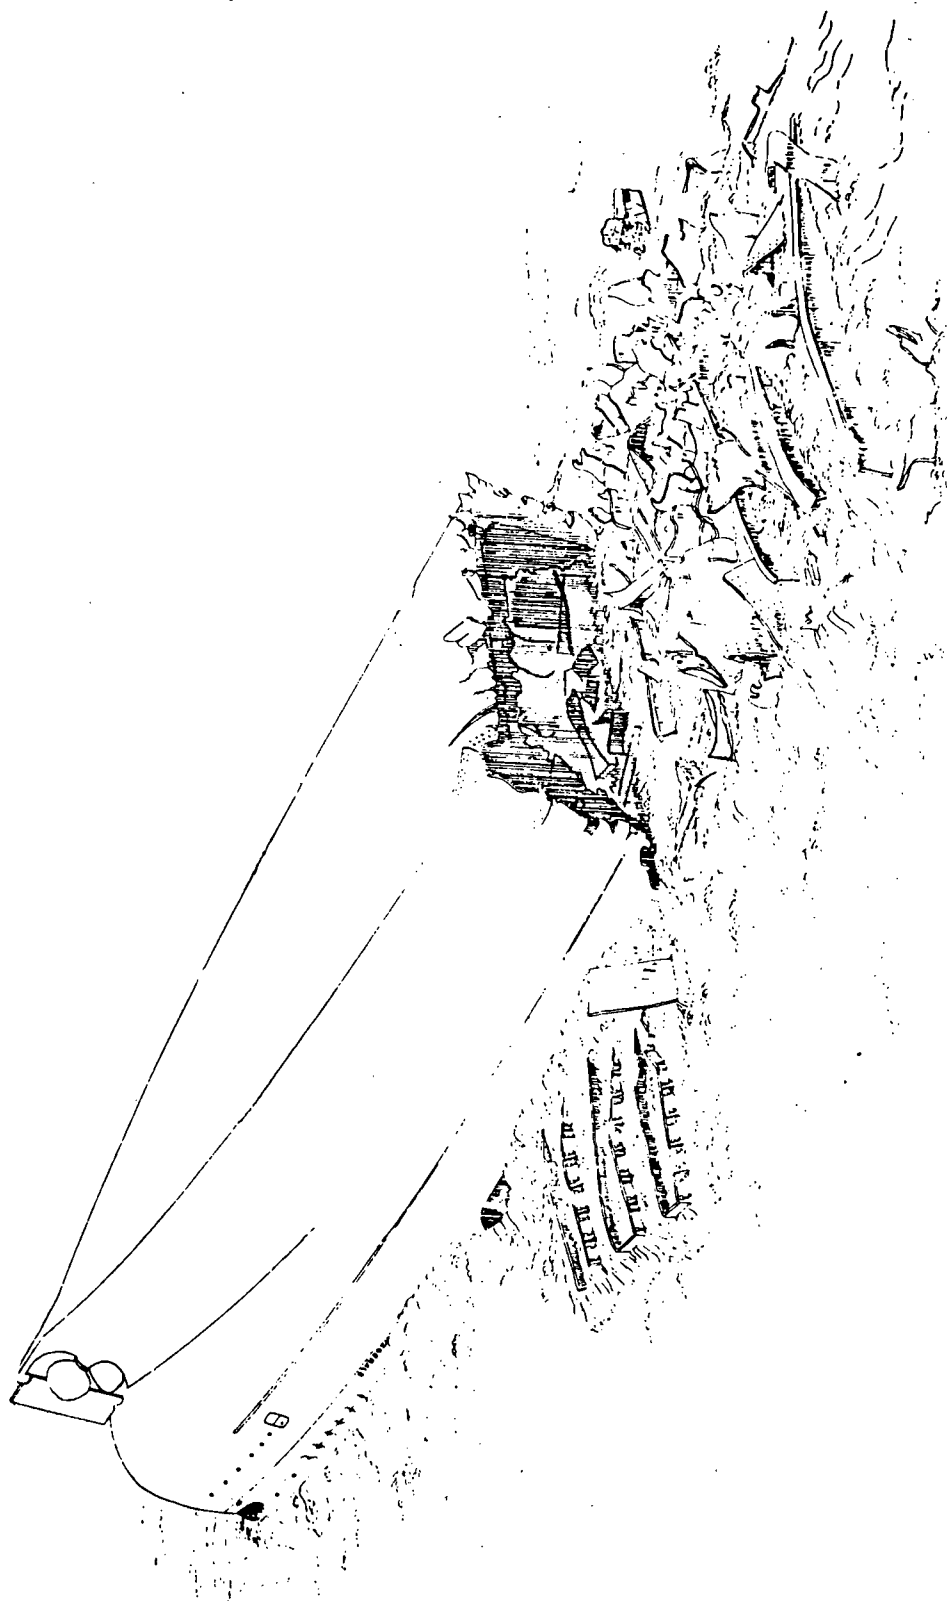
Figure 7. Sketch of stern section from ahead.

There was mud-covered wreckage extending out from the ruptured end of the stern section, but no identification of what part of the ship it came from can be determined. Three hatch coamings and a hatch cover were lying next to the stern section. One of the hatch coamings bore the numeral 11.

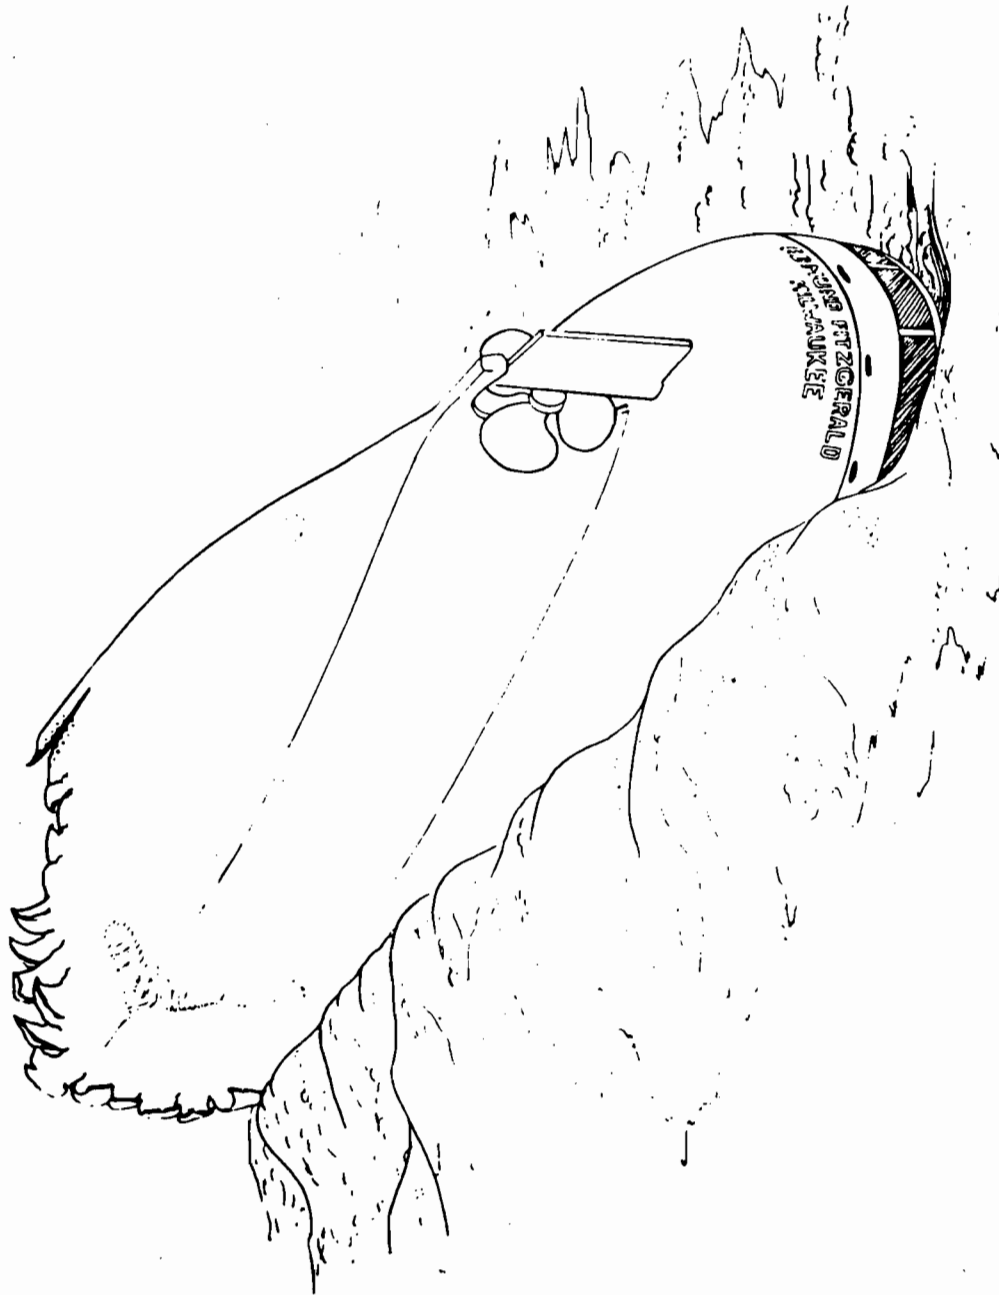
Figure 8. Sketch of stern section from astern.

No gouges, scraps, fractures, indentations, or other indications of grounding were visible on the exposed bottom plating on the after section of the wreckage. These observations were made during a close examination of the exposed bottom plating by underwater television from the CURV III. Damage to the bottom plating of a vessel from grounding on boulders in the rocky shoal north of Caribou Island during the severe sea conditions would probably have extended into the bottom plating of the stern section.
