NATIONAL TRANSPORTATION SAFETY BOARD

MARINE ACCIDENT REPORT

**GROUNDING OF
THE U.S. TANKSHIP EXXON VALDEZ
ON BLIGH REEF, PRINCE WILLIAM SOUND
NEAR VALDEZ, ALASKA
MARCH 24, 1989**

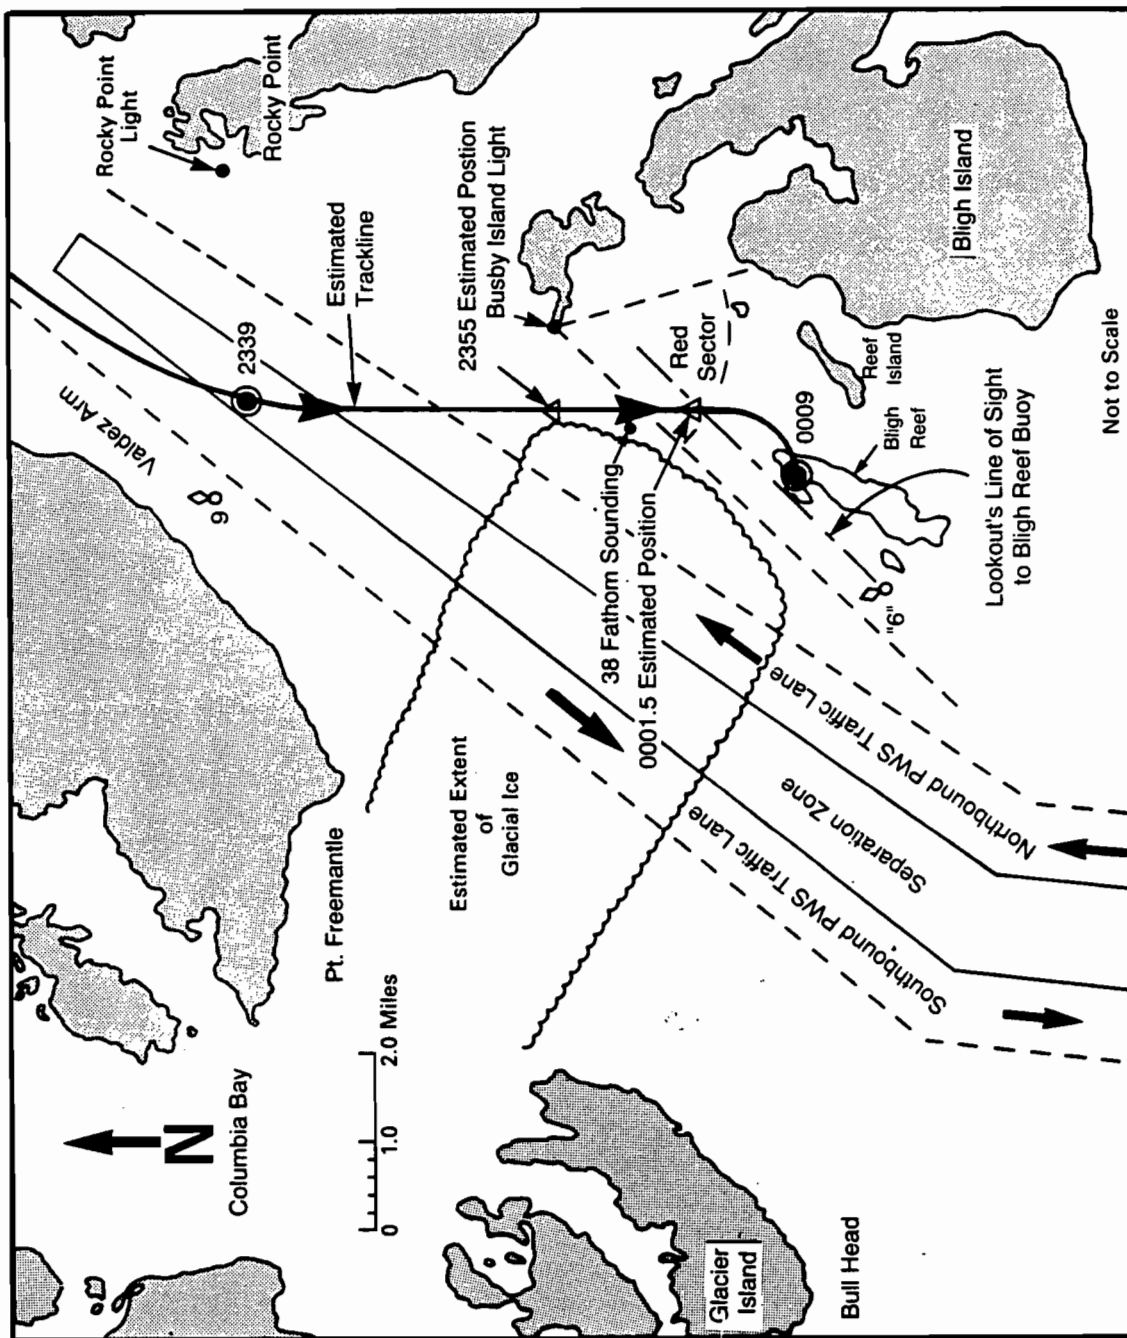
Figure 3.--Trackline of EXXON VALDEZ.

Light and Buoy No. 9 and a radar range to the land adjacent to Buoy No. 9. The third mate stated that the vessel was turning while he was taking the bearings. When plotted, his fix showed that the vessel's 2339 position was in the middle of the separation zone and approximately 2 miles west of Rocky Point Light. By about 2343, according to the course recorder, the vessel was steady on a course of 180°.

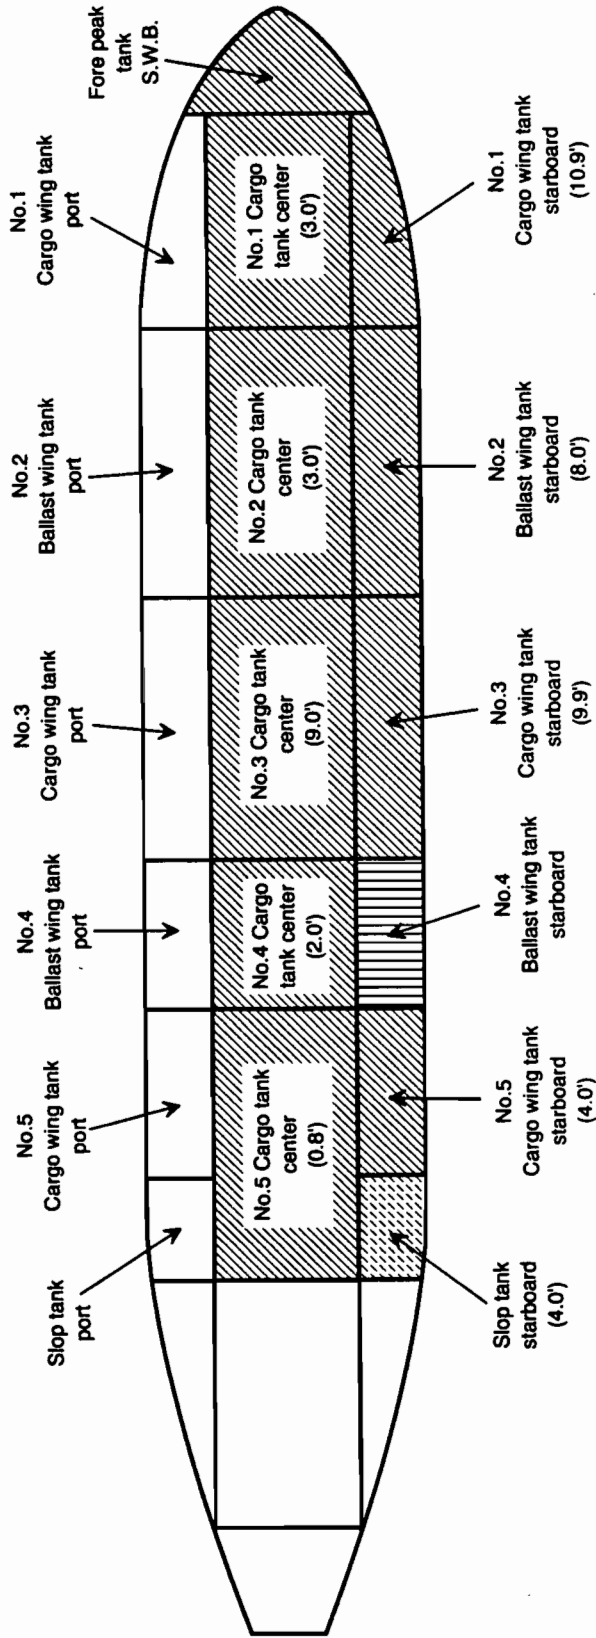
Figure 8.--Plan view showing damaged tanks.

An inspection of the vessel in drydock at the National Steel and Shipbuilding Company shipyard in San Diego was conducted on August 29, 30, and 31 and September 1, 1989. The inspection revealed that the forepeak tank was severely holed and that center cargo tanks Nos. 1, 2, 3, and 4 were ripped open over almost their entire lengths. Although holed, center cargo tank No. 5 sustained the least damage. Starboard cargo tanks Nos. 1, 3, and 5 also were severely holed, as was starboard ballast tank No. 2. Starboard ballast tank No. 4 sustained minor damage, resulting in a small opening at

the bottom of the forward bulkhead near the turn of the bilge caused by a separation of the bulkhead from the bottom plating. The void (double bottom) below the starboard slop tank was also ripped open. (See figure 8.)

The Safety Board found that the maximum vertical damage was 10.9 feet above the bottom of the vessel at two locations in the after half of starboard cargo tank No. 1. The most forward of the two locations was between frames Nos. 10 and 11, where a large boulder had lodged in the ship's hull structure, causing a longitudinal to break loose at frame No. 11 and curve upward to a height of 10.9 feet. The highest point of the boulder was about 8 feet. Upward bending and breaking of longitudinals near the after end of the tank between frames Nos. 12 and 13 resulted in the second 10.9 feet of vertical damage. In starboard ballast tank No. 2, frames Nos. 15 and 17 near the middle of the tank sustained deformation up to about 15 feet. There were two locations in the forward part of starboard cargo tank No. 3, between frames Nos. 23 and 24 and Nos. 24 and 25, where the vertical damage reached 9.9 feet. The maximum vertical damage in center cargo tank No. 3 was 9 feet in the forward part of the tank between frames Nos. 23 and 24 and Nos. 24 and 25. The vertical damage in the other cargo tanks ranged from less than 1 foot to 8 feet in a few locations.

The center vertical keel had broken loose from the after bulkhead of center cargo tank No. 2 from the tank bottom to a height of about 9 feet, and a small crack in the weld extended to a height of about 11 feet. On the other side of this bulkhead, which was the forward bulkhead of center cargo tank No. 3, the center vertical keel had broken loose from the bulkhead from the tank bottom to a height of about 9 feet.

There was no damage to the port tanks and except for the after part of the void under the starboard slop tank, which is outboard of the pumproom, all damage occurred forward of the pumproom.

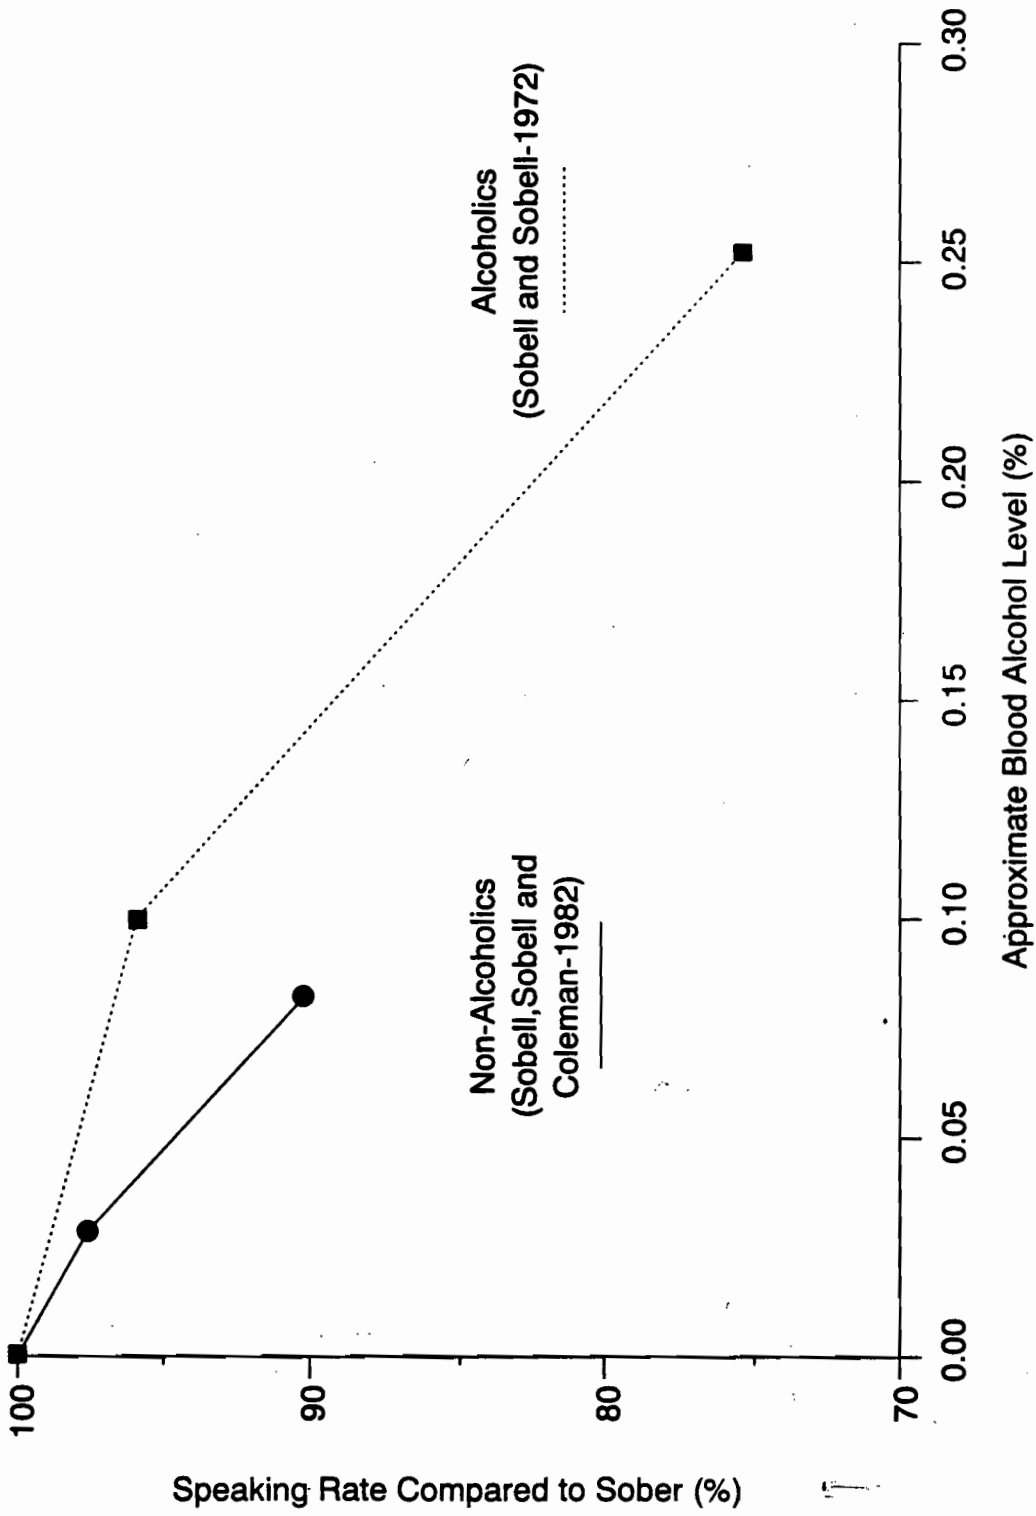
Figure 14.--Speaking rate changes with blood alcohol level.

speech 9 hours after the accident and that it was significantly slower than his speech 33 hours before the accident.

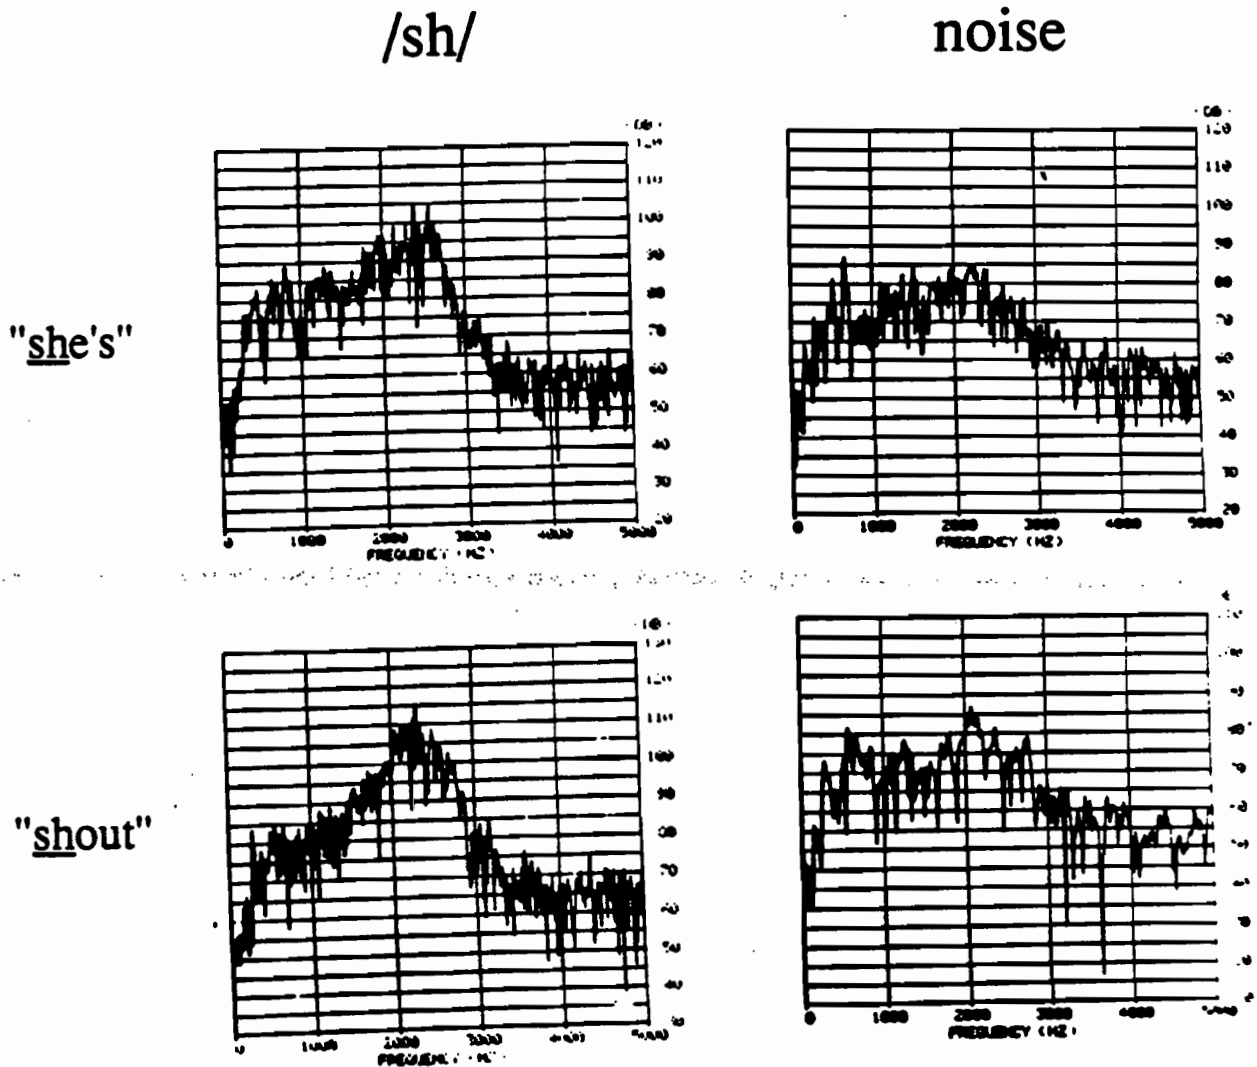
Figure 2. Power spectra of /sh/ produced by Captain Hazelwood in the words *she's* and *shout* recorded 33 hours before the accident. Each spectrum is paired with a spectrum of the background noise from a nearby open-mike pause.

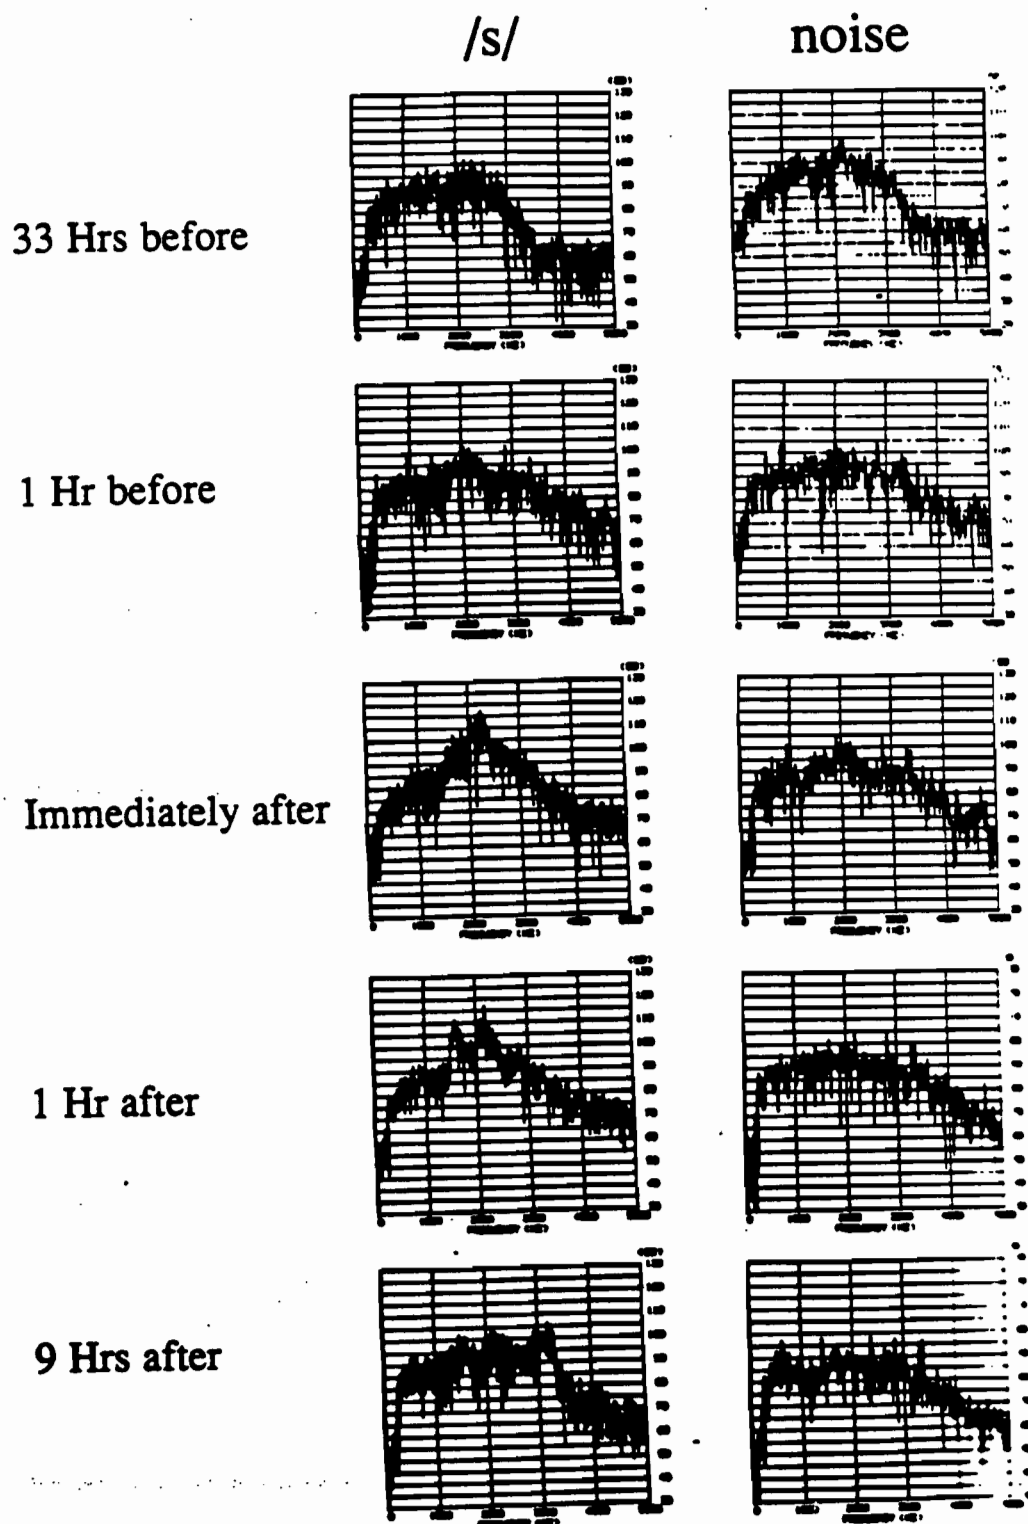
Figure 3. Power spectra of /s/ paired with spectra of nearby open-mike pauses from each of the NTSB recordings.

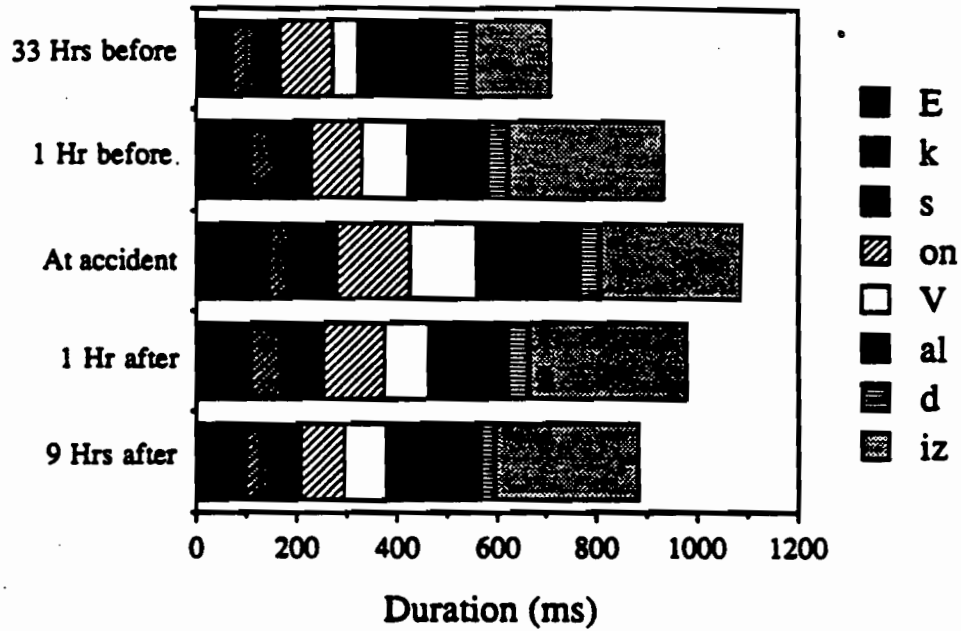
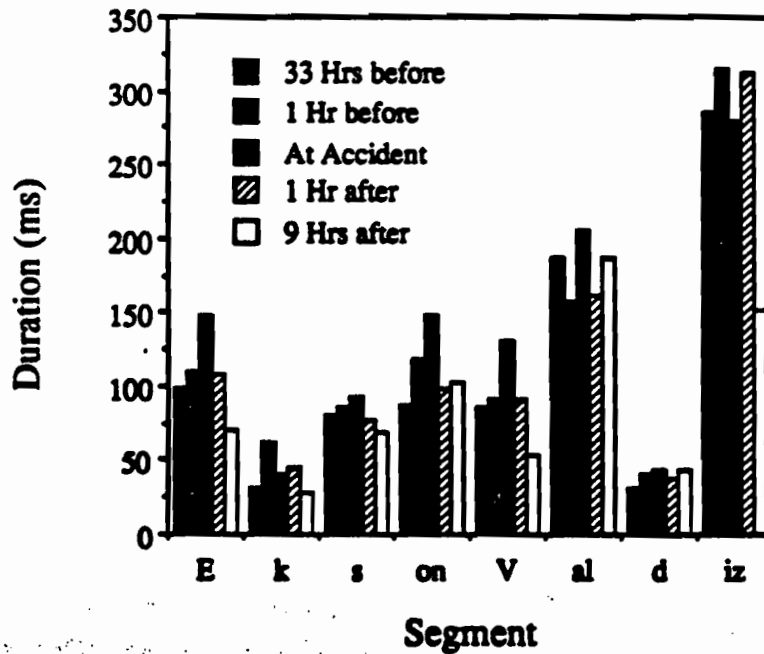
Segment Durations of "Exxon Valdez"

Durational changes are perhaps the most reliable effects we have found in the NTSB recordings and they suggest that Captain Hazelwood was speaking more slowly than normal around the time of the accident. These changes in duration are consistent with the laboratory

Figure 4. Durations of speech segments in the phrase, Exxon Valdez at the different times of recording. Top panel: cumulative durations indicating the overall increase in duration. Bottom panel: durations grouped by segments showing which segments had increased duration around the time of the accident.

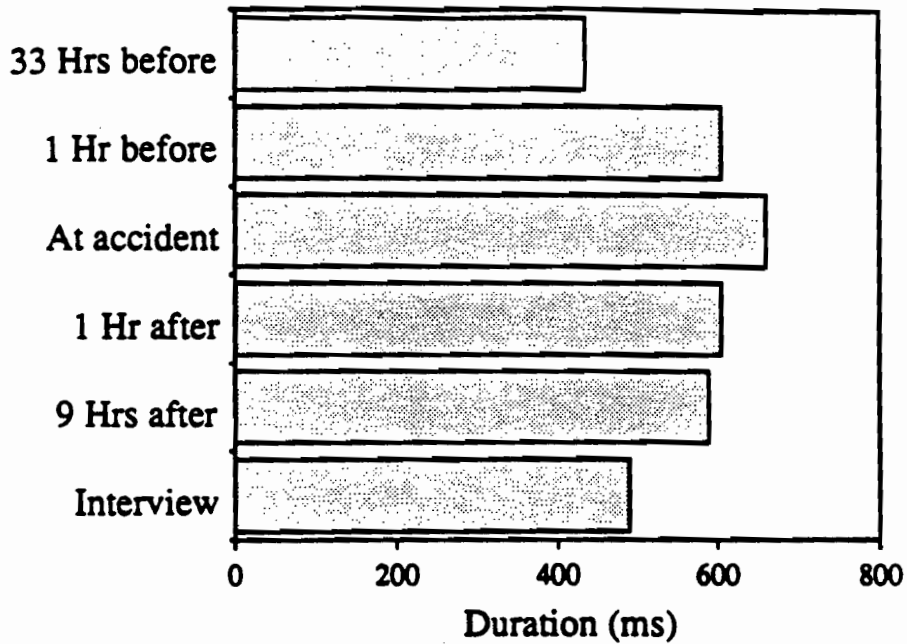
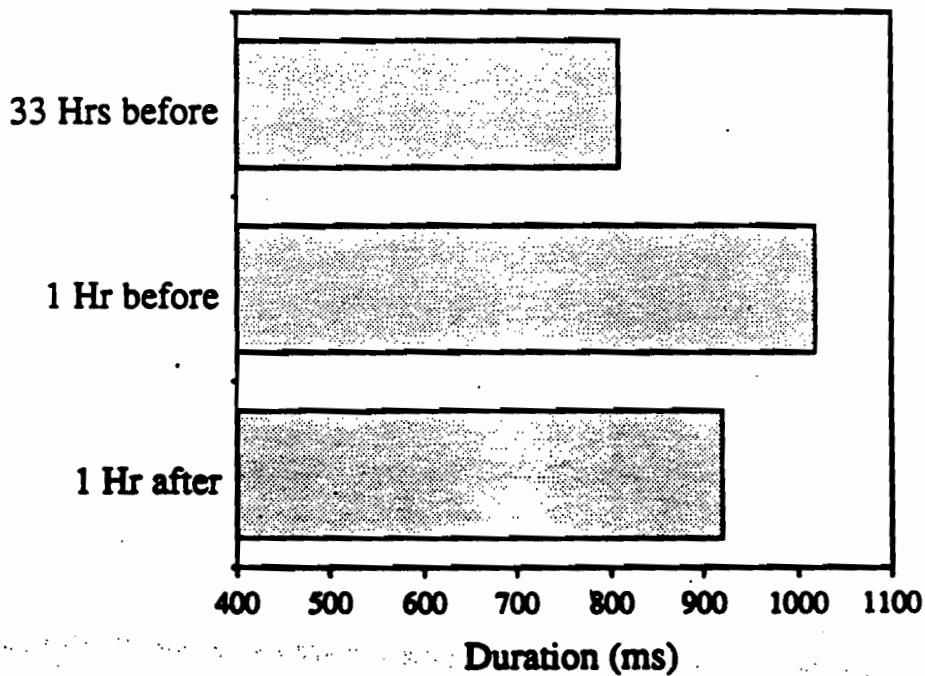
Figure 5. Top panel: Duration of the word *Valdez* from the NTSB tapes (data is the same as that in Figure 4) compared with the same word produced in a similar discourse position in the televised interview. Bottom panel: Duration of the phrase *thirteen and sixteen* from recordings made at three times around the time of the accident.

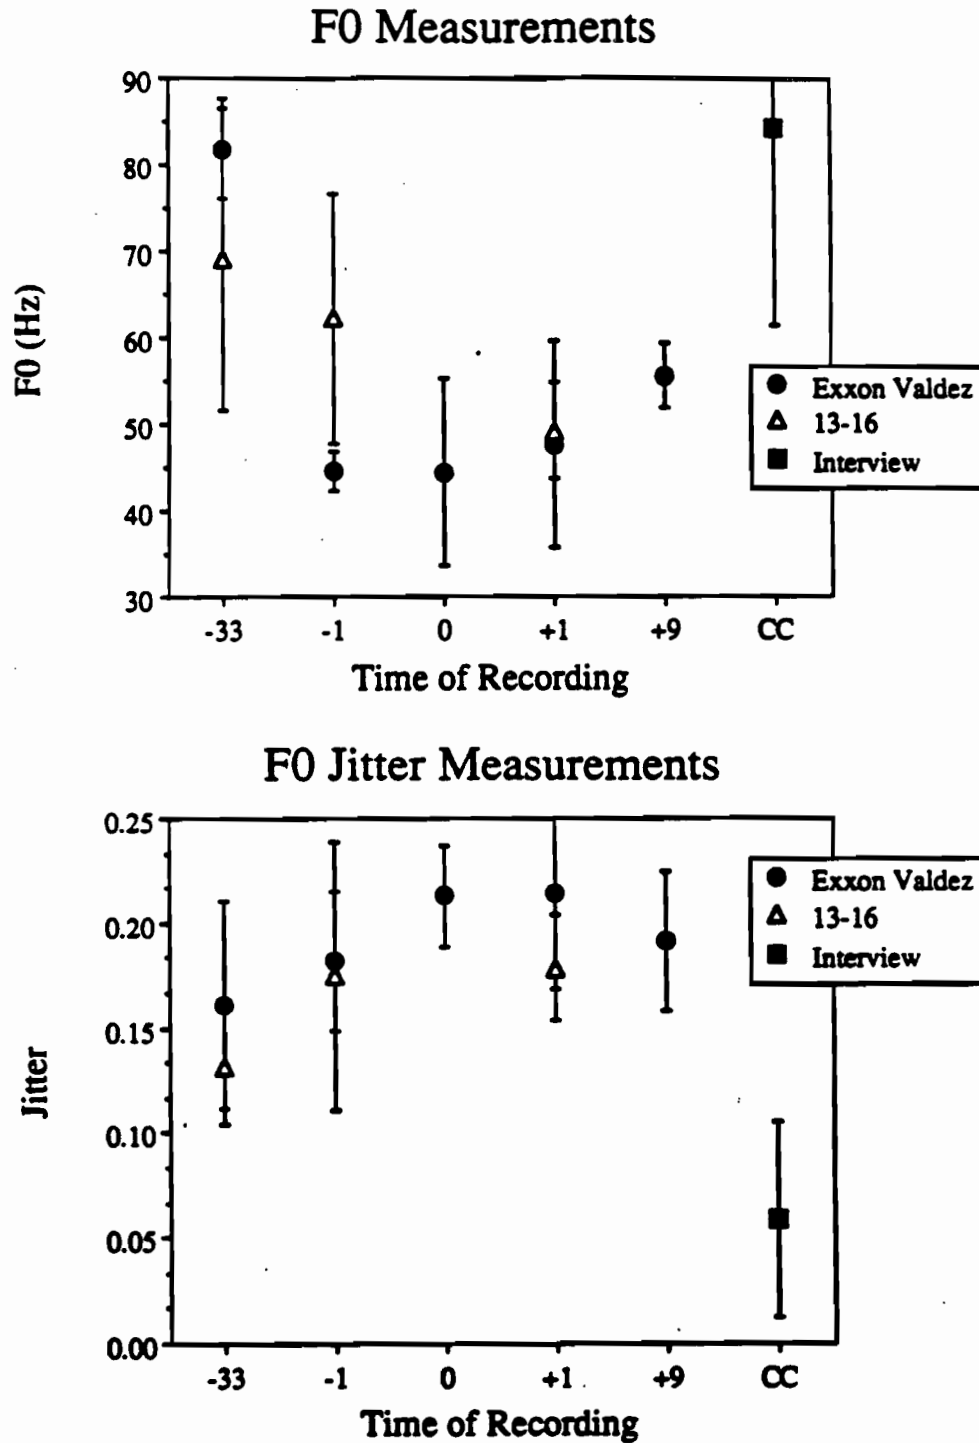
Figure 6. Top panel: Average fundamental frequency (pitch of voice) in *Exxon Valdez*, thirteen and sixteen and from one sentence in the televised interview as a function of time of recording. Bottom panel: F0 jitter measurements from the same speech samples.
