NATIONAL TRANSPORTATION SAFETY BOARD

MARINE ACCIDENT REPORT

GROUNDING OF THE UNITED KINGDOM
PASSENGER VESSEL RMS QUEEN ELIZABETH 2
NEAR CUTTYHUNK ISLAND
VINEYARD SOUND, MASSACHUSETTS
AUGUST 7, 1992

ADOPTED: MAY 25, 1993

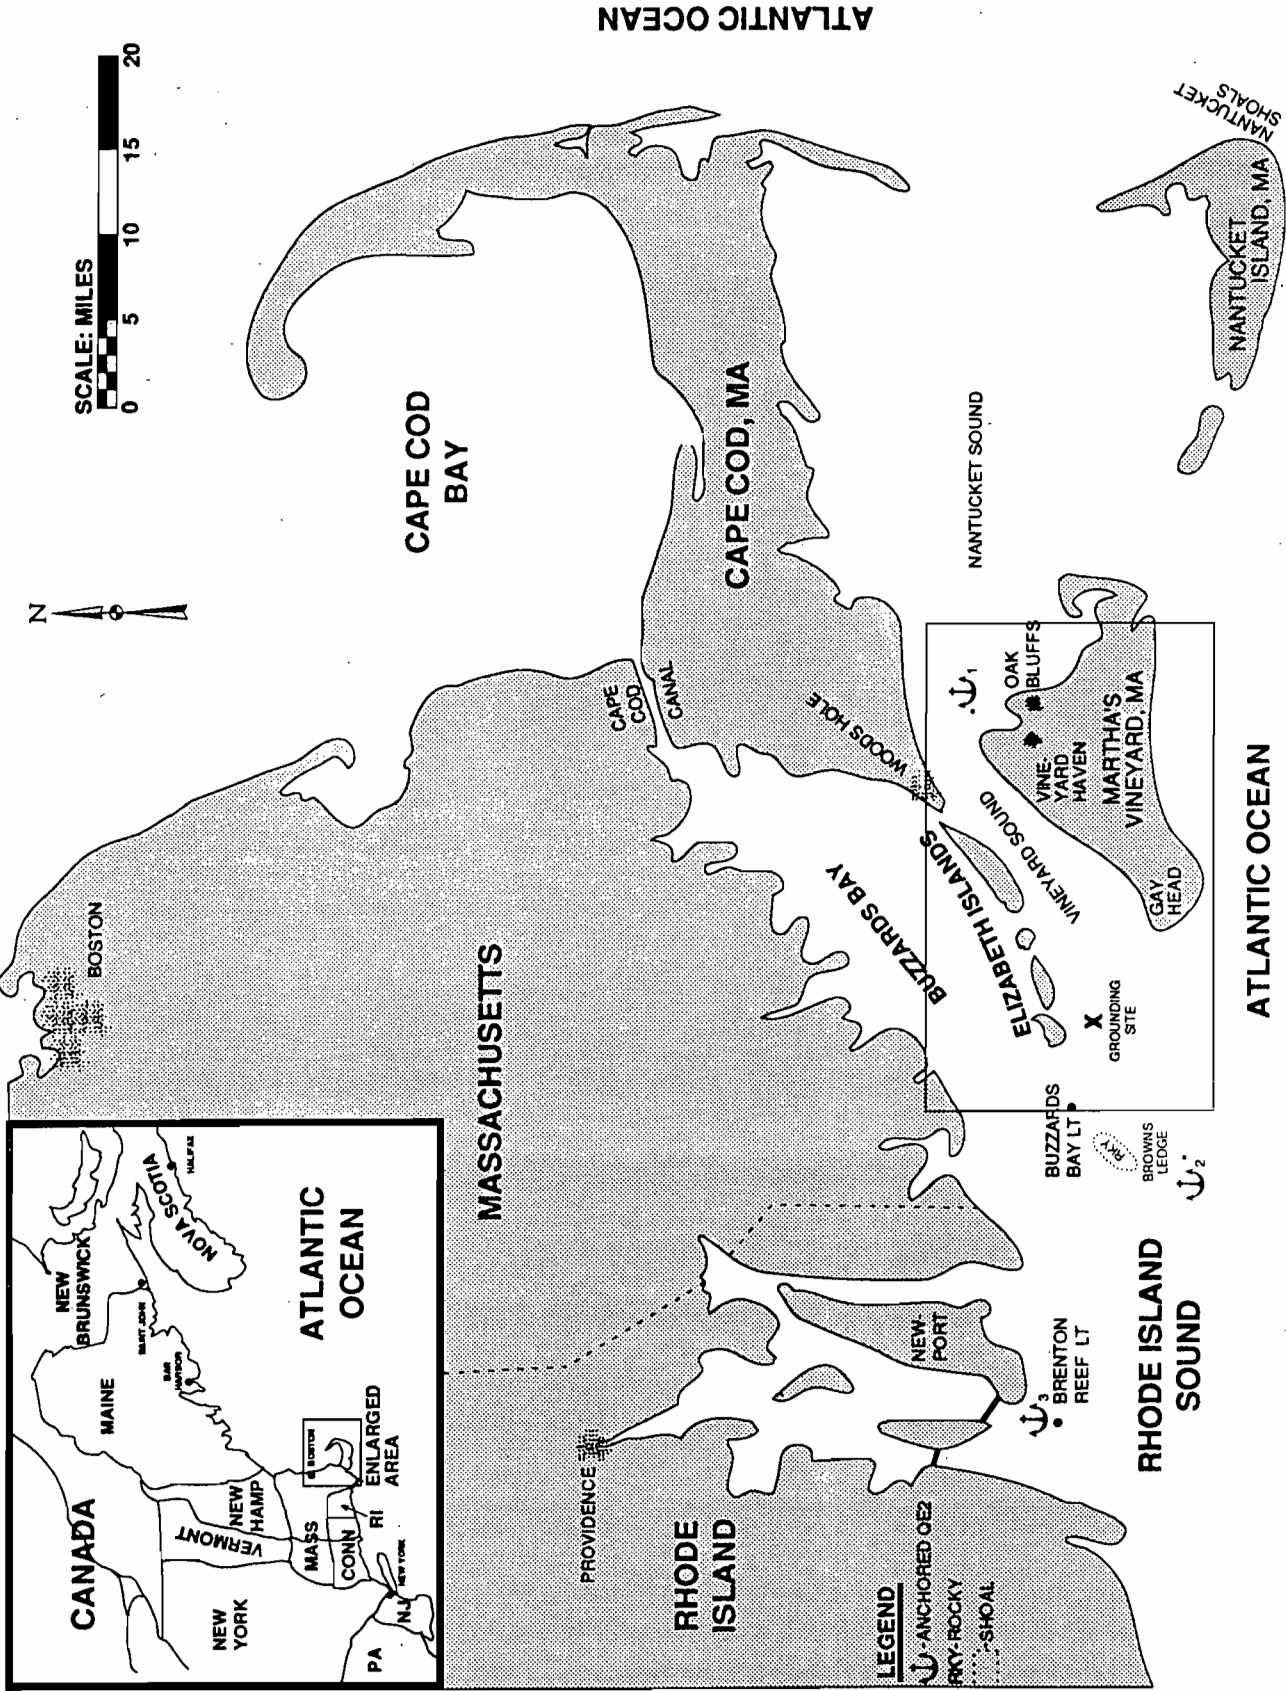
Figure 2.--Accident site.

On August 7, 1992, at 2158, the 963-foot-long United Kingdom (U.K.) passenger vessel RMS QUEEN ELIZABETH 2 (QE2) grounded on a rocky shoal south of Cuttyhunk Island, Massachusetts. The vessel, which was carrying 1,824 passengers and 1,003 crewmembers, was leaving Vineyard Sound, off the northwest coast of the island of Martha's Vineyard (The Vineyard). (See figures 1 through 3.)

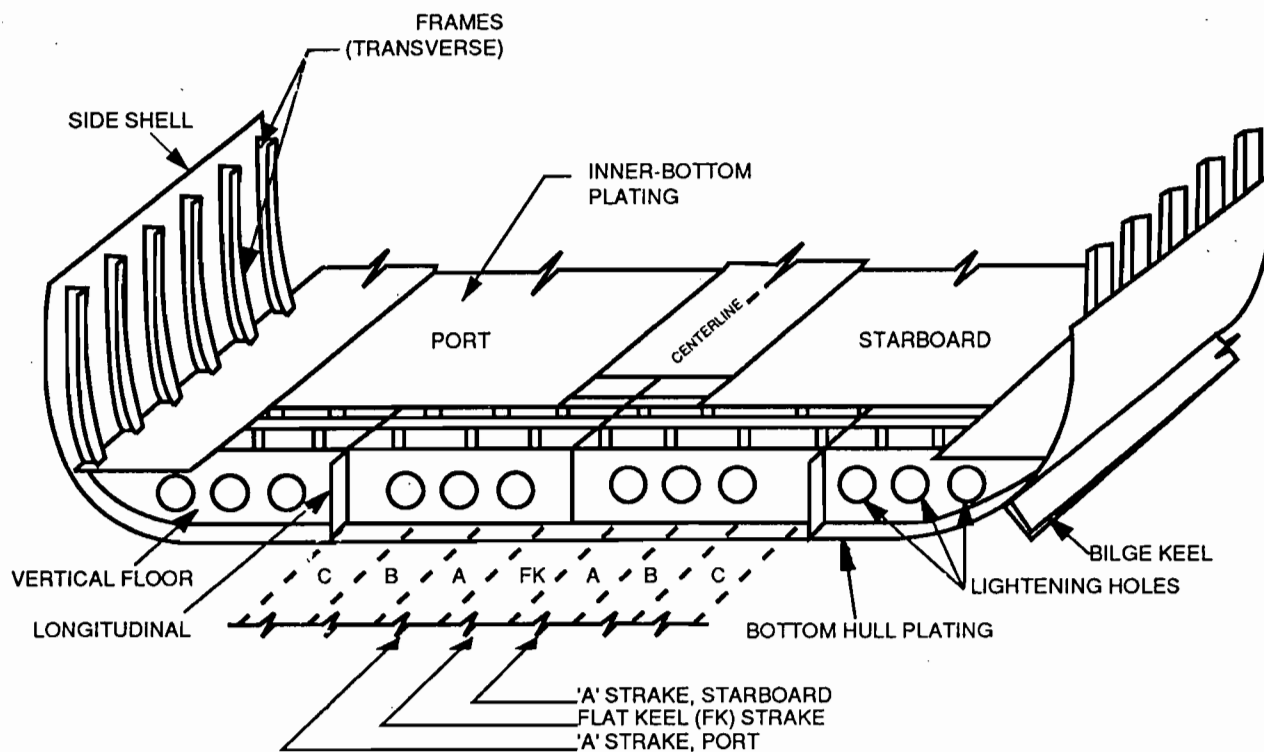
Figure 4.--Typical double-bottom arrangement.

After the disembarkation of passengers following the grounding, the QE2 moved into drydock at General Ship Repair in Boston. While the ship was in drydock, Safety Board investigators conducted a damage survey on August 14, 1992, to ascertain the condition and extent of damage to the underwater hull plating, the internal structural steel in the double-bottom and deep tanks,¹⁴ the tanktops of the double bottom, and the deep tanks. (See figure 4 for a typical double-bottom tank arrangement.)

Overall, the damage consisted of indents (dented plating pushed upward into the double-bottom space), gouges, and associated fractures in the bottom-hull plating. The damaged area extended from the bulbous bow aft to the forward diesel generator engine room, a length of about 400 feet. The width of the damage area was 81 feet, which extended from the bilge keel on the port side to the "D" strake¹⁵ longitudinal row of shell plating on the starboard side. The indents, gouges, and fractures were located in and to both sides of the centerline flat-keel plate. Twenty inner-bottom tanks and two void spaces sustained damage of varying degrees in the grounding. Most of the damaged tanks were water ballast tanks, except double-bottom fuel oil tanks Nos. 8, 9, and 10; of the three double-bottom tanks, only No. 10, an empty fuel oil tank, released oil residue at the time of the accident.

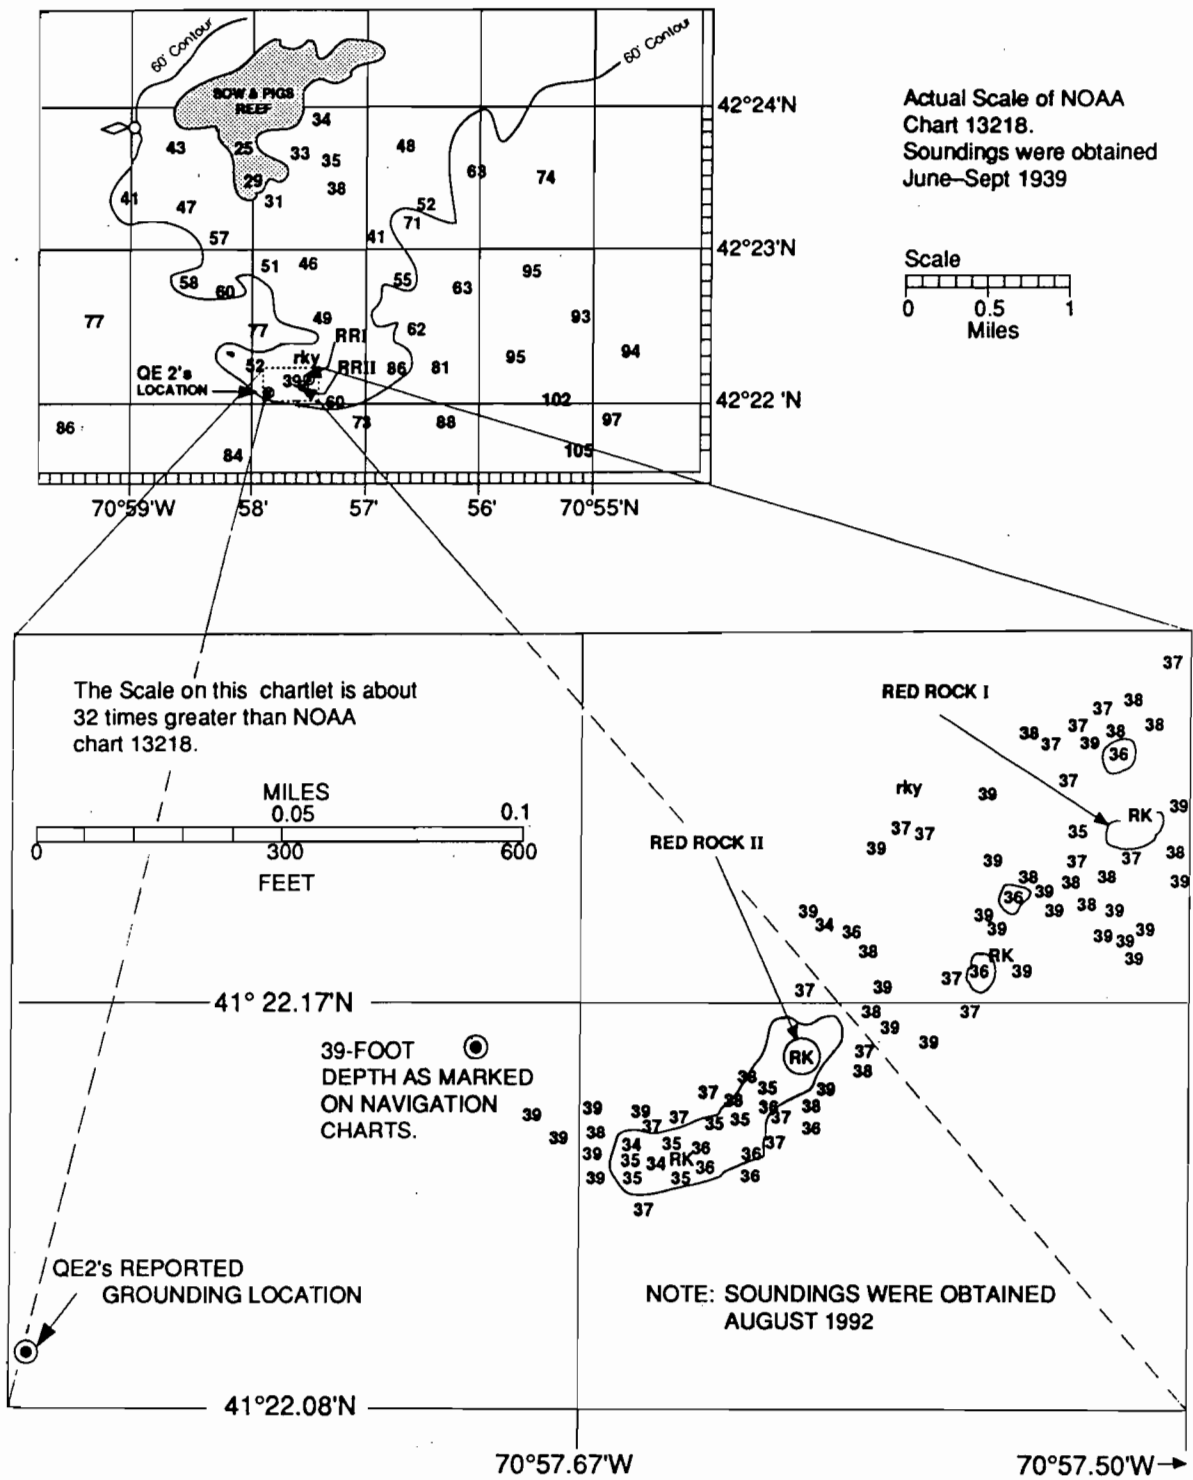
Figure 5.--Chart and survey data.

The RUDE's CO described the area of the grounding as having a considerably heavier concentration of rocks or boulders than the surrounding area, where the water is 50 to 60 feet deep, with a sandy bottom and only an occasional boulder in all directions. In the vicinity of RR II are "some more tumbled boulders and just a generally disturbed bottom," according to the RUDE's CO. The 39-foot depth shown on the navigation charts was verified by the RUDE as being about 400 feet to the west of RR II and about 660 feet northeast of the QE2's initially reported grounded position. The positions of the rocks relative to the 39-foot depth and grounding location are shown in figure 5 on the following page.

Survey data obtained by the RUDE indicate that the water depths at MLLW are 34.2 feet at RR I and 33.6 feet at RR II. Adding NOAA's calculated tidal effect of (+)0.8 feet to the MLLW sounding indicates that a depth of 35.0 feet at RR I and 34.4 feet at RR II existed at the time of the grounding.
