# National Transportation Safety Board

## Railroad Accident Brief

**Accident No.:** DCA-06-FR-009  
**Location:** Queens, New York  
**Date:** August 5, 2006  
**Time:** 3:53 p.m. eastern daylight time<sup>1</sup>  
**Railroad:** Long Island Rail Road  
**Property Damage:** None  
**Injuries:** None  
**Fatalities:** 1  
**Type of Accident:** Passenger fatality

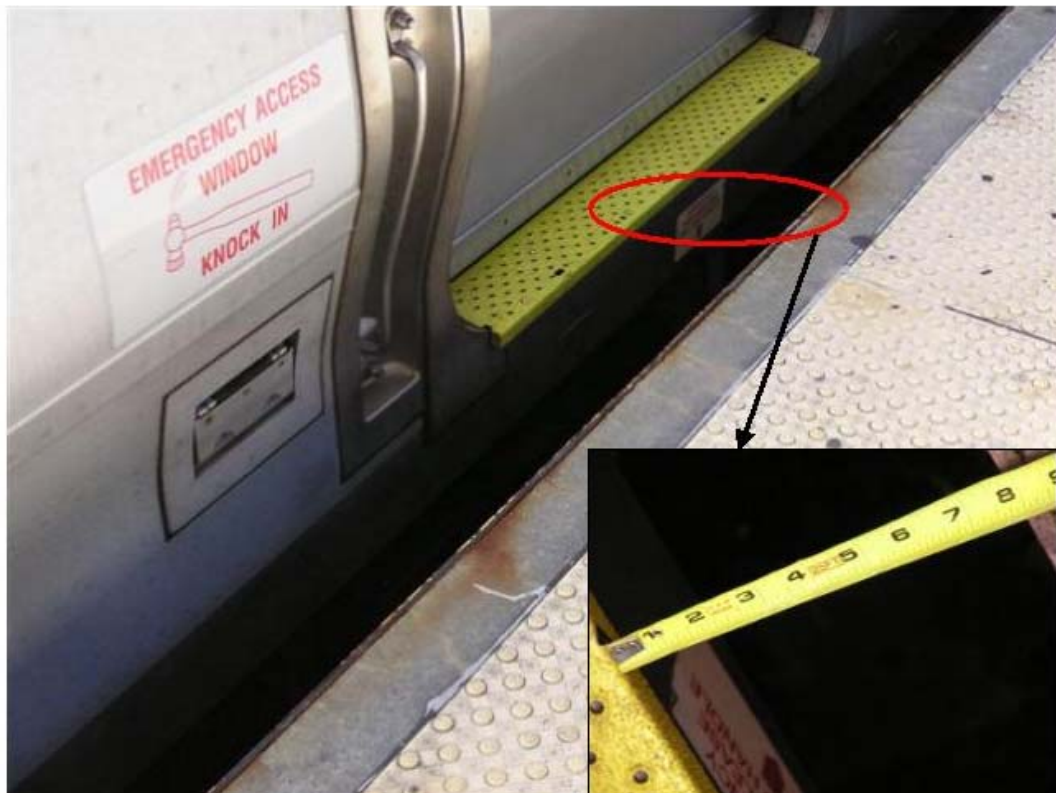
On August 5, 2006, about 3:53 p.m., a 5-foot 6-inch, 110-pound, 18-year-old female passenger exiting a Long Island Rail Road (LIRR) commuter train at Woodside station in Queens, New York, fell through a 7 7/8-inch horizontal gap between the rail car and the station platform. (See figure 1.) After falling through the gap to track level beneath the platform, she did not follow instructions from the train conductor and her friends to remain still and wait to be rescued. Instead, the woman crawled under the platform and into the path of an oncoming passenger train. She sustained fatal injuries. Toxicology testing showed that her blood alcohol concentration (BAC) was 0.23 gram percent.<sup>2</sup> The weather at the time of the accident was sunny, clear, and warm.

**Figure 1.** Gap into which passenger fell.

<sup>4</sup> Two days after the accident, State of New York Metropolitan Transit Authority police, using the accident equipment and positioning the train as close as possible to the accident site, measured the gap from the train to the platform at 7 7/8 inches.

The American Railway Engineering and Maintenance-of-Way Association (AREMA) *Manual for Railway Engineering* recommends a minimum horizontal distance of 5 feet 7 inches between track centerline and passenger platform edges (on straight track) to allow trains to travel safely past platforms.<sup>5</sup> The AREMA manual takes into consideration equipment irregularities, track variations, and train dynamics. At the time of the accident, the LIRR passenger station design guidelines set the distance between track centerline and platform edges at 5 feet 8 inches; after the accident, the LIRR changed the guidelines to 5 feet 7 inches. The postaccident track-centerline-to-platform-edge measurement at Woodside station was 5 feet 8 inches at the location of the door where the passenger fell; therefore, the gap size at this location was within tolerances expected.

The LIRR also conducted a systemwide measurement and analysis of every station and platform edge. The LIRR identified 154 door locations with gaps greater than 10 inches and reports that it has reduced the size of the gaps at 137 of those locations to date. In May 2008, the LIRR issued “Project Plan Book for 2008–2012: Gap Mitigation Plan.” The LIRR states that the book was prepared “to align the Departments on the LIRR with the initiatives that the Engineering Department will implement over the next four years to mitigate the gap.” There are several initiatives for this 4-year period, including the following: modifying existing station platforms to address the most serious gaps; installing 1-inch edge boards on platforms, which will allow the LIRR to revise the 5-foot-8-inch track-centerline-to-platform-edge to a 5-foot-7-inch standard; and installing 2-inch threshold plates at the doorway of passenger cars to reduce the gap by 2 inches.<sup>7</sup>

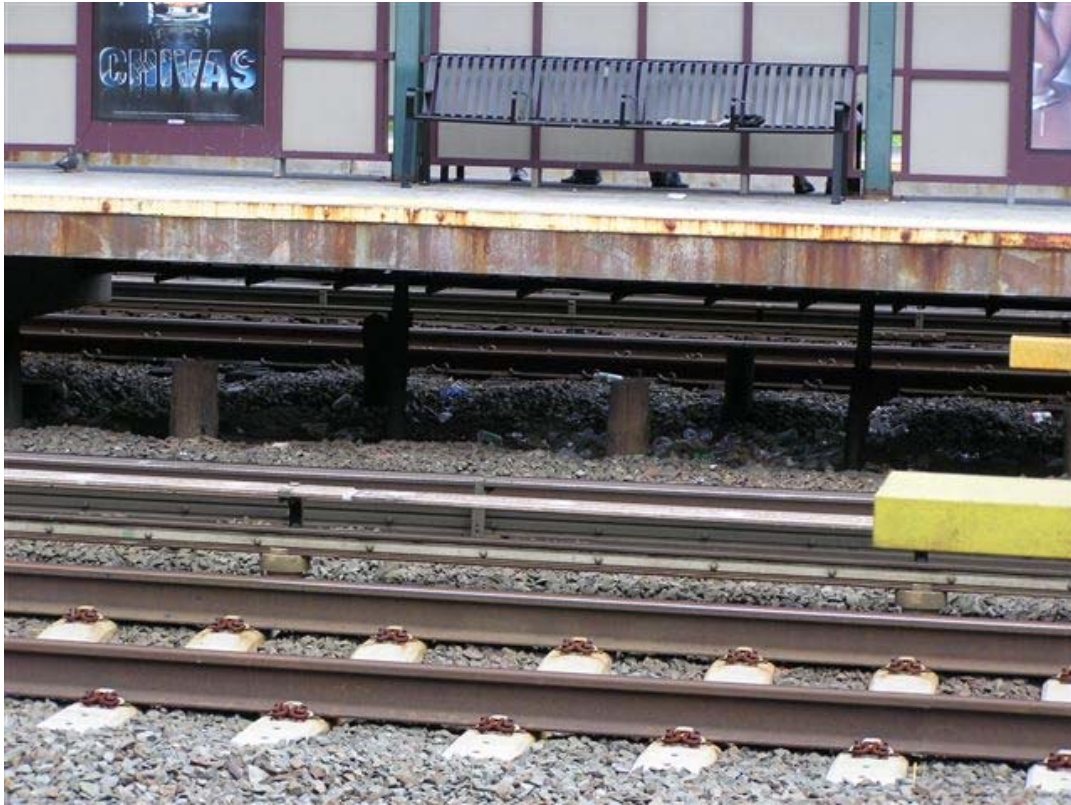
The event recorder from the locomotive showed that train 6113 stopped at the Woodside station alongside platform B on main line track 3 about 3:52 p.m. Platform B is an open, center, high-level platform<sup>3</sup> that allows trains to operate on both sides. (See figure 2.) After the train had stopped, the conductor opened the doors and the passengers began to exit. One passenger said that she noticed the gap between the car and the platform and yelled to the others, “watch the gap.” One of the group of friends traveling together said that as she exited the train, she turned and saw the door begin to close and her friend grab the door with both hands to prevent it from closing. Passengers on the platform yelled to the conductor to reopen the doors. When the conductor reopened the doors, the friend lost her balance and fell forward into the gap and onto the ground beneath the platform.<sup>4</sup>

pulled into the station on track 2. Event recorder data for train 6464 indicated that the train pulled into the station about 3:54 p.m. Upon observing the passenger on the track, the engineer of train 6464 said that he placed the train into emergency but was unable to stop in time to avoid hitting the passenger.

**Figure 2.** Center platform under which passenger crawled, crossing into path of oncoming train.
