# NATIONAL TRANSPORTATION SAFETY BOARD

## RAILROAD ACCIDENT REPORT

DERAILMENT OF  
STEAM EXCURSION TRAIN NORFOLK AND  
WESTERN RAILWAY COMPANY TRAIN  
EXTRA 611 WEST  
SUFFOLK, VIRGINIA  
MAY 18, 1986

NTSB/RAR-87/05

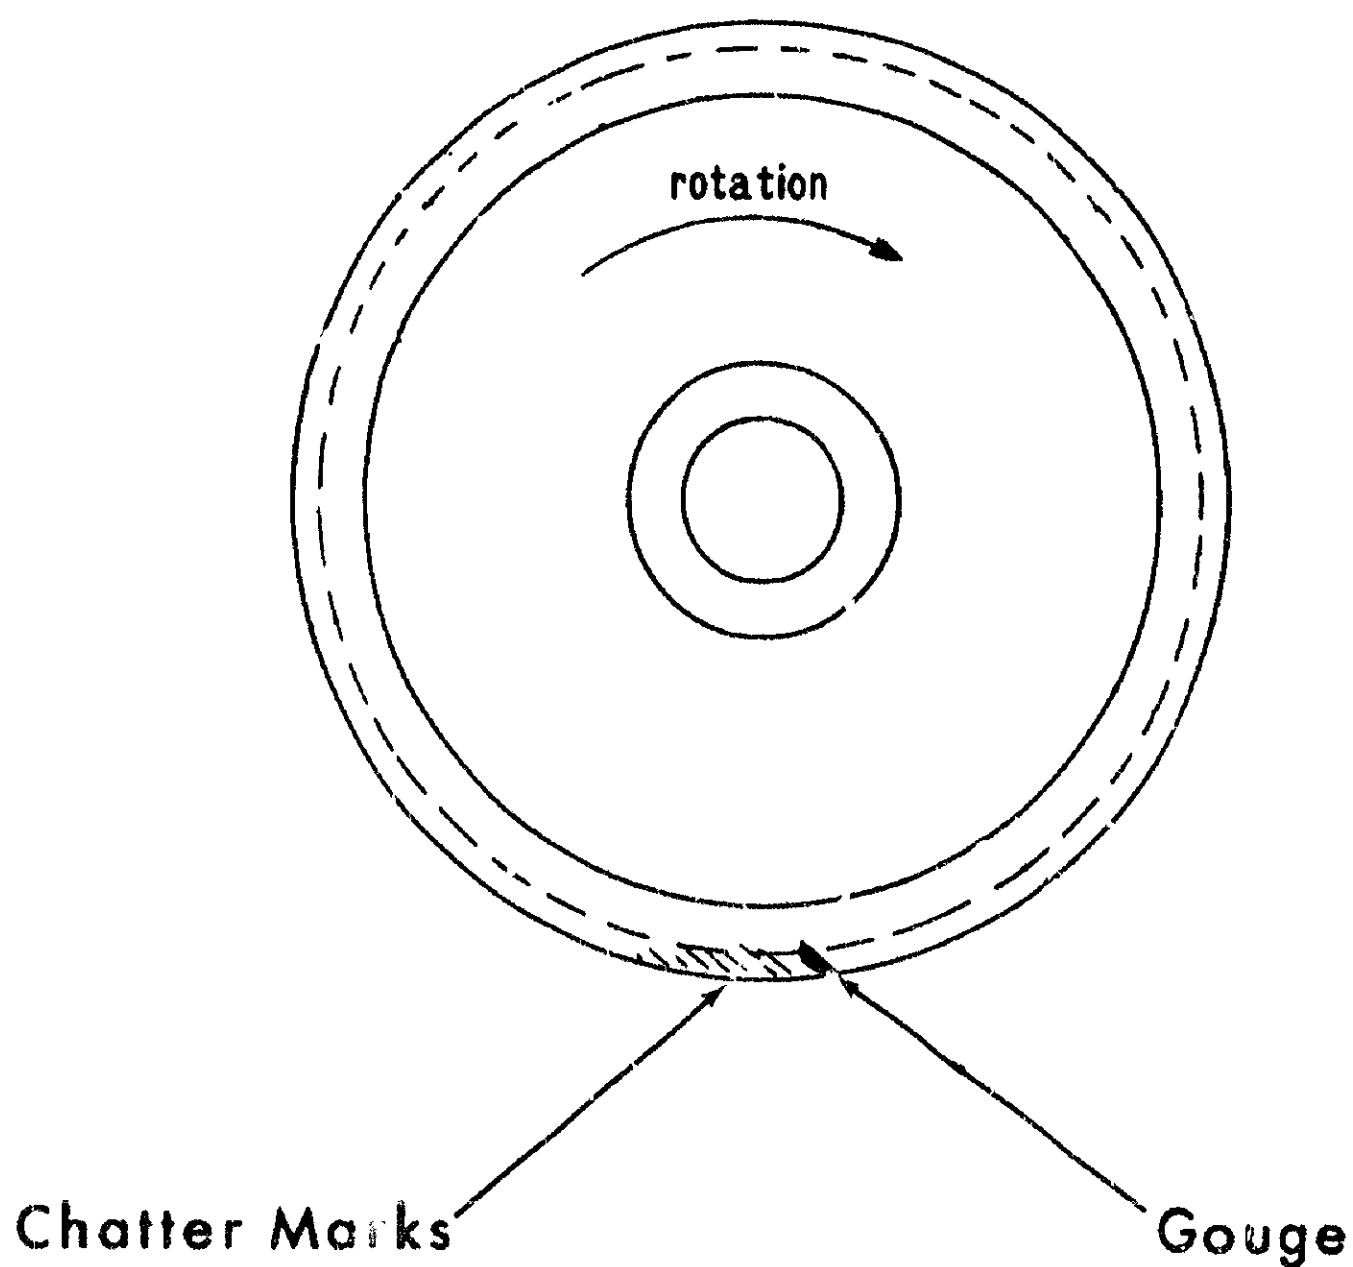
Figure 4.—Markings on southside of lead wheel,  
trailing truck on N&W 531.

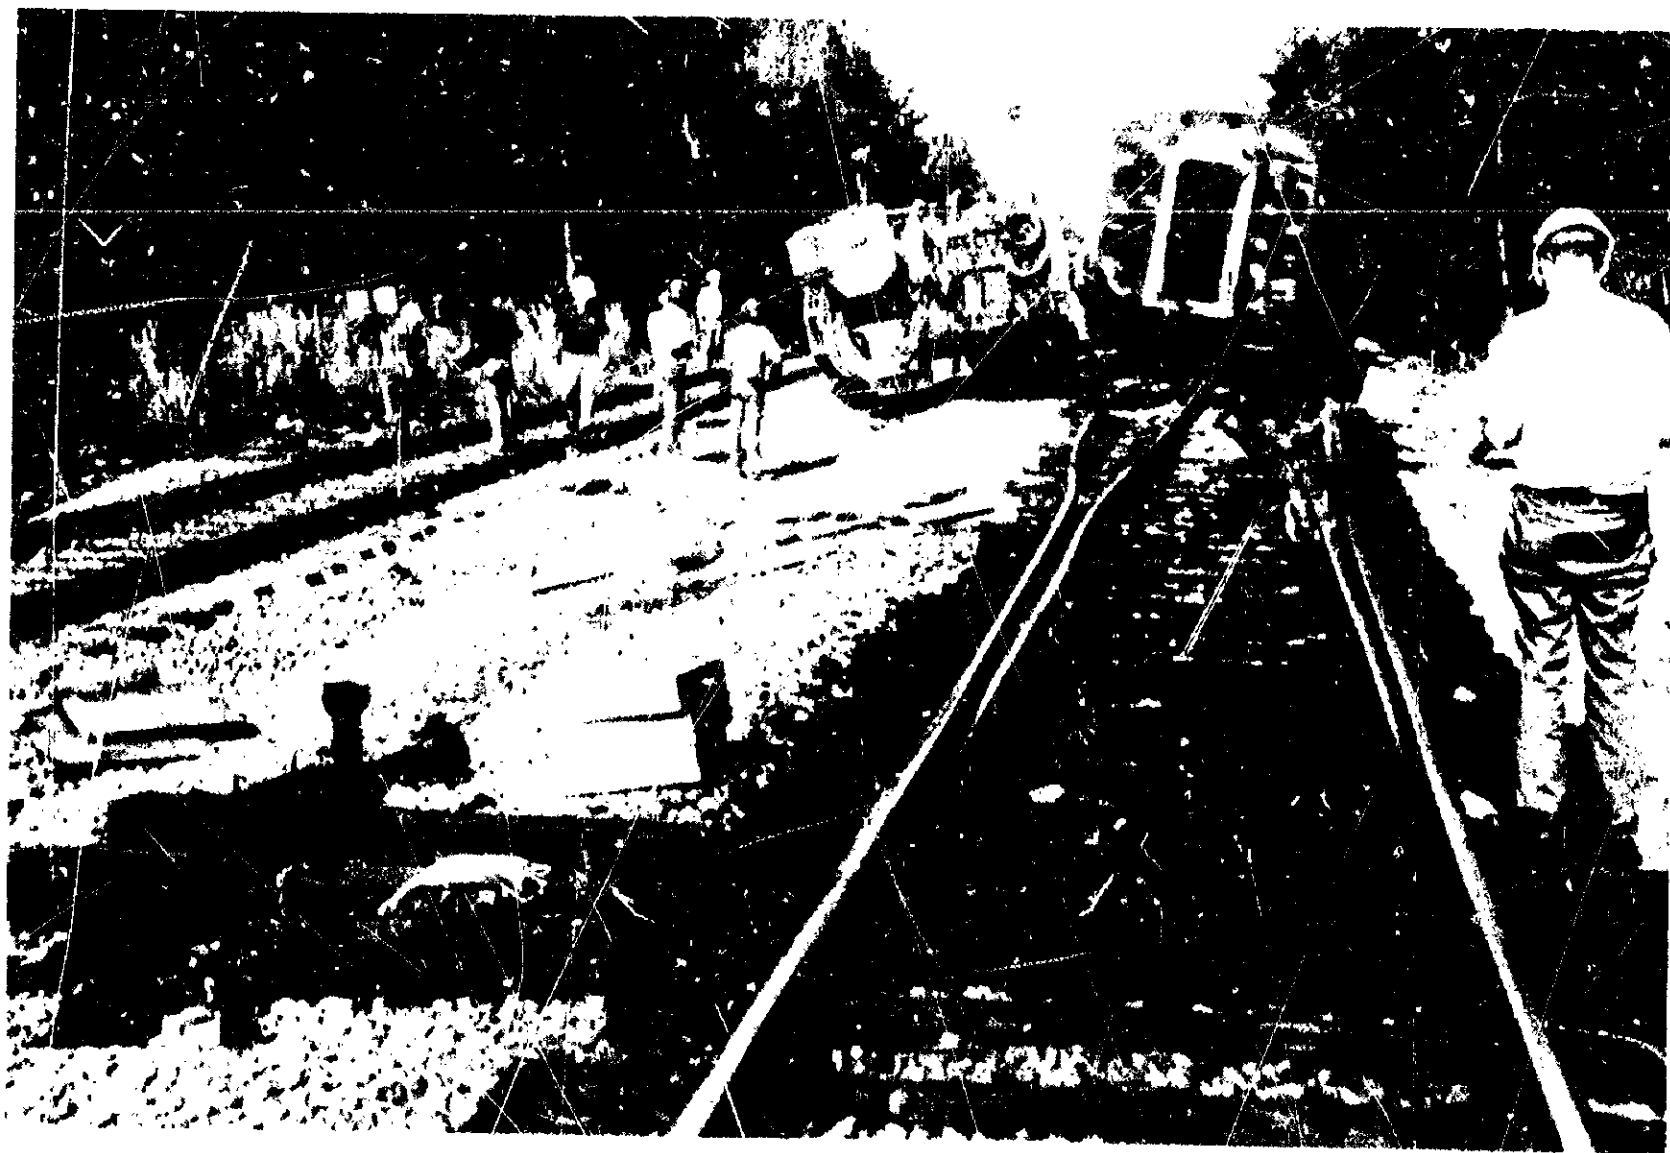
Figure 5.—Westbound turnout at Juniper.

Track and Signal.—About 1,000 feet of the westbound main track, including the guard rail and frog area of the turnout, were destroyed from approximately 65 feet west of the point of switch. The middle track, including the turnout connecting the middle track to the eastbound main track, was destroyed from the westbound turnout westward for approximately 960 feet. Approximately 157 feet of the eastbound main track was moderately damaged. The N&W estimated that the cost of restoring the track and turnout to its original state was \$106,341. However, the actual costs incurred were \$70,780 because two turnouts and 330 feet of track were not replaced. (See figure 5.)

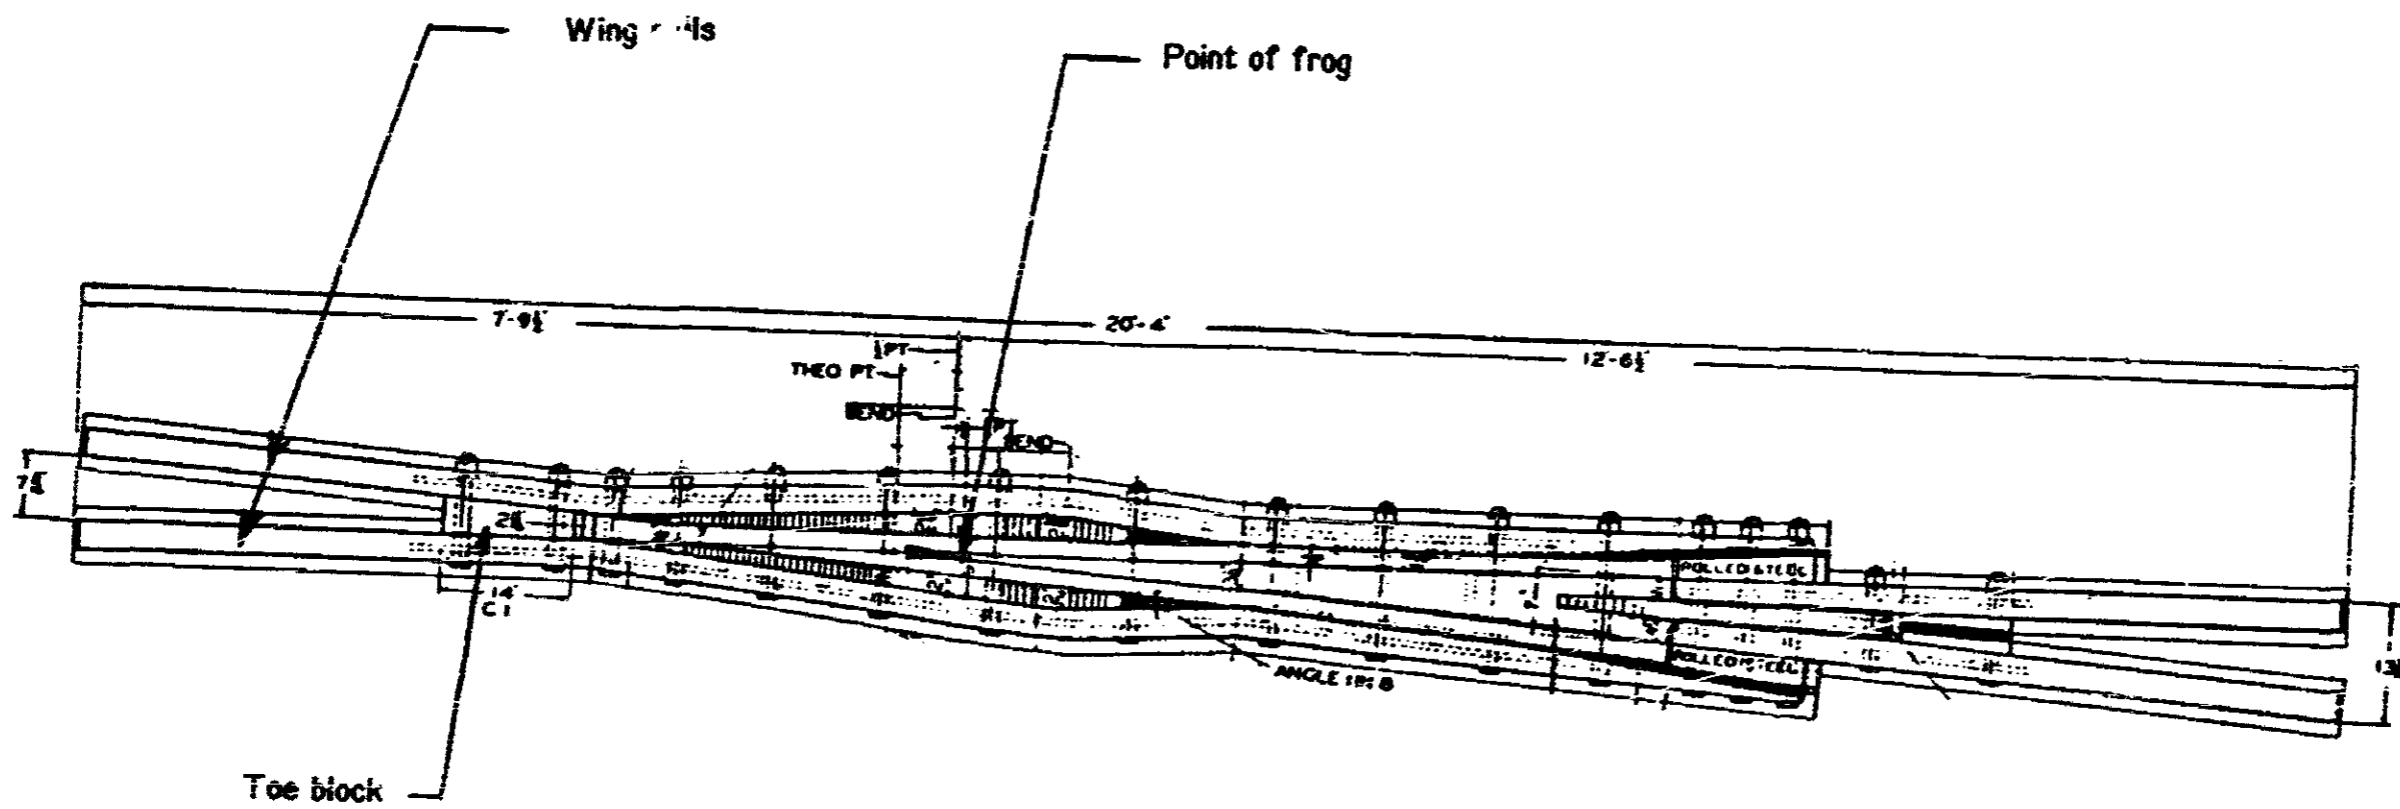
Figure 11.—No. 12 railbound manganese frog.

The wing rails 37/ had multiple wheel flange and abrasion marks from derailed car truck frames sliding on the rail. Several bolt holes were elongated on the west end of the right-hand wing rail with small chips broken out at the edges. A depression in the base of the right-hand wing rail was found in the area of the connection to the cast steel toe block. 38/ Recovered bolts and nuts from the frog were examined by the Safety Board's materials laboratory in Washington, D.C. With one exception, the laboratory found that all bolts had separated through the thread immediately adjacent to the shank. The exception was a bolt with a break flush with the rail side surface of the nut, approximately midway in the threaded length. Several bolts broke in an overstress condition, and some bolts showed overstress fracture features extending from a fatigue region. The nuts showed evidence of mechanical deformation, as if the nuts were struck by another object. The laboratory found that the location of the deformation on the nuts was consistent with the direction of the respective fracturing load, as if the blow on the nut produced the fracture on the bolt. The frog bolt nuts were located on the middle track side (southside) of the frog.
