National Transportation Safety Board

Aircraft Accident Investigative Update

On February 20, 2021, about 1309 mountain standard time (MST), United Airlines flight 328, a Boeing 777-222, N772UA, experienced a failure of the right engine, a Pratt & Whitney PW4077, while climbing through an altitude of about 12,500 feet mean sea level (msl) shortly after takeoff from Denver International Airport (DEN), Denver, Colorado. There were no injuries to the 239 passengers and crew onboard, and the airplane sustained minor damage. The regularly scheduled domestic passenger flight was operating under the provisions of Title 14 Code of Federal Regulations (CFR) Part 121 from DEN to Daniel K. Inouye International Airport (HNL), Honolulu, Hawaii.

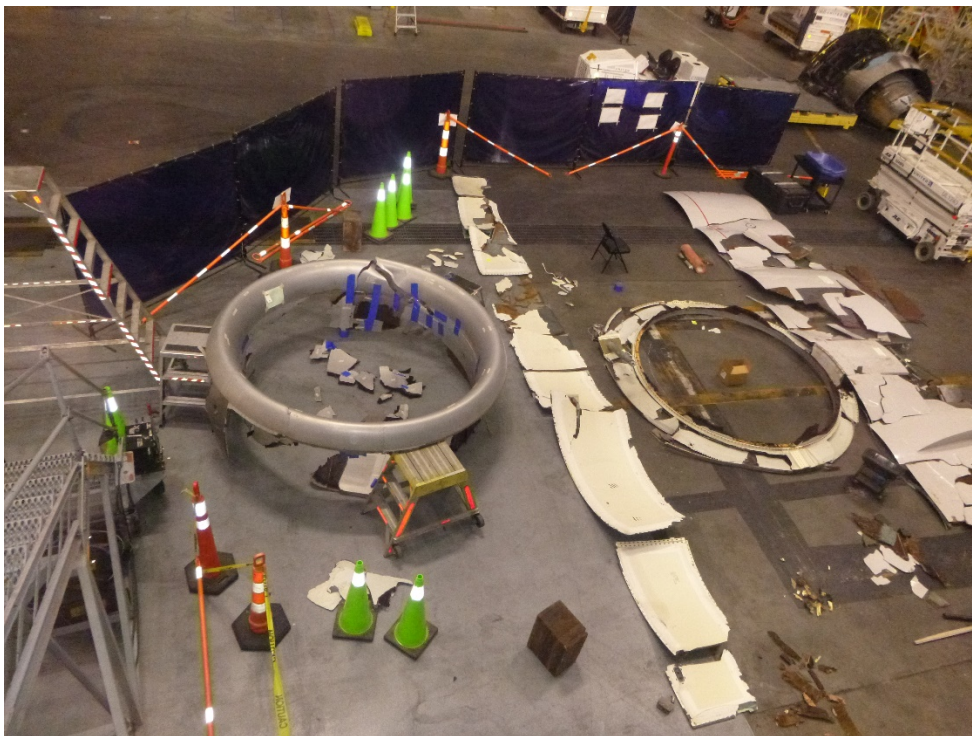
An NTSB structures engineer and two investigators from the NTSB's Denver office collected fallen debris with local law enforcement and safety agencies over the next several days. Most of the structure from the inlet cowl and fan cowl doors was recovered and identified. Recovered portions of the inlet cowl, fan cowl door structure, and inlet cowl attach ring were laid out in a hangar, as shown in figure 1. The inlet cowl, fan cowl doors, and thrust reversers will be examined further to map damage and cowl failure patterns after the fan blade failure, and to examine the subsequent progression of fire in the thrust reversers.

Figure 1. Inlet cowl and cowling debris laid out in hangar

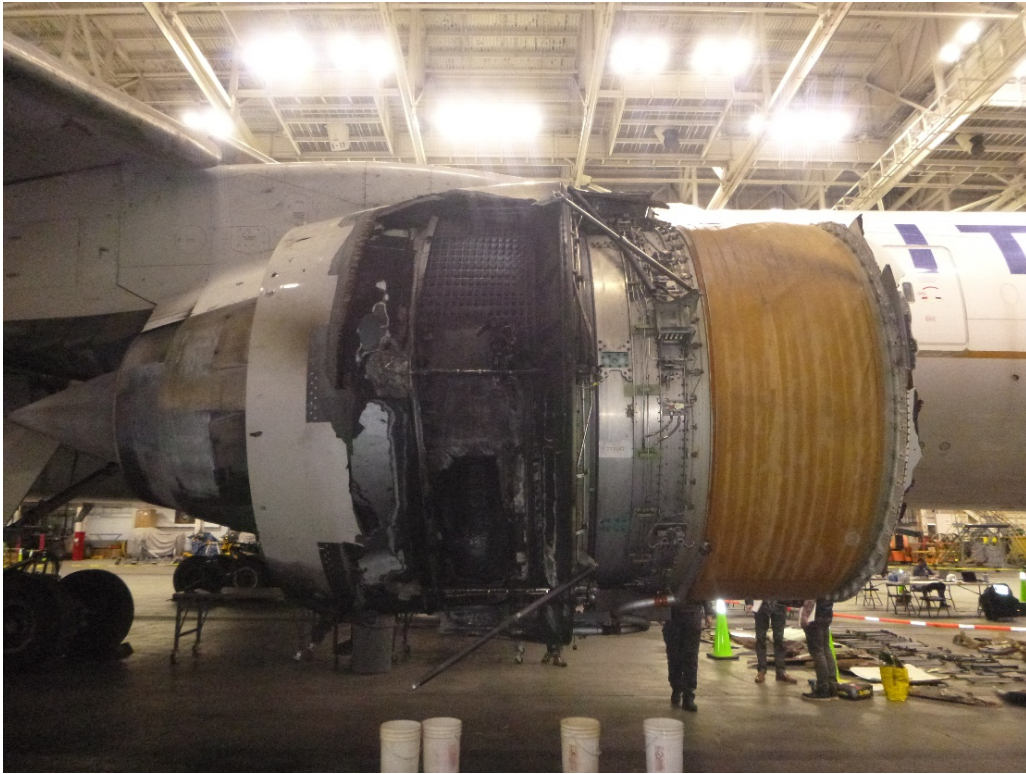
Initial examination of the right engine fire damage, as shown in figures 2 and 3, found it was primarily contained to the engine's accessory components, thrust reverser skin, and composite honeycomb structure of the inboard and outboard thrust reversers. Both halves of the aft cowl appeared to be intact and undamaged, and all four pressure relief doors were found in the open position. The spar valve, which stops fuel flow to the engine when the fire switch is pulled in the cockpit, was found closed; there was no evidence of a fuel-fed fire. Examination of the engine accessories showed multiple broken fuel, oil, and hydraulic lines and the gearbox was fractured.

Figure 2. Fire damage on the outboard side of the right engine.

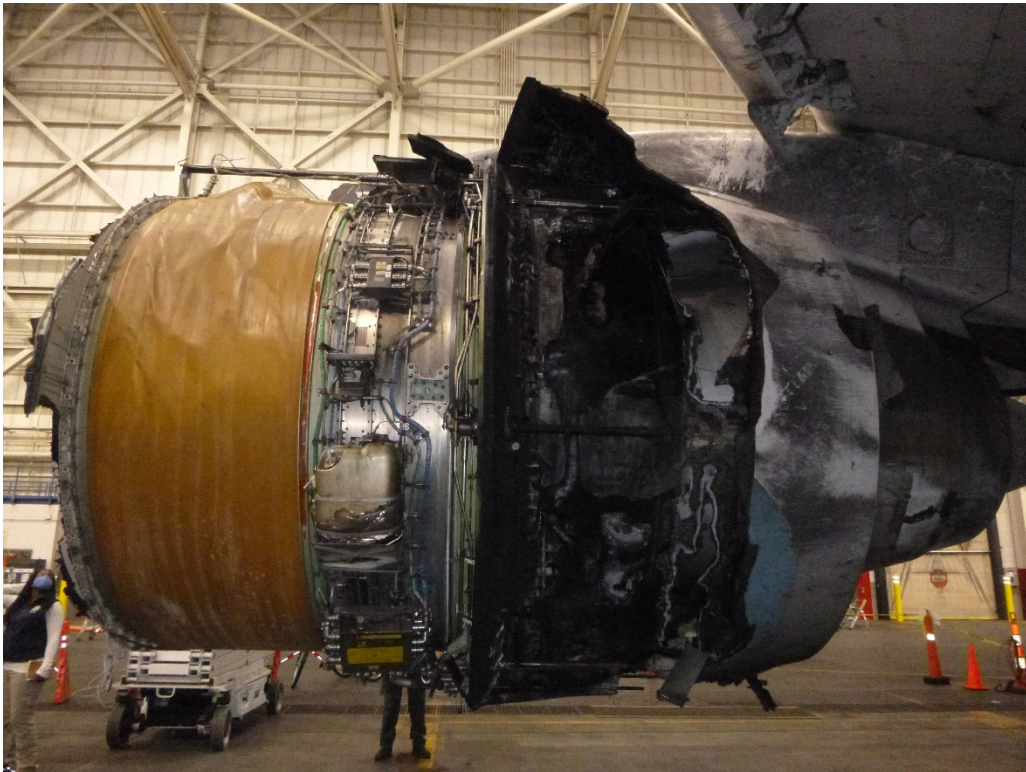
Figure 3. Fire damage on the inboard side of the right engine.

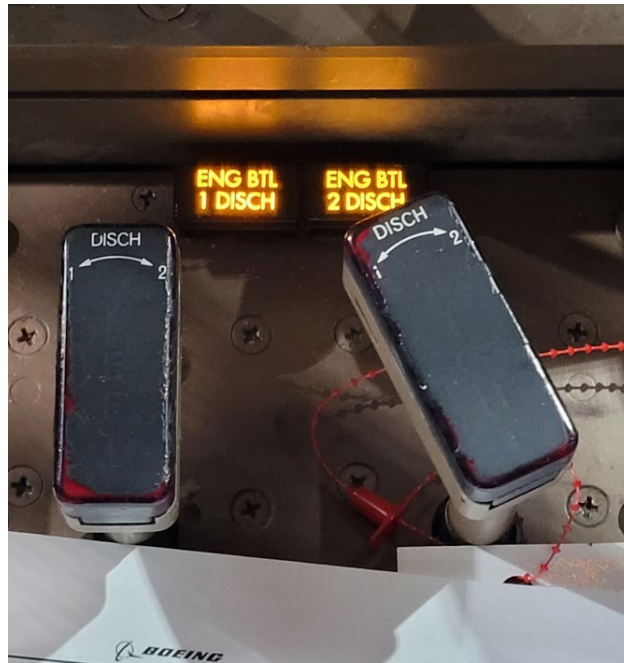
Examination of the cockpit found that the right engine fire switch had been pulled and turned to the “DISCH 1” position, and both fire bottle discharge lights were illuminated, as shown in figure 4.

Figure 4. Right engine fire switch and fire bottle status lights.

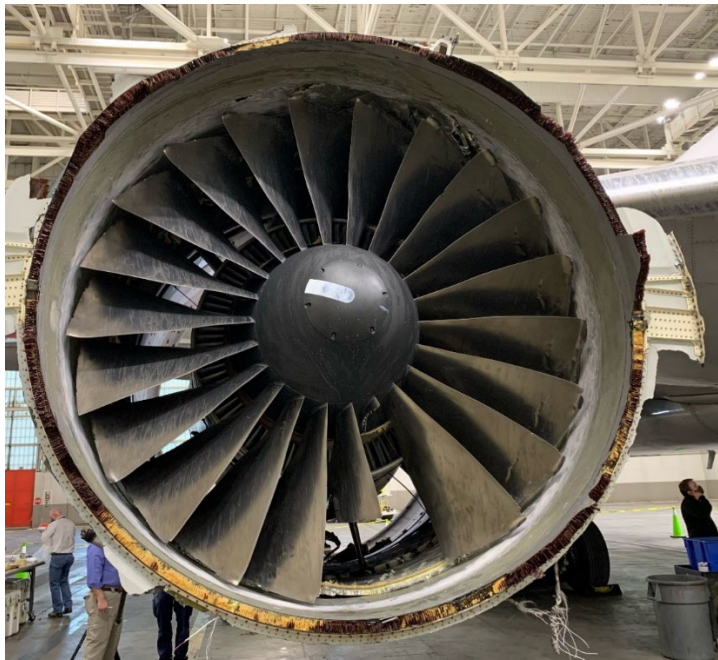
Initial examination of the right engine fan revealed that the spinner and spinner cap were in place and appeared to be undamaged (see figure 5). The fan hub was intact but could not be rotated by hand. All fan blade roots were in place in the fan hub, and two blades were fractured. One fan blade was fractured transversely across the airfoil about 5 inches above the base of the blade at the leading edge and about 7.5 inches above the base of the blade at the trailing edge. The blade's fracture surface was consistent with fatigue. A second fan blade was fractured transversely across the airfoil about 26 inches above the base of the blade at the leading edge and about 24 inches above the base of the blade at the trailing edge (see figure 6). The second blades fracture surfaces had shear lips consistent with an overload failure. The remaining fan blades were full length but all had varying degrees of impact damage to the airfoils.

Figure 5. The right engine fan, as viewed from the front.

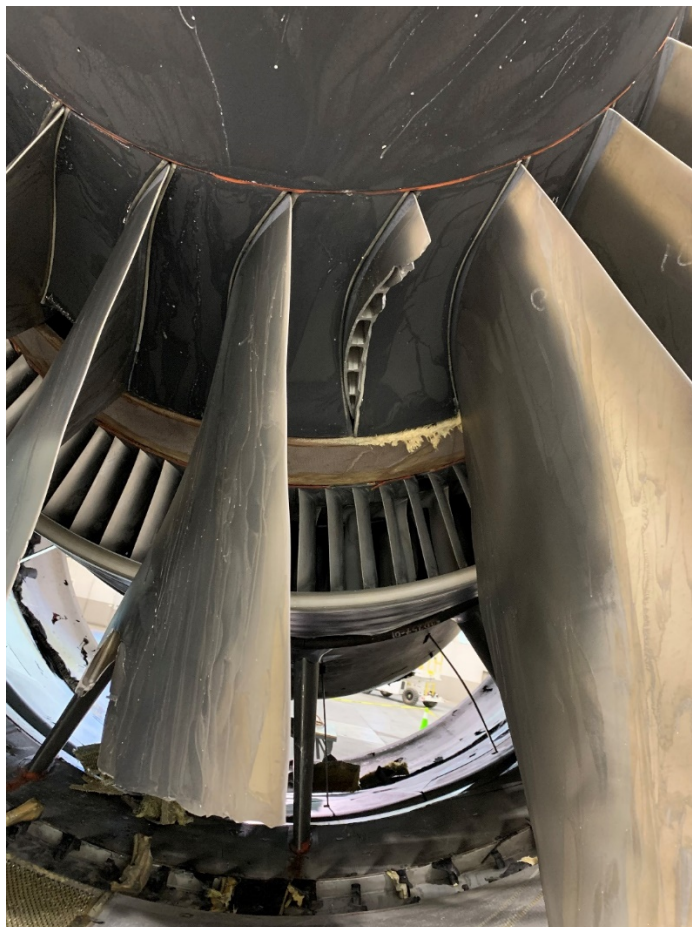
Figure 6. The two fractured blades on the right engine.

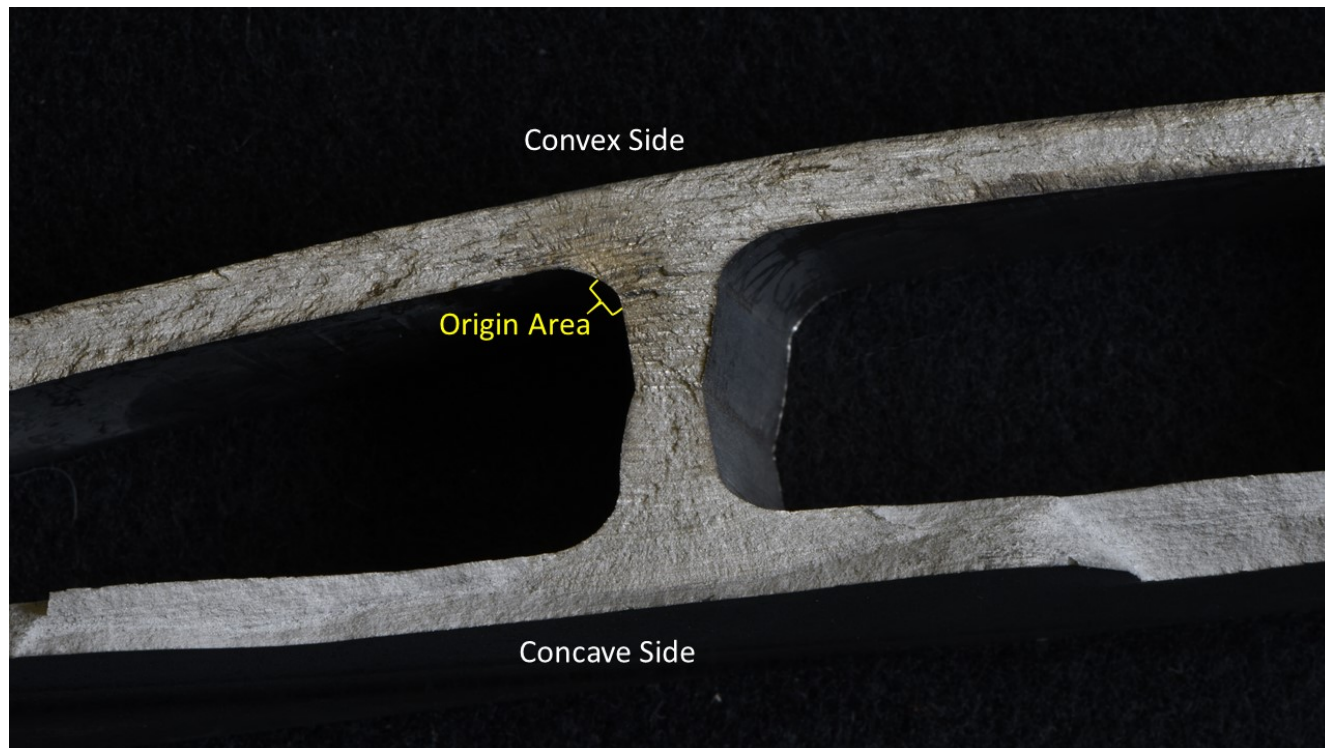
The right engine fan blades were removed from the hub, and the blade that exhibited fractures consistent with fatigue was sent to the metallurgical laboratory at Pratt & Whitney for further examinations led by a senior NTSB metallurgist. Preliminary findings from the scanning electron microscope (SEM) examination have identified multiple fatigue fracture origins on the interior surface of a cavity within the blade (see figure 7). Efforts to further characterize the fracture surface, including identifying the primary origin and counting striations, are ongoing.

Figure 7. Photo of the fan blade's fracture surface with the origin area identified.

Fluorescent penetrant inspection identified multiple secondary crack indications within an inch of the fracture surface in the same cavity as the fatigue failure origin, and SEM examination confirmed them as potential secondary cracks. Additional work is underway to further characterize the size and depth of the secondary cracks before attempting to open at least two of them for further examination. The NTSB metallurgy group also plans to analyze its chemical composition and the microstructure near the fracture surface.

An initial review of maintenance and inspection data for the blade that exhibited fractures consistent with fatigue revealed that it had experienced 2,979 cycles since its last inspection. The subject blade underwent TAI inspections in 2014 and 2016. The TAI inspection data collected in 2016 was examined again in 2018 because of a February 13, 2018, incident involving a Boeing 777 with Pratt & Whitney PW4077 engines ([DCA18IA092](#)). The maintenance records group and the powerplants group are

As a result of this incident, on February 22, 2021, Pratt & Whitney issued Special Instruction 29F-21 providing revised thermal acoustic image (TAI) inspection threshold intervals to 1000 cycles for the first stage low pressure compressor (LPC) blades on the affected engines. On February 23, 2021, the FAA issued Emergency Airworthiness Directive 2021-05-51, which instructs owners and operators of Pratt & Whitney PW4077 and similar type engines to, before further flight, perform a TAI inspection of the first stage LPC blades for cracks and to remove the blade from service if it does not pass the inspection and replace the blade before further flight.
