OFGEM

**REPORT ON
SUPPORT INVESTIGATIONS
INTO RECENT BLACKOUTS IN
LONDON AND WEST MIDLANDS**

**VOLUME 1
MAIN REPORT**

FEBRUARY 2004

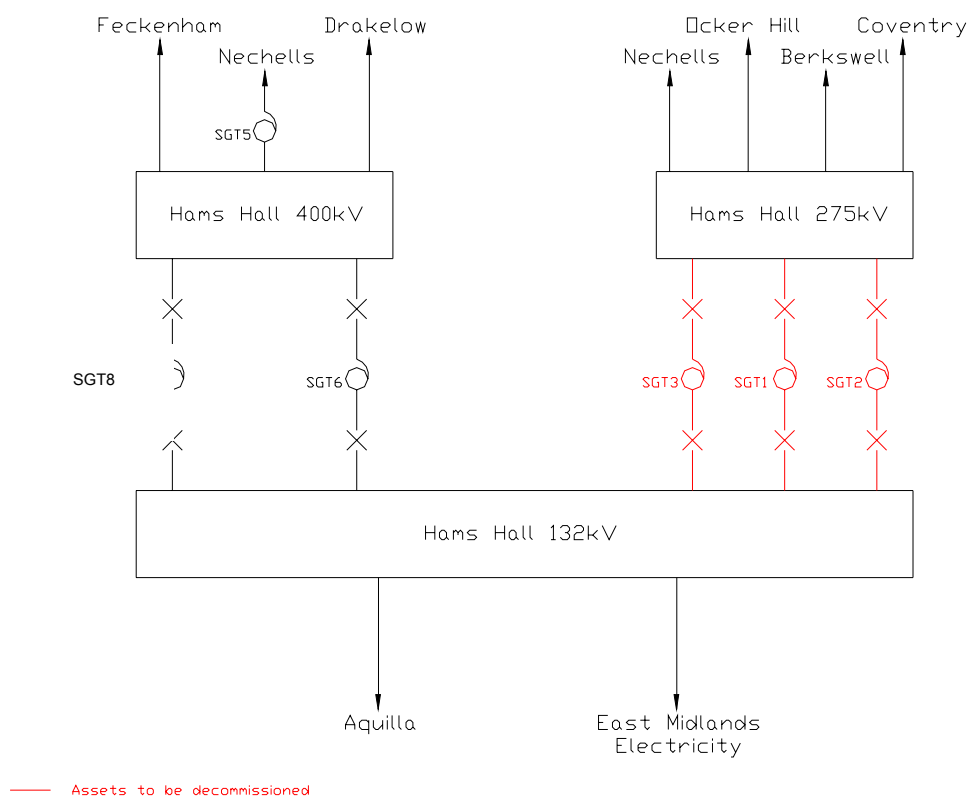
Figure 3.3: Layout of Hams Hall 400/275/132 kV substation prior to incident

Charred cables and localised sparking within the secondary wiring were observed in the cubicle and identified as being associated with wiring of some 132 kV Current Transformer (CT) circuits for SGT6. At this point, (10:09 hours) the site engineer contacted ENCC and requested permission to temporarily unload SGT6 and its 132 kV CT's by locally tripping the SGT6 132 kV circuit breaker. Permission was granted and the circuit breaker was opened at 10:10 hours.

It was later established that the 132 kV CT wiring problem had arisen as a result of equipment having been removed from one of the SGT6 132 kV CT circuits, through some confusion that had arisen in connection with the METRO replacement work. The CT circuit had been accidentally left open after a transducer had been removed without a wire link being inserted to close the circuit. Leaving an operational CT circuit open when the CT is passing primary load current will result in high voltages being developed across the CT secondary windings and wiring. It is a hazardous condition, in terms of the risk of fire, or injury to engineering staff and one which might result in damage to the CT winding. Such a fault obviously needs to be rectified with some urgency. Once the condition had been identified, NGC and the Contractor's staff on site realised that it could be safely dealt with by taking SGT6 and its 132 kV CT's off load for a short period, which was the course of action taken.

Concurrent with the restoration process, investigations on site into the SGT6 wiring problems had identified the cause and following remedial action to rewire the CT circuitry and undertake an on-site check, transformer SGT6 was made available for service at 10:36 hours. With SGT3, SGT2 and SGT6 operational again, giving a total installed capacity of 480 MVA, this provided adequate capacity to restore supplies to all of the lost demand and the supply to Aquila was fully restored by 10:52 hours.
