# PONTIAC

## Service Craftsman News

No. 2 S-280

February, 1956

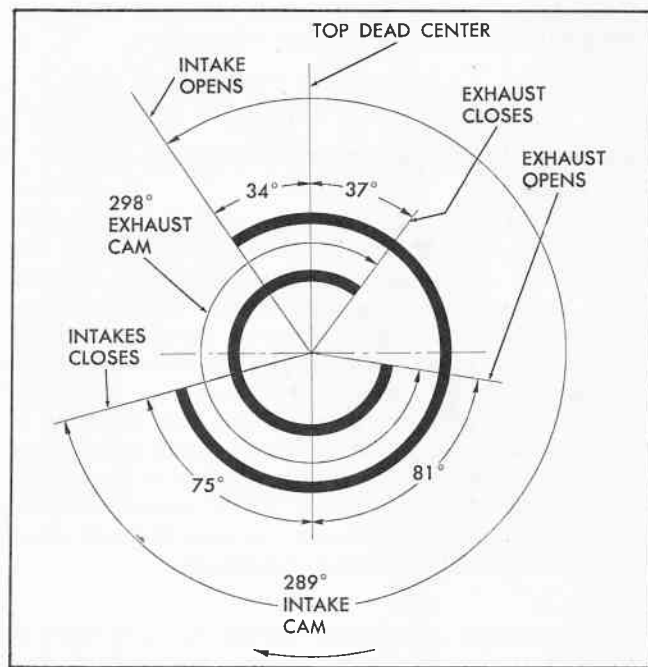
Fig. 1 Valve Timing Diagram

As mentioned above and as indicated in the illustration, Fig. 1, a new camshaft is used which gives greater valve "overlap" and facilitates engine breathing. This camshaft can be identified by the absence of lettering on the front end of the shaft.

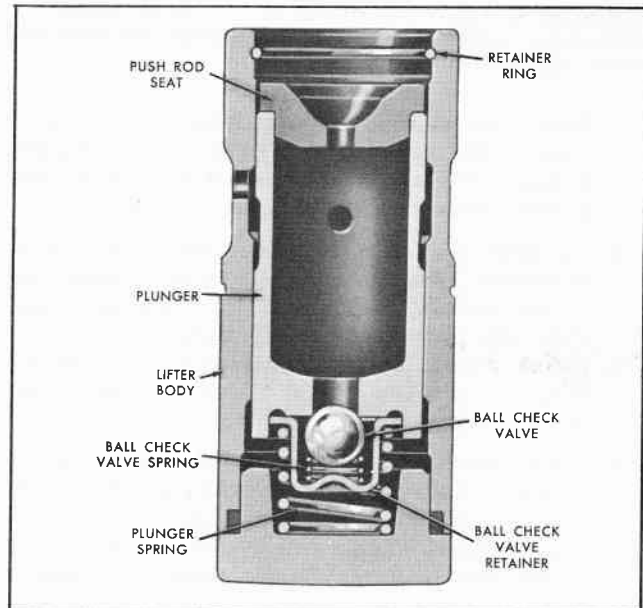
Fig. 6 285 Horsepower Engine Valve Lifter

standard production lifter shown in Fig. 5. It can be identified from the standard lifter by the letter "A" stamped on the lifter body and by the fact that the area that contacts the cam has a lubrited (blackened) finish. Internally, as shown in the illustration, the new lifter has a spring under the ball check valve and a redesigned ball check valve retainer.

It is extremely important that the regular production valve lifters are not used in the 285 horsepower engine.

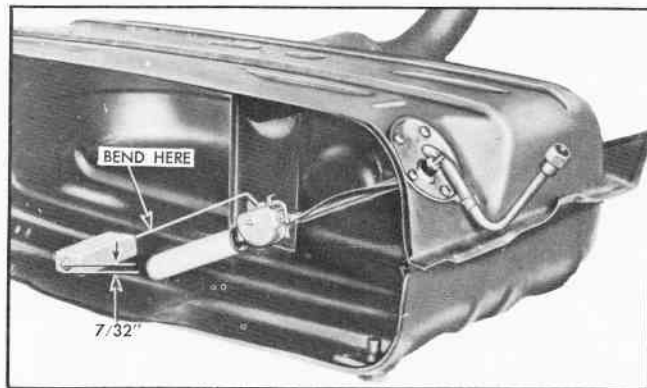
Fig. 7 Tank Unit Installed

Product Information Reports received from the field have indicated complaints on inaccuracy of the instrument panel fuel gauge. Our investigation shows that this is caused by the tank unit rheostat float arm being positioned improperly. In these cases the instrument panel gauge would read empty although there was a reserve in the tank of 6 or more gallons. To correct the condition, remove the unit, place unit in a vise, and bend the float arm so that the float will be 7/32" lower as shown in Fig. 7. This dimension should be scaled accurately.

The modification should be performed in all cases of complaints of this nature and also on gauge units in dealer stock with the exception of station wagon units which are not affected. The time allowance for removing the tank unit, bending float arm, and replacing is .5 hr.

This condition has been corrected in production and all warehouse stock has been purged. The corrected units will be marked with a daub of red paint on the gasoline tank fuel gauge unit outlet tube for a period of 90 days. Therefore, cars marked in this manner will not require this correction.
