# RAILWAY ACCIDENT

Report on the Derailment  
that occurred on 29th January 1975  
near Oxford Station

IN THE  
WESTERN REGION  
BRITISH RAILWAYS

DERAILMENT AT OXFORD (WESTERN REGION) ON 29th JANUARY 1975

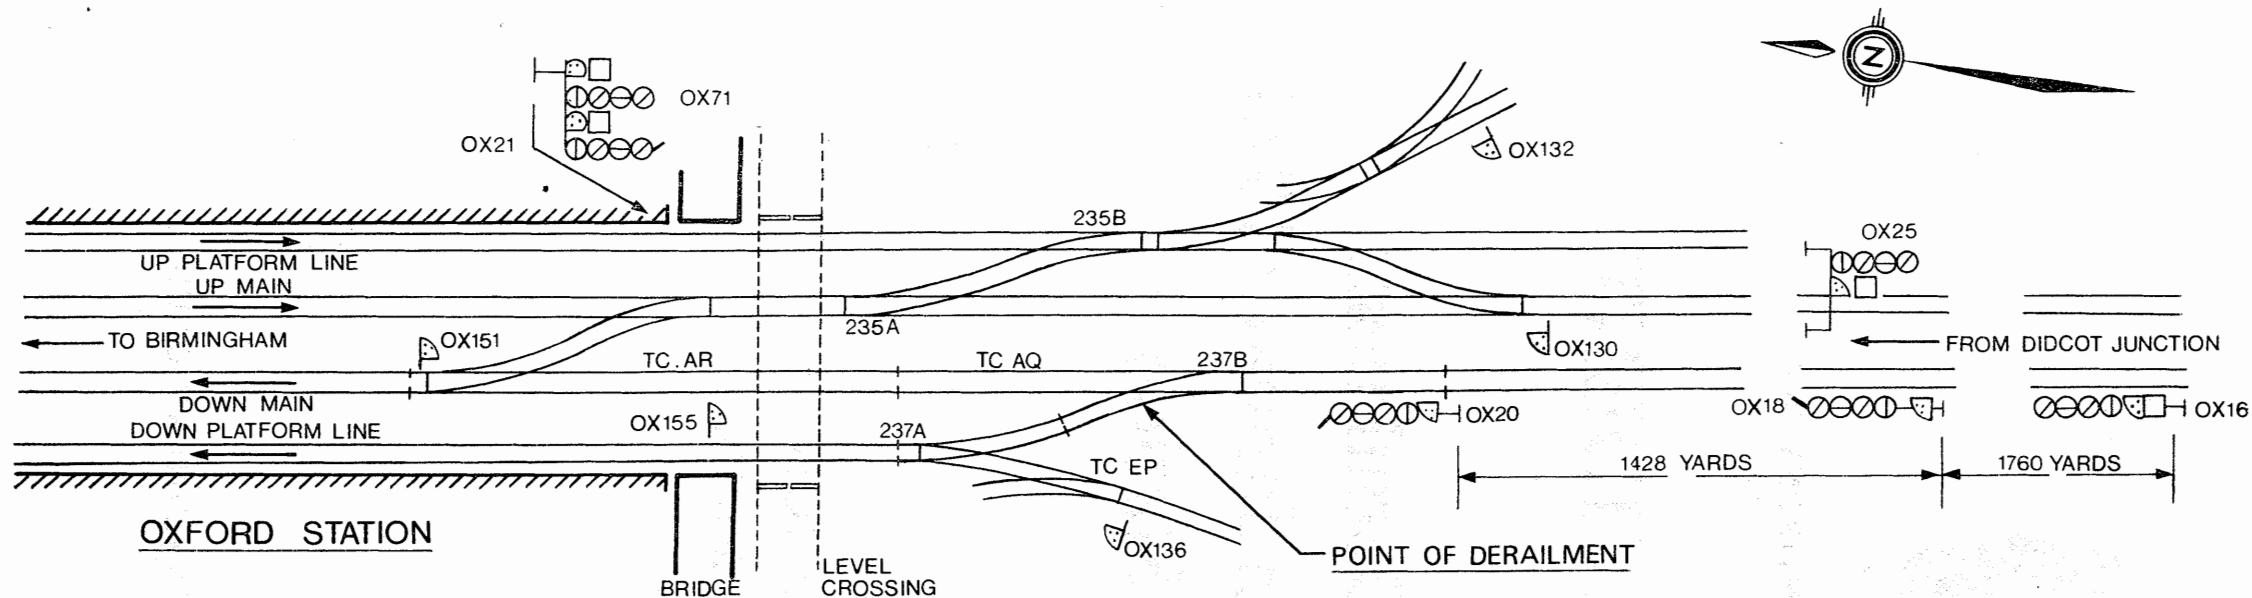
SKETCH SHOWING POINT OF DERAILMENT AND SIGNALLING – NOT TO SCALE

The accident happened as the 14.05 Paddington to Birmingham Class 1 passenger train, consisting of a Class 52 diesel-hydraulic locomotive and seven coaches, was travelling from the Down Main line to the Down Platform line on the approach to Oxford Station. Shortly after entering the turnout leading to the platform line, travelling at about 20 mile/h, the locomotive became derailed and was followed into derailment by the leading two coaches in the train. The train continued for some 80 yards before coming to a stand with the locomotive and all coaches upright and more or less in line. The derailment was caused by the sudden complete fracture of the locomotive's leading axle, which allowed the right-hand wheel to take the wrong side of the vee of the turnout crossing.

7. Examination of the track and the train soon after the accident established that the right-hand leading wheel of the locomotive had passed along the wrong side of the turnout crossing nose and had been diverted along the left-hand rail of the Down Main line. This had caused the centre and trailing right-hand wheels of the bogie to climb the crossing and derail between the lines. The left-hand wheels had passed along the correct side of the check rail, causing pressure marks and damage as the right-hand wheels were forcibly diverted to the right. Due to the divergence of the track the left-hand wheels of the leading bogie had then been drawn across to the right-hand rail of the Down Platform line beyond the turnout. This rail was pulled off its fastenings and spread wide to gauge, and the Down Main line was displaced en masse. The leading bogie of the locomotive came to a stand just short of the level crossing at the London end of Oxford Station having run derailed some 80 yards. Behind it, the leading two coaches in the train had derailed where the Down Platform line had spread wide to gauge. The remaining coaches were not derailed. The train remained properly coupled and upright.

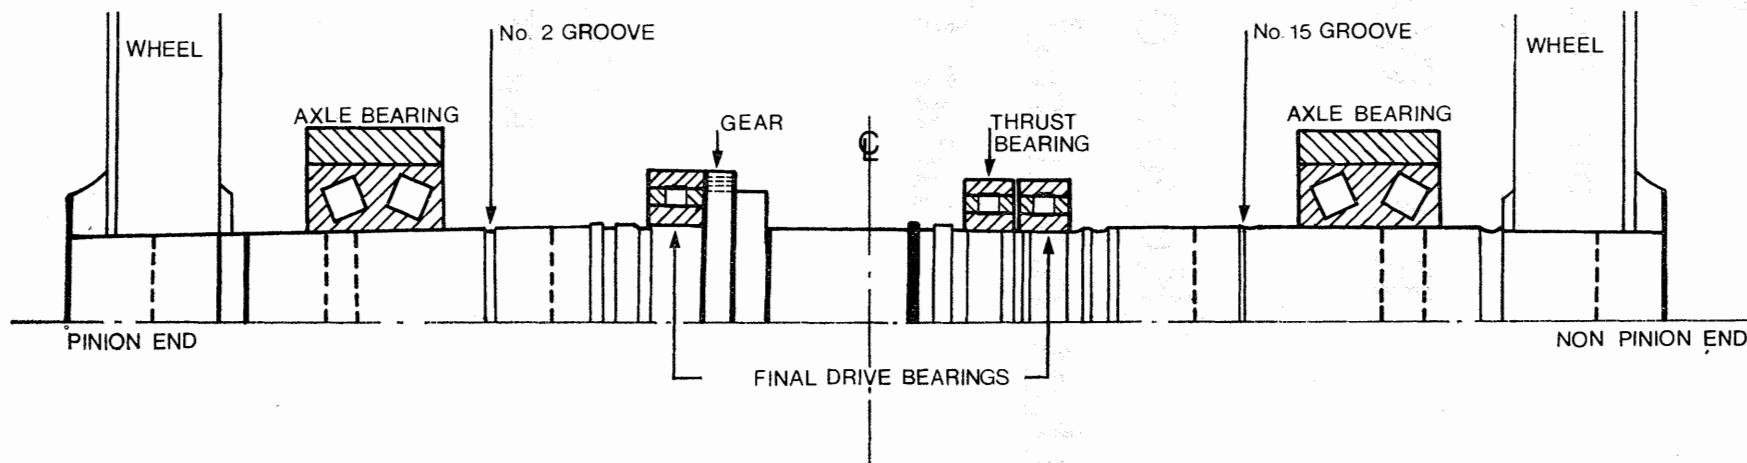
SKETCH SHOWING HALF-SECTION OF CLASS 52 LOCOMOTIVE AXLE – NOT TO SCALE

26. In order to minimise interference with traffic the actual re-railing did not start until 21.30. Shortly before midnight, the locomotive, which had been lifted and traversed sideways about 2 ft by hydraulic jacks, was lowered carefully back onto the track and it was found that all wheels engaged correctly, except the two leading ones each of which stood with its flange on the rail table. At this point the jacks were removed and the locomotive was moved slightly but the flanges of the leading wheels, instead of falling correctly into place, dropped to the outside of the rails. The front end was then again jacked up, high enough for an examination to be made underneath, and Mr. Jones-Gerrard was able to see that the leading axle was completely fractured at a point just to the inner side of the right-hand axle bearing.

46. The axle failed due to extensive fatigue cracking initiated from points on the No. 2 stress-relieving groove. It has not proved possible to estimate with any accuracy the length of time during which the fatigue cracks might have been developing. A period of some 16 weeks had elapsed since the last occasion on which the axle was ultrasonically tested and, whilst practical experience would seem to indicate that such a rapid growth rate, from initiation to complete failure, is highly unlikely, theoretical calculations have suggested that the possibility cannot be entirely discounted.

49. The failure of axle W 2606, one of the modified designs produced for the Class 52 locomotives, and the results of the subsequent investigations have obvious implications for safety. I have discussed these implications with the responsible Railway Officers. They have assured me that the doubts raised as to the suitability of the previous frequency of ultrasonic testing apply to the Class 52 axles only, and that there are no grounds for thinking that the present frequency of testing is unsatisfactory in the case of any other axle. So far as the remaining Class 52 axles are concerned, the interval between testing was reduced soon after the accident at Oxford to 3 months in every case, with more frequent testing whenever the slightest suspicion is aroused as to an axle's condition. In addition, every test is now carried out with the axle in two positions approximately 180° apart. The Railway Officers feel that, having weighed the available evidence, both practical and theoretical, the 3 months frequency is adequate, and I support their view.
