**05-116 collapse of Bridge 256 over Nuhaka River,
Palmerston North-Gisborne Line**

Report 05-116

collapse of Bridge 256 over Nuhaka River

6 May 2005

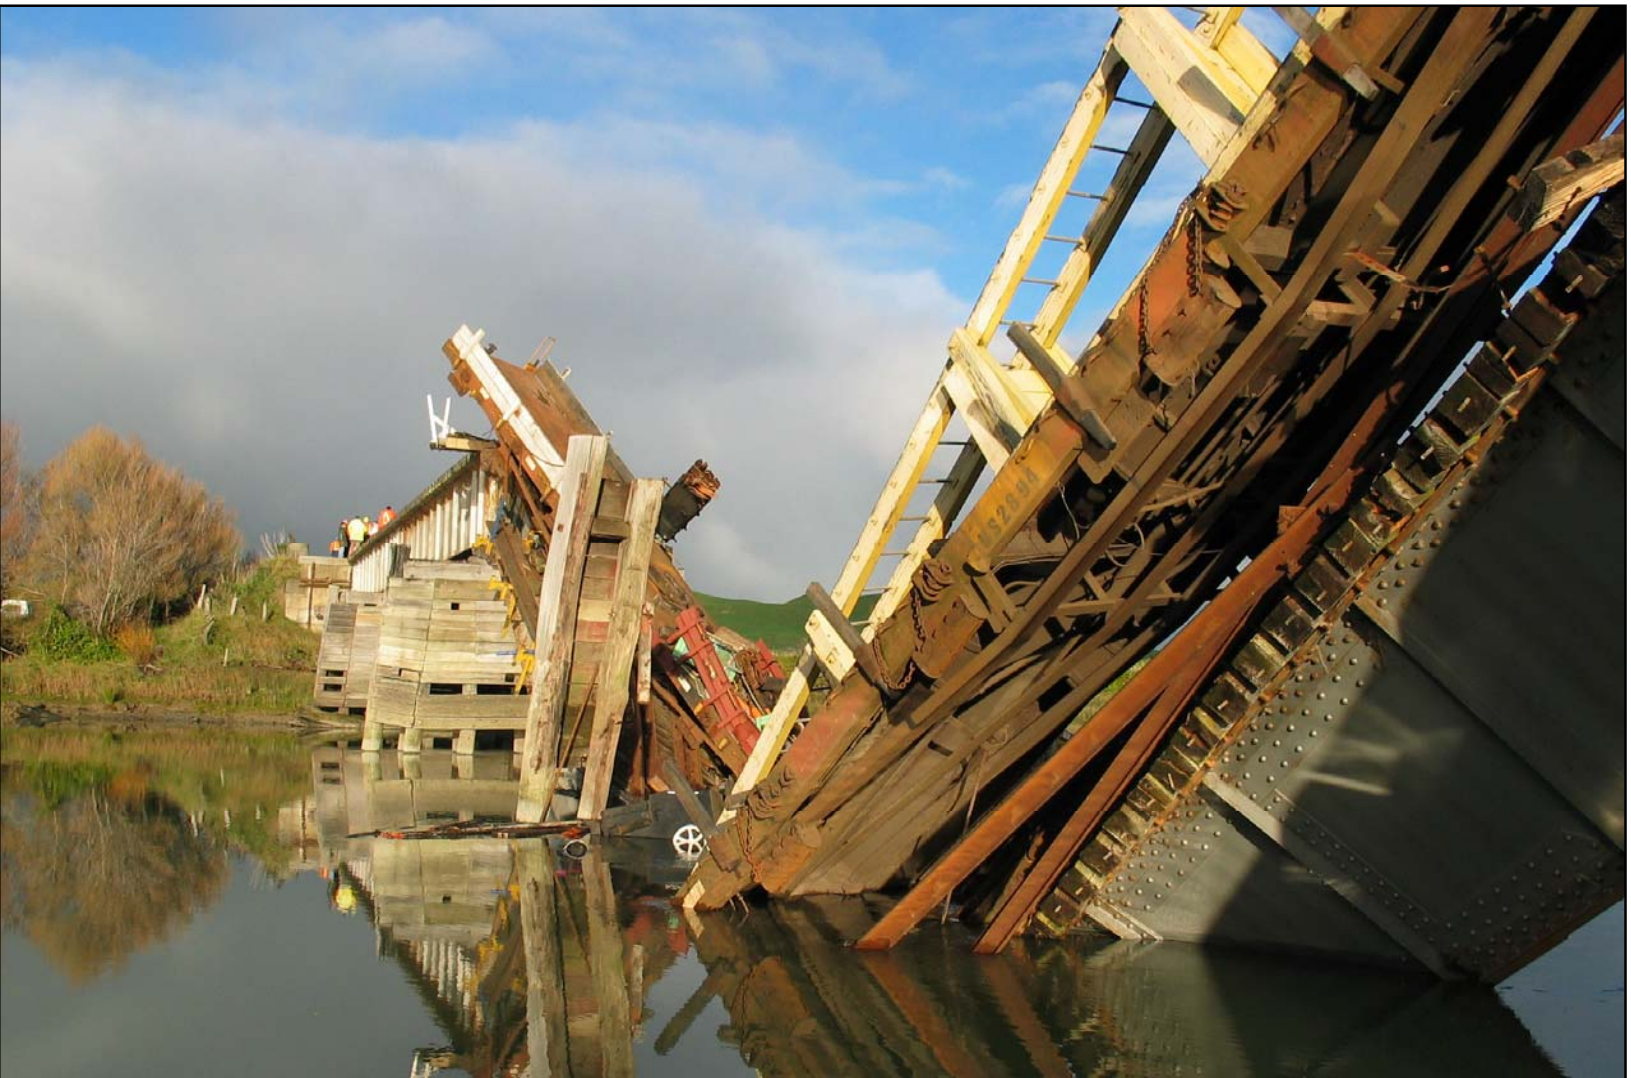
Collapsed Bridge 256

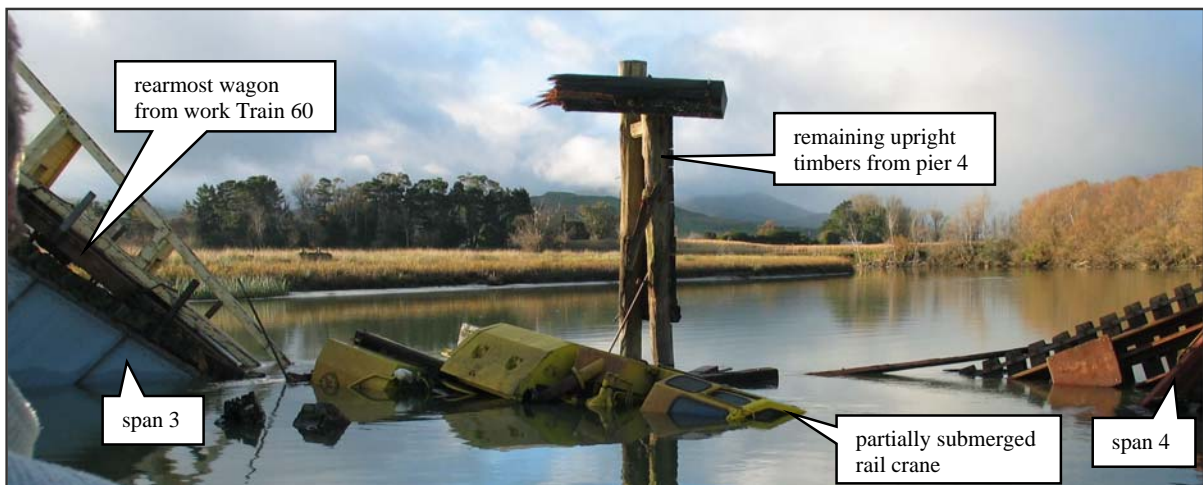
Figure 1
Bridge 256 following the collapse

- 1.1.6 After the 2 locomotives, 2 wagons of equipment and the first rail crane and its attendant wagon had travelled over pier 4, most of the pier collapsed. The ends of spans 3 and 4 that had been supported by the pier also collapsed.

- 1.1.7 The last 3 vehicles that were straddling spans 3 and 4 separated from the remainder of the work train. The trailing rail crane left the rails and fell into the river (see Figure 1). The 2 bridge spans, each still supporting a wagon, came to rest at opposing angles, with the ends that had been supported by pier 4 lying in the water. Nobody was injured.

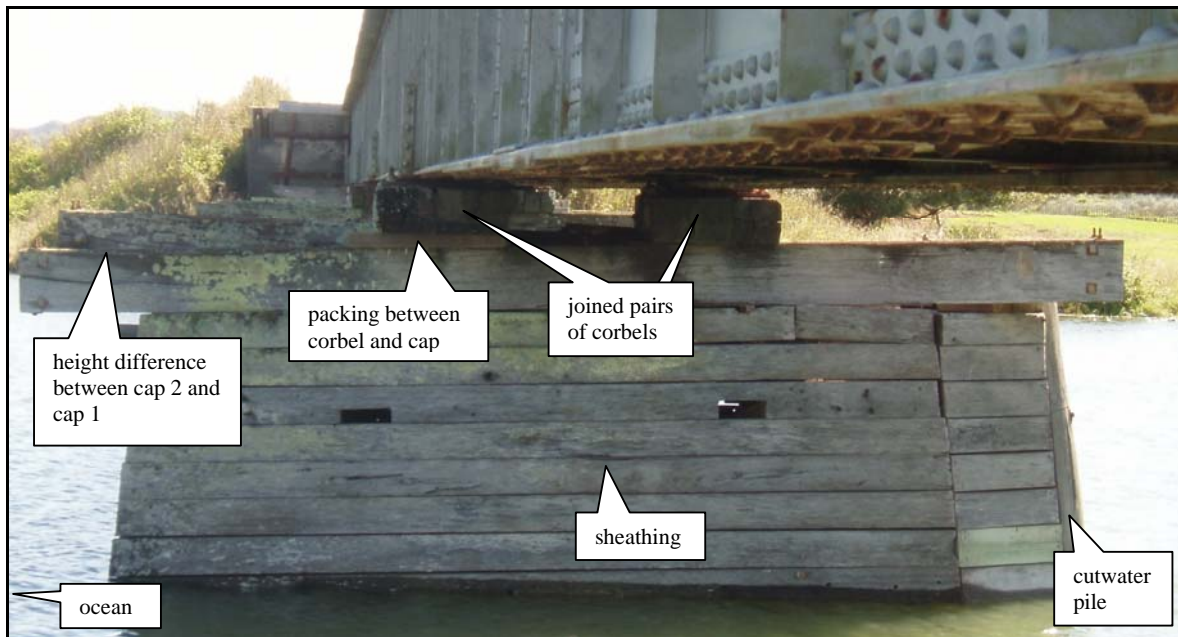
Figure 8
Pier 4, looking south
 (courtesy of Ontrack)

- 1.2.14 A single, non-load-bearing cutwater pile was driven upstream of the intermediate piers to form a bow to deflect any driftwood carried by the river (see Figure 8). Piers 3 to 6 were sheathed in timber to prevent any driftwood fouling the internal area of the pier structure.

- 1.2.18 Bridge 256 had not been subjected to any major rebuilding during its lifetime, although over the years a few of the bridge piles may have been stumped⁴ or replaced. In 1969, the cutwater pile on pier 4 was replaced following flood damage.

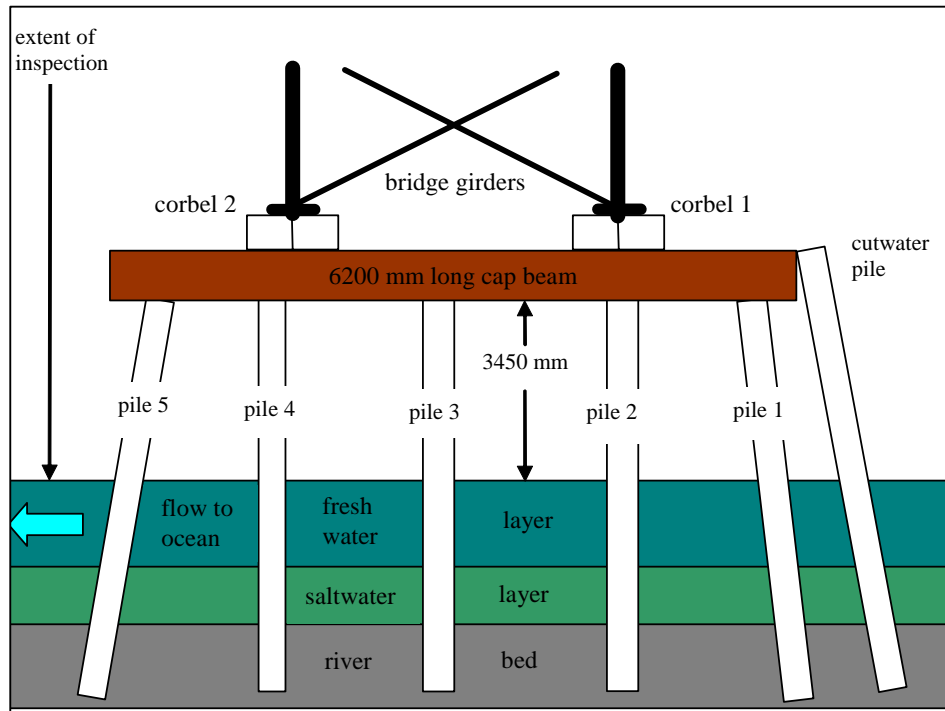
Figure 9
Elevation of pier 4 looking south (not to scale)

- 1.9.1 The most recent detailed inspection of Bridge 256 was undertaken on 17 July 2002. The structures inspector used the report of the previous inspection carried out by a different inspector in 1996, as the basis for the 2002 inspection.
- 1.9.2 The inspection report noted minor deterioration at the top of 4 piles in row 1 of pier 4 and deterioration in the cap. A supplementary inspection of pier 4 was scheduled for 2006 as a result of these findings. The deterioration in the cap had been detected by boring in the area where piles 3, 4 and 5 joined the cap (see Figure 9).

- 1.9.3 On row 2 of pier 4, the 5 piles and cap were reported as unchanged from their 1996 condition. The report noted that both pairs of corbels had been replaced in 1997 and were in sound condition. None of the 11 piles, including the cutwater pile, had dates or lengths chiselled into them that indicated when the piles had been driven, and the length the piles had been driven at installation.

- 1.9.5 No condition changes were noted since the previous inspection and the bridge was rated with an overall index of 2, but individual ratings on all the timber piles and caps were unchanged at index 4.

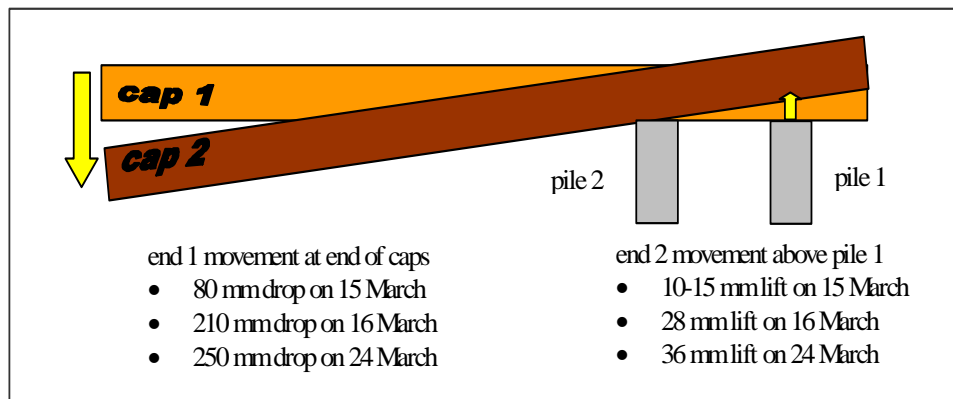
Figure 10
Amount of monitored cap movement above pier 4 (not to scale)

- 1.11.11 On Thursday 24 March 2005, the length ganger made a further inspection and found the track had again subsided above pier 4 and was slightly worse than when first recorded on 4 March. He estimated the track was 25 mm out of line and had 20 mm of cross cant. He reported this to the leading hand who passed on the details to the structures inspector. The leading hand returned to the bridge and drove the existing packers about 300 mm further under the corbels. He stopped the packing when the line and level of the track had been restored. The leading hand re-measured the height difference of end 2 of cap 2 and found it was now 250 mm below cap 1 and the gap between the cap and pile 1 had further increased to 36 mm (see Figure 10). The leading hand passed on these details to the structures inspector.

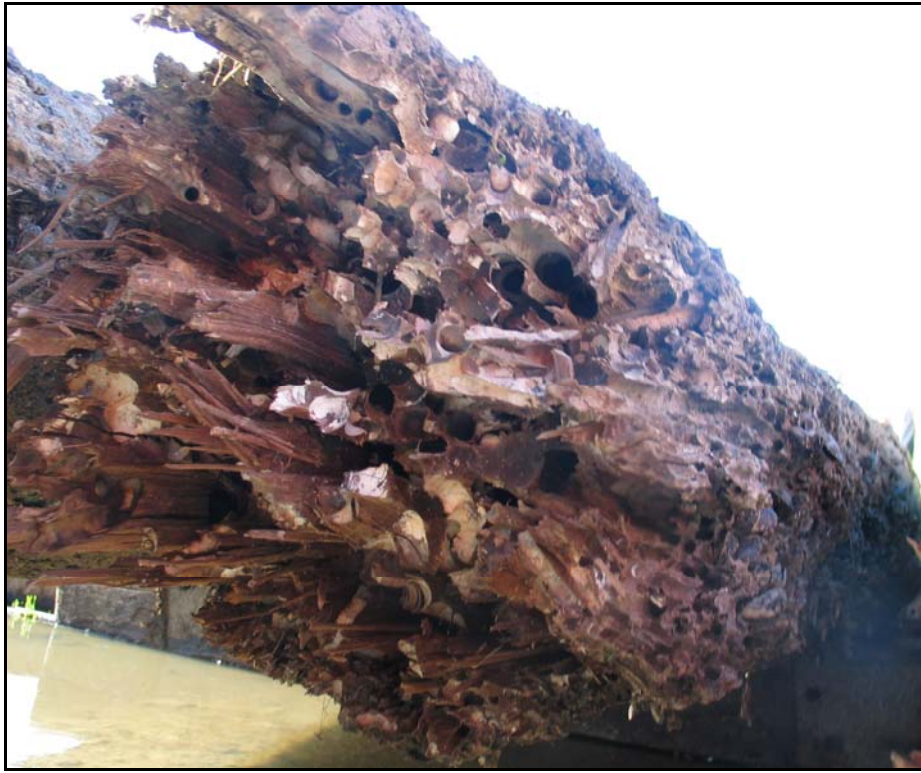
- 1.14.1 Following the collapse, the bridge piles were salvaged from the Nuhaka River and were transported to Woburn workshops and made available for inspection. Of the 11 piles that made up pier 4, 2 remained upright and were relatively unaffected by the collapse and one was never recovered. It was not possible to match the 8 retrieved piles to their exact positions within the pier 4 structure.
- 1.14.2 Severe infestation by invertebrate marine borer was evident across the 9 load-bearing piles and the cutwater pile (see Figure 14). Five of the piles had been eaten completely through by marine borers, and of the rest, little sound timber was left to carry the vertical loads.
- 1.14.3 On all the piles, the area of infestation was about one metre to 2 m below normal water level, 5 to 6 m below the pile tops and about one metre to 2 m above bed level.

Figure 14
Severely infested pile from pier 4
