Category Vehicle Exterior

Section	Exterior Panels/Trim	Market USA	Toyota Supports
---------	----------------------	------------	-----------------

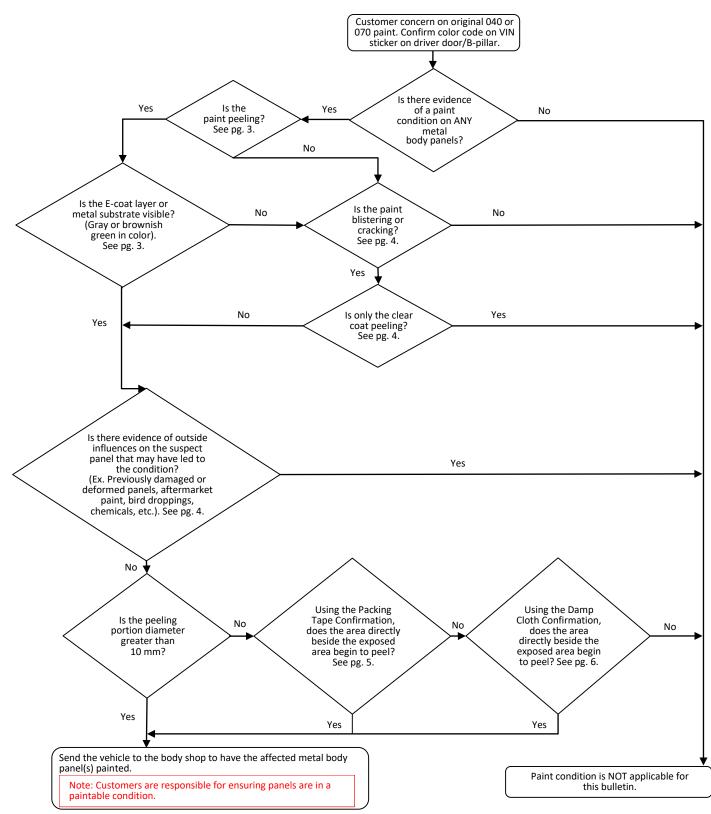
#### **Repair Procedure**

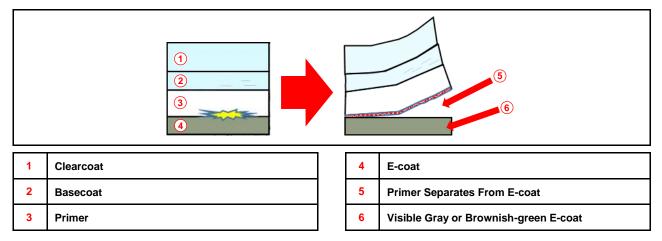
#### Figure 1. Exposed Substrate

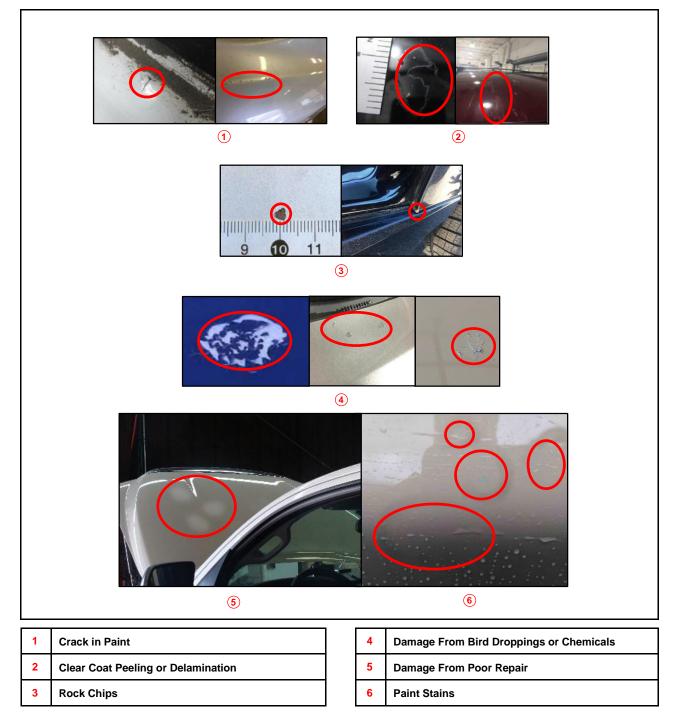
#### **Repair Procedure (continued)**
