# IKEN, ST BOTOLPH, AND THE COMING OF EAST ANGLIAN CHRISTIANITY

by S. E. WEST, M.A., PH.D., F.S.A. and NORMAN SCARFE, M.A., F.S.A.  
with a contribution by ROSEMARY CRAMP, M.A., B.LITT., F.S.A.

## IKEN CHURCH

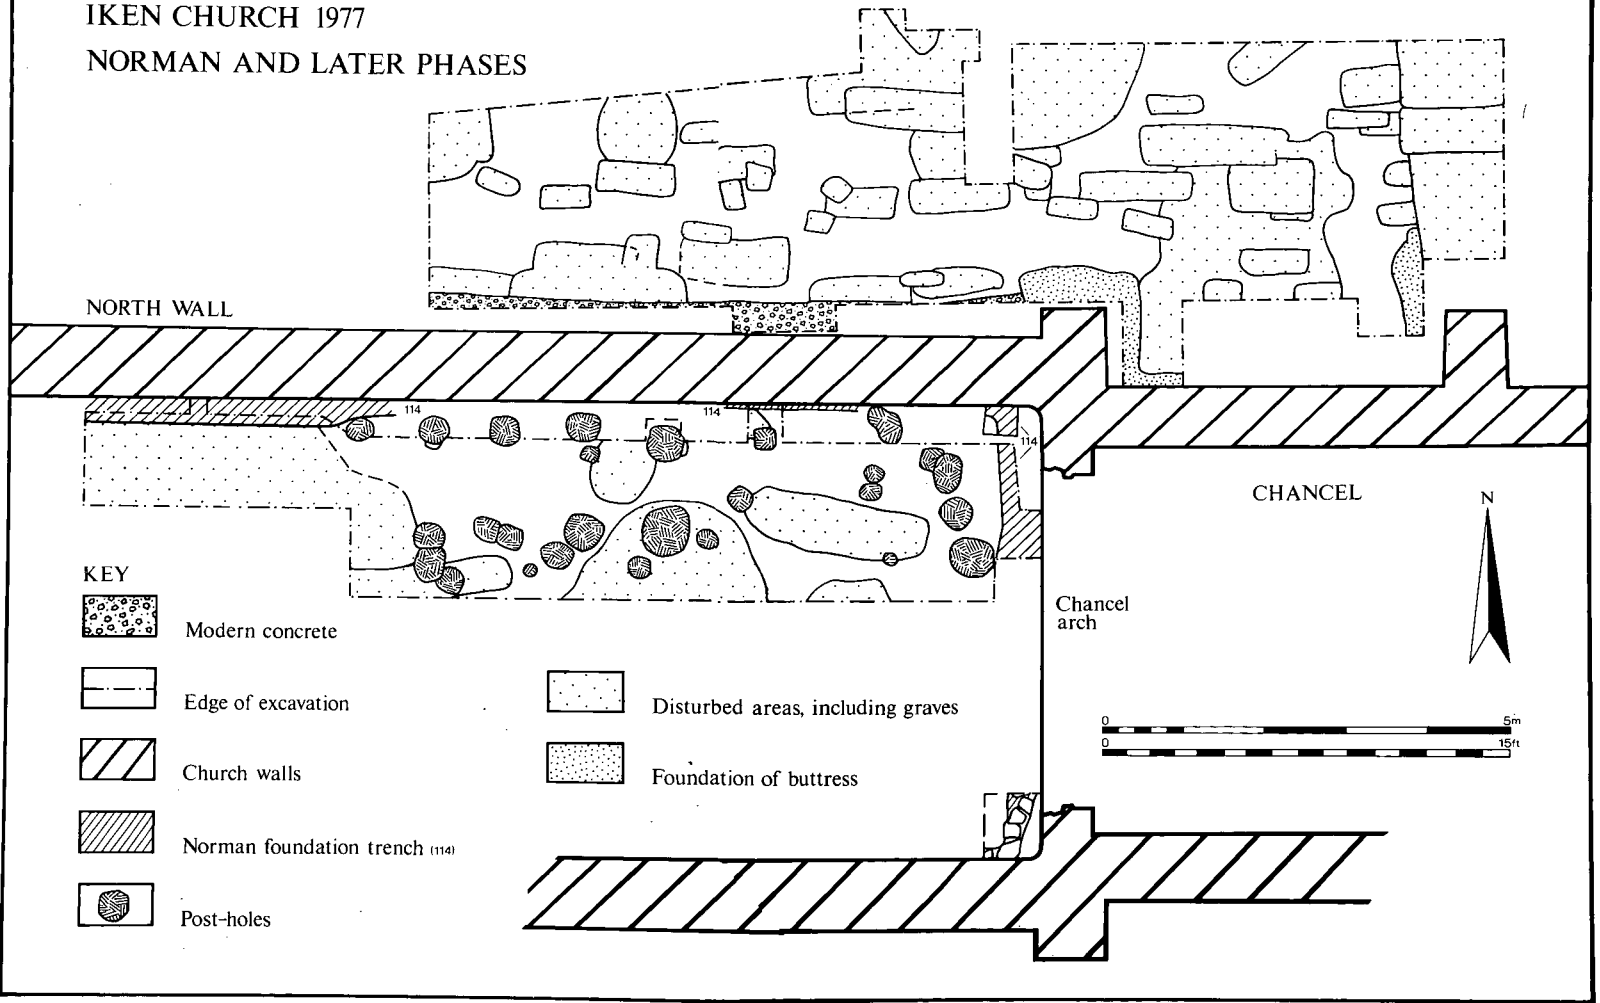
FIG. 73 — Iken church: Norman and later phases.

IKEN CHURCH 1977  
 NORMAN AND LATER PHASES

From the plan (Fig. 73) and the difference in the fills, it is possible to discern more than one phase for these features: the majority of the post-holes were filled with a greenish/grey or blue clay, sometimes mixed with sand. Three had a yellowish clay with sand and traces of mortar and two had sand and mortar only. In the case of the latter five post-holes two were cut by post-holes with blue clay in their fills. At the western end of the excavation no post-holes were found, but there were large areas of disturbance, possibly later than the post-holes. Only in one area, toward the east of the series, is there a break in the pattern, suggesting that the grave (004), in that position, was later than the post-holes.

foundation trench was 50cm from the edge of the 15th-century chancel arch. The width and nature of the foundation trench at the crossing suggests that the original Norman opening had been much narrower. The trench itself was steep sided, 1.5m deep beneath the lowest layer of septaria blocks of which the nave walls are constructed. The filling of the trench consisted of a series of layers of rounded flint pebbles, of average size 3 x 2 x 2cm; sand and septaria and hard packed yellowish-brown and blue clay, with rounded flints and septaria. The mortared septaria forming the core of the wall could barely have penetrated the original ground surface.

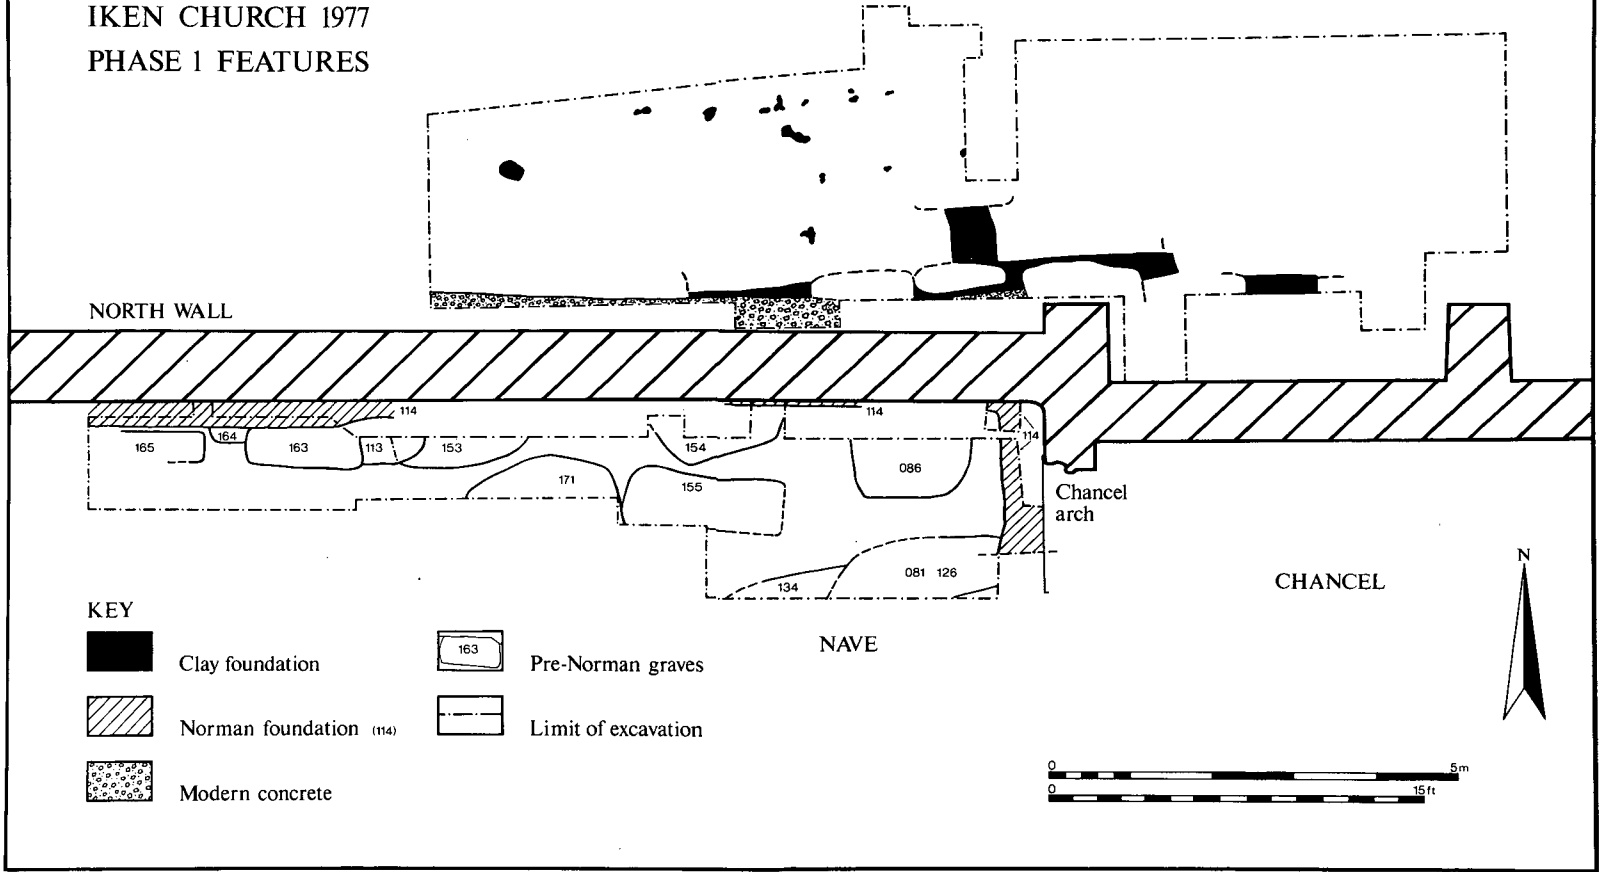
FIG. 74 — Iken church: Phase I features.

IKEN CHURCH 1977  
 PHASE I FEATURES

At 58cm from the surface the excavation was narrowed and taken down a further 28cm to clarify suspected further graves. A series of graves were identified (Fig. 74), some of which were cut by the Norman foundation trench for the nave wall. (Graves 165, 163, 113; cutting 168, 164 and 153; 154 and, by the chancel crossing, grave 126 cutting 134).

In the trench to the north of the nave wall a number of lumps of yellowy-green clay were found at a depth of *c.* 30 to 35cm from the modern ground surface. Their distribution can be seen in Fig. 74. At 70cm from the surface larger areas of yellow-green clay were found, close to the nave wall. Although badly cut about by graves and, at the extremities, totally destroyed, enough remained to show that there had been two shallow, clay-filled trenches at right-angles to one another. The east to west feature (152) was 40cm wide, the north to south feature (151) 50cm wide. The east/west line was at an angle of 6° north of the Norman nave wall and, at the west end, was cut by the concrete plinth of the nave wall. The lumps of yellowy-green clay already noticed suggest that a similar feature had been destroyed by grave digging, some 2.3m from the main east to west alignment. In section the clay was 12cm thick, filling a shallow trench with sloping sides.

A further patch of similar clay (110) was found closer to the north wall of the chancel in an area much disturbed by burials. Although it could not be traced very far the fragment found appeared to be in its original position. Clay does not occur naturally on the site and it is important to note that the clay in features 151, 152 and the scattered fragments beyond is not the same as the yellowy-blue clay found in the interior of the church.

The clay was cut by the modern concrete plinth underpinning the nave wall so that it is reasonable to assume that the clay-filled trench predates the Norman nave and that it represents a foundation for timber walling. The projection to the north would suggest a side chamber, the north wall of which is perhaps represented by the line of clay fragments disturbed by later graves.

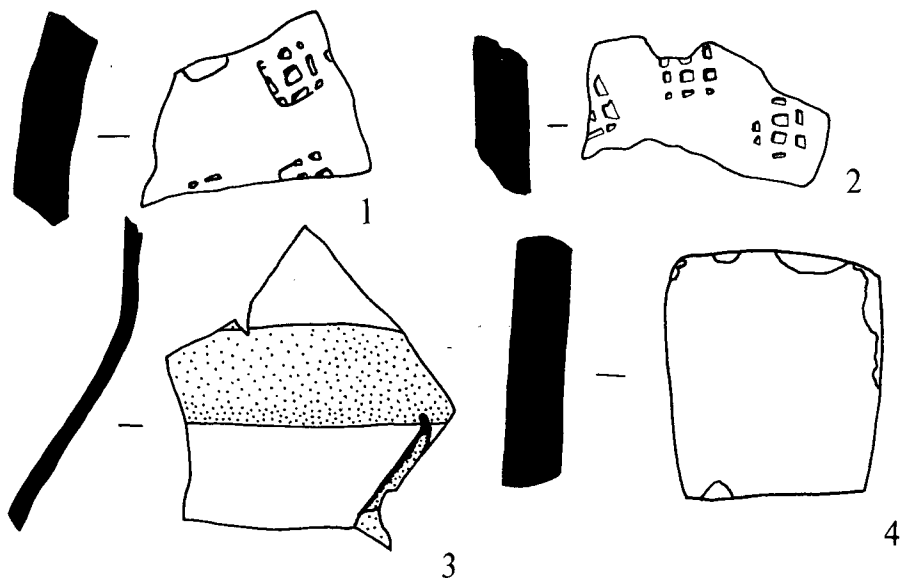
FIG. 75 — The finds: Ipswich ware; Saintonge ware and stone inlay.

- Fig. 75; 1, 2: Ipswich ware. Sandy fabric with rectangular, cross-hatched stamps. Possibly from same vessel, probably a spouted, lugged pitcher.
- Fig. 75; 3: Polychrome Saintonge Ware. Clear glaze, over green horizontal stripe and part of figure outlined in black. Two joining fragments, from general layer (040), 35cm above the natural.
- Fig. 75; 4: Rectangular slab of stone with main surfaces polished and edges chipped to shape. Green igneous rock, olivine with felspar crystals. From just above natural levels (084) in trench to north of chancel. Probably decorative inlay from a tomb.

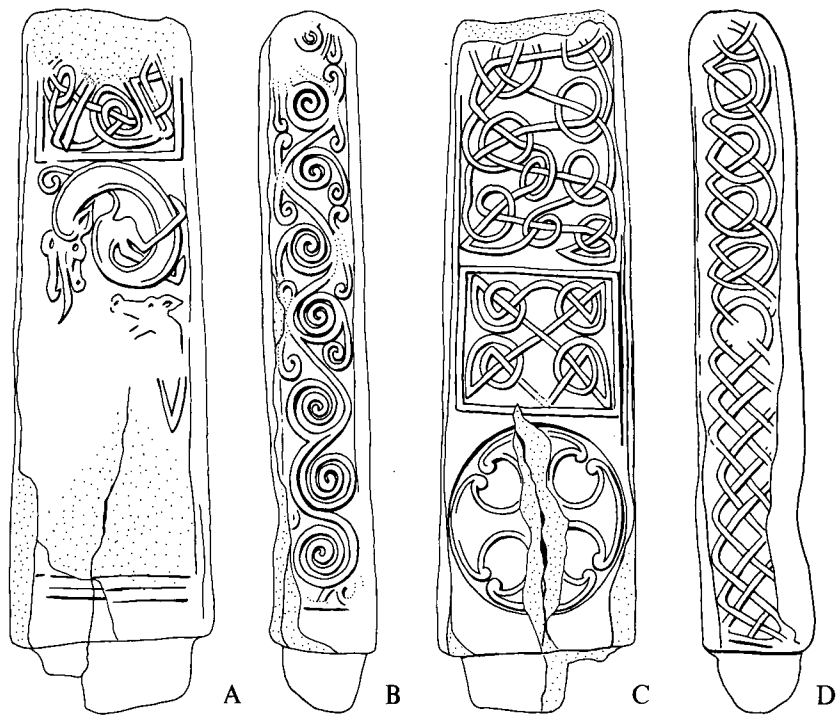
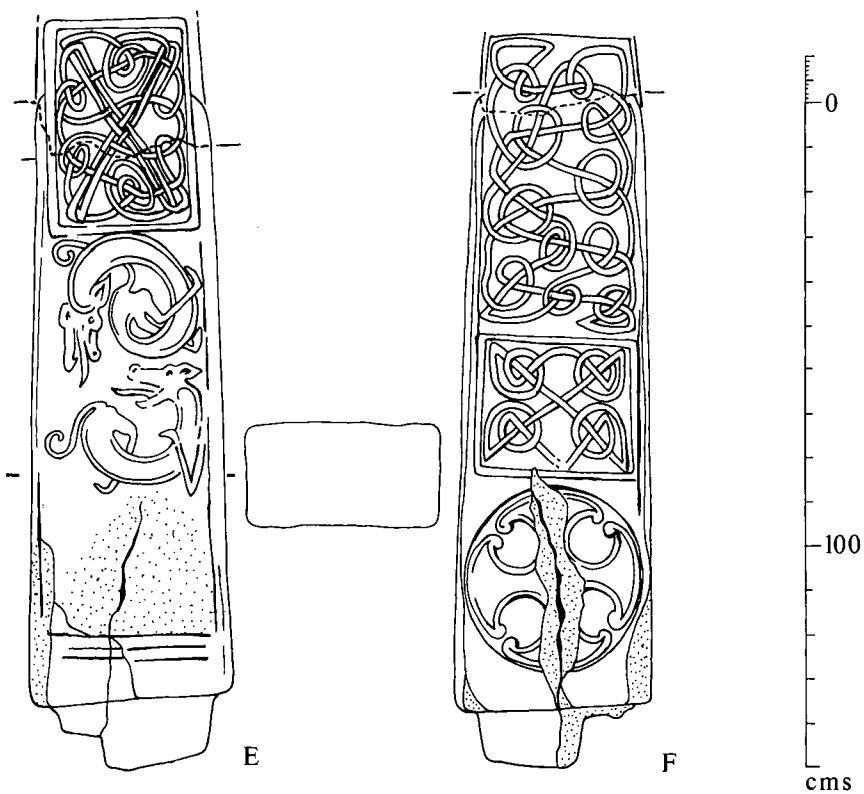
FIG. 76 — Iken cross-shaft: sides A-D as extant; E and F with suggested reconstructions.

The fragment consists of the lower part of a monolithic cross-shaft, rectangular in section and tapering slightly toward the upper, broken, end. The freestanding portion is 1.5m long, with a further 14cm of broken tenon at the base. From the proportions of the surviving piece, it is very likely that the complete cross was originally at least 3m high. The tenon has a rounded profile which appears to be original; presumably the base must have been a substantial block of stone. There is extensive damage; the broken upper end has a rounded, weathered appearance and the tenon has lost about a third of its mass. A long crack extends from the fractured tenon into the body of the shaft, plainly visible through the cross on side C and probably the cause of the deep flaking scar on side A.

- Side C : Two panels of interlace above an equal-armed cross. The uppermost panel is loose, poorly designed interlace although it does, in fact, work. It is enclosed by a single border which extends down to the second panel. This second panel is a more competent rendering of a simple knot design based upon a diagonal cross. Even so, although the design is understood, the execution is rather loose. The third design is of an equal-armed cross within a circle. Unfortunately the crack extends across the middle and the resulting flaking has destroyed the centre. The cross stands in relief against the background. Although well carved, it is not symmetrical, the left and right arms being of unequal widths.

- Side A : This side is extensively damaged. The top panel is incomplete, but has, within a heavy border like the middle panel of side C, a complex interlace pattern. Initial impressions of the design suggest that the main elements are two pairs of animal legs or beaks diagonally interwoven with ribbon interlace. An alternative solution is offered here (Fig. 8, E) which shows all the elements as part of a compacted pattern which works, but was not properly understood as a design. The central panel has clear animal ornament without interlace, a coiled, wolf-like creature, with open mouth and protruding tongue is facing downwards. Only the tail and rear limbs are depicted, under and over the body. The body is outlined; the pointed ear, nostril and eye clearly visible. Beneath this animal the surface is badly damaged but on the right side, beneath the first animal, part of the head and other members of a second can just be discerned with oblique lighting. The muzzle, eye and pointed ear are apparent, with a suggestion of the lower jaw and a pointed fragment lower down. The two animals are facing each other as part of the same design; there is no dividing frame. A suggested reconstruction of this animal is offered here (Fig. 76, E) as another coiled shape opposing the one above. Below this point the stone has flaked so that nothing remains of the lowermost panel.

- Side B : The upper part of this narrow side was that which was first seen in the east wall of the tower. The design consists of a tight running scroll with tendrils in the upper part where the scroll tends to degenerate into separate elements.

- Side D : The second narrow side has an angular interlace at the bottom, which becomes an untidy series of knots towards the top.

The reconstructions in Fig. 76, E, F, do not agree with Professor Cramp's interpretation but are offered here as an alternative view.

The cross is 1.5m high with a broken tenon at the base and is of slab-like section, which in other regions, such as Northumbria, would be considered a late characteristic (Fig. 76, A-D).

On one broad face, A, the ornament is weathered away save at the top where parts of two panels survive; in the uppermost which is surrounded by an inner roll moulding, seem to be the heads of two creatures, with long, beaked jaws with rolled tips, enmeshed in interlace. Below an elegant, confidently drawn ribbon animal with a coiled contoured body. It has a canine head with open jaws and extended tongue; its eye is lightly dotted and it has a pointed ear. Its hindquarters terminate in long spindly legs and a tail which passes under its body and terminates in a tight coil. The head of a second beast of similar type is just discernible below, but the stone has so flaked away that the rest of it is lost. The origins of such creatures in 7th/8th-century Insular manuscripts can hardly be in dispute and it would seem that the dog
