Lars Andersen's Timber Tramways

J D. Kerr * and M. M. Philpott †

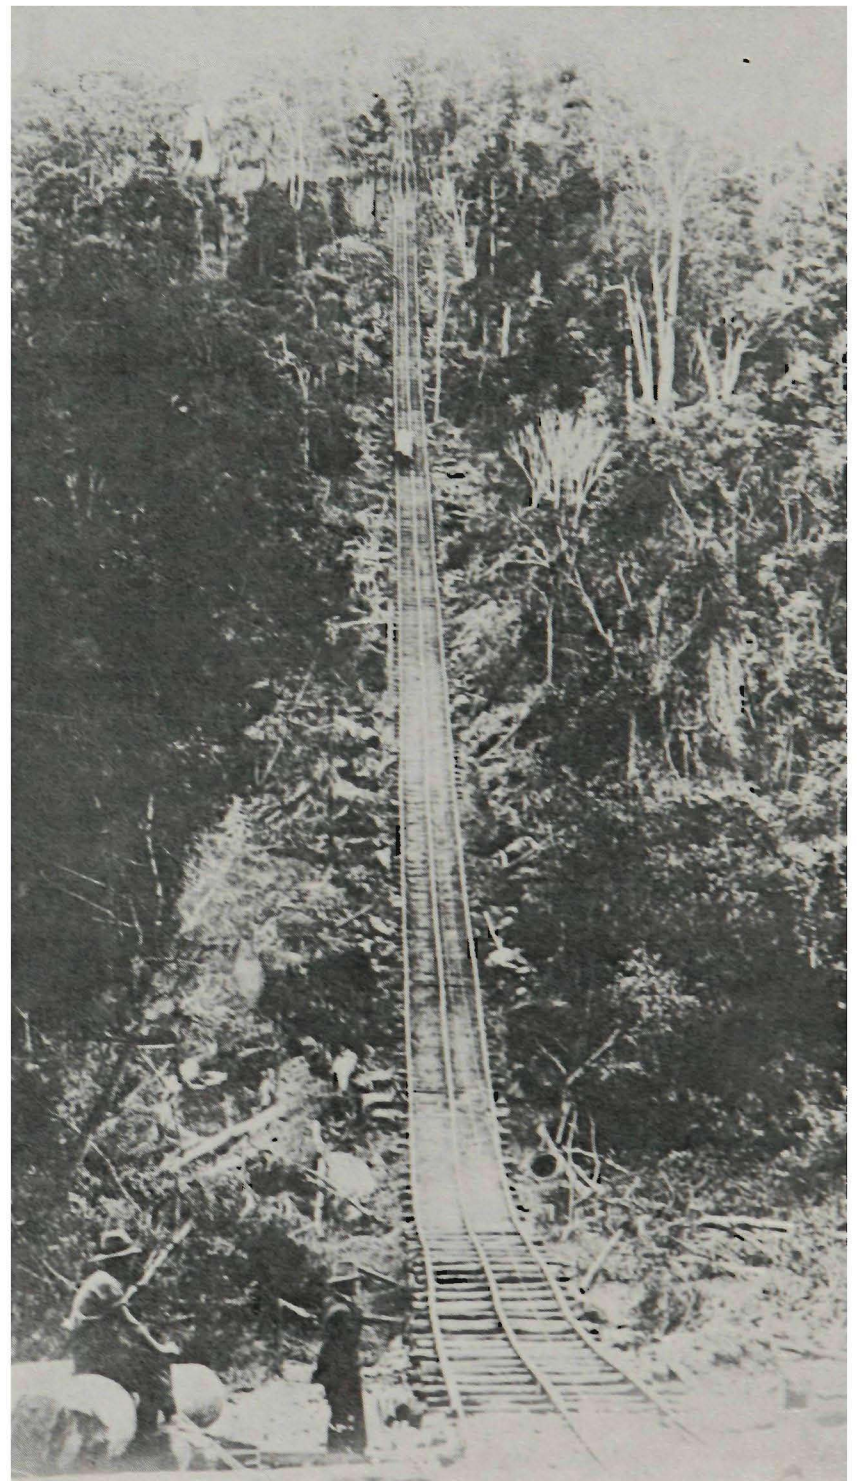
Cressbrook Creek Incline.

The major problem was the descent from Pine Cliffe down to the creek. This was achieved by a steep three-rail mountain tramway or incline operated by wire rope with the weight of the descending loaded wagon being used to pull up the empty wagon. There was a bridge over the creek at the bottom and a loading bank where logs were transferred to the ordinary tramway mentioned above. For those interested, further details of both tramway and incline are to be found in the Appendix.

The incline comprised a steeply graded track and two wagons, the weight of the descending wagon pulling up the empty one ready for its next load. The two were connected by a wire which ran around a drum at the top of the incline. The drum was fitted

with a braking device. For economy, the two wagons shared a common centre rail. The three-rail tramway first crossed the creek by a bridge on the level and then immediately began the ascent of the ridge with grade averaging at least 1 in 3. Half way up, the two tracks diverged slightly, the middle rail becoming two separate rails for roughly one hundred feet to enable the two trucks to pass safely. The mode of operation is illustrated, as is the braking device by which the man at the top of the ridge was able to control the descent. Skill was necessary owing to the danger of a runaway. The line was only thirty seven chains long but most of this was invisible from the top owing to the convexity of the ridge. The rails on the incline were also of wood but were spiked on to the sleepers instead of being wedged into a v-notch on the sleeper as on the flat valley floor section. The steep grade probably rendered this necessary for reasons of stability. During the construction of the line, the rails and sleepers were carried up the steep slopes on the backs of the workmen. A telephone was later installed to facilitate communication between ridge top and valley bottom. Stones were loaded into the empty truck when required to help balance the load, thus reducing the strain on the brake drum. The descent of eight hundred feet was accomplished in a matter of minutes.

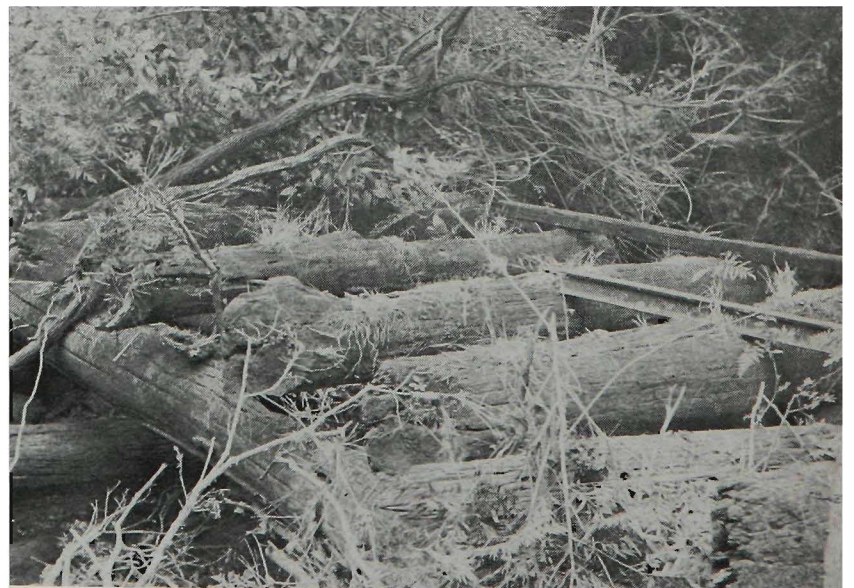
Bridge, Cressbrook.

The Pine Cliffe area was taken over by James Campbell & Sons around 1930. It is thought that the tramway passed out of use in the early 1930s. A flood in February 1931 washed out the bridge crossing over Cressbrook Creek but '... fortunately the tramline erected some years ago by Mr. Lars Andersen at considerable expense and later sold to Messrs. Campbell and Sons suffered little damage'. The bridge was evidently replaced for it still stands today.

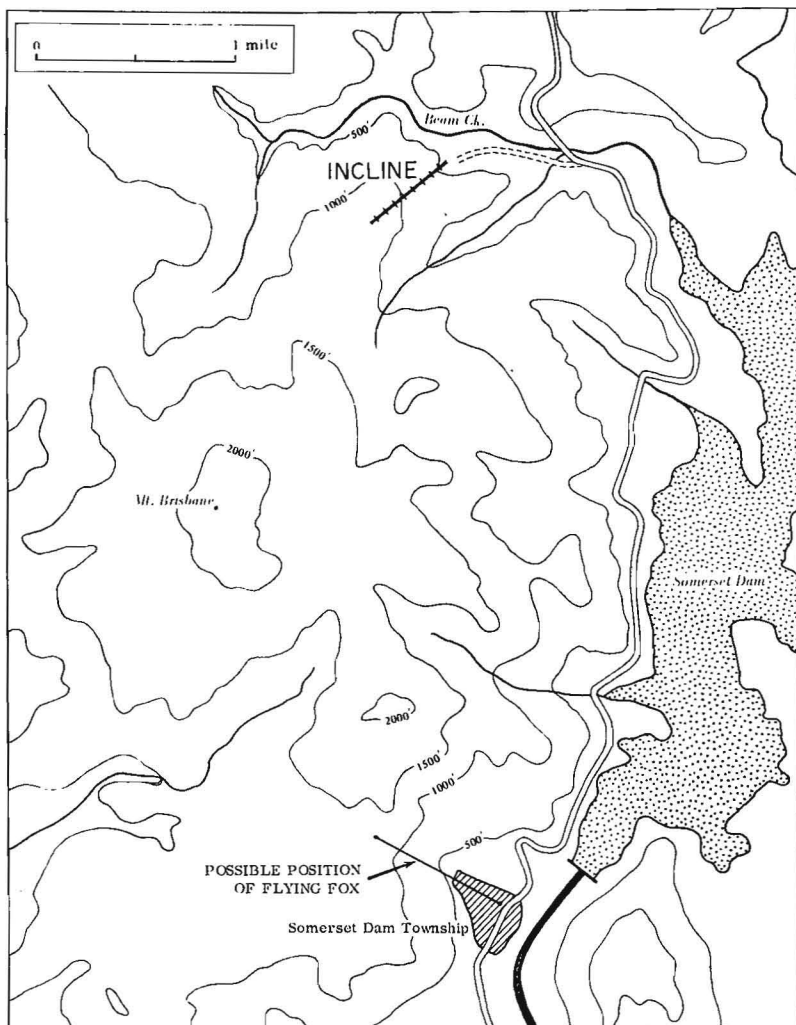
Beam Creek Tramway

Andersen also drew timber from an area near Mount Brisbane — about two miles west of the present Somerset Dam and a couple of miles north of the dam wall. There was a sawmill known as Mount Brisbane far up Beam Creek but this was closed about 1924 before the introduction of improved transport which enabled logs to be brought down the ridge and into Esk. Near Beam Creek, tapping the north end of the region, an incline tramway was built rising up from a small tributary of Beam Creek straight up a ridge, again rising about eight hundred feet in no more than half a mile. At the bottom end the logs were unloaded on to road vehicles to take the timber to the Esk mill. Eventually the tramway was superseded and a road built, enabling complete road transport which, however, was not without its problems — there was at least one spectacular runaway. At the south end of the area, the terrain was too steep and irregular for normal transport methods. No suitable slope could be found for a tramway and a flying fox was erected instead. It was supported by high poles at the top end and attached to a tree at the bottom. The wire was at one point one hundred and fifty feet above the ground and carried two twelve inch grooved pulleys which supported a log below the wire. The load was braked by means of a tail rope which was also used to return the pulleys to the top for further loads.

The loading bank and a distinctive three rail bridge were located at the base of the Beam Creek incline in 1971. This area has been much disturbed by the clearing of the land and subsequent erosion and growth of lantana so that the exact path up the ridge could not be followed. The summit is still noticeable as a more open space along the top of the ridge.

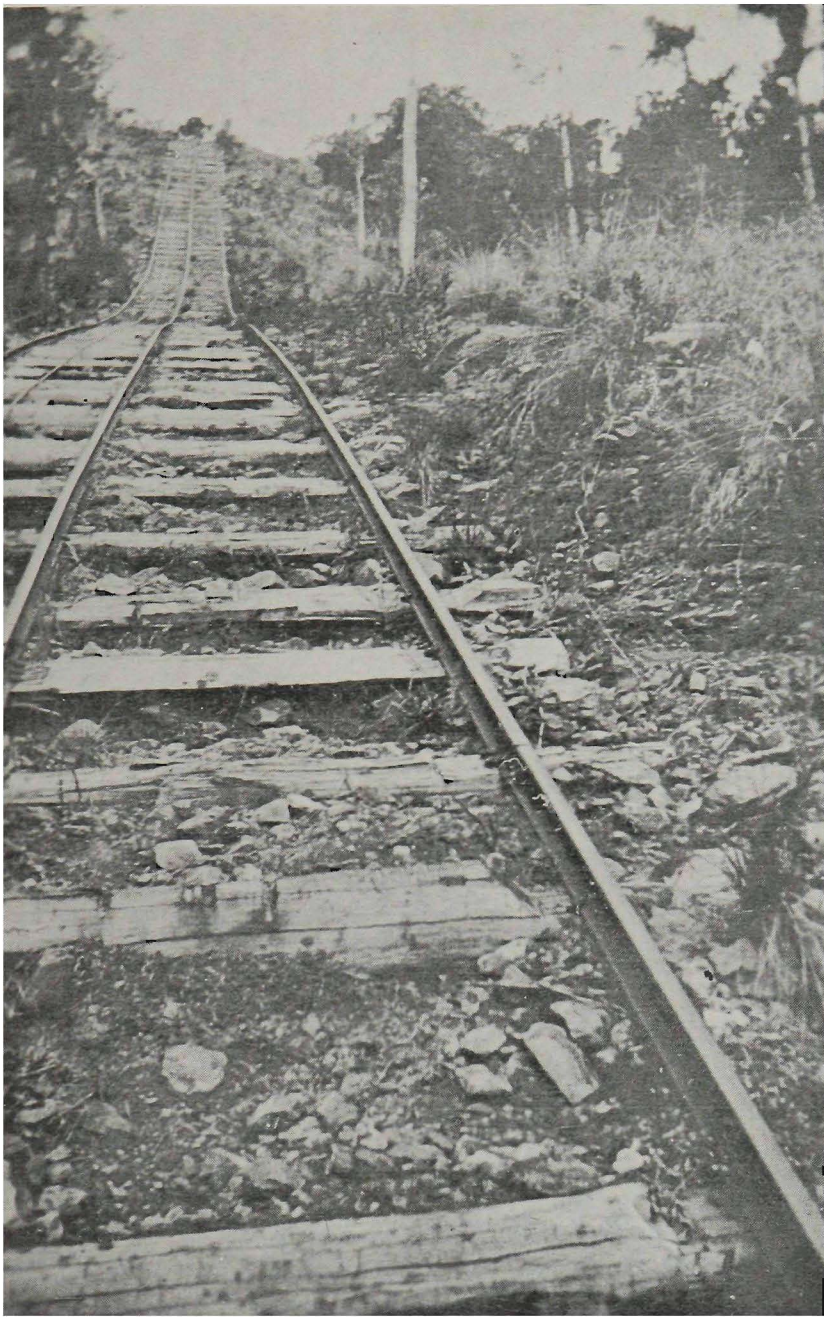
Bunya Mountains Incline.

The incline descended six to eight hundred feet in thirty three chains or so, but was not as steep as that at Cressbrook Creek. Again very few earthworks were provided, a fairly uniform grade being obtained by careful selection of the route which was straight from top to bottom. Steel rails were used for this incline. These came from the Queensland Box Company's line at Aribaby Creek via Moore, the transaction being a barter in return for butter boxes, according to Mr. Forsyth⁷. To ensure safe working of the incline, a gong was provided at the top and another at the bottom. When the wagon at the top was loaded and ready for despatch, the top gong was sounded. The man at the bottom gonged when the bottom wagon was unloaded and ready to return to the top. The unloaded logs were rolled on to the wagons on the tramway which, for convenience, terminated in a short low cutting. Later the gong (which could be heard 'for miles') was replaced by a telephone line between top and bottom.

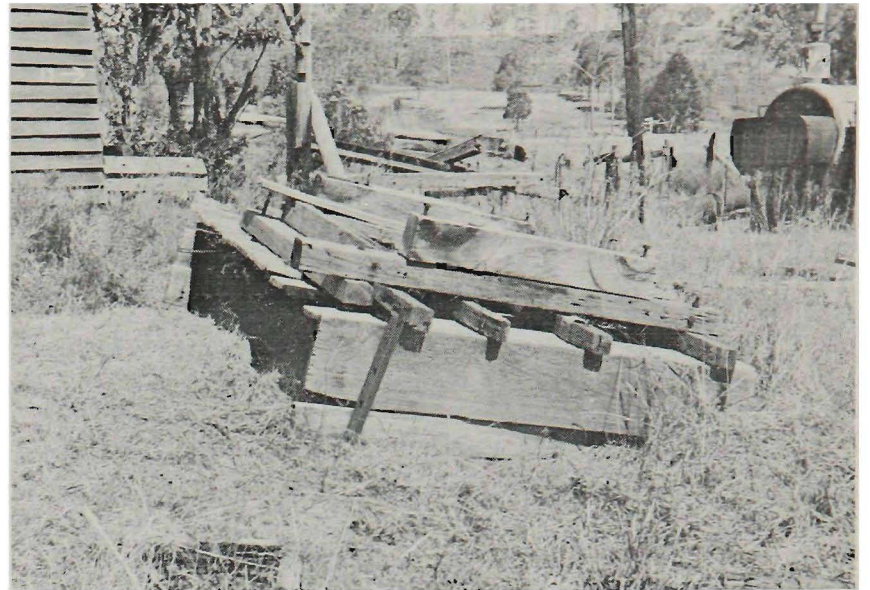
Old Wagon Body at Wengenville Sawmill — believed used on Bunya Mountains Incline or Tramway.

On a visit to the Bunya Mountains in October 1970 it was found that much of the tramway was clearly visible from the road and that much remained of two large bridges although both were in a state of disrepair. At the mountain end, the line runs through forest and many sleepers and wooden rails were visible, still held in place in some sections by stone and dirt ballast. The smaller bridges have vanished. Measurements showed the gauge of the tramway to be three feet. The incline site was easily located, including the passing section, together with a few steel rails left behind when it was dismantled. The summit is less than one hundred yards from the bitumen road which now climbs the range from the direction of Nanango. A few posts marked where the brake drum had been. At Wengenville, the remains of a four wheel wooden truck of approximately three feet gauge were found amongst the remains of the sawmill. This might have been used on the incline.

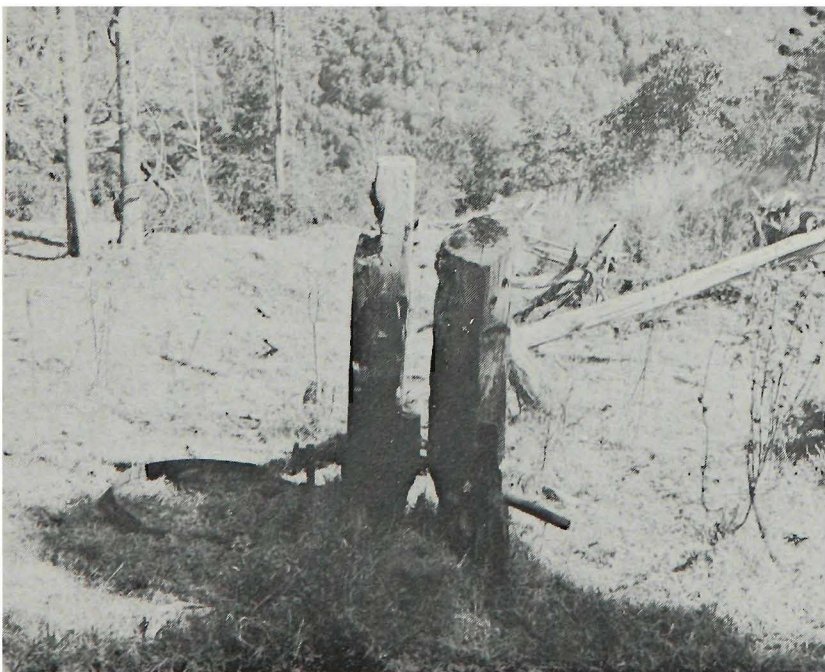
Posts at top of incline, Bunya Mountains, presumably held drum.

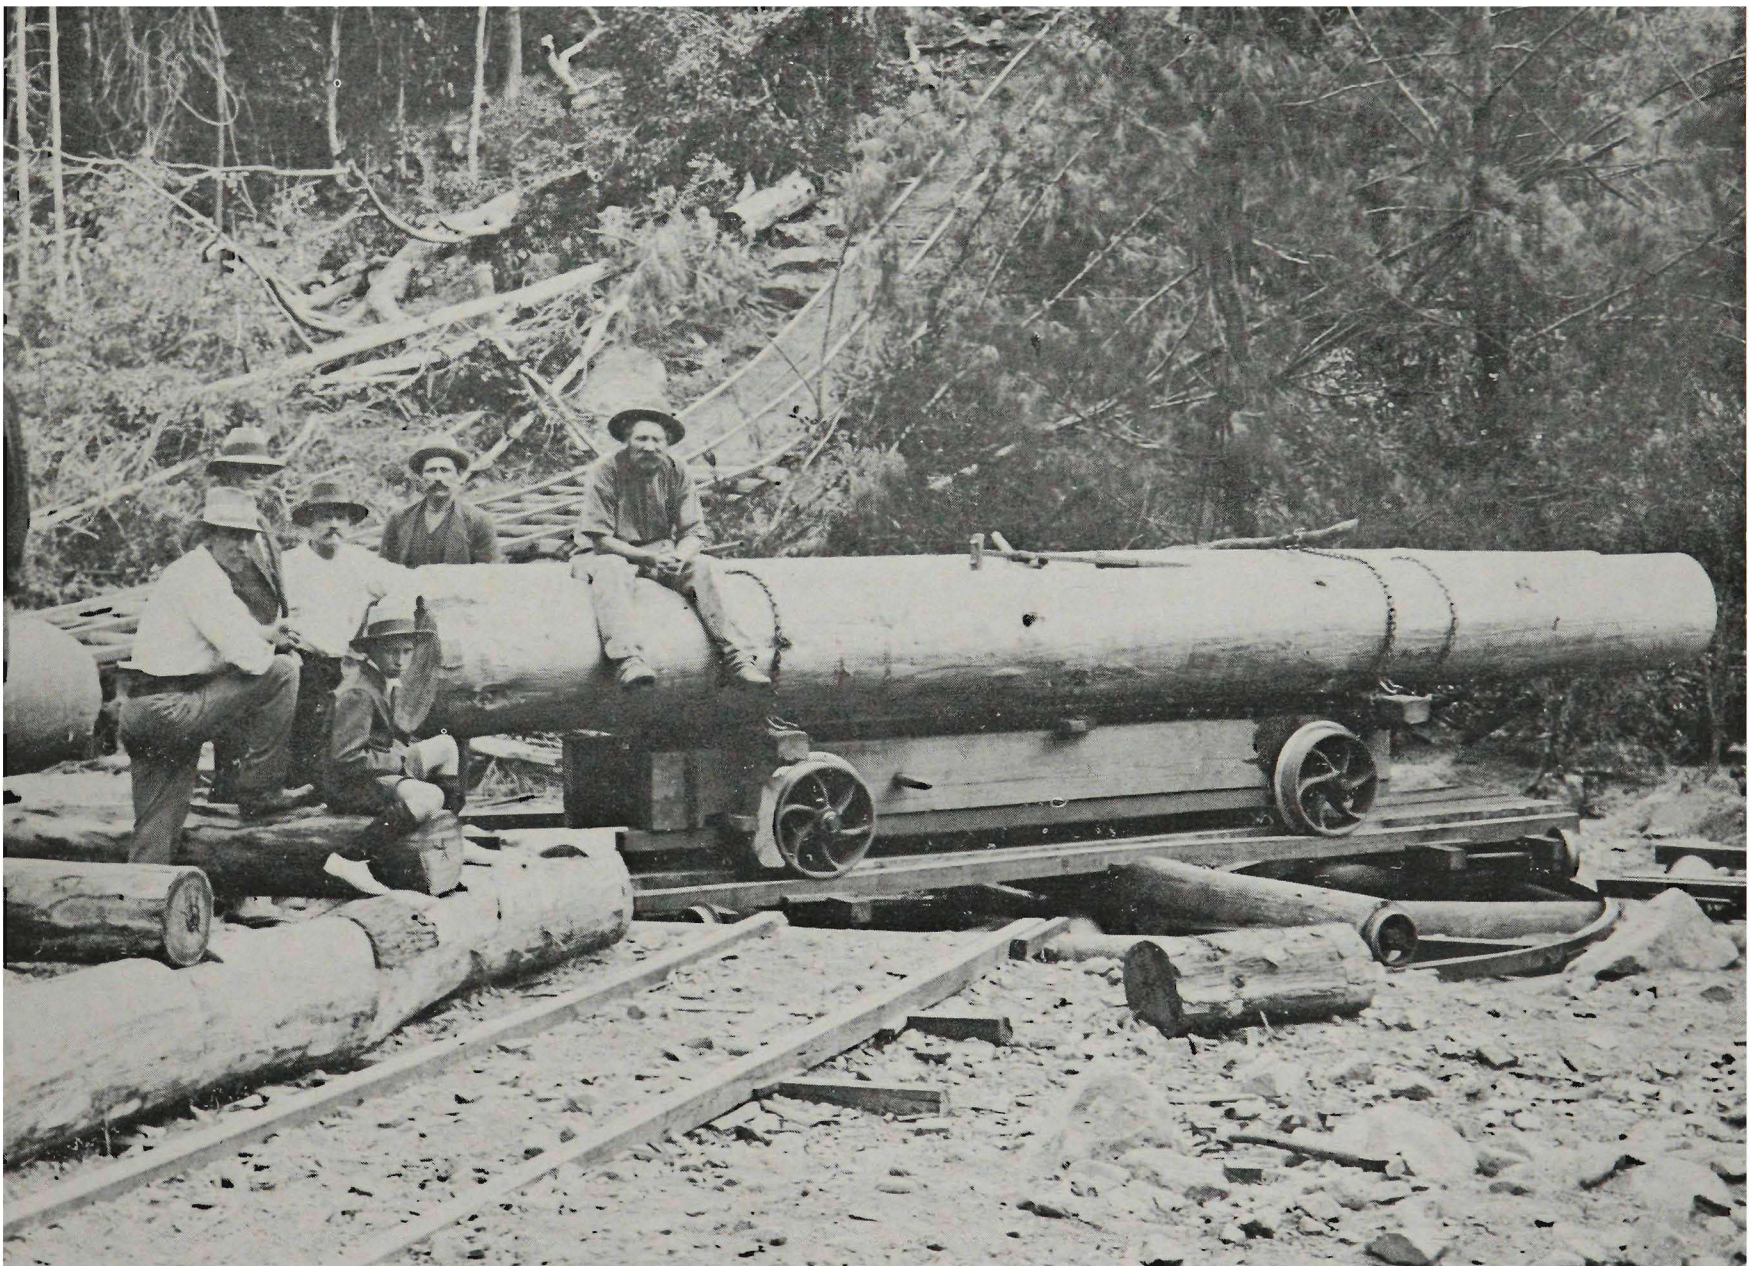
Turntable, Cressbrook Creek.

The tramline ended in a turntable, by means of which the need for a sharp curve (rather difficult using timber rails) was overcome. A short spur off the turntable at right angles to the main line ran beside a loading bank where logs were transferred from the incline, to complete their journey to the mill.

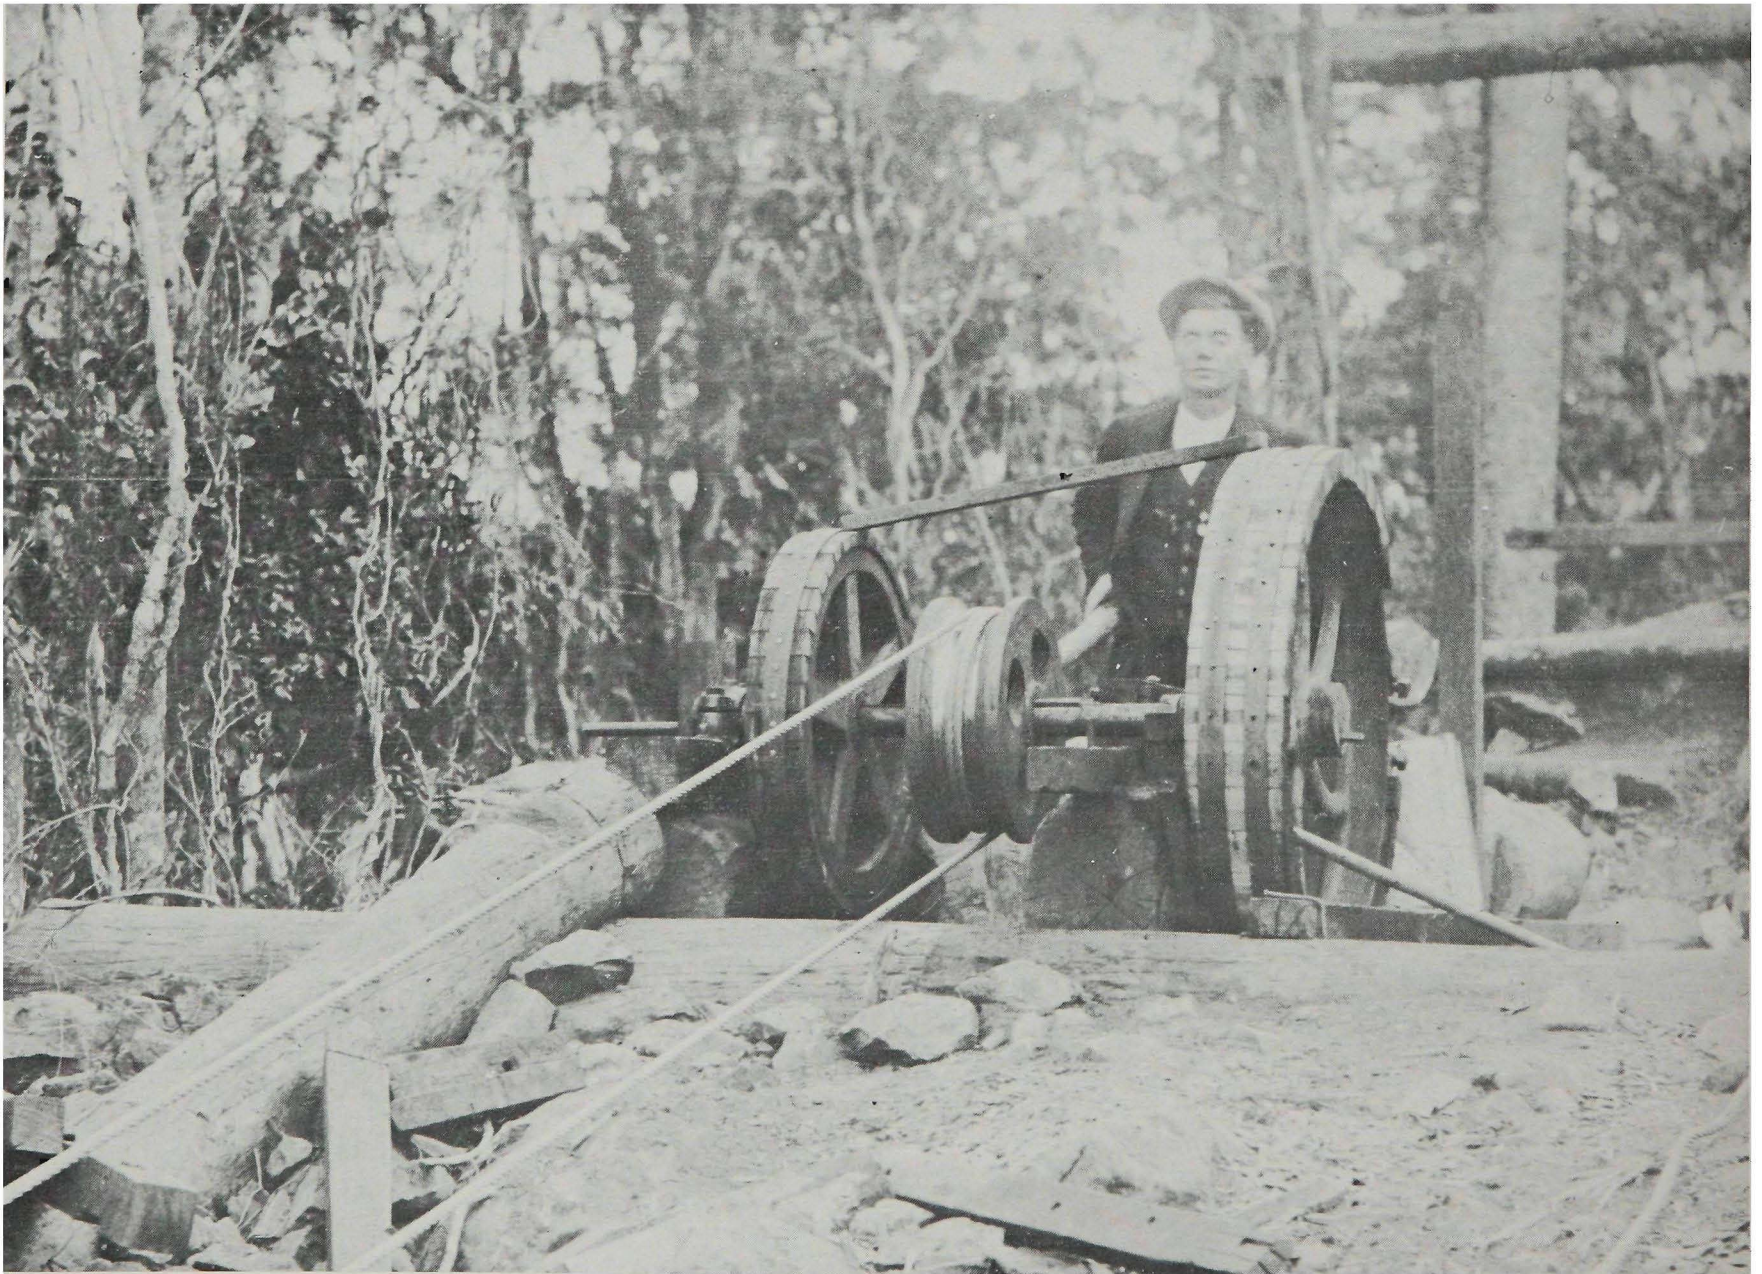
Braking Drum and Man in Charge, Cressbrook Creek.

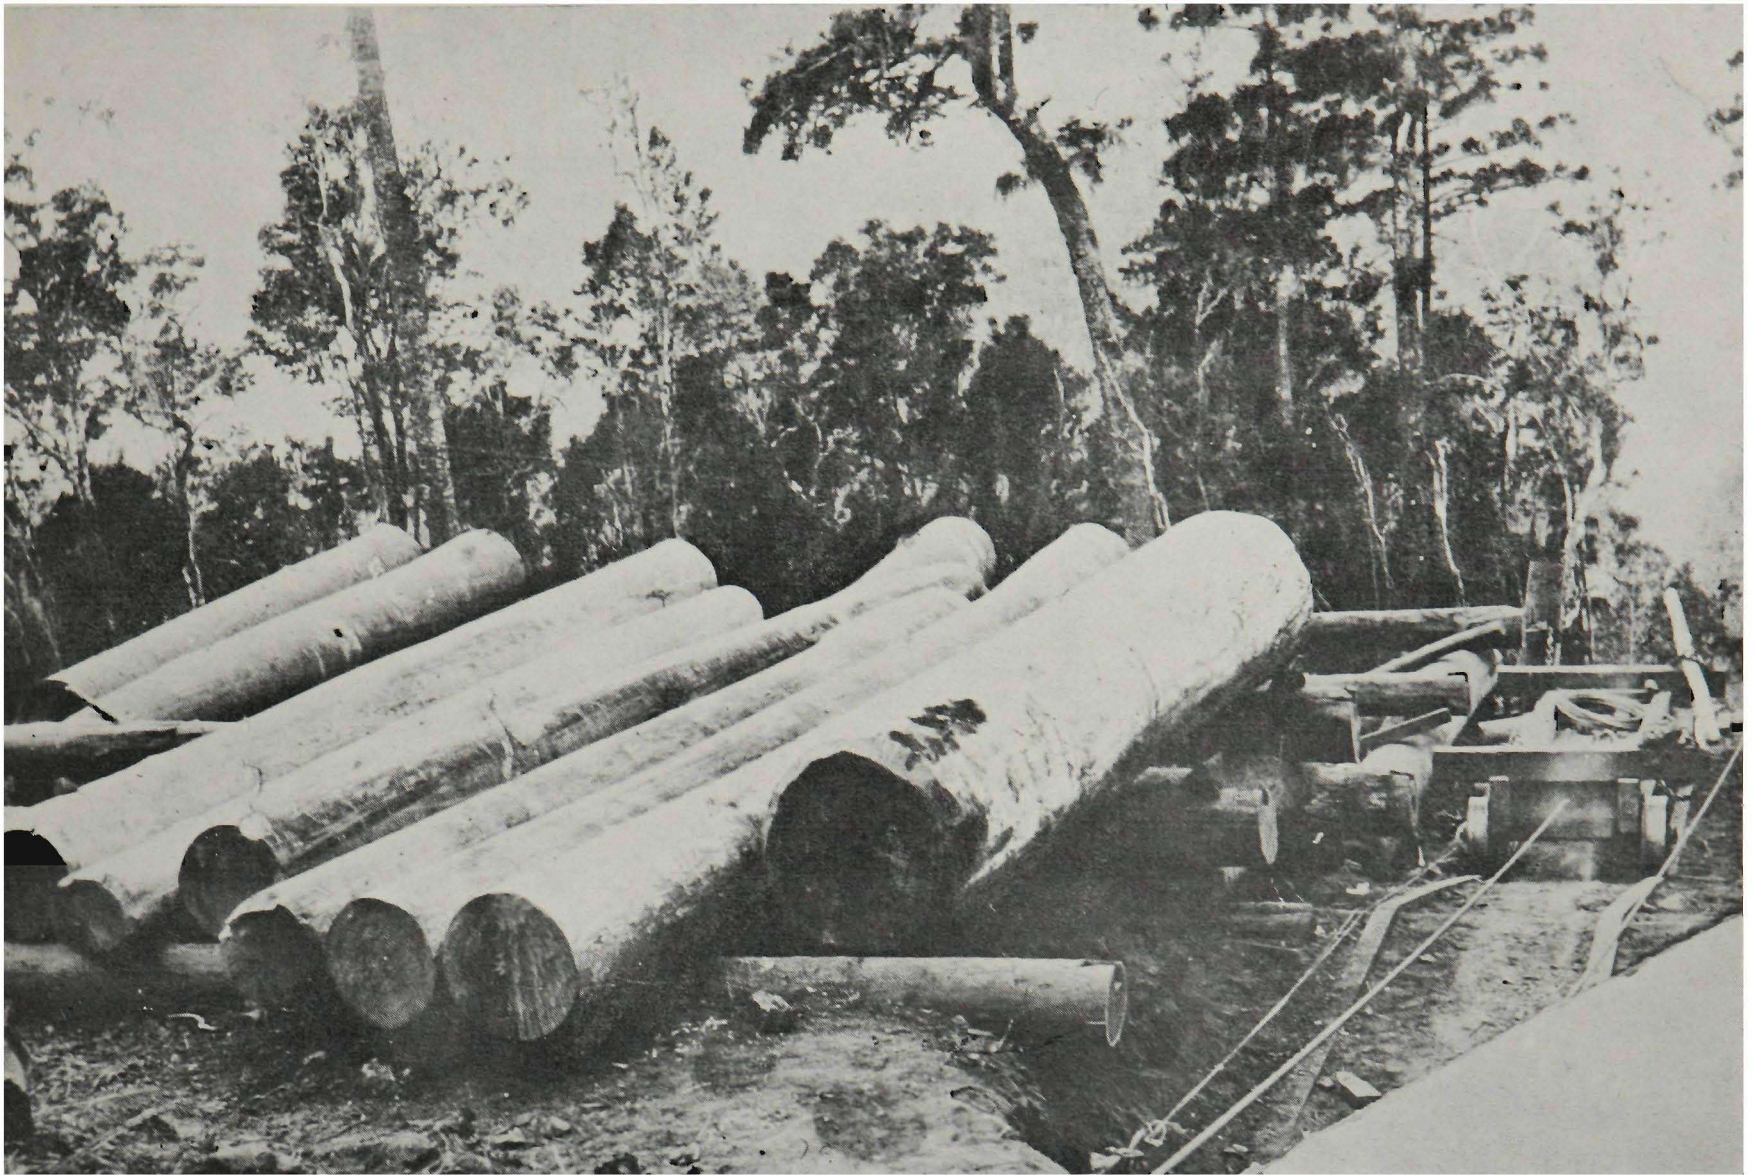
Log Ramp, Cressbrook Incline.
