## Incomplete understanding of biogas chemical hazards – Serious gas poisoning accident while unloading food waste at biogas plant

*Published in:*  
Journal of Chemical Health and Safety

# **Incomplete understanding of biogas chemical hazards – Serious gas poisoning accident while unloading food waste at biogas plant**

*At a biogas plant, a truck driver was overcome by toxic fumes while unloading food waste slurry collected at sites that operate a shredder and tank system. Trucks unload their cargo into a feedstock pit. While unloading, hydrogen sulfide, carbon dioxide and possibly other toxic gases were released. Ventilation systems were overwhelmed. The driver narrowly escaped death. Several would-be rescuers collapsed. Under marginally different conditions, this accident could have led to five fatalities.*

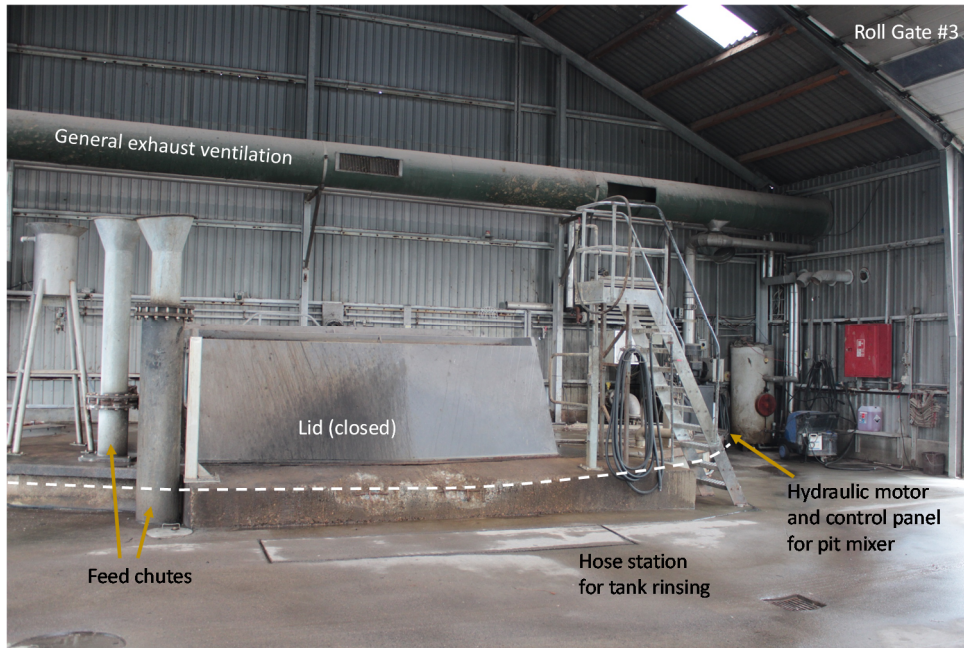
Figure 2 The feedstock pit with the lid closed. Feed chutes are at centre left.. Dotted line shows pit tank contour (Photo: Frank Hedlund)

Trucks use the #2 gate in the gable wall, reverse in and dump the cargo into in the feedstock pit (Figure 2). The pit has an actuated lid and continuous local exhaust ventilation. Road tankers use the side wall gates #1 and #3 and unload manure into the pit via a feed chute (Figure 3). The chute also has continuous local exhaust ventilation.

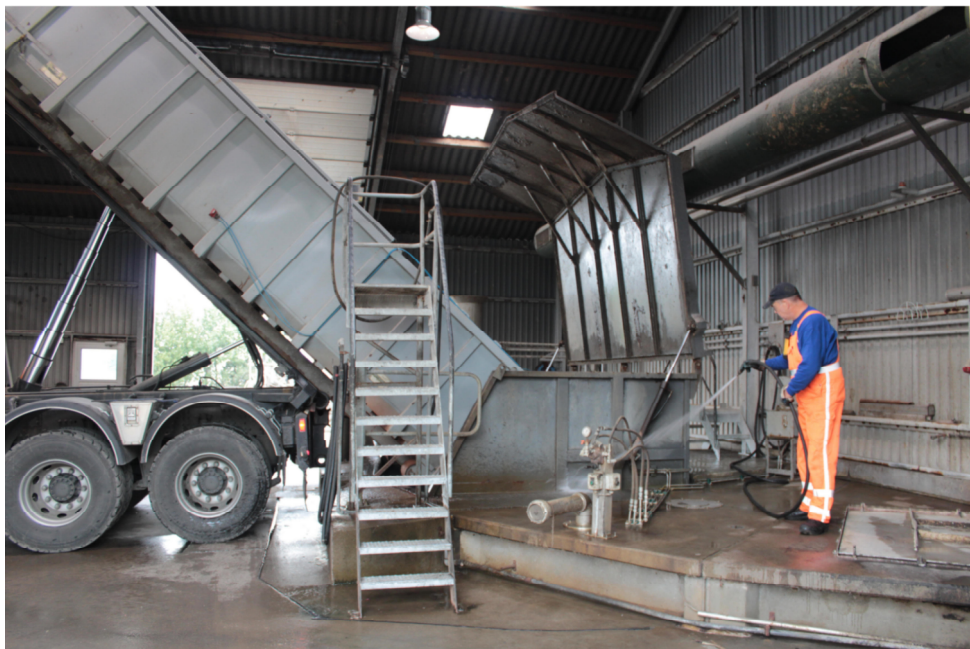
Figure 3 A container tank is hosed down after having unloaded pork abattoir offal (intestines) into the feedstock pit. Note the open lid. (Photo: Frank Hedlund)
